Facility Condition Assessment

June 2017

Austin T. Levy School, located at 135 Harrisville Main Street in Harrisville, Rhode Island, was built in 1958. It comprises 42,600 gross square feet. Each school across the district was visited three times during the Facility Condition Assessments by three teams of specialists in the spring/summer of 2016.

Burrillville - Austin T. Levy School

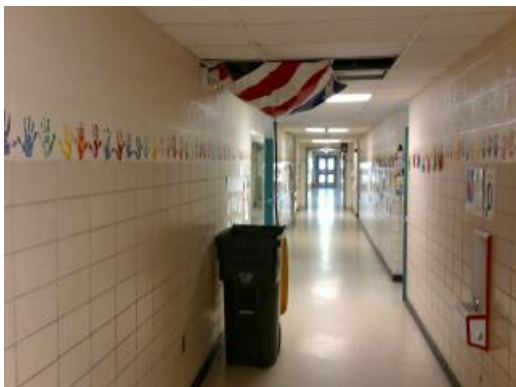
Roof Leak Damage To ACT

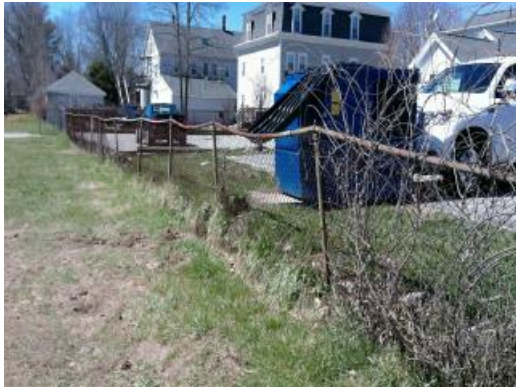
Damaged Fence

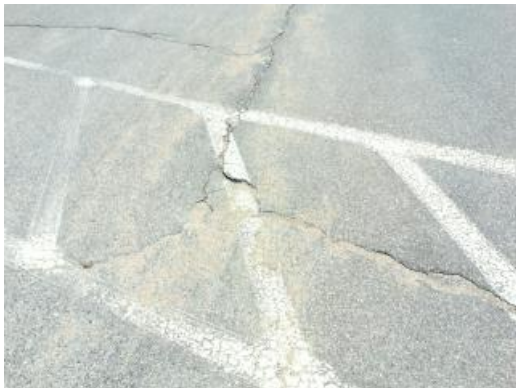
Cracked Pavement

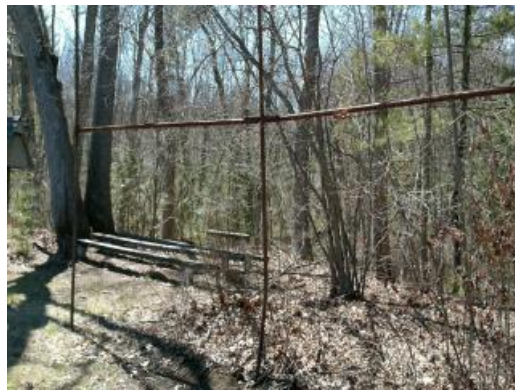
Rusted and Damaged Fence

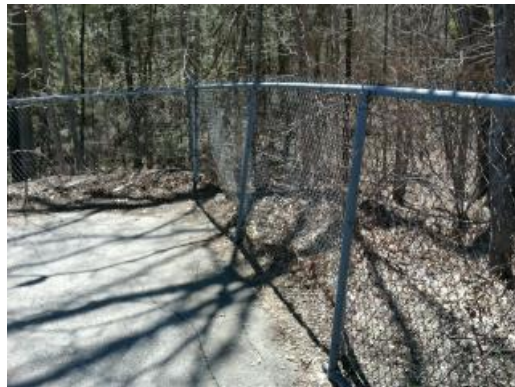
Damaged Fence

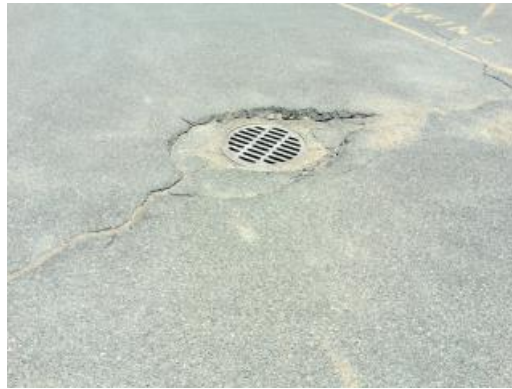
Parking Lot Damage

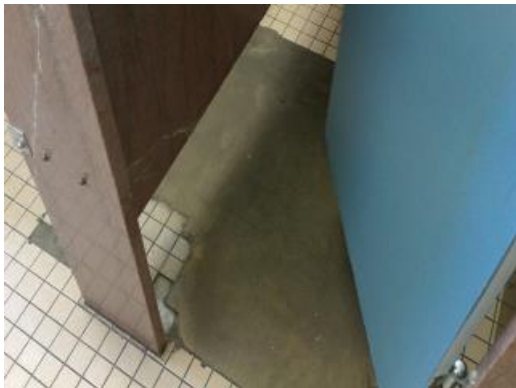
Damaged Ceramic Tile

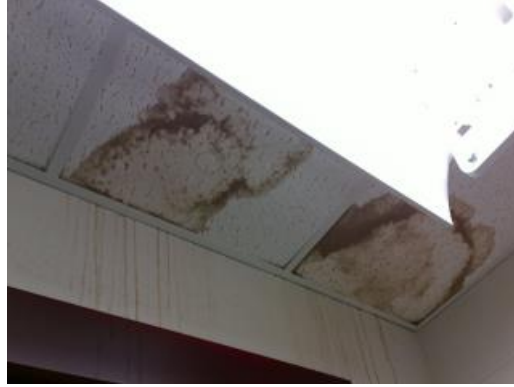
Stained Ceiling Tiles

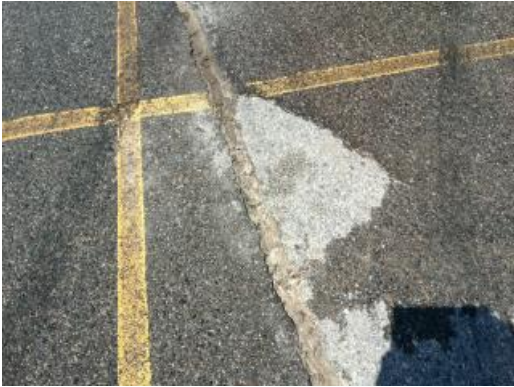
Worn Asphalt Paving

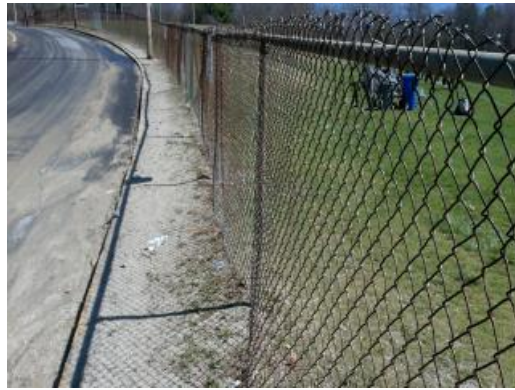
Rusted Fencing

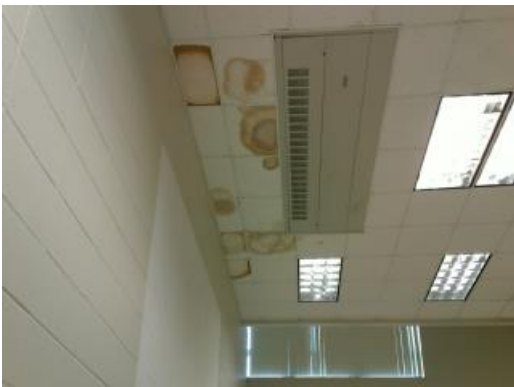
Stained Ceiling Tiles

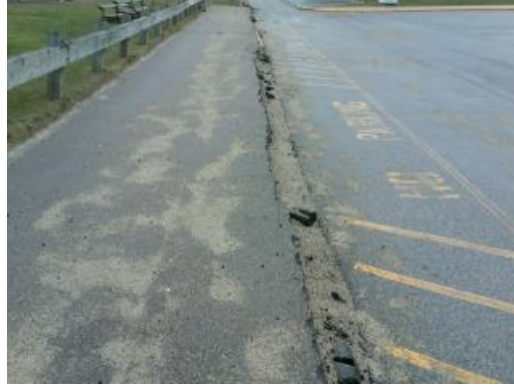
Damaged Pavement

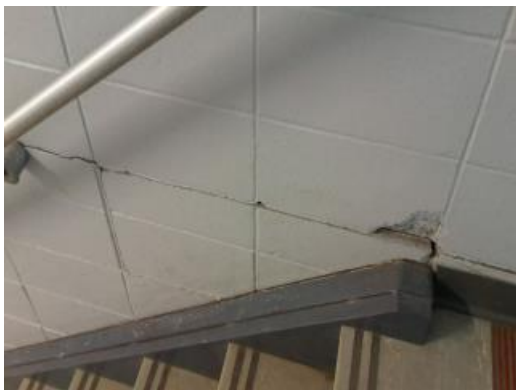
Cracked CMU

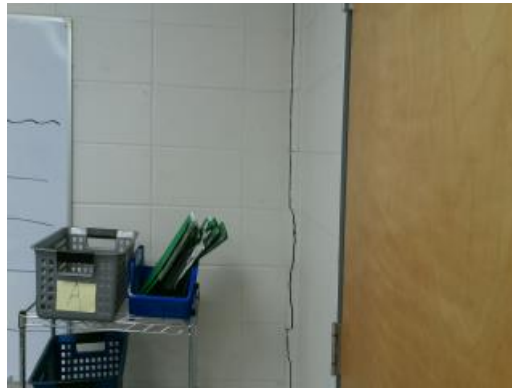
Cracked CMU

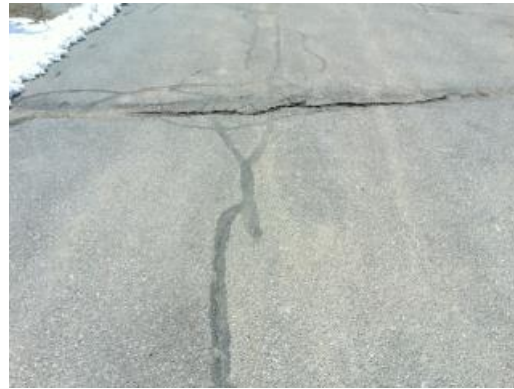
Parking Lot Damage

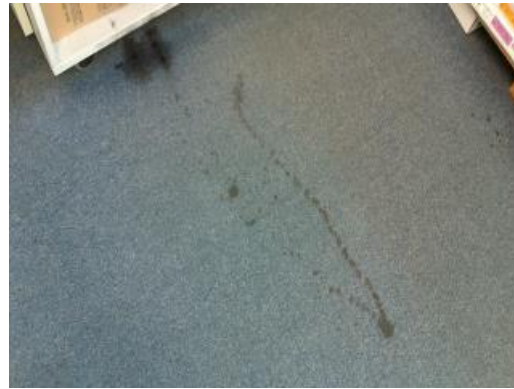
Worn and Stained Carpet

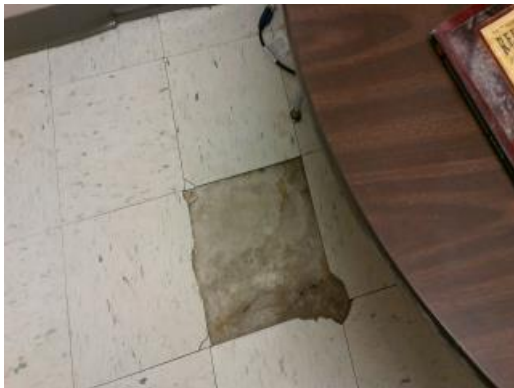
Damaged VCT

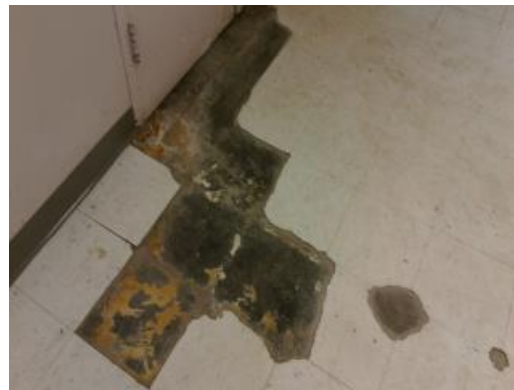
Damaged VCT

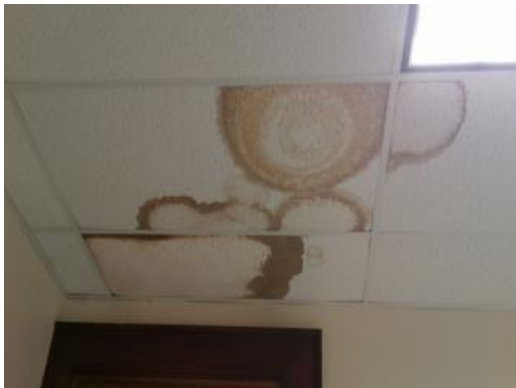
Damaged Ceiling Tile

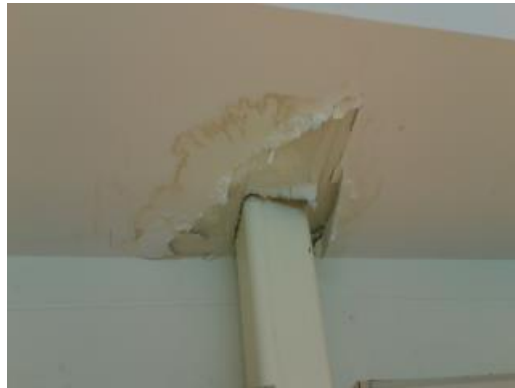
Damaged Ceiling

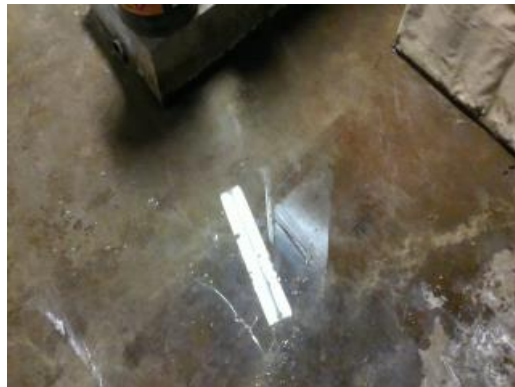
Flood in Boiler Room
