Exeter-West Greenwich totals 309,120 square feet and consists of the school type(s) detailed below. School(s) were visited three times during the Statewide Facilities Assessment by teams of specialists in March 2016. This report provides LEA summary findings for the statewide assessment program.

# Exeter-West Greenwich

# Facility Condition Assessment

Exeter-West Greenwich - Exeter-West Greenwich Regional High School

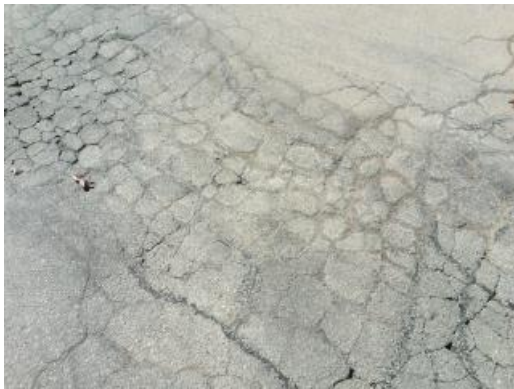
Site - Cracked Asphalt Pavement

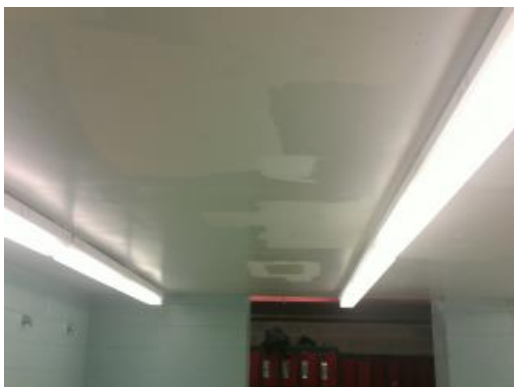
Main Building - Damaged Gypsum Board Ceiling

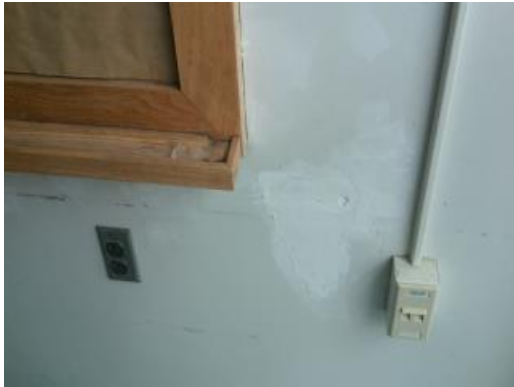
Main Building - Damaged Interior Wall

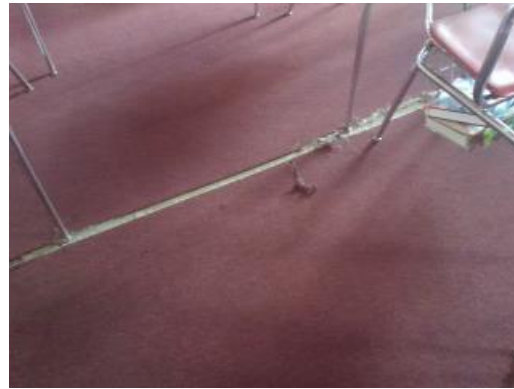
Main Building - Worn And Bubbling Carpet

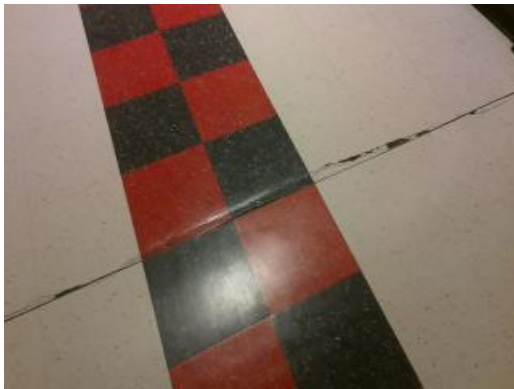
Main Building - Cracked VCT

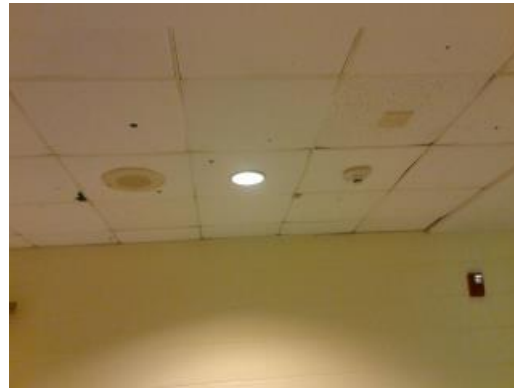
Main Building - Damaged Acoustical Ceiling Tiles

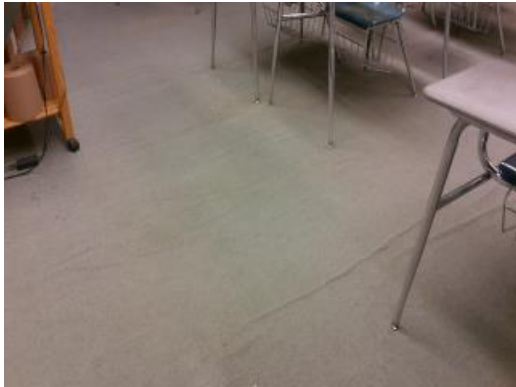
Worn Classroom Carpet

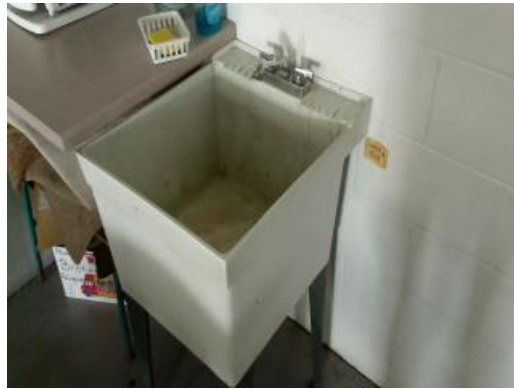
Stained Mop Sink

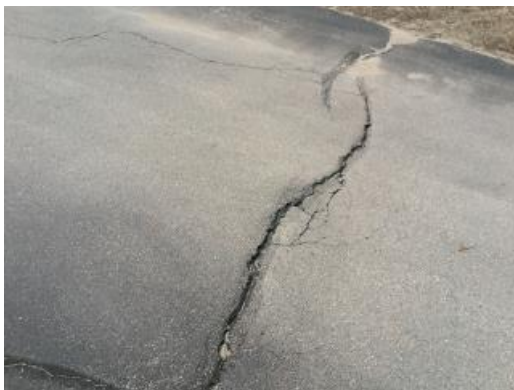
Cracked Asphalt Roadway

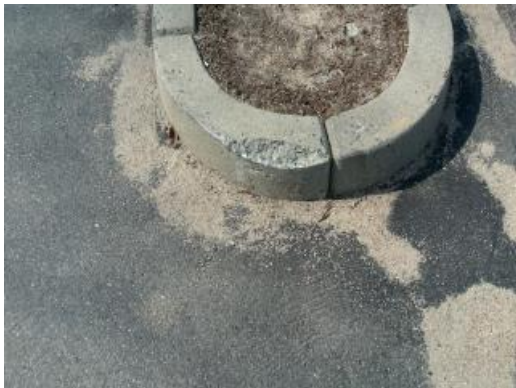
Damaged Concrete Curbs

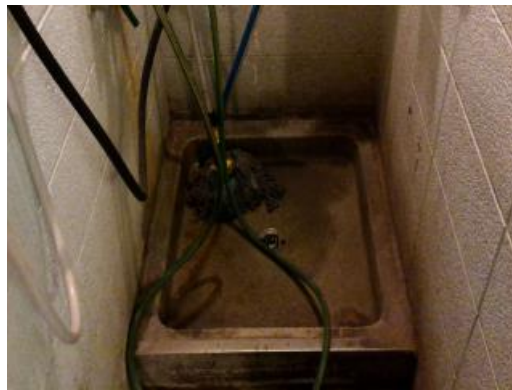
Original Corroded Mop Sink

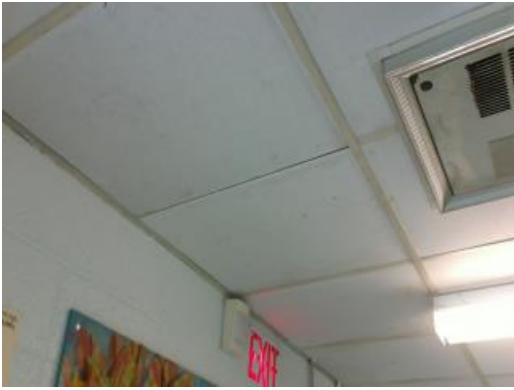
Ceiling Grid Missing Pieces

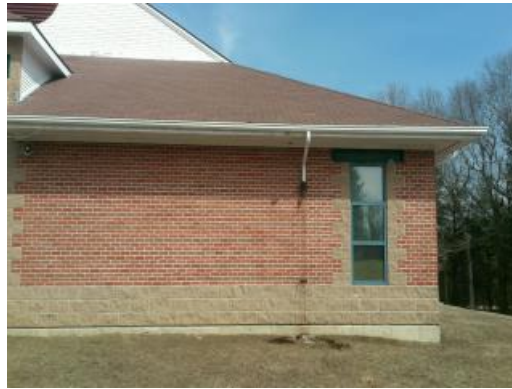
Missing Downspouts

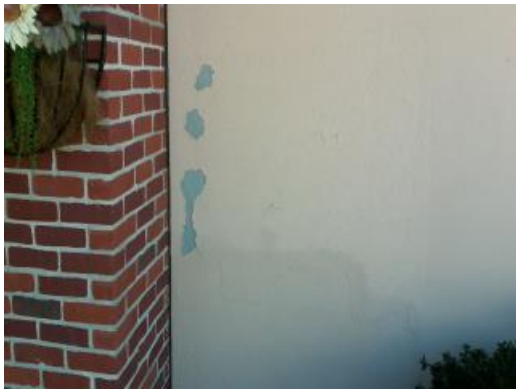
Chipped EIFS Wall

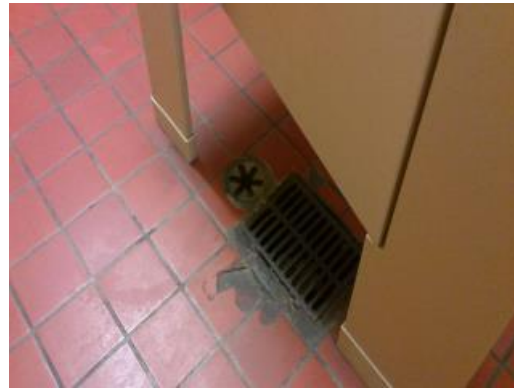
Broken Quarry Tile Flooring
