Facility Condition Assessment

June 2017

Charter - Highlander Charter School - Lower School (Providence)

Charter - Highlander Charter School - Upper School (Warren)

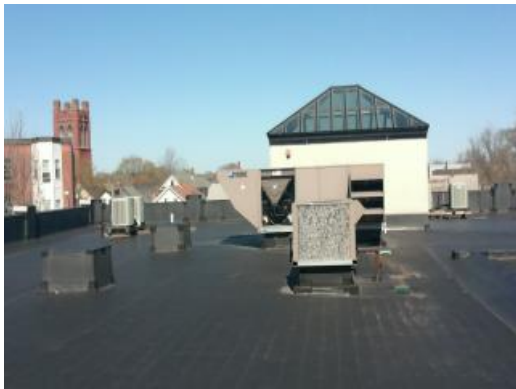
Typical Roof Condition

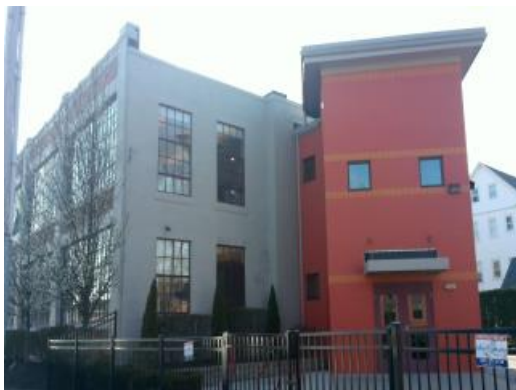
Building Exterior

Deficiency	Category	Qty	UoM	Priority	Repair Cost	ID
The Brick Exterior Requires Repointing Note: Brick mortar repointing is needed.	Capital Renewal	3,000	SF Wall	3	\$137,606	9217
Sub Total for System		1	items		\$137,606

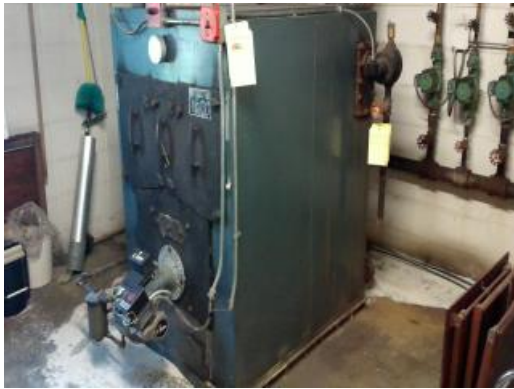
Leaking Boiler

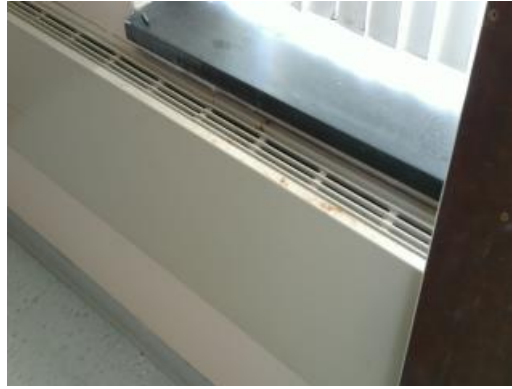
Fin Tube Heater

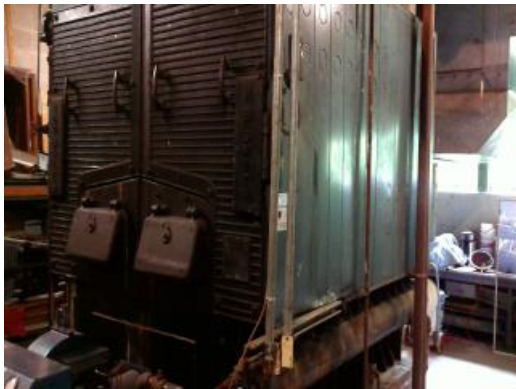
1965 Boiler

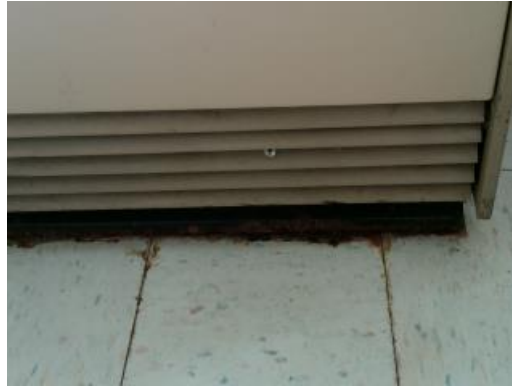
Rusted Unit Vent

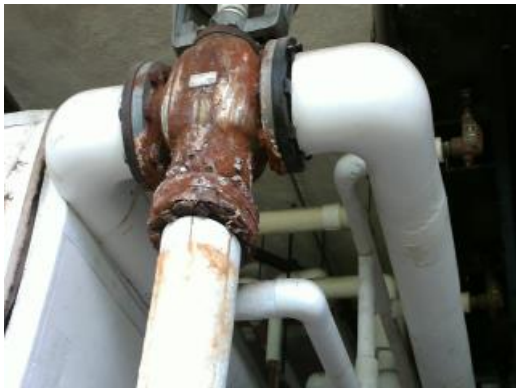
Rusted Piping

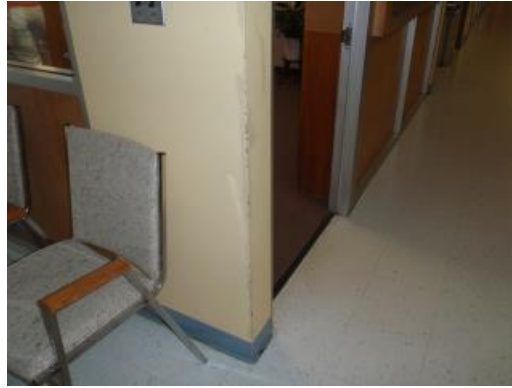
Chipped Wall Paint

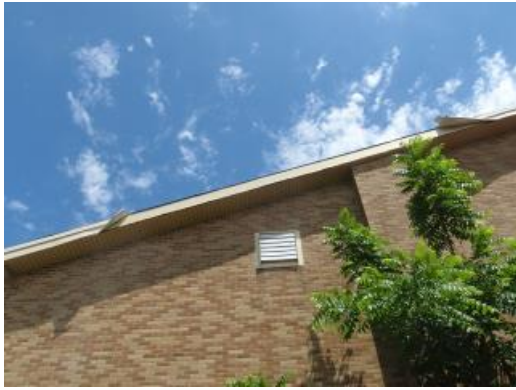
Damaged Flashing

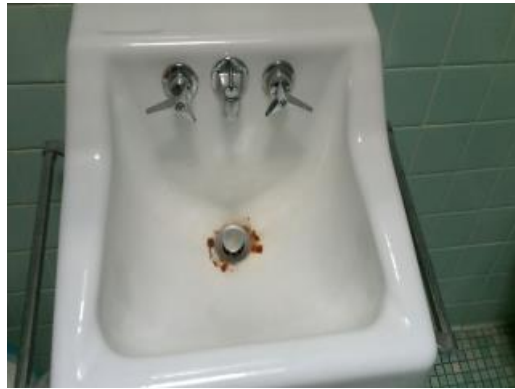
Rusted Lavatory

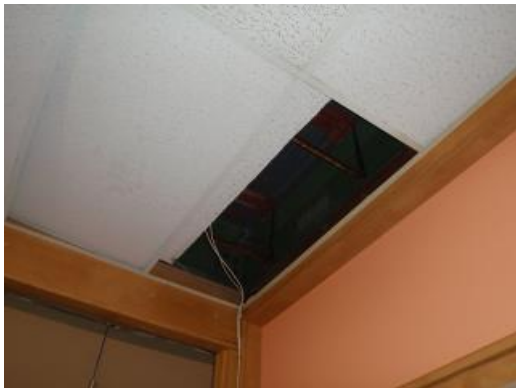
Missing Ceiling Tile

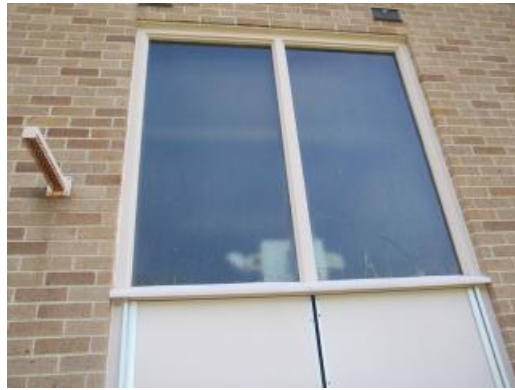
Broken Glass Pane

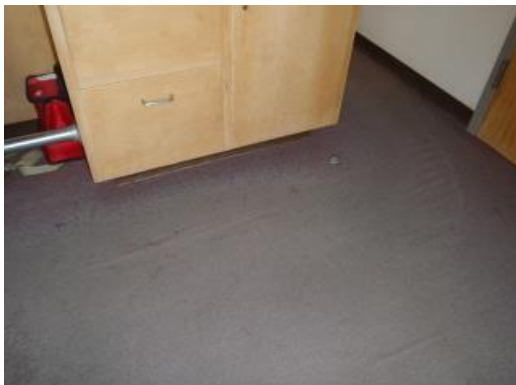
Worn Bubbled Carpet

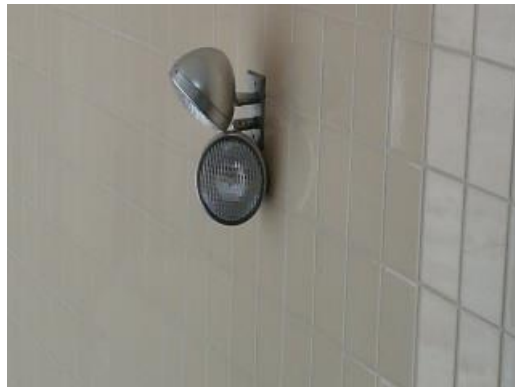
Original Wall Pack Light

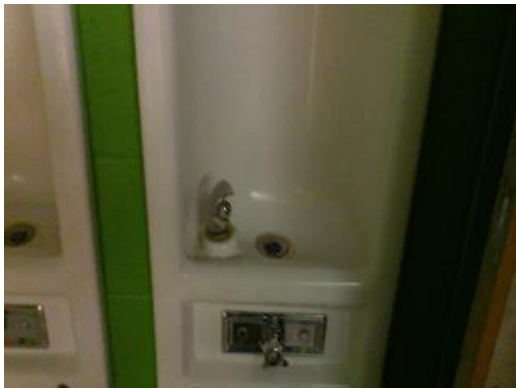
Aged Drinking Fountain

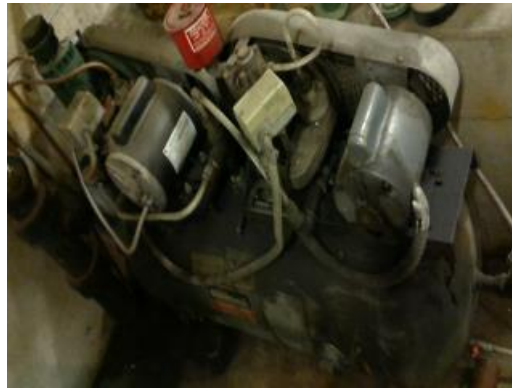
Leaking Air Compressor

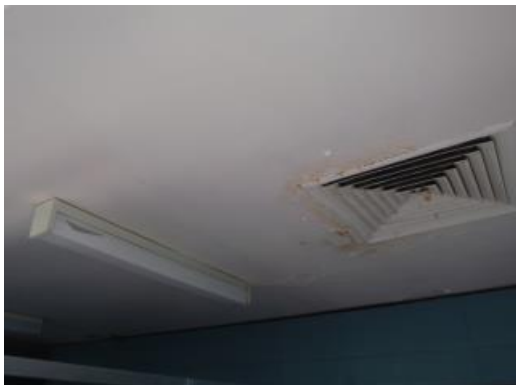
Peeling Plaster Ceiling

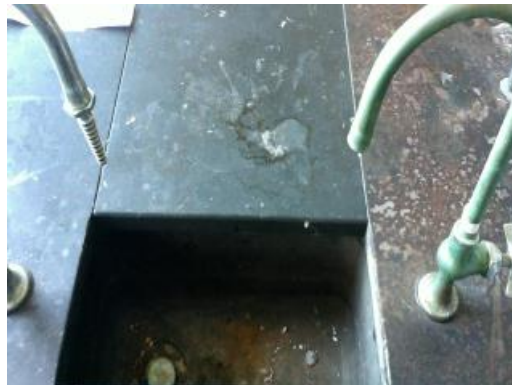
Corroded Classroom Lavatory

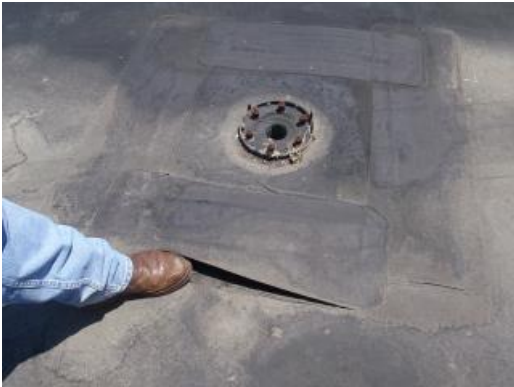
Open Roof Seam

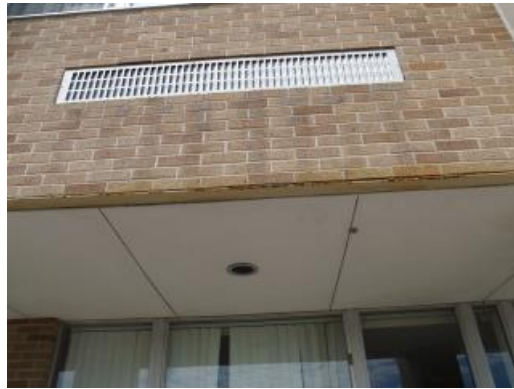
Weathered Trim

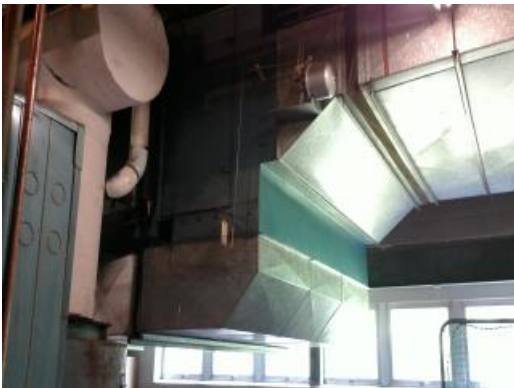
Original AHU

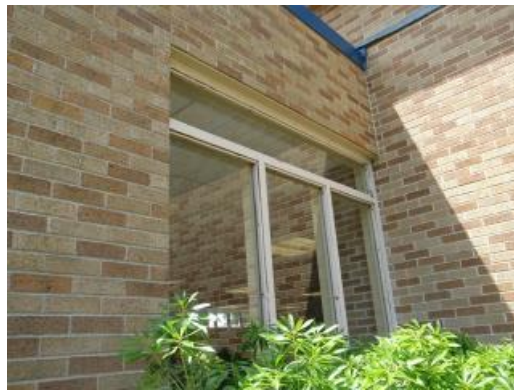
Aged Steel Windows

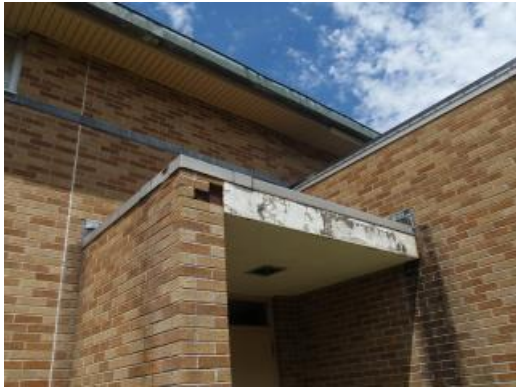
Damaged Brick
