# North Providence

# Facility Condition Assessment

June 2017

North Providence - Birchwood Middle School

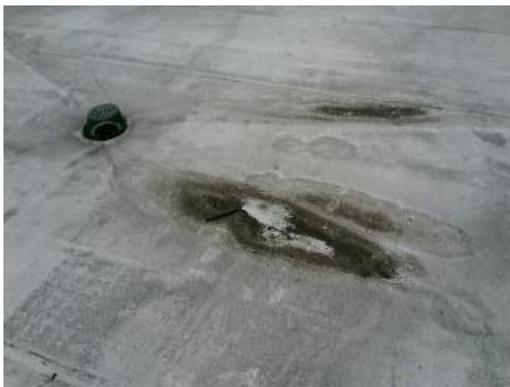
Damaged Roof

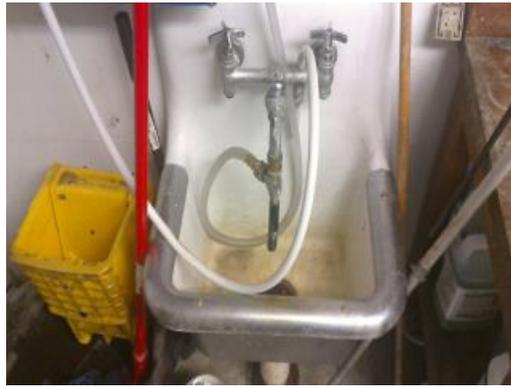
Stained Custodial Sink

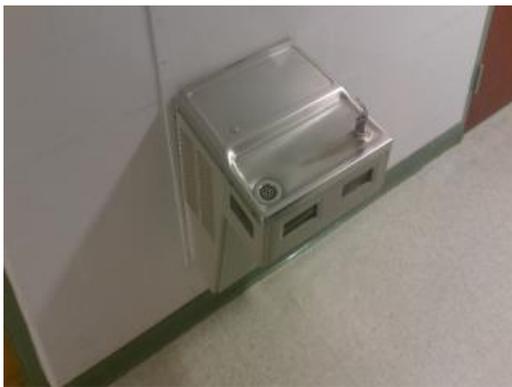
Non-Functional Drinking Fountain

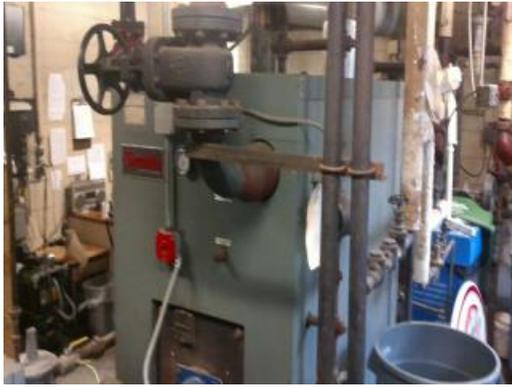
Aged Boiler

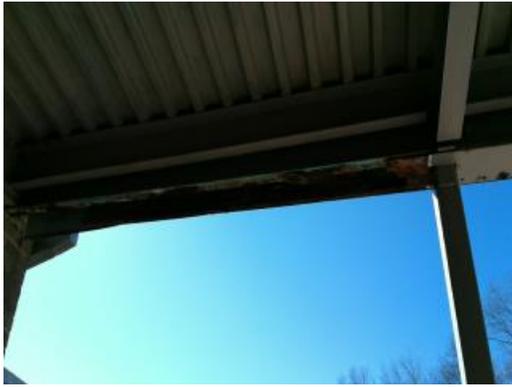
Wood Rotting Around Canopy Roofing

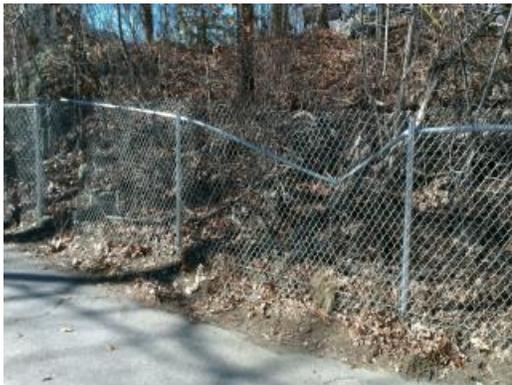
Damaged Fence

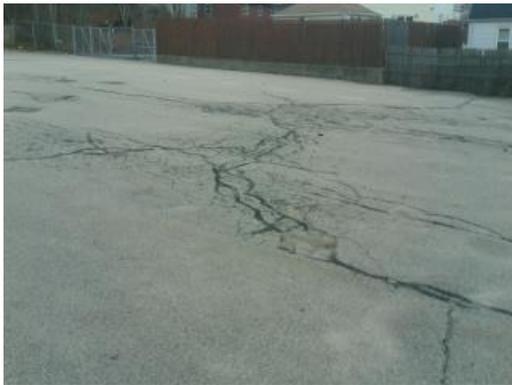
Cracked Asphalt Paving

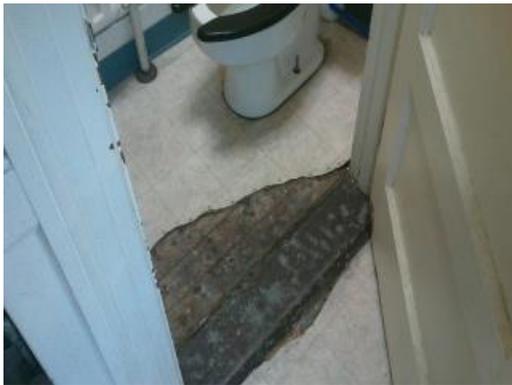
VCT Tile Damage In Faculty Restroom

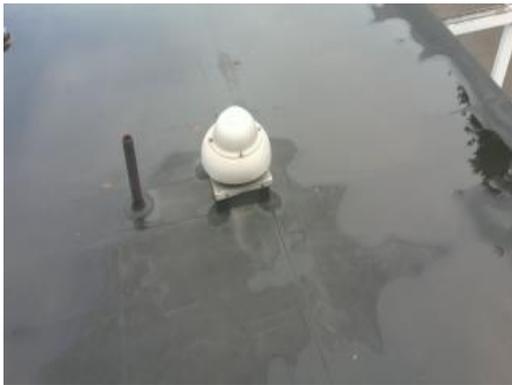
Small Roof Exhaust And Roof Ponding

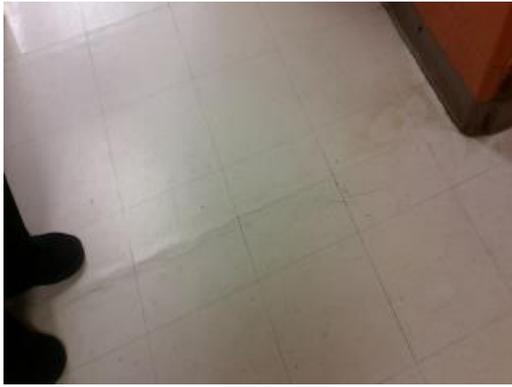
Cracked VCT

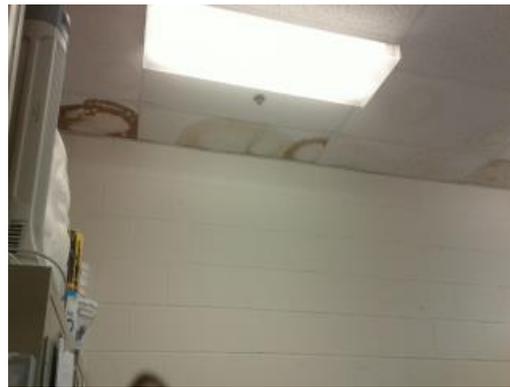
Stained Ceiling Tiles

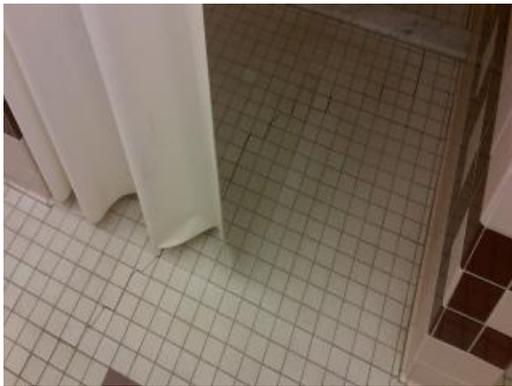
Cracked Ceramic Tile Floor

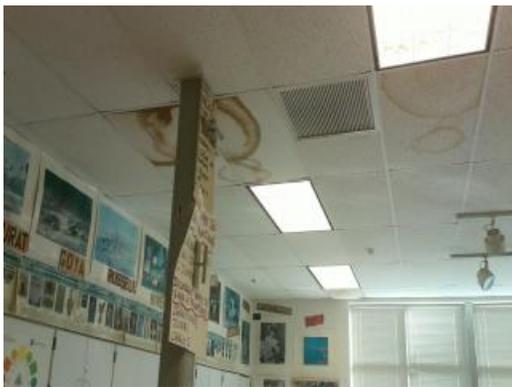
Stained Ceiling Tiles

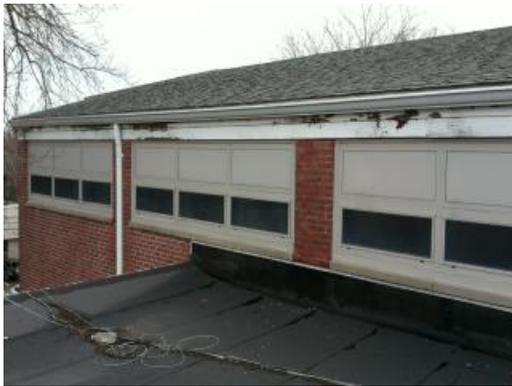
Weathered Roof

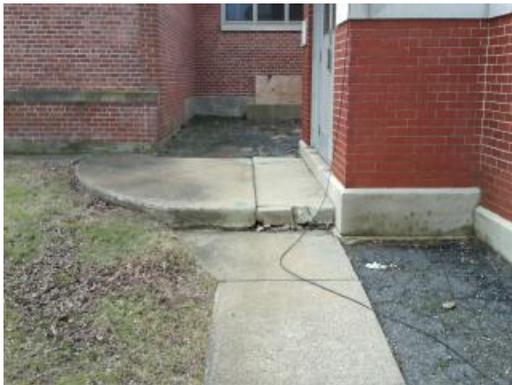
Cracked Walkway Pavement
