# South Kingstown

# Facility Condition Assessment

Academic Success Academy, located at 153 School Street in Wakefield, Rhode Island, was built in 1920. It comprises 26,503 gross square feet. Each school across the district was visited three times during the Facility Condition Assessments by three teams of specialists in the spring/summer of 2016.

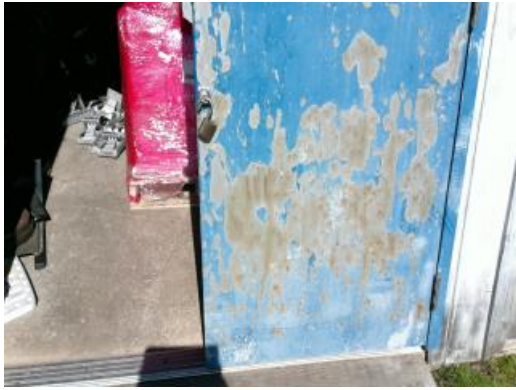
Paint Peeling On Exterior Door

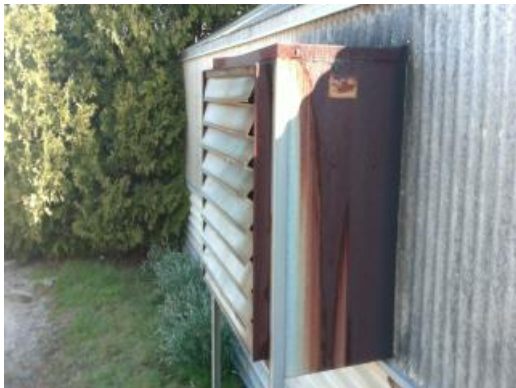
Rusted Wall Exhaust

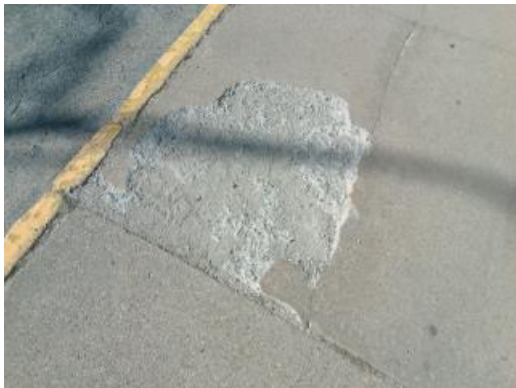
Spalling Concrete Walkway

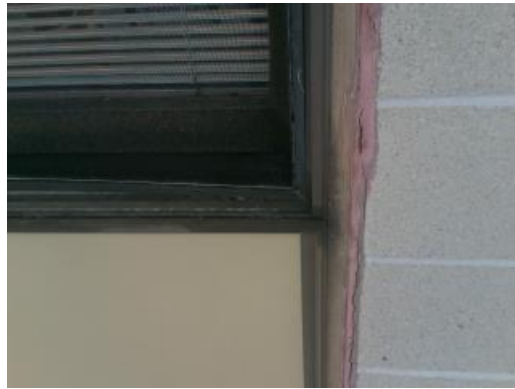
Failed Window Caulking

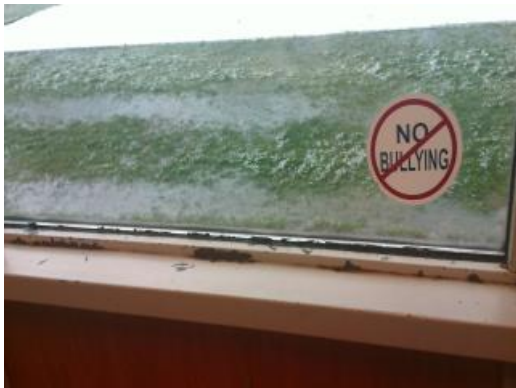
Rusting Window

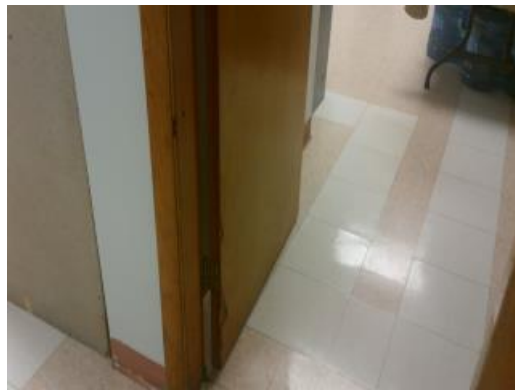
Chipped Laminate Wood Door

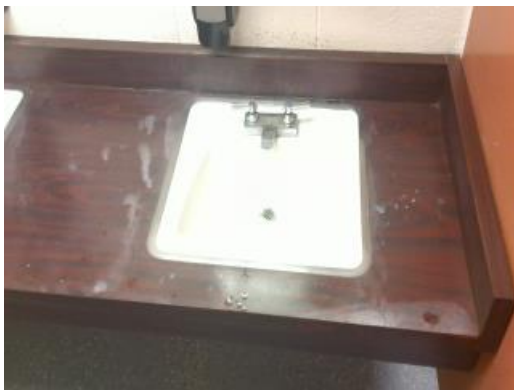
Aged And Stained Restroom Lavatory

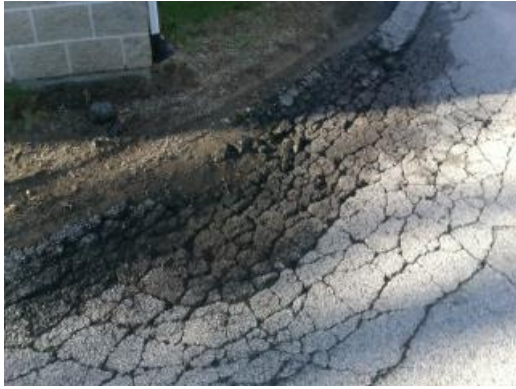
Roadway Alligator Cracking

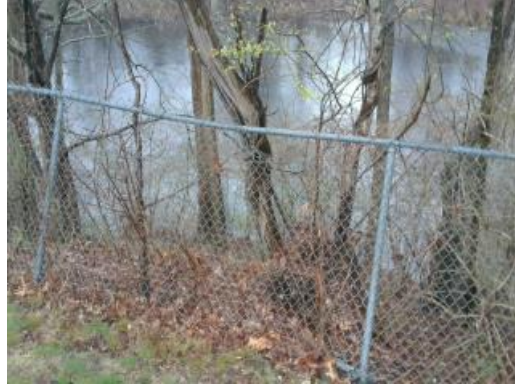
Falling Fence

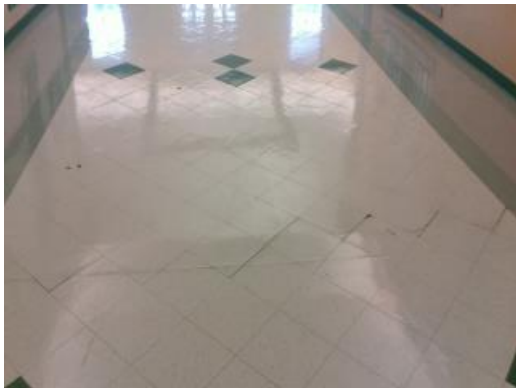
Typical VCT Damage

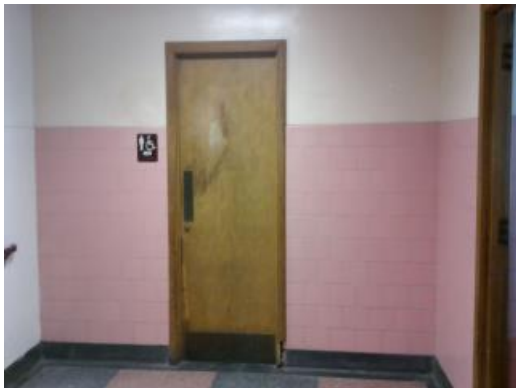
Damaged Door And Frame

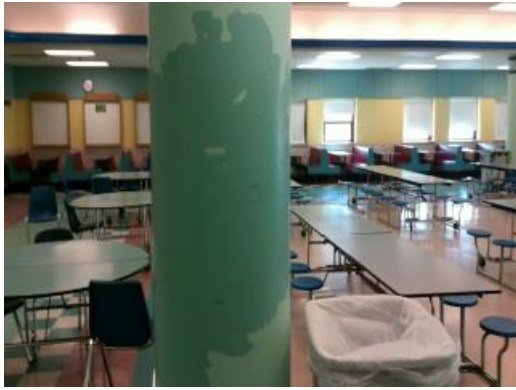
Peeling Paint

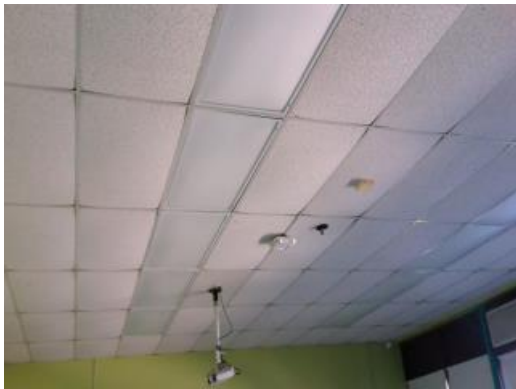
Stained And Sagging Ceiling Tiles

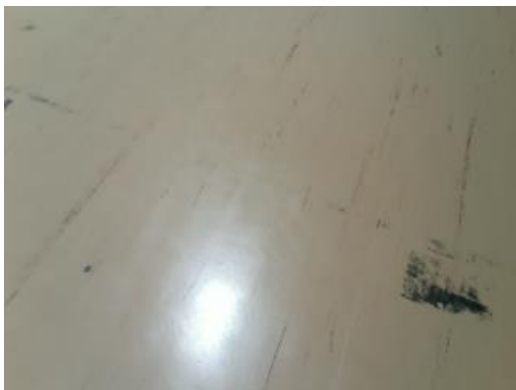
Worn Athletic Flooring

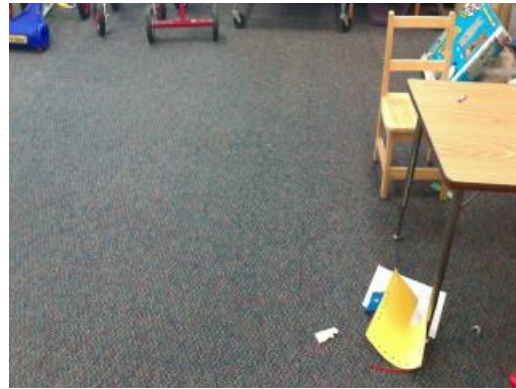
Worn Carpet

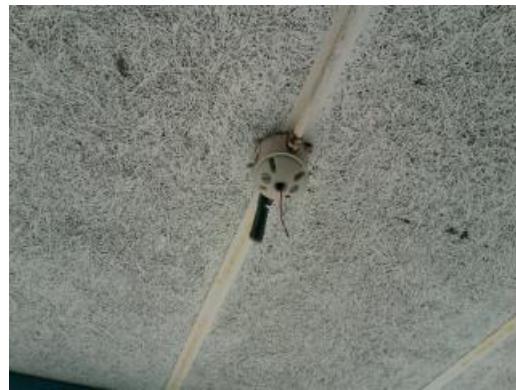
Broken Canopy Light

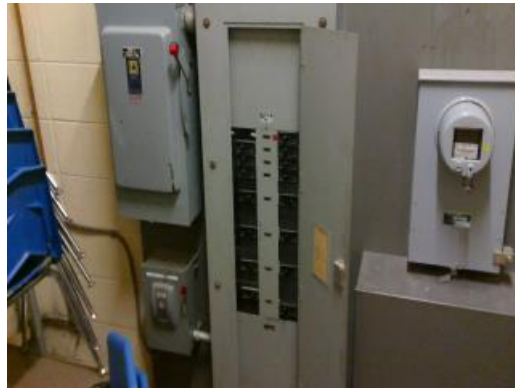
Aged Distribution Panel

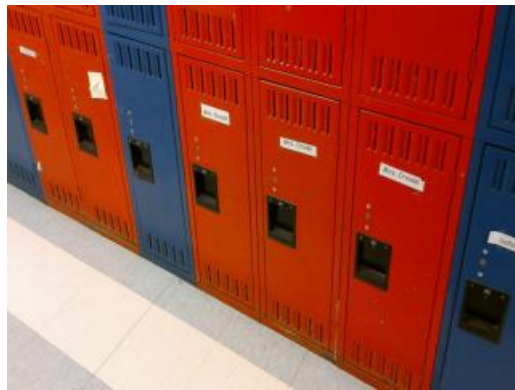
Rusting Lockers

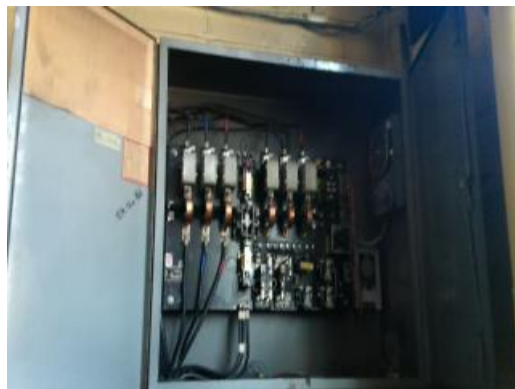
Non-Functional Transfer Switch

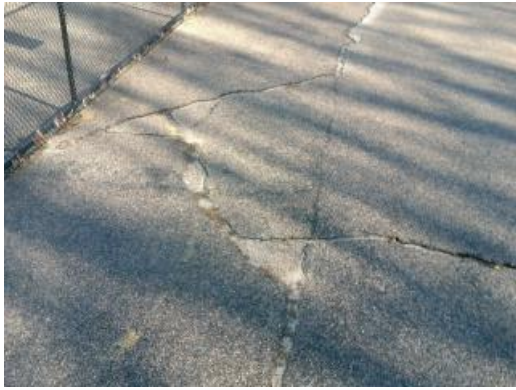
Cracked Asphalt Play Area

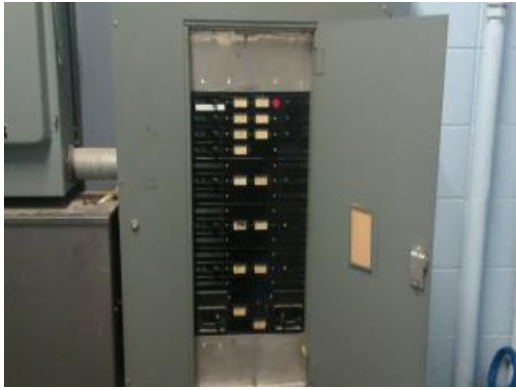
400 Amp Panel With Improper Repairs

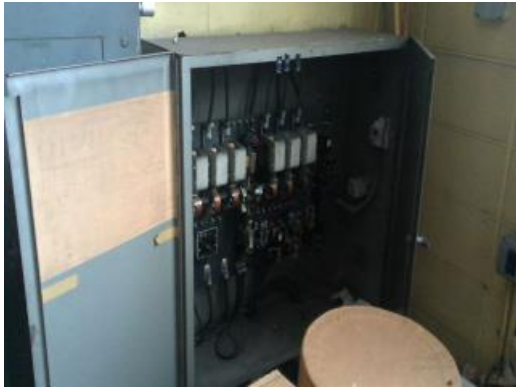
Transfer Switch With Burned Contacts

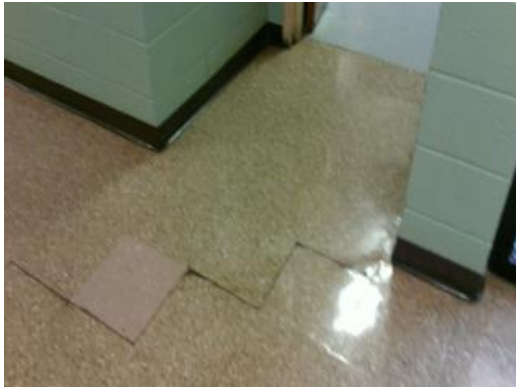
Cracked VCT Floor At Lobby

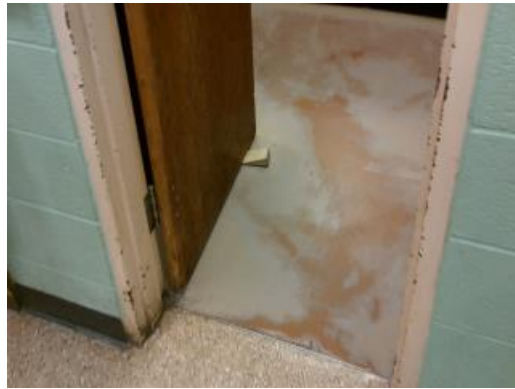
Worn Epoxy Floor
