Facility Condition Assessment

Barrington - Barrington High School

June 2017

220 Lincoln Avenue, Barrington, RI 02806

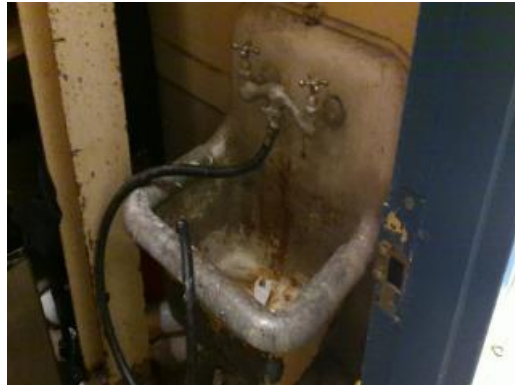
Main Building - Corroded Janitor Sink

Deficiency	Category	Qty	UoM	Priority	Repair Cost	ID
Roof Drainage Piping Requires Repair Note: Roof drain boot connection is damaged. Location: Canopy/kitchen	Capital Renewal	15	LF	3	\$3,166	2078
The Custodial Mop Or Service Sink Requires Replacement Note: Mop sink at the janitor closet off of the gym has significant corrosion.	Capital Renewal	1	Ea.	4	\$2,576	2072
The Refrigerated Water Cooler Requires Repair Note: Bi-level fountain outside the small gym does not have any water pressure. Water fill spouts in the large gym do not work. Location: 500 wing	Capital Renewal	5	Ea.	4	\$4,753	2074
Room lacks a drinking fountain.	Educational Adequacy	6	Ea.	5	\$6,617	Rollup
The Class Room Lavatories Plumbing Fixtures Are Missing And Should Be Installed	Educational Adequacy	18	Ea.	5	\$27,209	Rollup
Sub Total for System		5	items		\$44,322

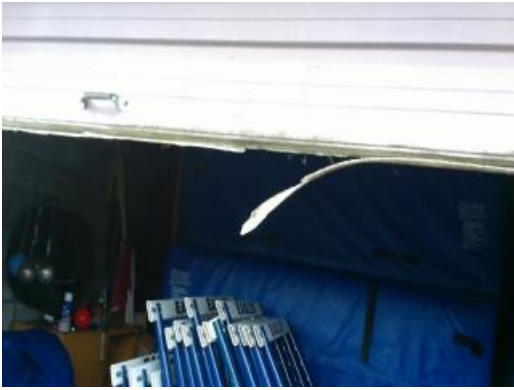
Building 03 - Soffit Damage

Deficiency	Category	Qty	UoM	Priority	Repair Cost	ID
The Exterior Soffit Requires Replacement	Capital Renewal	50	SF	4	\$6,180	2066
	Sub Total for System	1	items		\$6,180	
	Sub Total for Building 03 - Field Storage	1	items		\$6,180	
	Total for Campus	80	items		\$5,696,233

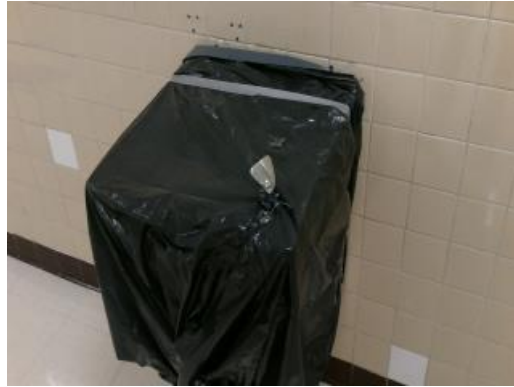
Main Building - Broken Water Cooler

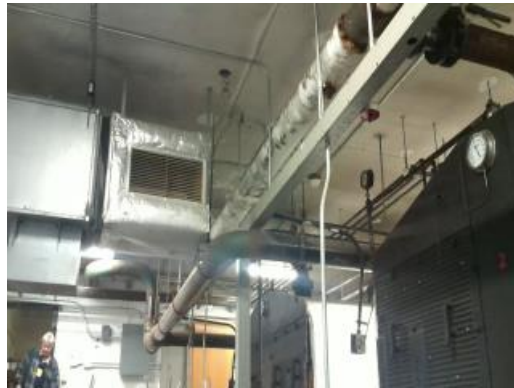
Main Building - Damaged Insulation

Deficiency	Category	Qty	UoM	Priority	Repair Cost	ID
Component Insulation Deteriorated And Requires Replacement Note: Older mechanical room, pipe insulation is damaged and should be replaced.	Functional Deficiency	300	LF	3	\$9,669	2075

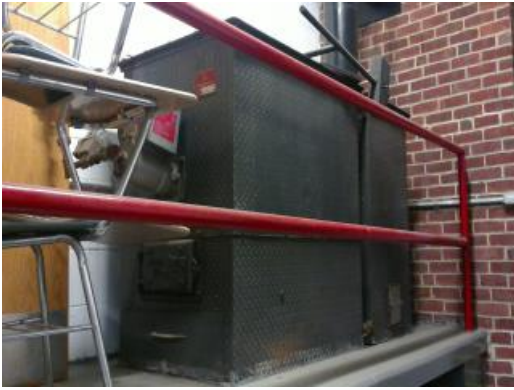
Main Building - Abandoned Incinerator

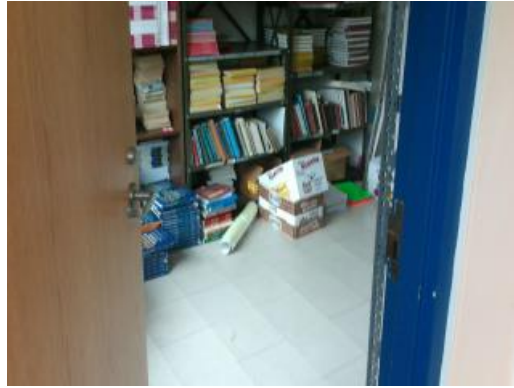
Main Building - Curling VCT

Deficiency	Category	Qty	UoM	Priority	Repair Cost	ID
Classroom Entry Doors Provide Insufficient Sound Isolation Note: All classrooms	Acoustics	70	Ea.	3	\$582,635	4632
The Vinyl Composition Tile Requires Replacement Location: Room 116B	Capital Renewal	130	SF	3	\$1,491	1992
Caulking - significant areas of broken pieces &/or deteriorating caulk	Hazardous Material	292	LF	4	\$5,552	Rollup
Light Deterioration or Damage of 9x9 Asbestos Floor Tile is Present	Hazardous Material	200	SF	4	\$5,704	Rollup
Paint (probable pre-1978 in base layer(s)) - large areas (> 10 sq. ft.) of peeling/damage & area in active use - children (measurement unit - each)	Hazardous Material	219	Ea.	4	\$62,461	Rollup
Paint (probable pre-1978 in base layer(s)) - large areas (> 10 sq. ft.) of peeling/damage & area in active use - children (measurement unit - linear feet)	Hazardous Material	7	LF	4	\$160	Rollup
Paint (probable pre-1978 in base layer(s)) - large areas (> 10 sq. ft.) of peeling/damage & area in active use - children (measurement unit - square feet)	Hazardous Material	12,990	SF	4	\$123,496	Rollup

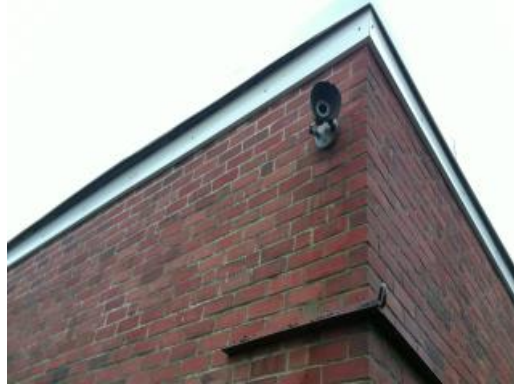
Main Building - Damaged Building Mounted Lighting

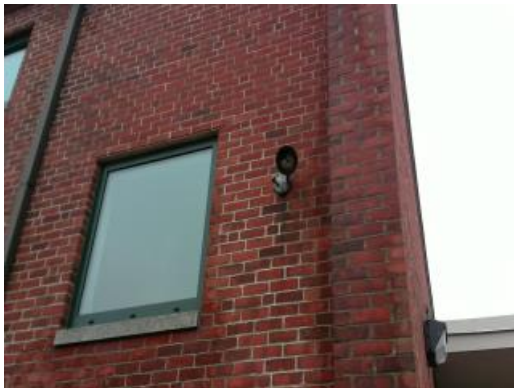
Main Building - Damaged Building Mounted Lighting

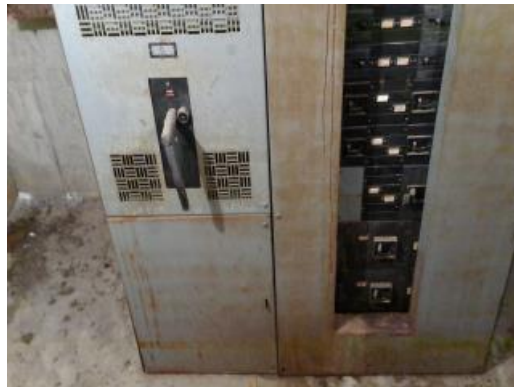
Main Building - Distribution Panel

Deficiency	Category	Qty	UoM	Priority	Repair Cost	ID
The Distribution Panel Requires Replacement Location: Boiler room	Capital Renewal	1	Ea.	2	\$51,908	1954
The Electrical Service And Distribution Requires Replacement Note: All panelboards are old and should be replaced. New main distribution panel (2000 amp) is fine.	Capital Renewal	171,500	SF	2	\$514,851	1952
The Mounted Building Lighting Requires Replacement Location: By door 3C	Capital Renewal	1	Ea.	3	\$1,493	2024
The Mounted Building Lighting Requires Replacement Location: By door 4D	Capital Renewal	1	Ea.	3	\$1,493	2025
Transfer Switch Requires Replacement Location: Boiler room	Capital Renewal	800	Amps	3	\$26,800	2082
Wall Pack Lighting Requires Repair Note: Wall facing the football stadium seats.	Capital Renewal	1	Ea.	3	\$238	2022
Remove Abandoned Equipment Note: Incinerator in secondary mechanical room is no longer active.	Capital Renewal	1	Ea.	5	\$3,321	2080

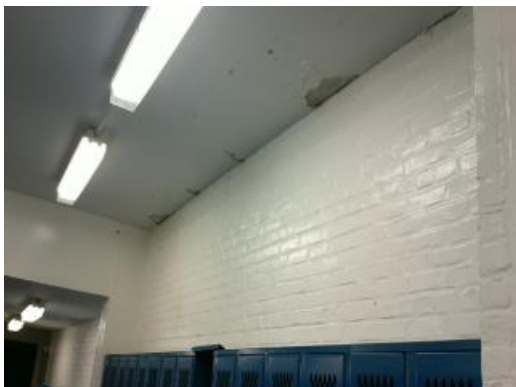
Main Building - Damaged Plaster Ceiling

Paint (probable pre-1978 in base layer(s)) - damaged area < 9 sq. ft. OR overall worn AND in children-accessible area (measurement unit - each)	Hazardous Material	1	Ea.	4	\$285	Rollup
Paint (probable pre-1978 in base layer(s)) - damaged area < 9 sq. ft. OR overall worn AND in children-accessible area (measurement unit - square feet)	Hazardous Material	361	SF	4	\$3,432	Rollup
Paint (probable pre-1978 in base layer(s)) -large areas (> 10 sq. ft.)of peeling/damage & area in active use-adults only (measurement unit - square feet)	Hazardous Material	265	SF	4	\$2,519	Rollup
Paint (probable pre-1978 in base layer(s)) -large areas(> 10 sq. ft.)of peeling/damage & area in active use-adults only (measurement unit - each)	Hazardous Material	10	Ea.	4	\$2,852	Rollup
The Plaster Ceilings Require Replacement Note: Ceiling damage in small areas, possibly due to water infiltration.	Capital Renewal	300	SF	4	\$1,996	1967
