# Facility Condition Assessment

Bristol Warren - Mt. Hope High School

June 2017

199 Chestnut Street, Bristol, RI 02809

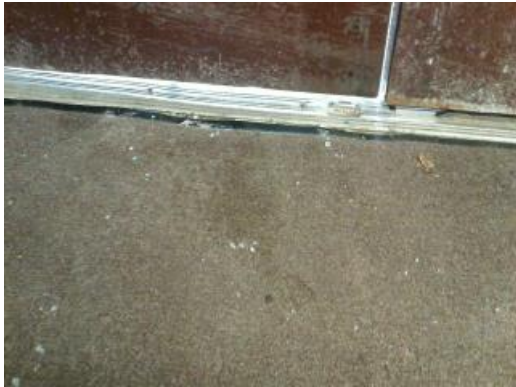
Exterior Door Rusted At Bottom

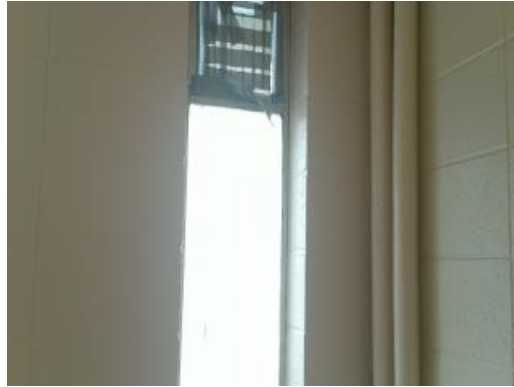
Broken Window

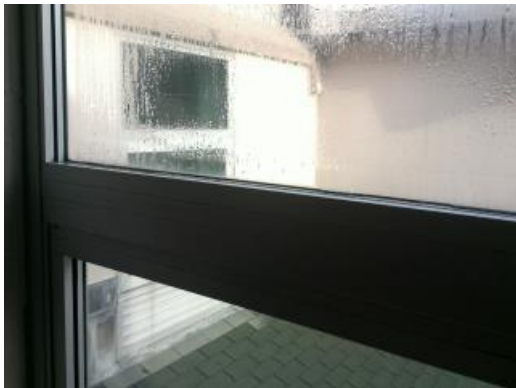
Poor Seals At Window

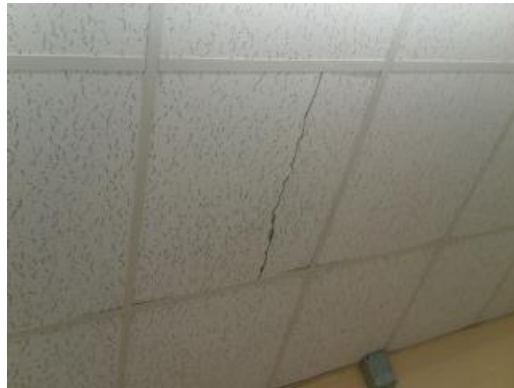
Broken Ceiling Tile

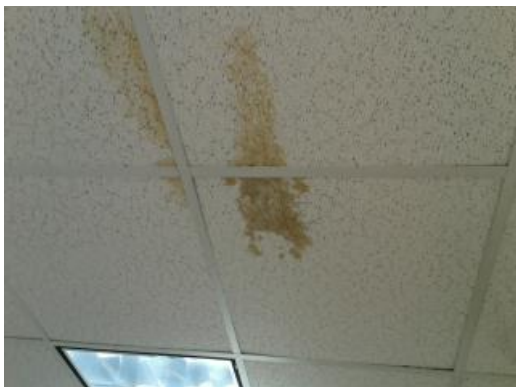
Stained Ceiling Tiles

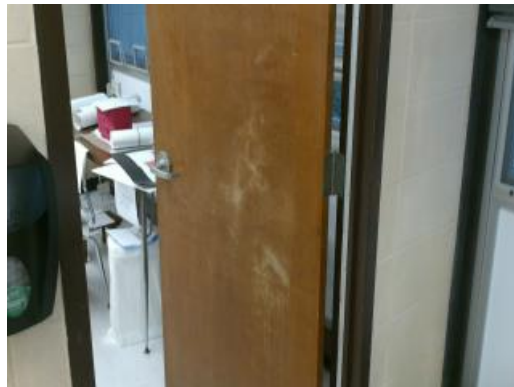
Worn Wood Door

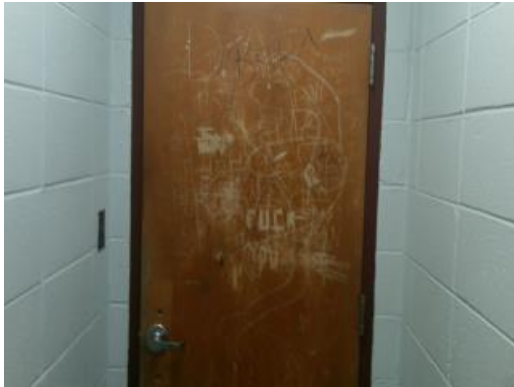
Vandalized Interior Door

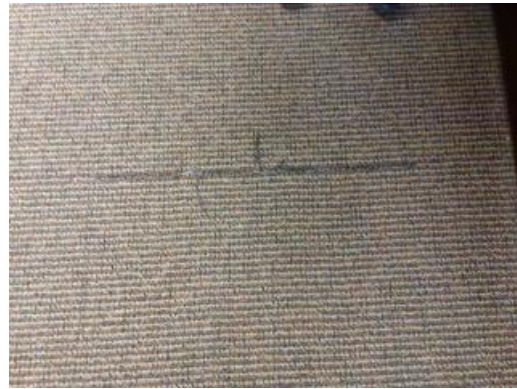
Frayed Carpet In Office

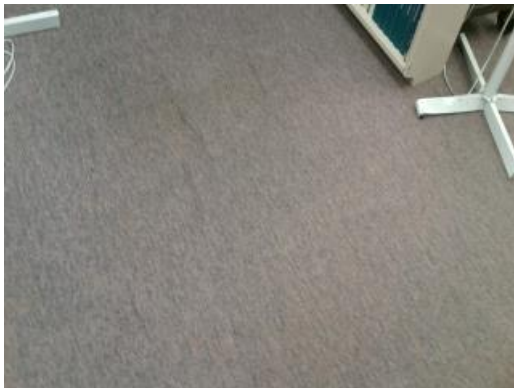
Worn Carpet

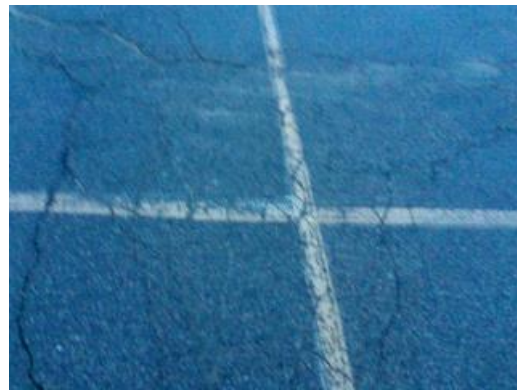
Alligatoring Parking Lot Pavement

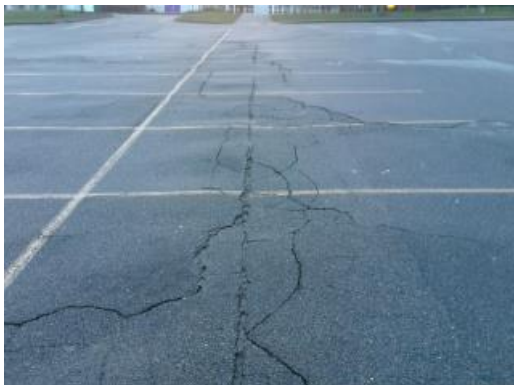
Cracked Parking Lot Pavement

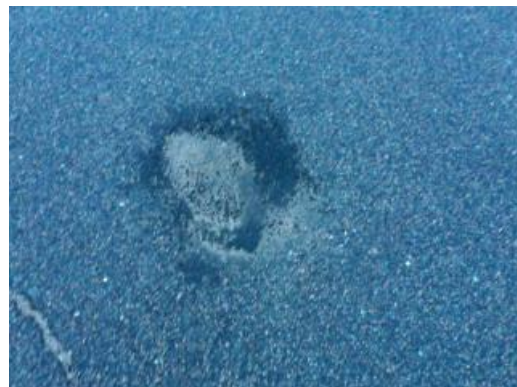
Pot Hole In Parking Lot

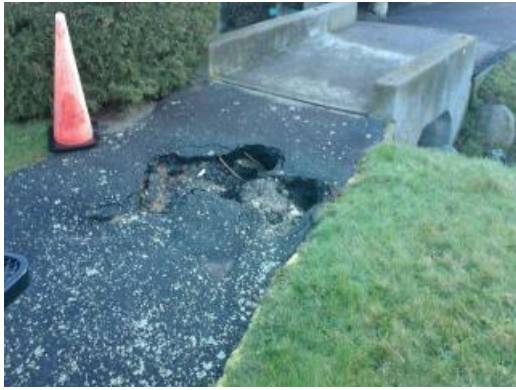
Pot Hole In Asphalt Walkway

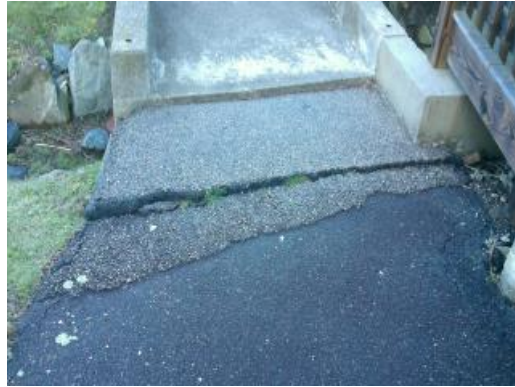
Uneven Walkway

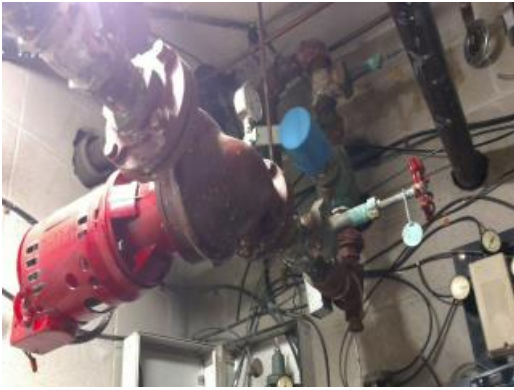
Aged Pump

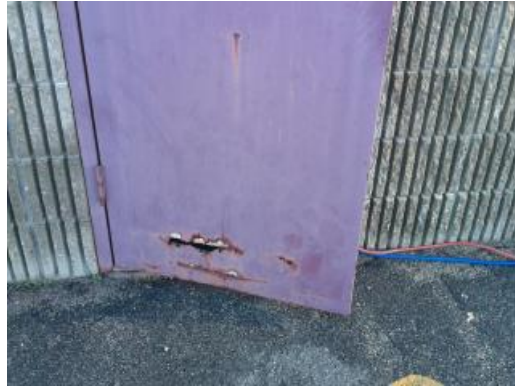
Rusted Exterior Door

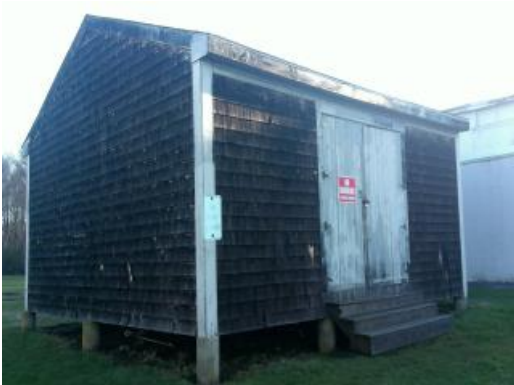
Weathered Wood Siding

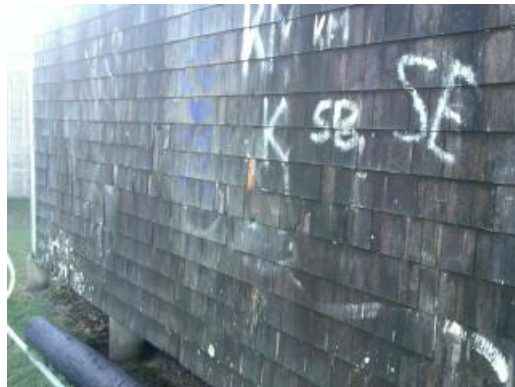
Weathered And Vandalized Wood Siding

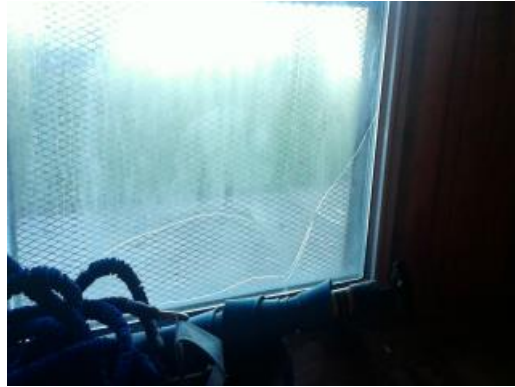
Cracked Window At Concessions Building

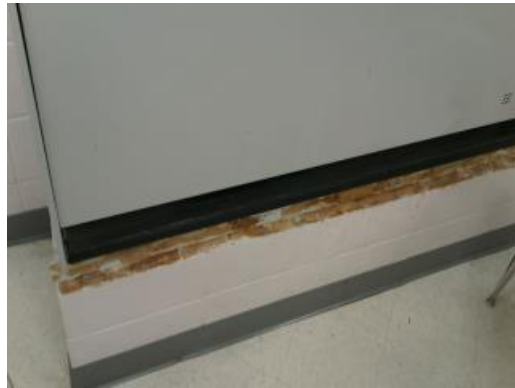
Damaged Cabinet Unit Ventilator

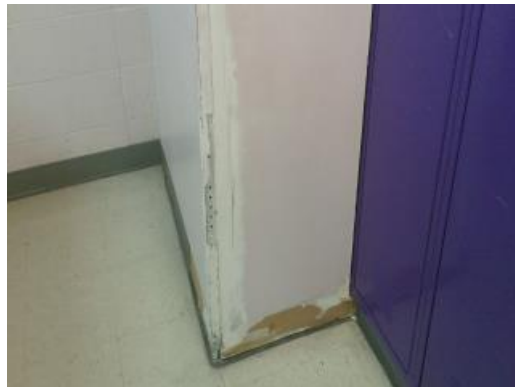
Damaged Wall

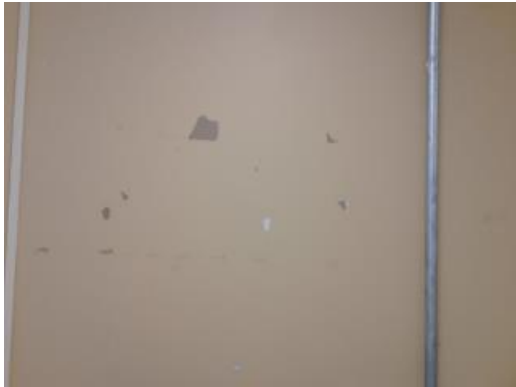
Chipped Paint

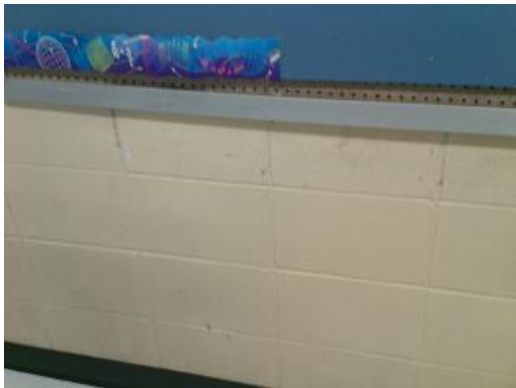
Worn CMU Wall

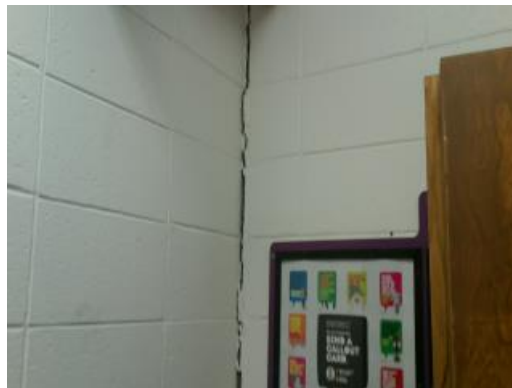
Cracked CMU Wall

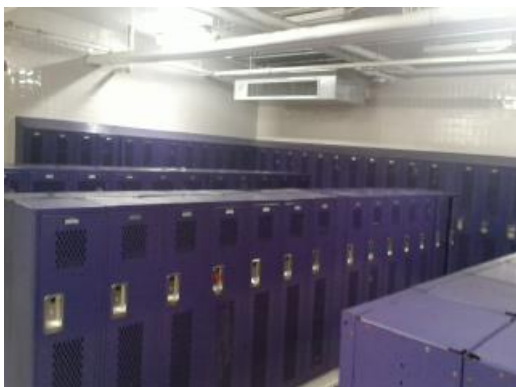
Damaged Locker Room Lockers

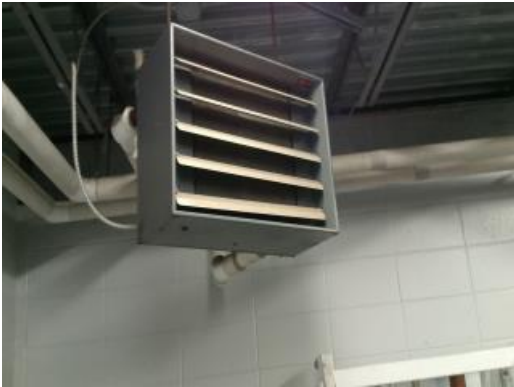
Aged Unit Heater

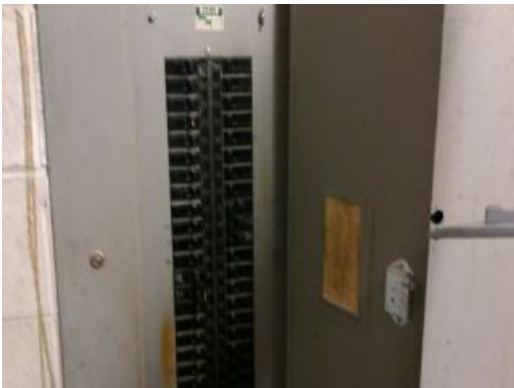
Aged Panelboard

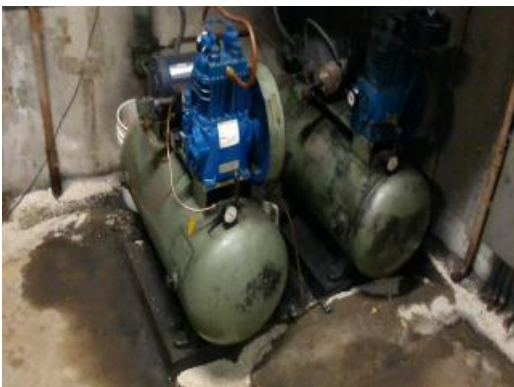
Aged Air Compressors

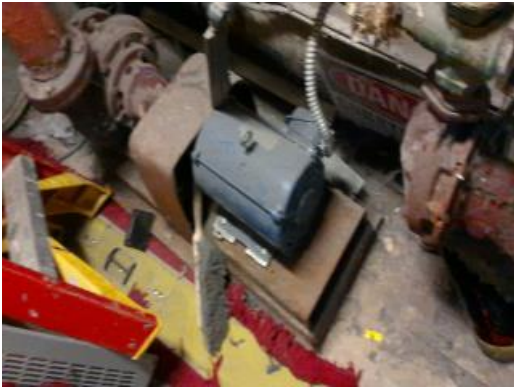
Aged Pump

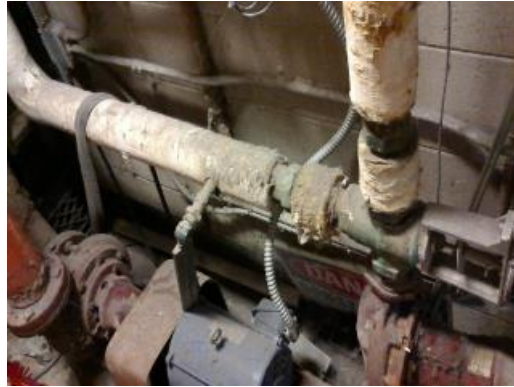
Aged Piping

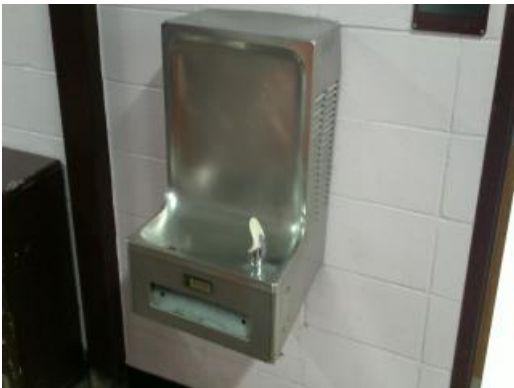
Damaged Drinking Fountain

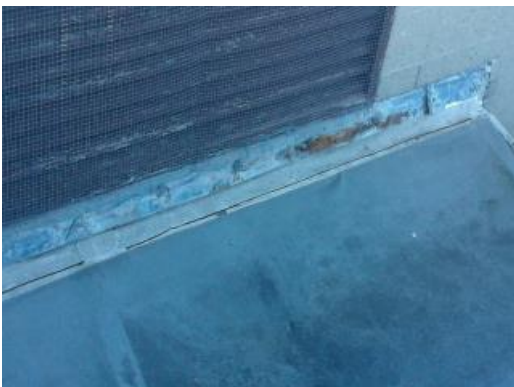
Corroded Metal At Termination Wall

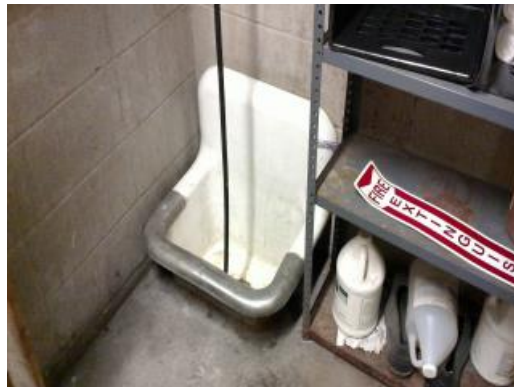
Aged Service Sink

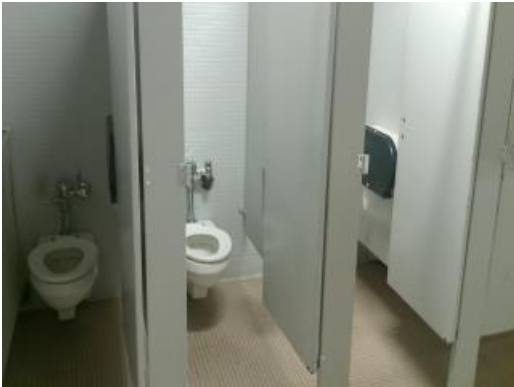
Non-Compliant Toilet Stalls

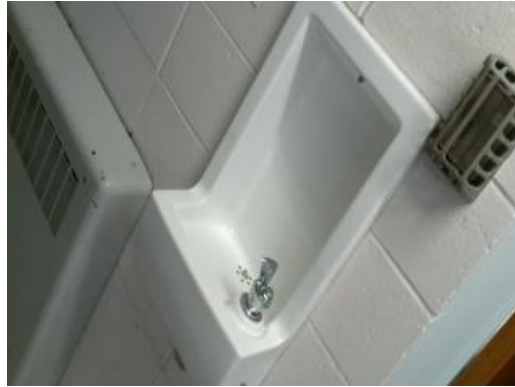
Non-Refrigerated Drinking Fountain

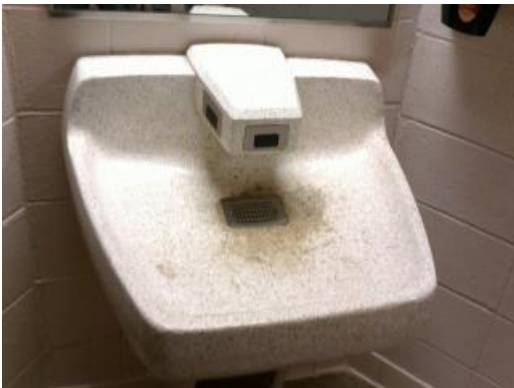
Worn Bathroom Sink

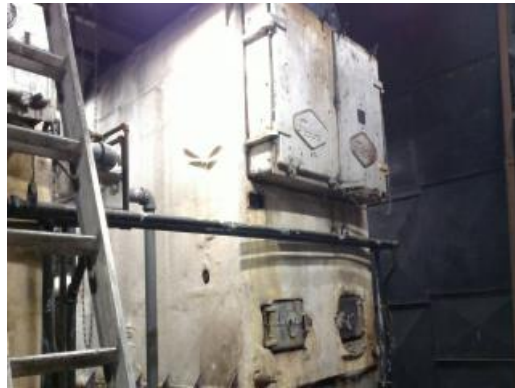
Original Boilers

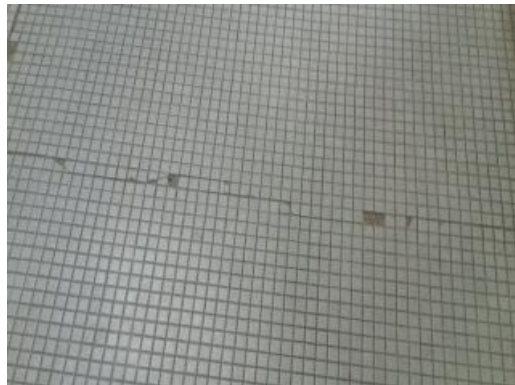
Cracked And Missing Ceramic Tile

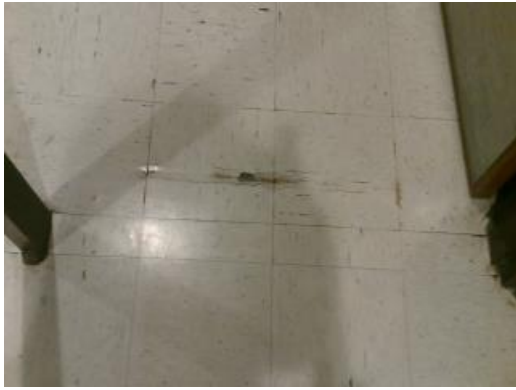
Cracked VCT Flooring

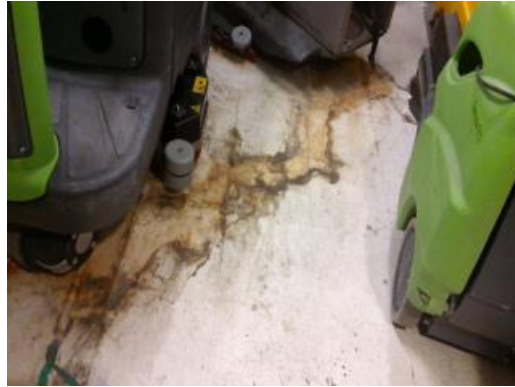
Stained And Broken VCT
