Facility Condition Assessment

Central Falls - Central Falls Senior High School

June 2017

24 Summer Street, Central Falls, RI 02864

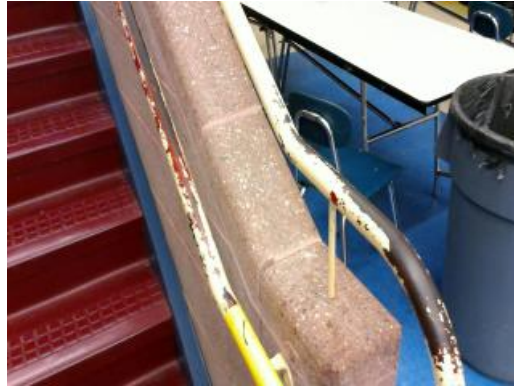
Worn Cafeteria Handrail

Deficiency	Category	Qty	UoM	Priority	Repair Cost	ID
The Metal Exterior Door Requires Replacement Note: Exterior entrance doors are chipped and faded, with rust beginning to take hold.	Capital Renewal	20	Door	2	\$139,039	1926
Handrail Requires Repainting Note: Exterior and interior handrails have chipped and faded paint.	Capital Renewal	150	LF	4	\$1,699	1939
Sub Total for System		2	items		\$140,739

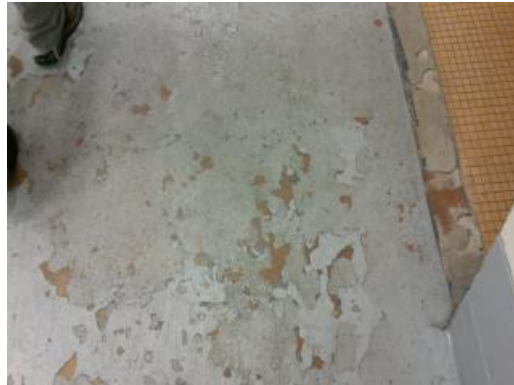
Worn Concrete Floor

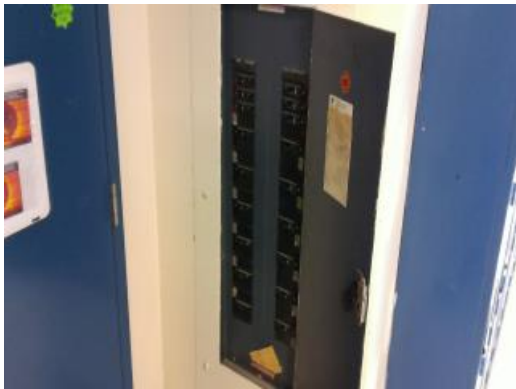
Aged Panelboard

Deficiency	Category	Qty	UoM	Priority	Repair Cost	ID
The Lighting Fixtures Require Replacement Note: Low efficiency units with water damage and rust.	Capital Renewal	112,641	SF	2	\$725,071	2035
The Panelboard Requires Replacement Note: Panels are aged and cracking.	Capital Renewal	5	Ea.	2	\$31,413	1993
The Panelboard Requires Replacement Note: Breakers are aged and cracked.	Capital Renewal	4	Ea.	2	\$27,190	1994
The Panelboard Requires Replacement Note: Breakers no longer manufactured.	Capital Renewal	4	Ea.	2	\$21,010	2016
The Mounted Building Lighting Requires Replacement Note: Existing lighting is broken and lighting is insufficient for parking lots and common areas.	Capital Renewal	6	Ea.	3	\$9,702	2038
Room Has Insufficient Electrical Outlets	Educational Adequacy	180	Ea.	5	\$89,328	Rollup
Sub Total for System		7	items		\$1,053,341

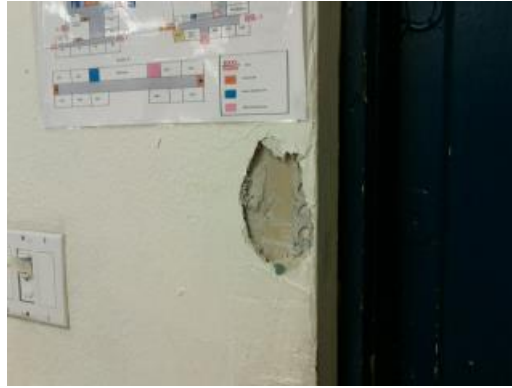
Hole In Wall

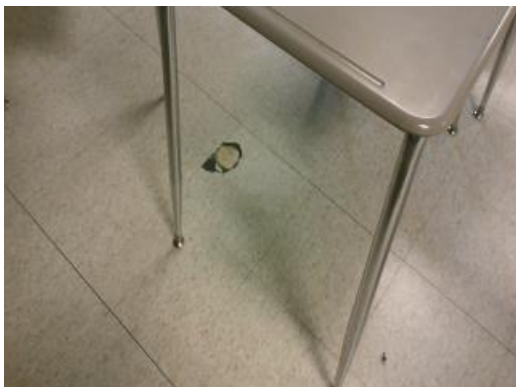
Chipped And Separating VCT

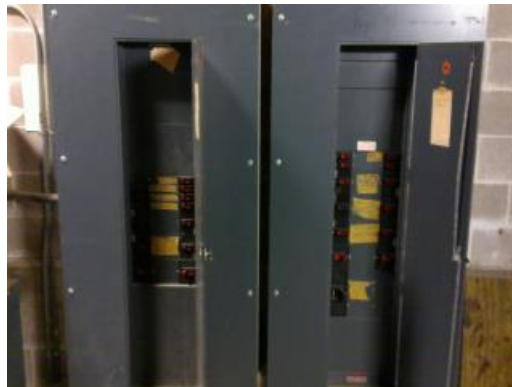
Aged Panelboards

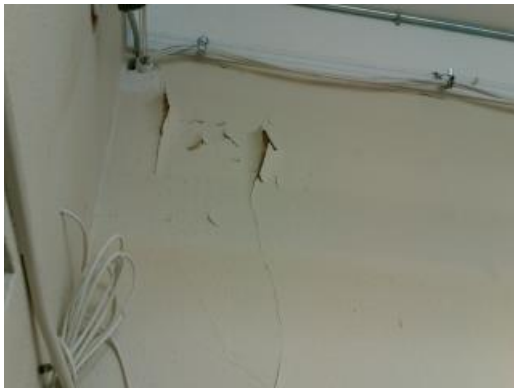
Cracking And Peeling Painted Walls

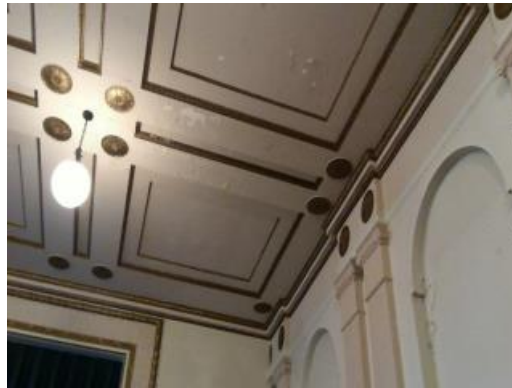
Cracked Ceiling In Auditorium

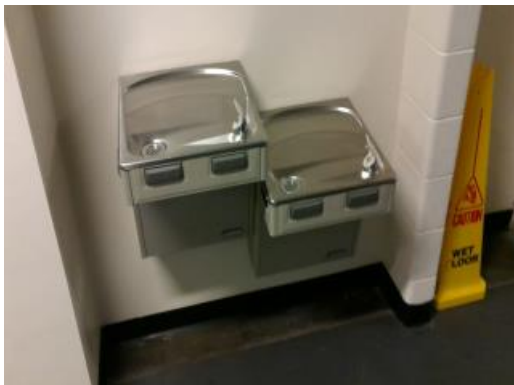
Non-Functional Drinking Fountains

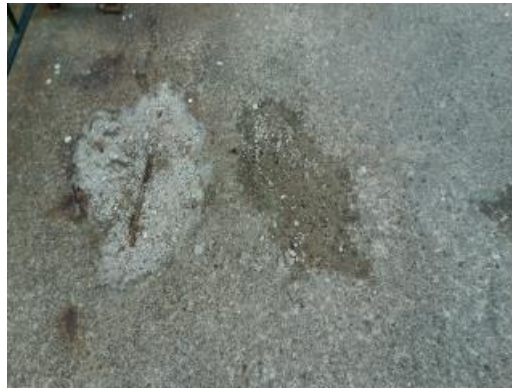
Worn Concrete At Main Entrance Stairs

Deficiency	Category	Qty	UoM	Priority	Repair Cost	ID
Exterior Concrete Stairs Require Repair And Repainting Note: The main entrance stairs have worn through on the landing and pose a tripping hazard.	Capital Renewal	150	SF	4	\$11,741	1940
Sub Total for System		1	items		\$11,741

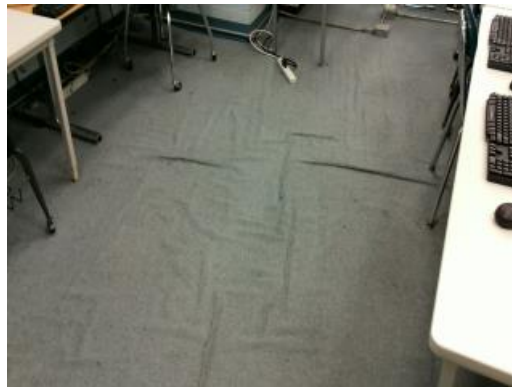
Buckled Carpet In Library

Deficiency	Category	Qty	UoM	Priority	Repair Cost	ID
The Carpet Flooring Requires Replacement	Capital Renewal	11,264	SF	3	\$265,484	1931
Note: The carpet throughout the facility and particularly in the library is worn and buckling, creating a tripping hazard.						
The Vinyl Composition Tile Requires Replacement	Capital Renewal	56,320	SF	3	\$699,929	1930
Note: The majority of the VCT in the facility is chipped, faded, and worn, with numerous cracks across the floors (particularly in the hallways).						
Adhered Acoustical Ceiling Tile Requires Replacement	Capital Renewal	5,632	SF	4	\$66,162	1935
Note: The adhered ceiling tiles, particularly in the boys locker room, are falling off of the ceiling or are otherwise deficient.						
Caulking - significant areas of broken pieces &/or deteriorating caulk	Hazardous Material	610	LF	4	\$12,565	Rollup
Ceiling Grid Requires Replacement	Capital Renewal	61,953	SF	4	\$796,026	1934

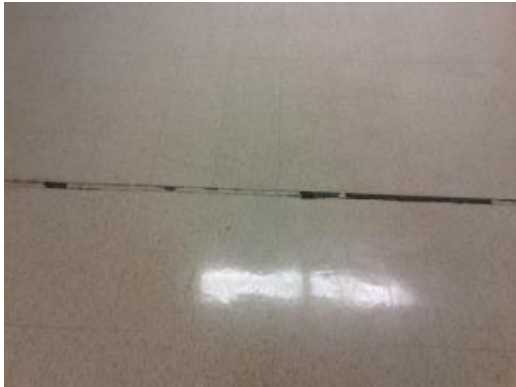
Cracks In VCT

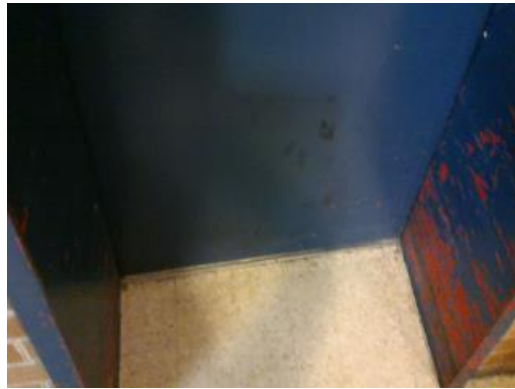
Non-Compliant Elevator Door

Deficiency	Category	Qty	UoM	Priority	Repair Cost	ID
The Existing Building Elevator Is Not ADA Compliant	Barrier to Accessibility	3	Stop	3	\$926,930	1938
<p>Note: The passenger elevator door is less than 3' wide; it is unlikely a wheelchair could easily access the elevator. It also does not go to the third floor.</p>						
Sub Total for System		1	items		\$926,930

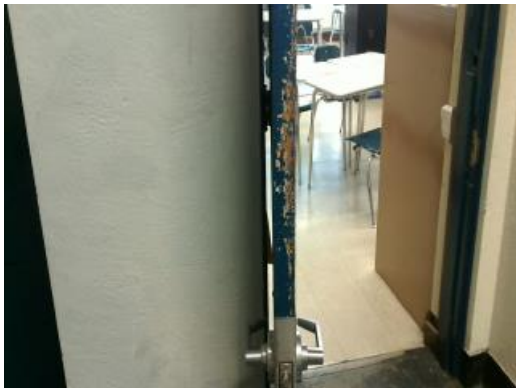
Worn Interior Door

Deficiency	Category	Qty	UoM	Priority	Repair Cost	ID
Interior Doors Require Replacement Note: Interior doors are chipped, allow air to leak, and often stick.	Capital Renewal	124	Door	3	\$619,395	1927
The Acoustical Ceiling Tiles Require Replacement Note: Acoustic tiles throughout the facility show signs of roof leaks; they are stained, torn, flaking, and are often bulging out of the grid.	Capital Renewal	61,953	SF	3	\$606,164	1937

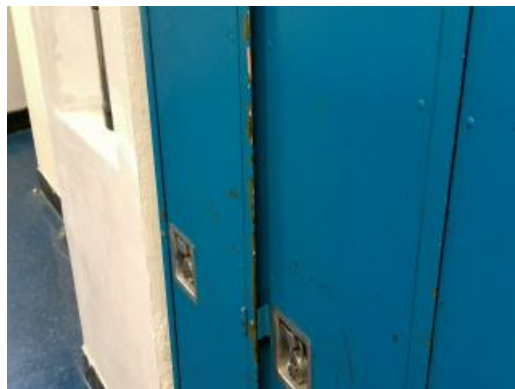
Typical Worn Lockers

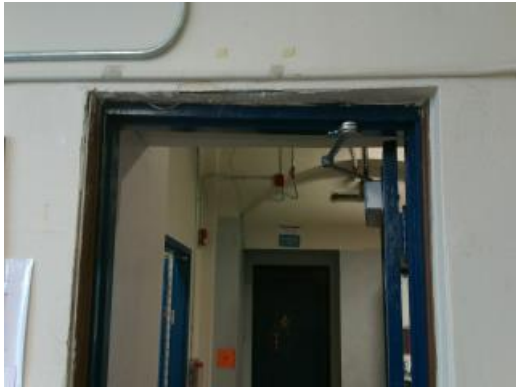
Door Frame Separated From Wall

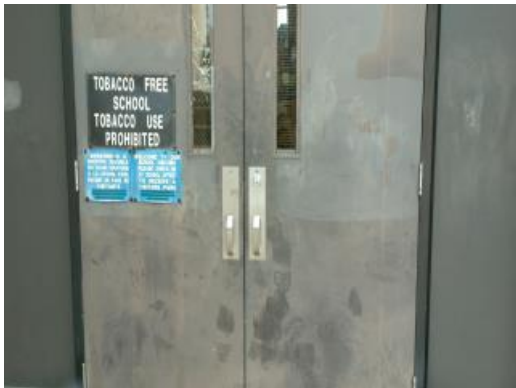
Faded Exterior Doors

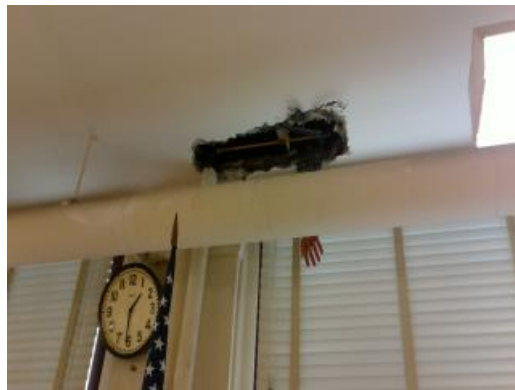
Hole In Gypsum Board Ceiling

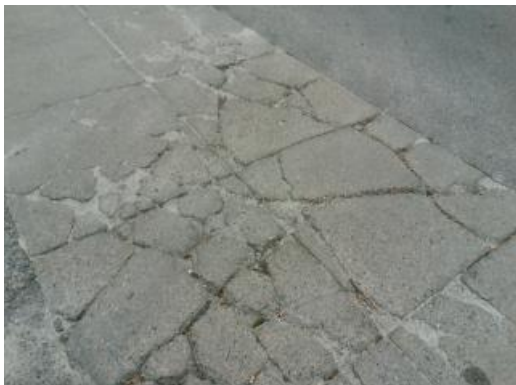
Cracked Sidewalk

Deficiency	Category	Qty	UoM	Priority	Repair Cost	ID
Concrete Walks Require Replacement Note: The sidewalks surrounding the school are cracked and pose a tripping hazard.	Capital Renewal	800	SF	3	\$21,121	4361
Traffic Signage Is Required Note: Add school zone speed zone signage along Summer Street and Illinois Street	Traffic	4	Ea.	3	\$196,477	4470
Backstops Require Replacement Note: Backstops Require Replacement	Educational Adequacy	1	Ea.	4	\$36,840	28418
Fencing Requires Replacement (8' Chain Link Fence)	Capital Renewal	150	LF	4	\$13,025	3034
PE / Recess Playfield is Missing and is Needed Note: PE / Recess Playfield is Missing and is Needed	Educational Adequacy	1	Ea.	5	\$64,020	54864
School has insufficient # of tennis courts. Note: School has insufficient # of tennis courts.	Educational Adequacy	1	Ea.	5	\$210,145	28998
School has insufficient baseball fields. Note: School has insufficient baseball fields.	Educational Adequacy	1	Ea.	5	\$270,156	28315

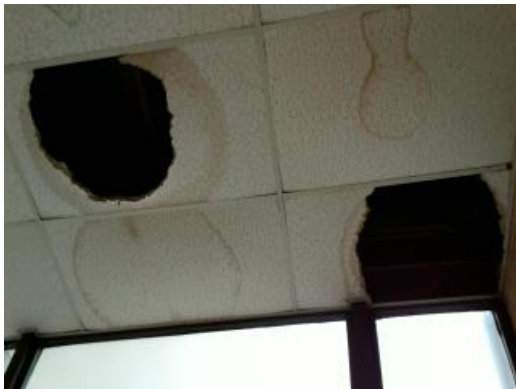
Stained And Broken Ceiling Tiles

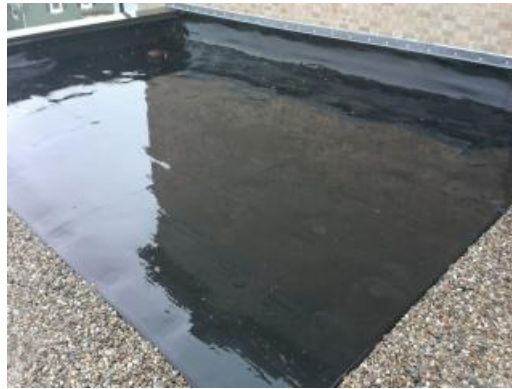
Water Ponding On Roof

Deficiency	Category	Qty	UoM	Priority	Repair Cost	ID
Built-up Roofing With Aggregate Ballast Requires Replacement Note: This roof has not been resurfaced or replaced in recent years; only a small patch on one side of the 1973 addition was repaired recently and continues to leak. It may have exacerbated the issue by allowing water to leak under the ballast and membrane of the adjacent areas. Where the original building and addition meet shows signs of continuous water damage and leaks.	Capital Renewal	35,000	SF	2	\$1,441,890	2034
Sub Total for System		1	items		\$1,441,890

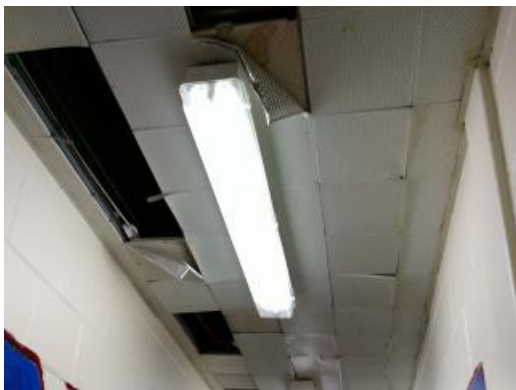
Failing Adhered Ceiling Tiles

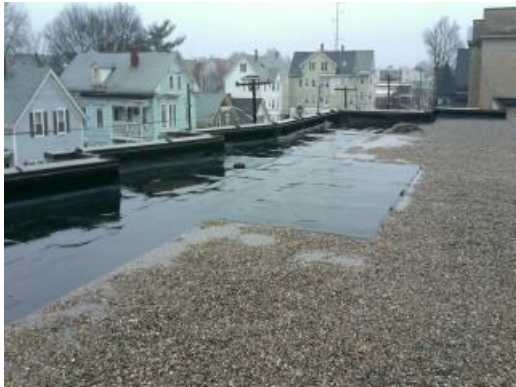
Ponding On Roof

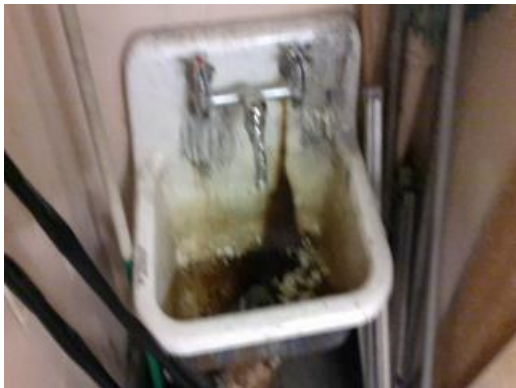
Corroded Mop Sink

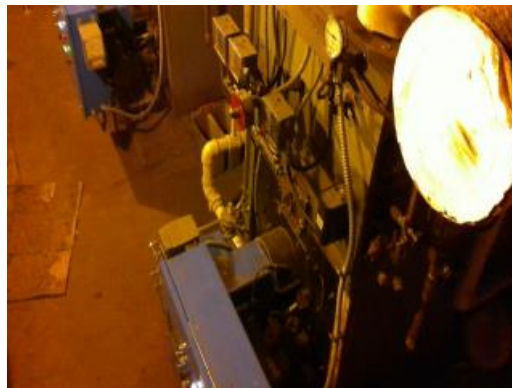
1965 Boiler

Deficiency	Category	Qty	UoM	Priority	Repair Cost	ID
The Boiler HVAC Component Requires Replacement	Capital Renewal	2	Ea.	2	\$369,075	2005
The Mechanical / HVAC Piping / System Is Beyond Its Useful Life	Capital Renewal	112,641	SF	2	\$940,613	2037
Note: System is corroded and leaking.						
The Steam/Hot Water Radiant Heater Requires Replacement	Capital Renewal	147	Ea.	2	\$822,699	1999
Note: Corrosion at connections and fins are clogged.						
The Window AC Unit Component Requires Replacement	Capital Renewal	9	Ea.	2	\$32,554	2000
Note: Condenser fins are collapsed.						
The Make Up Air Equipment Requires Replacement	Capital Renewal	5	Ea.	3	\$86,122	2003
Note: Blower shaft is bent and heat exchangers are rusted.						
Unit Ventilators Are Excessively Noisy	Acoustics	4	Ea.	3	\$27,495	2008
Unit Ventilators Are Excessively Noisy	Acoustics	31	Ea.	3	\$213,085	4647
Note: All classrooms						
Existing Controls Are Inadequate And Should Be Replaced With DDC Controls	Capital Renewal	112,641	SF	4	\$502,735	2149

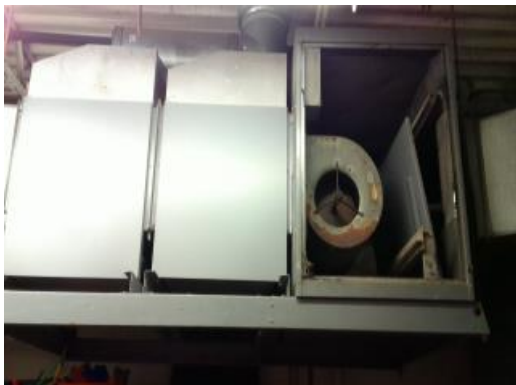
Rusted Make-Up Air Unit
