Facility Condition Assessment

Chariho - Chariho Regional High School

June 2017

453 Switch Road, Wood River Junction, RI 02894

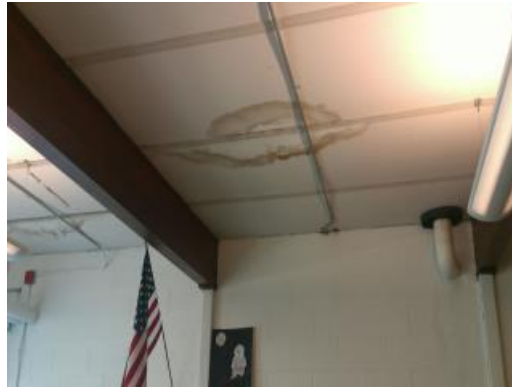
Stained Ceiling Tiles

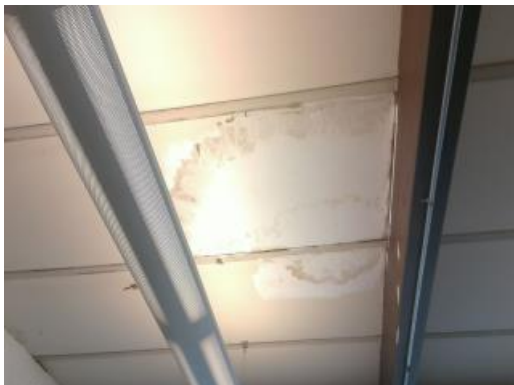
Stained Ceiling Tiles

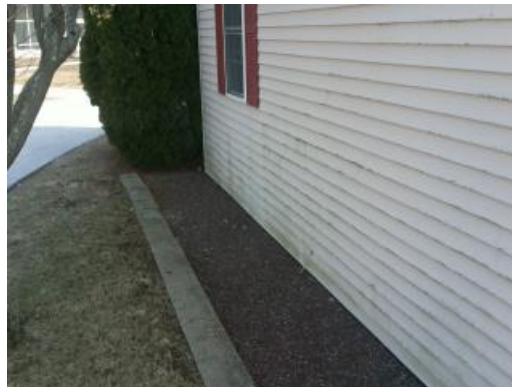
Deficiency	Category	Qty	UoM	Priority	Repair Cost	ID
The Exterior Requires Cleaning	Capital Renewal	10,000	SF Wall	5	\$27,095	1725
Note: The exterior has pollen and mildew on the vinyl siding and should be power washed.						
Sub Total for System		1	items		\$27,095

Admin Building Mildew And Pollen Stained Exterior

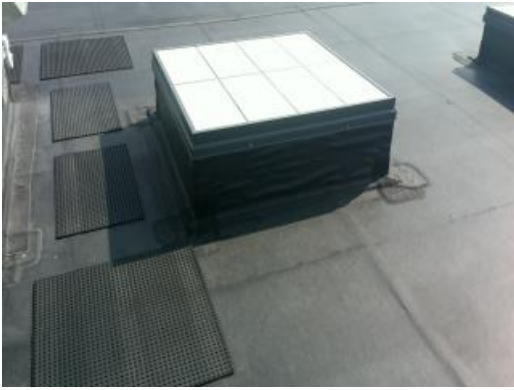
Deficiency	Category	Qty	UoM	Priority	Repair Cost	ID
Snap-On-Seams Require Repair	Capital Renewal	200	LF	3	\$4,278	1736
Note: Ripples or blisters in the roof flashing should be addressed.						
Sub Total for System		1	items		\$4,278

Ripples In The Membrane Flashing

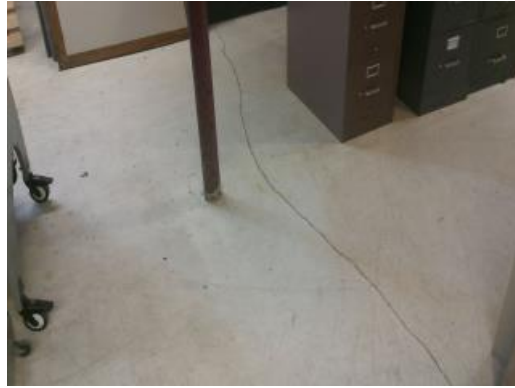
Deficiency	Category	Qty	UoM	Priority	Repair Cost	ID
The Concrete Flooring Requires Replacement	Capital Renewal	1,800	SF	4	\$23,436	1724
Note: There are cracks in the concrete floor basement storage area.						
Sub Total for System		1	items		\$23,436	
Sub Total for Building 03 - Administration Offices		2	items		\$50,531

Admin Building Cracked Concrete Floor

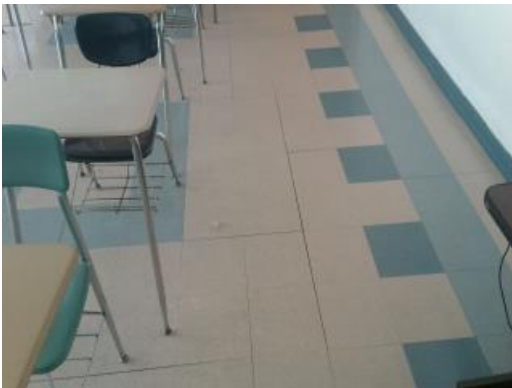
Separating VCT

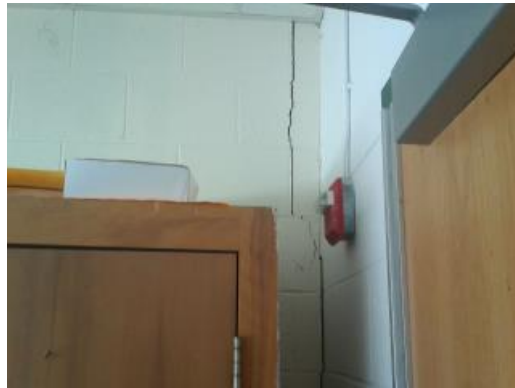
Cracked CMU
