Facility Condition Assessment

Coventry - Coventry High School

June 2017

40 Reservoir Road, Coventry, RI 02816

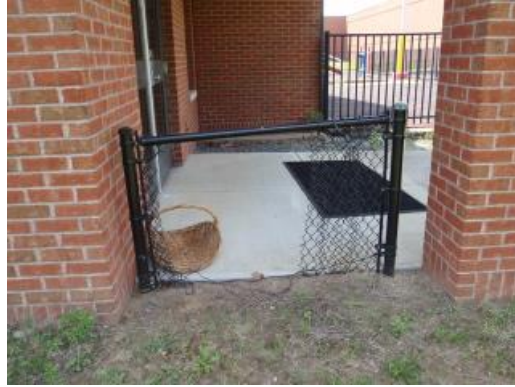
Damaged Chain Link

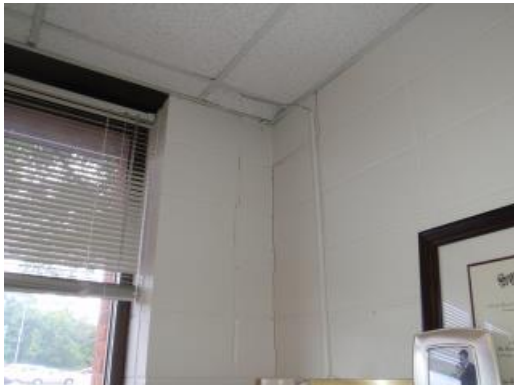
CMU Wall Crack

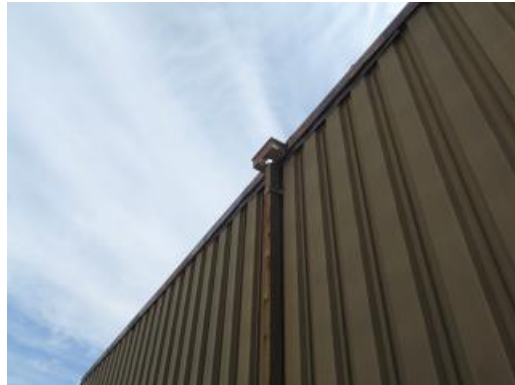
Rusted And Deteriorated Downspout

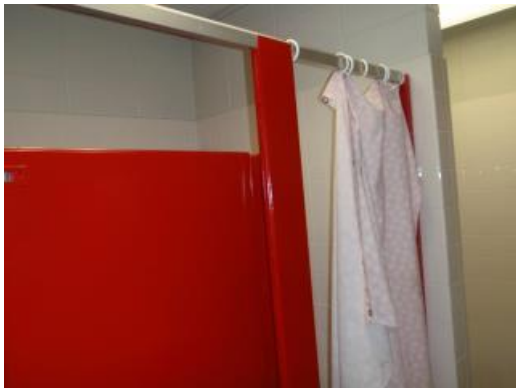
Missing Partition Door

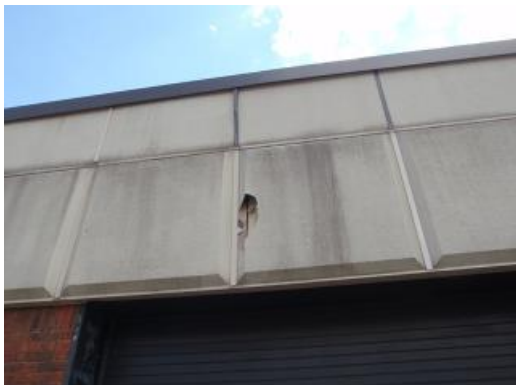
Damaged And Stained Exterior Roof Trim

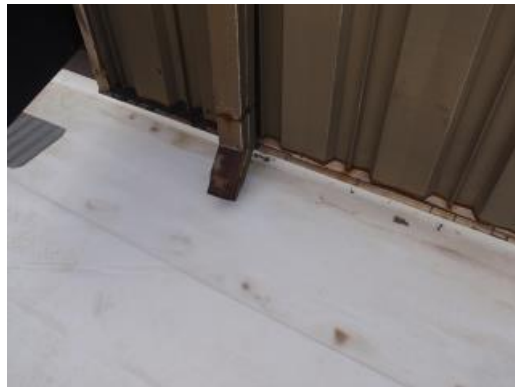
Missing Splash Block

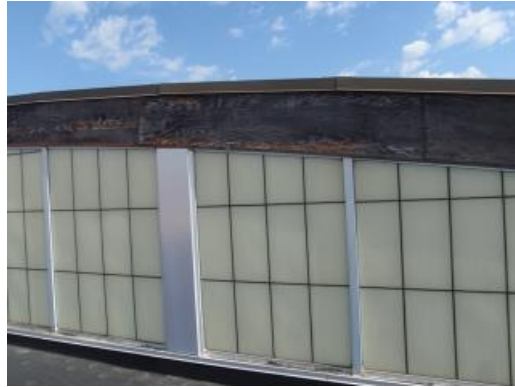
Weathered Wood Edge Trim

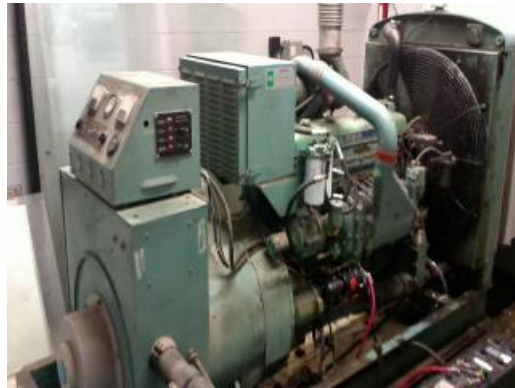
1975 Generator

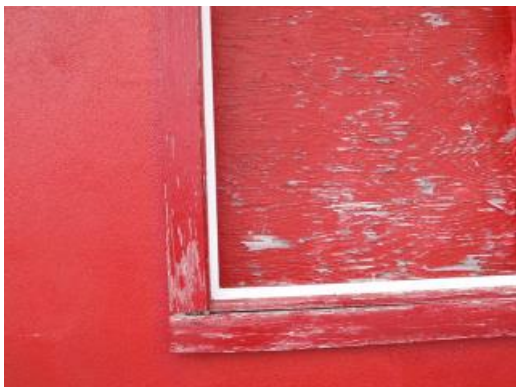
Worn Exterior Paint

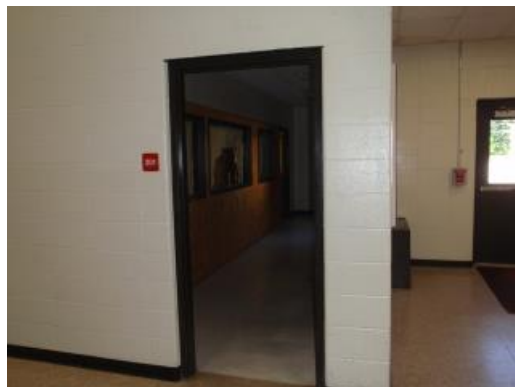
Missing Door
