# Facility Condition Assessment

Cranston - Cranston High School East

June 2017

899 Park Avenue, Cranston, RI 02910

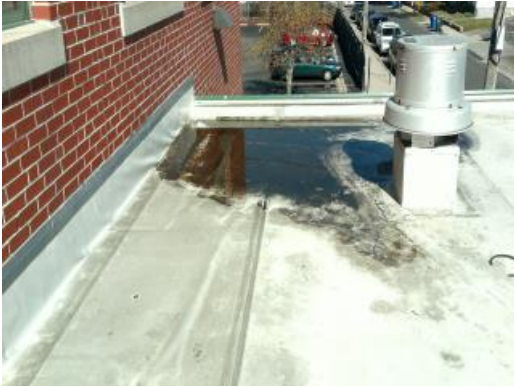
Deficiency	Category	Qty	UoM	Priority	Repair Cost	ID
The Single-Ply Membrane Roof Covering Requires Replacement	Capital Renewal	65,000	SF	2	\$914,767	9701
<b>Note:</b> Ponding, staining, buckling of membrane and insulation feels loose when you walk on it.						
<b>Location:</b> Original building and gym addition						
The Roof Drains Require Cleaning	Capital Renewal	2	Ea.	3	\$87	9671
<b>Note:</b> At the front of the building between the gym addition and original building and on the low roof near the access ladder to the gym roof. Deep standing water in both areas.						
<b>Sub Total for System</b>		<b>2</b>	<b>items</b>		<b>\$914,854</b>

Ponding On Roof

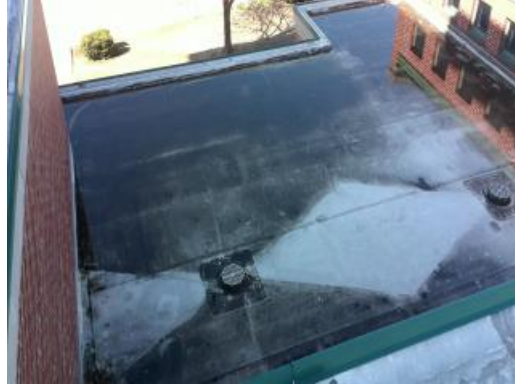
Ponding On Roof

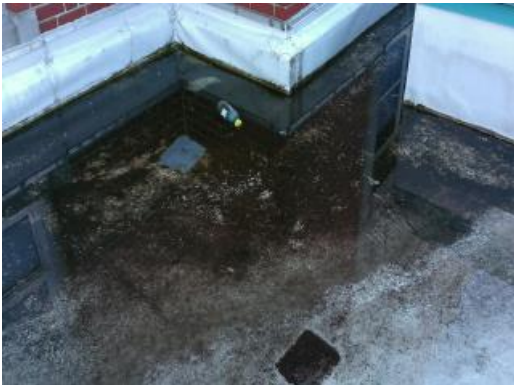
Ponding And Debris On Roof

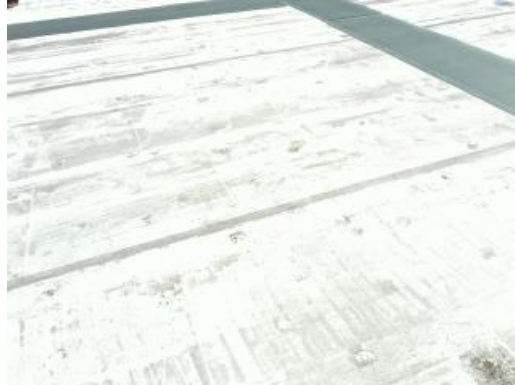
Weathered Roof Membrane

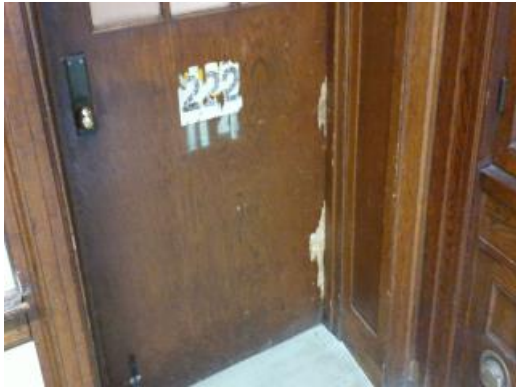
Deficiency	Category	Qty	UoM	Priority	Repair Cost	ID
Interior Doors Require Replacement	Capital Renewal	157	Door	3	\$793,789	9673
<b>Note:</b> Doors and hardware are worn and damaged.						
The Acoustical Ceiling Tiles Require Replacement	Capital Renewal	16,000	SF	3	\$158,455	9672
<b>Location:</b> 4th floor corridor, Nurses' Office, and miscellaneous older classrooms						
The Interior Door Hardware Requires Replacement	Capital Renewal	303	Door	3	\$1,042,366	9681
<b>Note:</b> No master key. Custodian has ring with 20+ keys for all doors in building.

Damaged Interior Wood Door

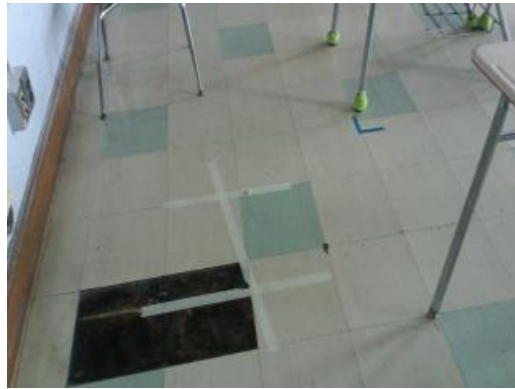
Deficiency	Category	Qty	UoM	Priority	Repair Cost	ID
The Vinyl Composition Tile Requires Replacement	Capital Renewal	35,721	SF	3	\$449,339	9674
<b>Note:</b> VCT in classrooms needs replacement, it's damaged and seams are lifting.						
Adhered Acoustical Ceiling Tile Requires Replacement	Capital Renewal	5,000	SF	4	\$59,453	9703
<b>Note:</b> Adhesive is failing and the tiles are falling in cafe.						
Light Deterioration or Damage of 9x9 Asbestos Floor Tile is Present	Hazardous Material	130	SF	4	\$4,066	Rollup
Paint (probable pre-1978 in base layer(s)) - damaged area < 9 sq. ft. OR overall worn AND in children-accessible area (measurement unit - each)	Hazardous Material	76	Ea.	4	\$23,768	Rollup
Paint (probable pre-1978 in base layer(s)) - damaged area < 9 sq. ft. OR overall worn AND in children-accessible area (measurement unit - linear feet)	Hazardous Material	320	LF	4	\$8,006	Rollup
Paint (probable pre-1978 in base layer(s)) - damaged area < 9 sq. ft. OR overall worn AND in children-accessible area (measurement unit - square feet)	Hazardous Material	23,730	SF	4	\$247,378	Rollup

Damaged VCT In Classrooms

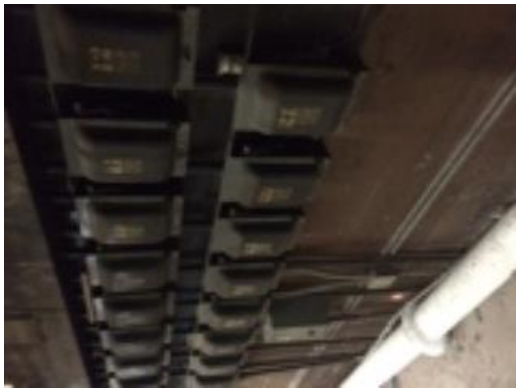
Original Disconnects

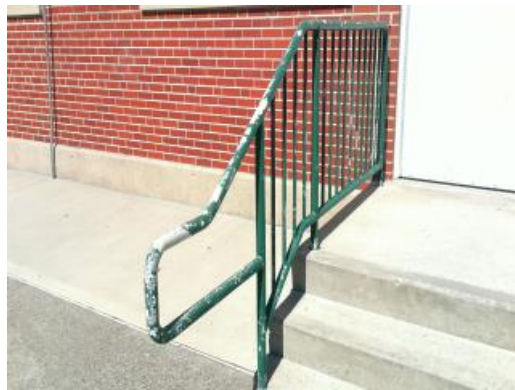
Peeling Handrail

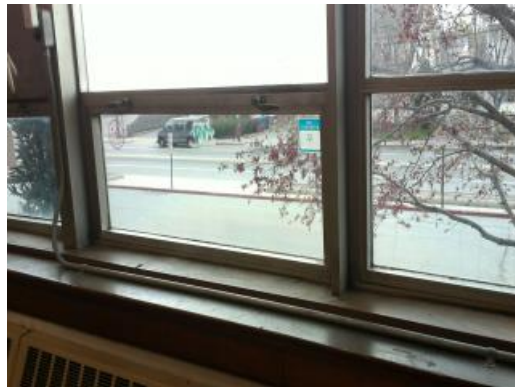
Single Pane Windows

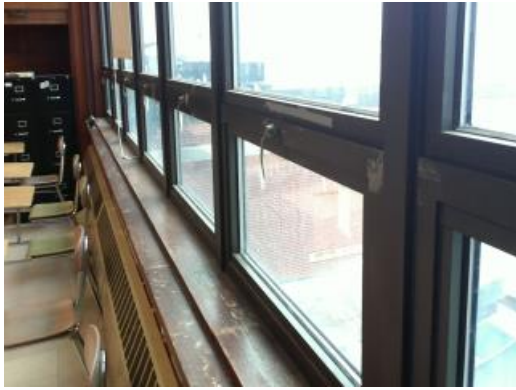
Deficiency	Category	Qty	UoM	Priority	Repair Cost	ID
The Storefront/Curtain Wall Requires Replacement (Bldg SF)	Capital Renewal	7,000	SF	2	\$618,810	9695
<b>Note:</b> Storefront windows in 3rd and 4th floor classrooms at rear of building are being kept shut with duct tape.						
The Storefront/Curtain Wall Requires Replacement (Bldg SF)	Capital Renewal	16,829	SF	2	\$1,487,708	9696
<b>Note:</b> Original single pane glass. Do not operate properly and let air in.						
Exterior Metal Door Requires Repainting	Capital Renewal	24	Door	3	\$5,464	9670
<b>Note:</b> All exterior doors need scraping, priming and painting.						
Handrail Requires Repainting	Capital Renewal	20	LF	4	\$229	9680
<b>Note:</b> Paint is peeling at exterior handrail.						
<b>Sub Total for System</b>		<b>4</b>	<b>items</b>		<b>\$2,112,212</b>

Storefront Windows

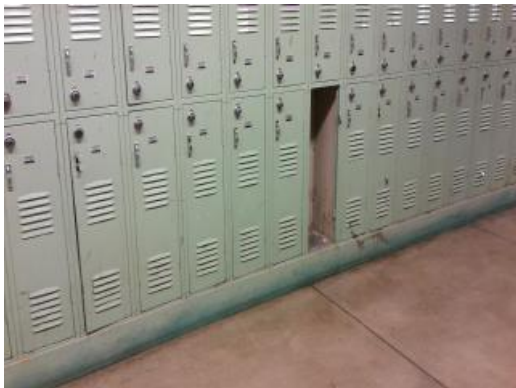
Deficiency	Category	Qty	UoM	Priority	Repair Cost	ID
Room has insufficient writing area.	Educational Adequacy	6	Ea.	3	\$27,714	Rollup
The Metal Student Lockers Require Replacement <b>Note:</b> Many lockers are broken and the locks do not function well.	Capital Renewal	2,000	Ea.	4	\$1,078,956	9697
Welding Bays Are Required	Educational Adequacy	1	Ea.	4	\$5,485	Rollup
Room lacks an appropriate refrigerator.	Educational Adequacy	10	Ea.	5	\$86,605	Rollup
The room lacks a washer and/or dryer.	Educational Adequacy	1	Ea.	5	\$13,857	Rollup
<b>Sub Total for System</b>		<b>5</b>	<b>items</b>		<b>\$1,212,617</b>	
<b>Sub Total for Building 01 - Main Building</b>		<b>79</b>	<b>items</b>		<b>\$18,412,791</b>	
<b>Total for Campus</b>		<b>87</b>	<b>items</b>		<b>\$19,798,009</b>

Damaged Lockers
