# Facility Condition Assessment

Cranston - Cranston High School West

June 2017

80 Metropolitan Avenue, Cranston, RI 02920

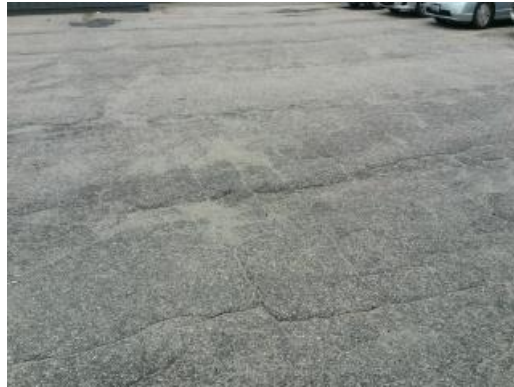
Weathered Roadway Asphalt

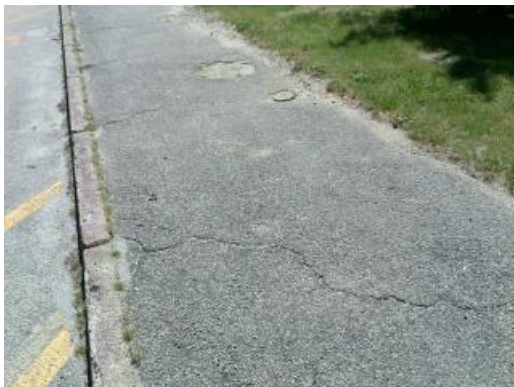
| Deficiency | Category | Qty | UoM | Priority | Repair Cost | ID |
|---|---|---|---|---|---|---|
| Asphalt Walks Require Replacement<br><b>Note:</b> Asphalt walkways are cracked and uneven. | Capital Renewal | 6,507 | SF | 3 | \$70,352 | 12117 |

Cracked And Weathered Sidewalk

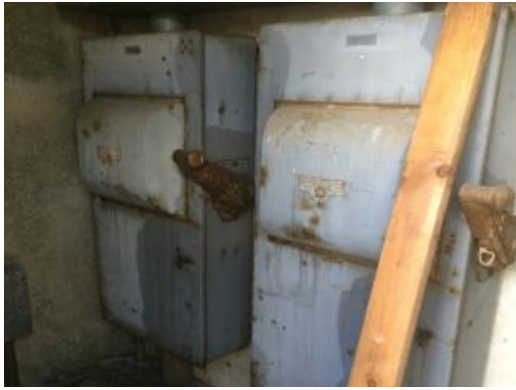
| Deficiency | Category | Qty | UoM | Priority | Repair Cost | ID |
|---|---|---|---|---|---|---|
| The Electrical Disconnect Requires Replacement<br><b>Note:</b> Electrical disconnects in the remote vault are heavily corroded and should be replaced. | Capital Renewal | 6 | Ea. | 2 | \$121,969 | 12119 |

Rusted Disconnects

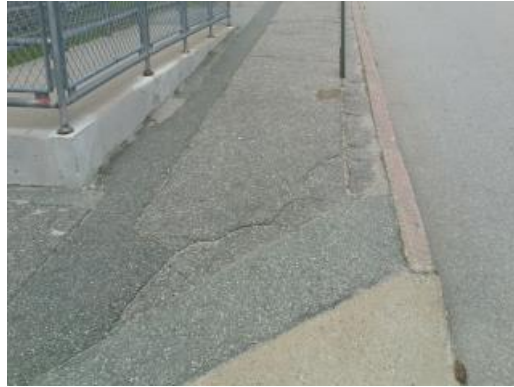
Uneven Sidewalk

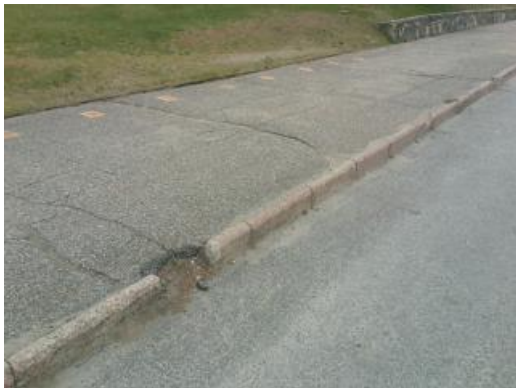
| Deficiency | Category | Qty | UoM | Priority | Repair Cost | ID |
|---|---|---|---|---|---|---|
| Parking Or Roadway Curbs Require Replacement<br><b>Note:</b> Concrete curbs at the front of the school are cracked and broken and pose a tripping hazard. | Capital Renewal | 1,000 | LF | 3 | \$96,228 | 12120 |

Damaged Curb At Main Entrance

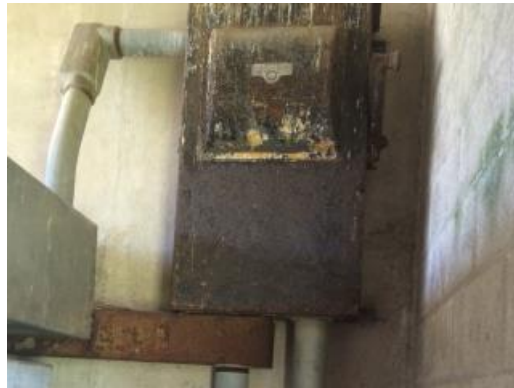
Corroded Disconnect

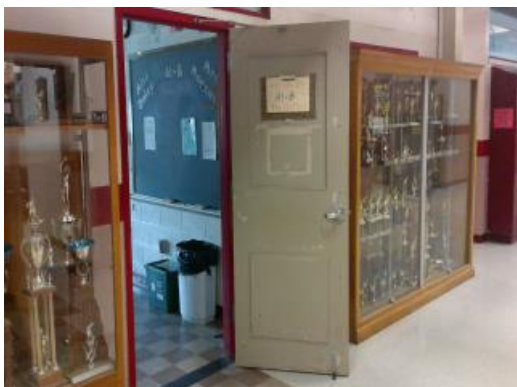
| Deficiency | Category | Qty | UoM | Priority | Repair Cost | ID |
|---|---|---|---|---|---|---|
| Interior Doors Require Replacement<br><b>Note:</b> Original wood doors are aged and worn. | Capital Renewal | 170 | Door | 3 | \$826,458 | 12122 |

Original Wood Door

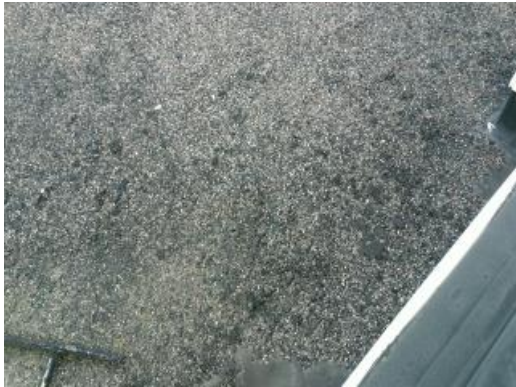
| Deficiency | Category | Qty | UoM | Priority | Repair Cost | ID |
|---|---|---|---|---|---|---|
| Built-up Roofing With Aggregate Ballast Requires Replacement<br><b>Note:</b> Original roof has some membrane patching and is showing signs of wear and age. Staff reported that it is scheduled to be replaced in the summer of 2016. | Capital Renewal | 18,890 | SF | 2 | \$757,395 | 12127 |

Weathered Roof

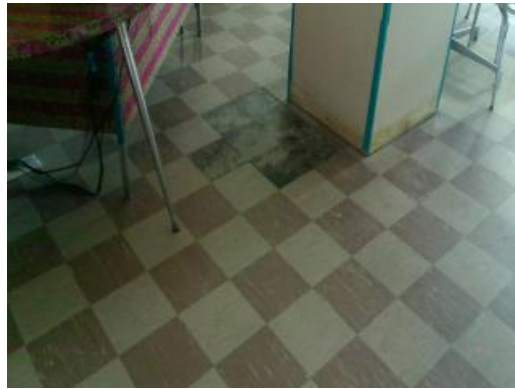
| Deficiency | Category | Qty | UoM | Priority | Repair Cost | ID |
|---|---|---|---|---|---|---|
| Asbestos 9x9 Tile is Present. Limited Areas of Lifting or Broken Tiles Exist | Hazardous Material | 68,003 | SF | 4 | \$2,044,935 | Rollup |

9x9 Tile

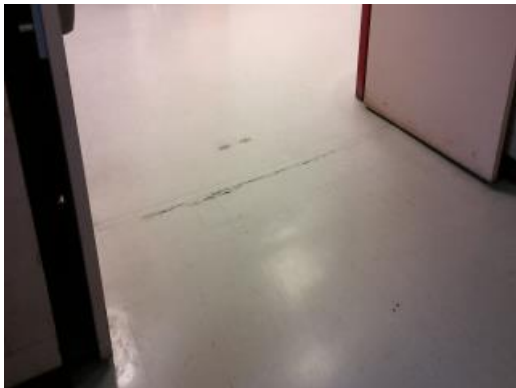
Worn Vinyl Composition Tile

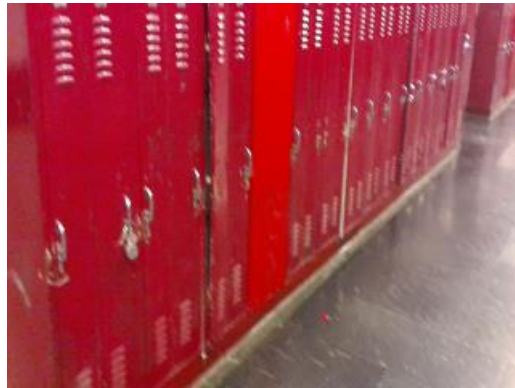
Damaged Lockers

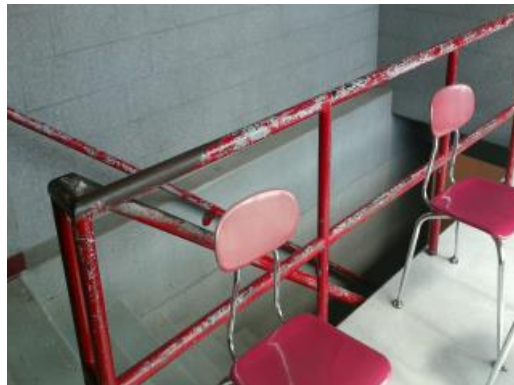
Chipped Handrail Paint

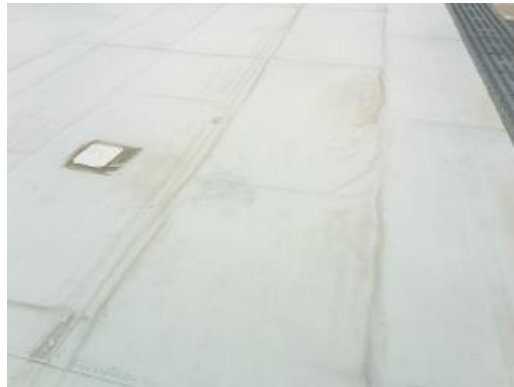
Weathered Gym Roofing

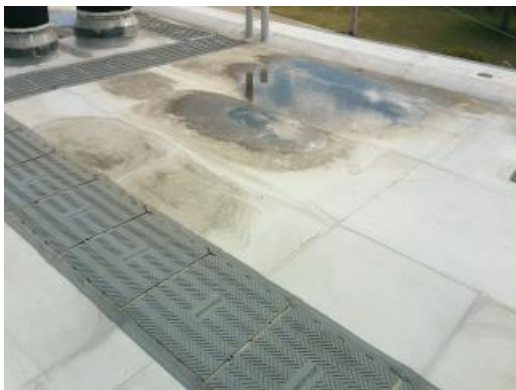
Ponding On Roof

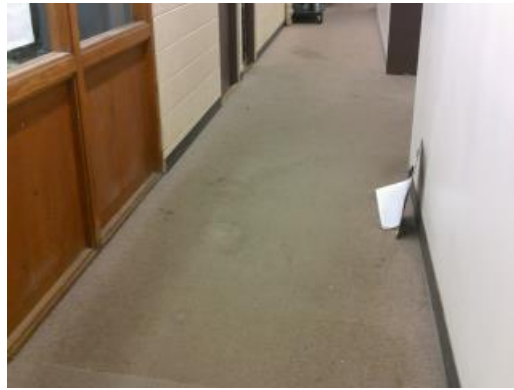
Worn And Stained Carpet

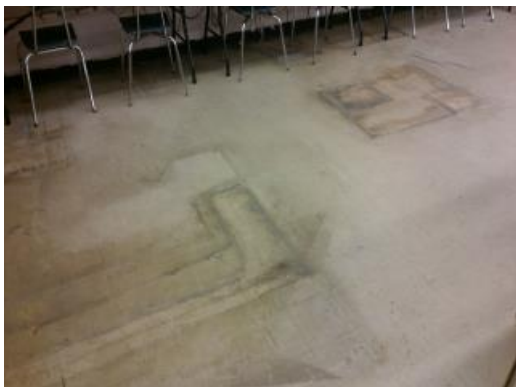
Worn And Stained VCT

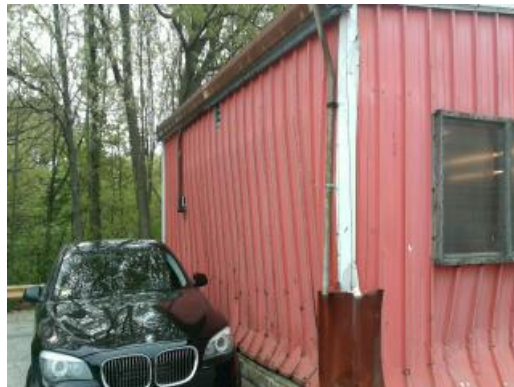
Damaged Metal Facade

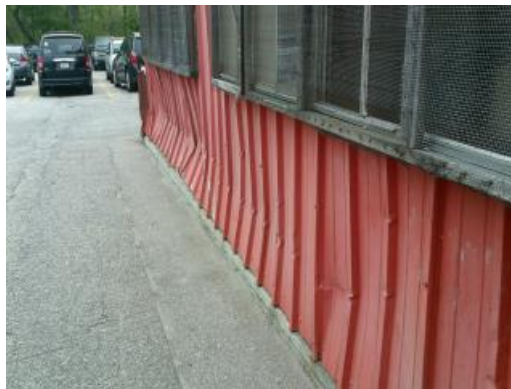
Damaged Facade

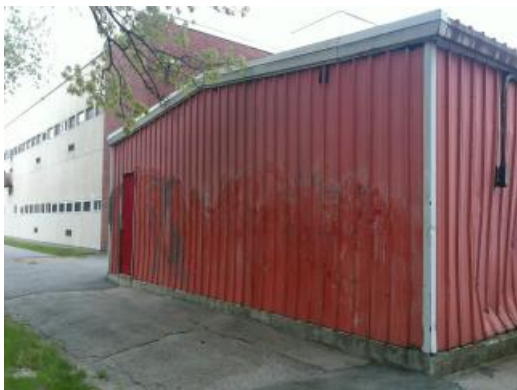
Damaged Facade

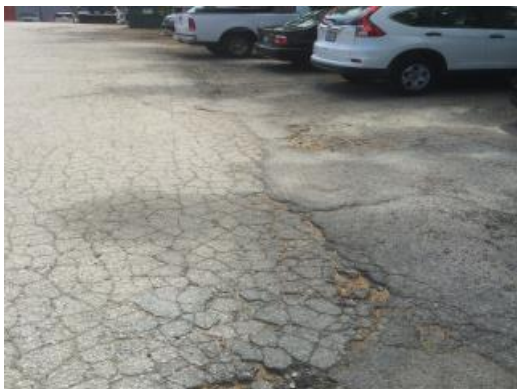
| Deficiency | Category | Qty | UoM | Priority | Repair Cost | ID |
|---|---|---|---|---|---|---|
| Asphalt Paving Requires Replacement<br><b>Note:</b> Asphalt is alligatored and heaving. | Capital Renewal | 448 | CAR | 4 | \$1,875,345 | 12116 |

Alligatoring Parking Lot

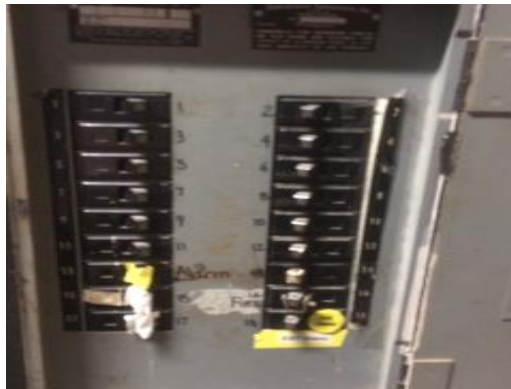
| Deficiency | Category | Qty | UoM | Priority | Repair Cost | ID |
|---|---|---|---|---|---|---|
| The Panelboard Requires Replacement<br><b>Note:</b> The panelboards are obsolete. | Capital Renewal | 8 | Ea. | 2 | \$40,897 | 12131 |

Aged Panelboard

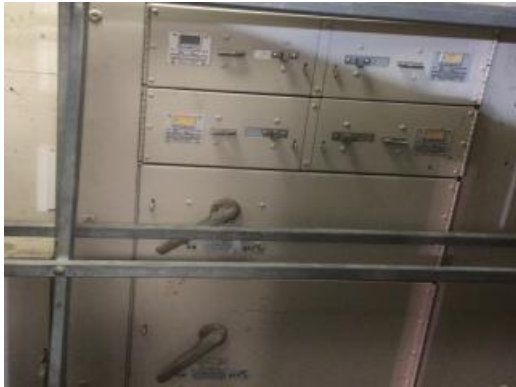
| Deficiency | Category | Qty | UoM | Priority | Repair Cost | ID |
|---|---|---|---|---|---|---|
| Switchgear Is Needed Or Requires Replacement<br><b>Note:</b> Electrical service and distribution switchgear is obsolete. | Capital Renewal | 2 | Ea. | 2 | \$40,656 | 12137 |

Aged Electrical Distribution

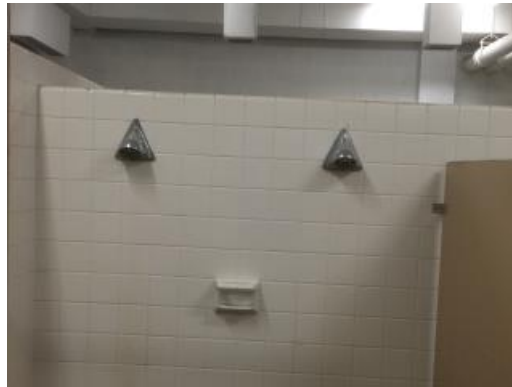
Aged Shower Fixtures

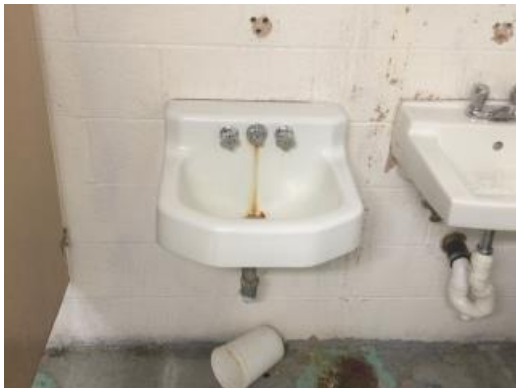
Rusted Sink

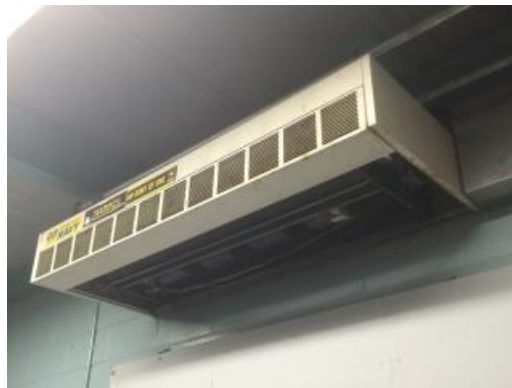
Aged Heating Unit

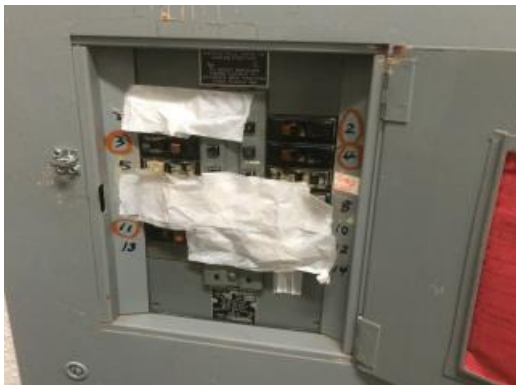
Aged Panelboard

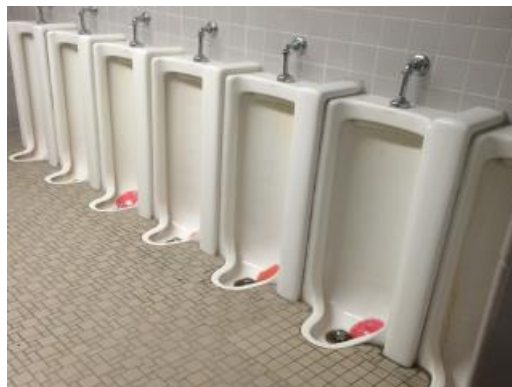
| Deficiency | Category | Qty | UoM | Priority | Repair Cost | ID |
|---|---|---|---|---|---|---|
| The Urinal Plumbing Fixtures Require Replacement<br><b>Note:</b> Urinals are aged and stained and should be replaced. | Capital Renewal | 39 | Ea. | 3 | \$54,651 | 12128 |

Aged Urinal

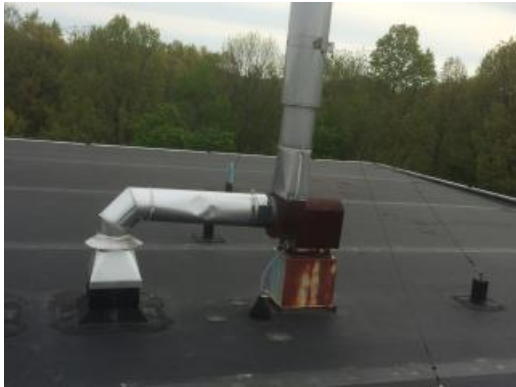
| Deficiency | Category | Qty | UoM | Priority | Repair Cost | ID |
|---|---|---|---|---|---|---|
| The Chemistry Lab Fume Hood(s) Require Replacement<br><b>Note:</b> Fume hood stack is rusted and deteriorating. | Capital Renewal | 2 | Ea. | 4 | \$60,143 | 12121 |

Fume Hood Exhaust Fan Stack

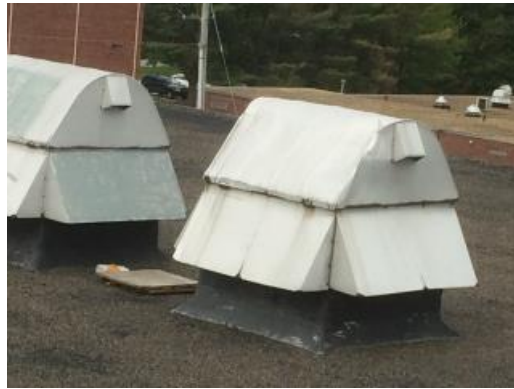
| Deficiency | Category | Qty | UoM | Priority | Repair Cost | ID |
|---|---|---|---|---|---|---|
| The Exhaust Hood Requires Replacement<br><b>Note:</b> Exhaust fans are outdated and deteriorating. | Capital Renewal | 9 | Ea. | 4 | \$49,383 | 12136 |

Aged Exhaust Fans
