Facility Condition Assessment

Cumberland - Cumberland High School

June 2017

2600 Mendon Road, Cumberland, RI 02864

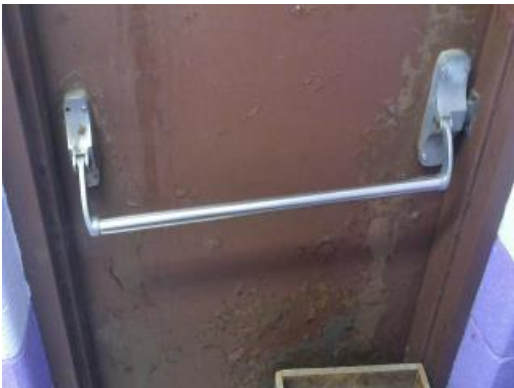
Corroded Exterior Metal Door

Deficiency	Category	Qty	UoM	Priority	Repair Cost	ID
The Metal Exterior Door Requires Replacement	Capital Renewal	7	Door	2	\$44,920	11026
Sub Total for System		1	items		\$44,920

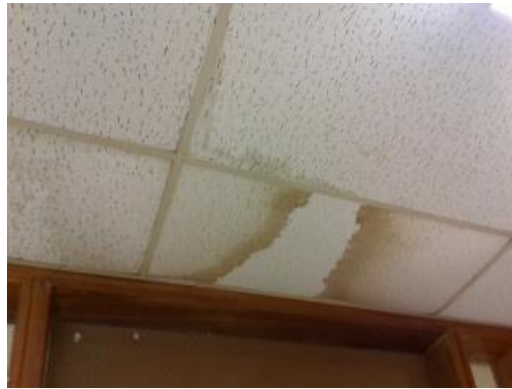
Stained Ceiling Tiles

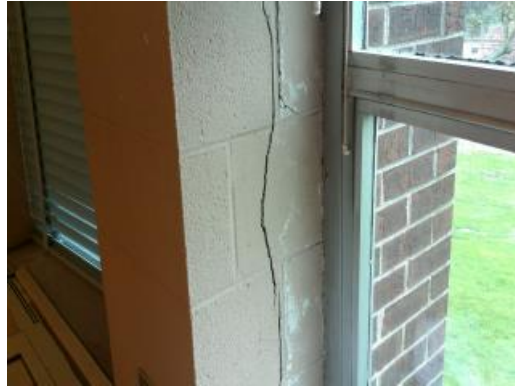
Deficiency	Category	Qty	UoM	Priority	Repair Cost	ID
Interior CMU Walls Require Repair	Capital Renewal	313	SF	3	\$11,367	11031
Note: Cracked CMU in Rooms 200, 201, 202 and 203.						
The Acoustical Ceiling Tiles Require Replacement	Capital Renewal	59,837	SF	3	\$540,425	11027
The Carpet Flooring Requires Replacement	Capital Renewal	6,994	SF	3	\$152,163	11028
The Vinyl Composition Tile Requires Replacement	Capital Renewal	46,626	SF	3	\$534,882	11029
Ceiling Grid Requires Replacement	Capital Renewal	59,837	SF	4	\$709,697	11036
Room Lighting Is Inadequate Or In Poor Condition.	Educational Adequacy	468	SF	4	\$17,833	Rollup
Sub Total for System		6 items			\$1,966,366

Cracked CMU

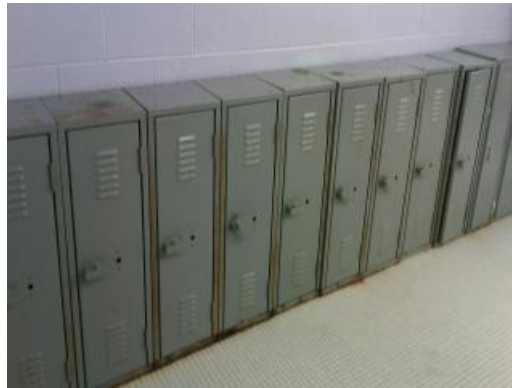
Aged Pool Lockers

Deficiency	Category	Qty	UoM	Priority	Repair Cost	ID
Room has insufficient writing area.	Educational Adequacy	16	Ea.	3	\$73,014	Rollup
The Metal Student Lockers Require Replacement Location: Pool locker rooms	Capital Renewal	65	Ea.	4	\$31,979	11025
Work Tables Are Required	Educational Adequacy	2	Ea.	4	\$7,170	Rollup
Room lacks an appropriate refrigerator.	Educational Adequacy	14	Ea.	5	\$119,788	Rollup
Sub Total for System		4	items		\$231,951	
Sub Total for Building 01 - Main Building		53	items		\$11,771,975

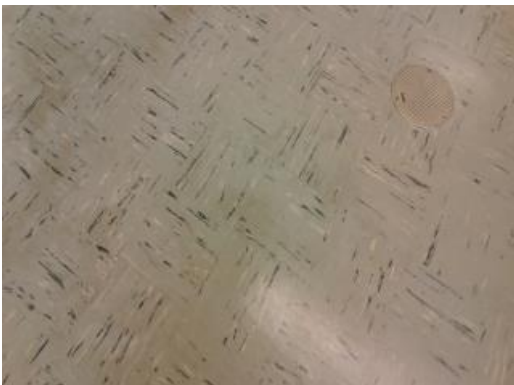
Worn VCT
