# Facility Condition Assessment

East Greenwich - East Greenwich High School

June 2017

300 Avenger Drive, East Greenwich, RI 02818

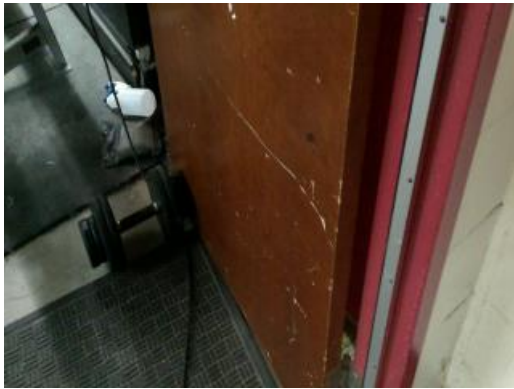
Weight Room Door

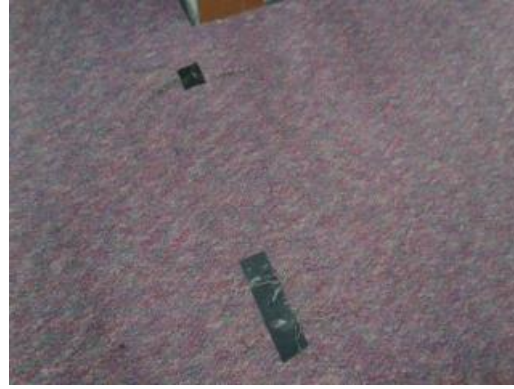
Auditorium Carpet

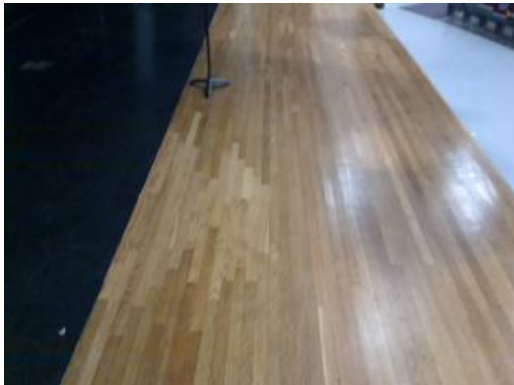
Worn Wood Flooring at Stage

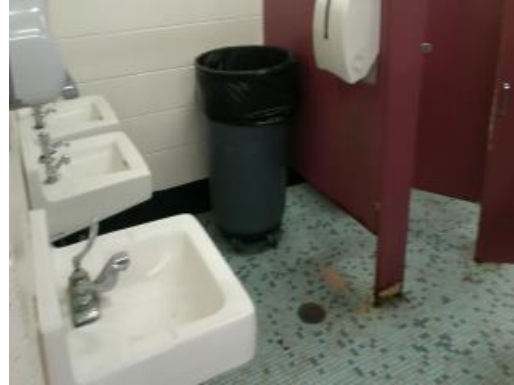
Girls Locker Room Tile Flooring

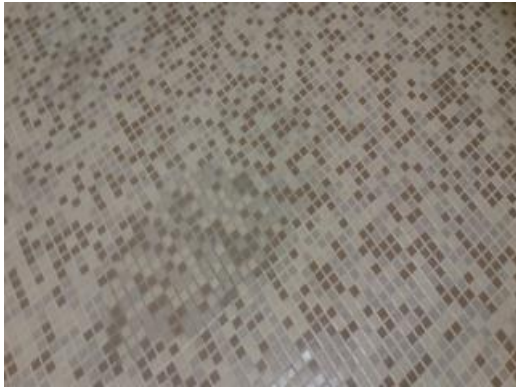
Worn Tile Flooring

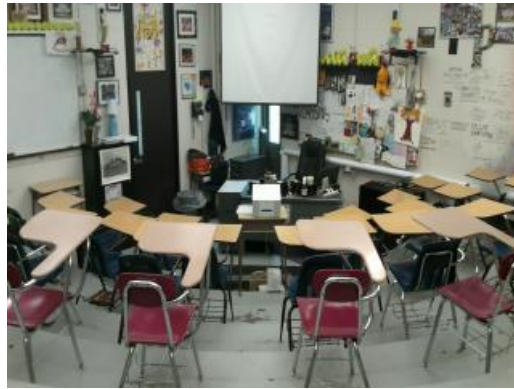
Paint Theater Flooring

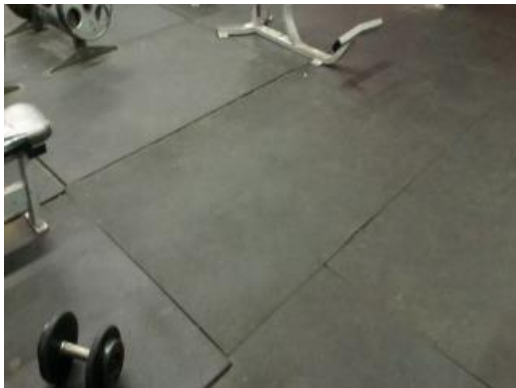
Worn Flooring at Weight Room

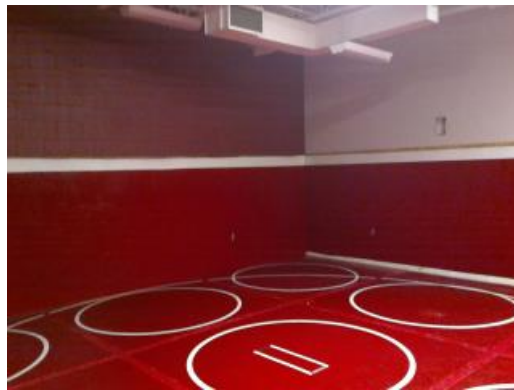
Wrestling Flooring

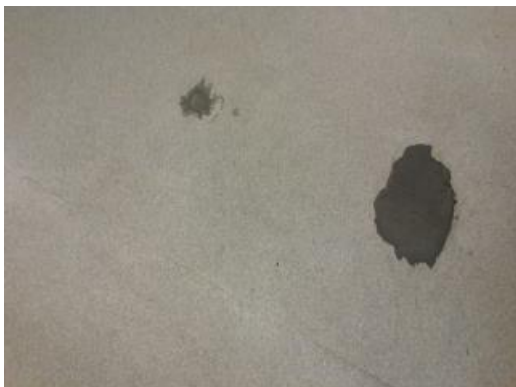
Epoxy Flooring at Kitchen

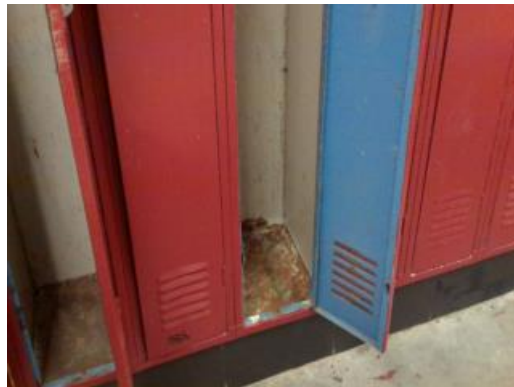
Deficiency	Category	Qty	UoM	Priority	Repair Cost	ID
The Metal Student Lockers Require Replacement <b>Note:</b> Lockers are corroding and coming apart	Capital Renewal	85	Ea.	4	\$41,819	12706
Work Tables Are Required	Educational Adequacy	3	Ea.	4	\$10,755	Rollup
Room lacks an appropriate refrigerator.	Educational Adequacy	1	Ea.	5	\$8,556	Rollup
	<b>Sub Total for System</b>	<b>5</b>	<b>items</b>		<b>\$191,262</b>	
	<b>Sub Total for Building 01 - Main Building</b>	<b>83</b>	<b>items</b>		<b>\$16,975,370</b>	
	<b>Total for Campus</b>	<b>87</b>	<b>items</b>		<b>\$17,589,521</b>

Corroded Locker at Boy's Locker Room

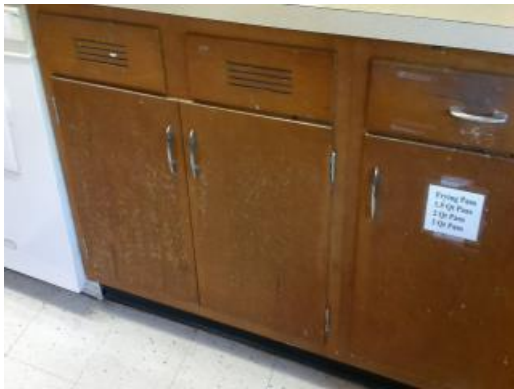
Deficiency	Category	Qty	UoM	Priority	Repair Cost	ID
Room has insufficient writing area.	Educational Adequacy	4	Ea.	3	\$18,253	Rollup
Replace Cabinetry In Classes/Labs	Capital Renewal	10	Room	4	\$111,878	12707
<b>Note:</b> Cabinetry is scratched and worn

Family and Consumer Science Cabinetry

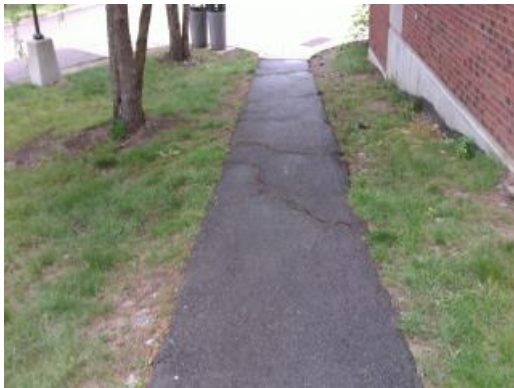
Deficiency	Category	Qty	UoM	Priority	Repair Cost	ID
Asphalt Walks Require Replacement <b>Note:</b> Asphalt walks are cracked and damaged	Capital Renewal	3,200	SF	3	\$27,161	12686
Asphalt Paving Requires Replacement <b>Location:</b> Visitor and Rear Faculty Parking	Capital Renewal	143	CAR	4	\$469,932	16337
Asphalt Paving Requires Replacement <b>Note:</b> Asphalt roadway is damaged next to track	Capital Renewal	27	CAR	4	\$88,729	16338
Backstops Require Replacement <b>Note:</b> Backstops Require Replacement	Educational Adequacy	1	Ea.	4	\$28,329	28461
<b>Sub Total for System</b>		<b>4</b>	<b>items</b>		<b>\$614,151</b>	
<b>Sub Total for School and Site Level</b>		<b>4</b>	<b>items</b>		<b>\$614,151</b>

Asphalt Walkway

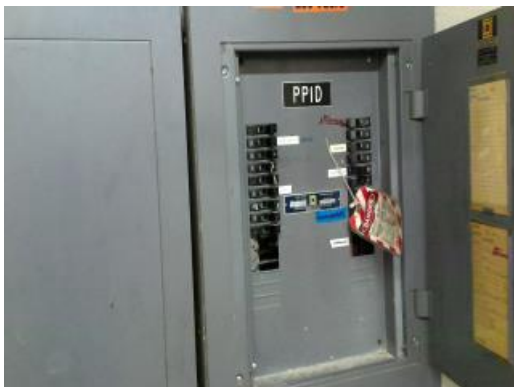
The Panelboard Requires Replacement	Capital Renewal	7	Ea.	2	\$53,905	16351
The Panelboard Requires Replacement	Capital Renewal	2	Ea.	2	\$23,920	16352
Room Has Insufficient Electrical Outlets	Educational Adequacy	76	Ea.	5	\$37,716	Rollup
<b>Sub Total for System</b>		<b>14</b>	<b>items</b>		<b>\$495,565</b>

Typical Panelboard

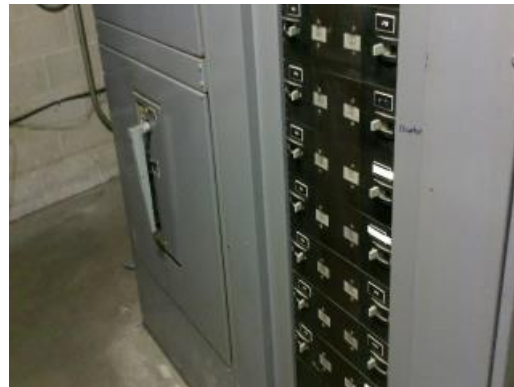
Deficiency	Category	Qty	UoM	Priority	Repair Cost	ID
Room last power shut-off valves for utilities	Educational Adequacy	7	Ea.	1	\$9,886	Rollup
Switchgear Is Needed Or Requires Replacement	Capital Renewal	1	Ea.	2	\$82,102	16343
The Distribution Panel Requires Replacement	Capital Renewal	1	Ea.	2	\$51,908	16346
The Electrical Disconnect Requires Replacement	Capital Renewal	3	Ea.	2	\$5,499	16353
The Electrical Transformer Requires Replacement	Capital Renewal	11	Ea.	2	\$77,345	12702
The Electrical Transformer Requires Replacement	Capital Renewal	3	Ea.	2	\$24,117	16344
The Electrical Transformer Requires Replacement	Capital Renewal	1	Ea.	2	\$10,520	16345
The Panelboard Requires Replacement	Capital Renewal	14	Ea.	2	\$67,880	16347
The Panelboard Requires Replacement	Capital Renewal	1	Ea.	2	\$3,898	16348
The Panelboard Requires Replacement	Capital Renewal	7	Ea.	2	\$40,595	16349
The Panelboard Requires Replacement	Capital Renewal	1	Ea.	2	\$6,275	16350

Main Switchgear

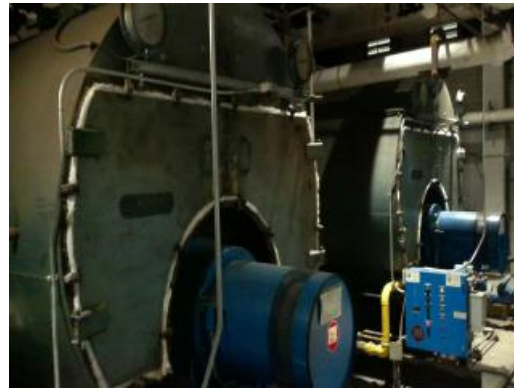
Deficiency	Category	Qty	UoM	Priority	Repair Cost	ID
The Cast Iron Water Boiler Requires Replacement <b>Note:</b> 250 MBH	Capital Renewal	2	Ea.	2	\$62,510	16540
The Fin Tube Water Radiant Heater Requires Replacement	Capital Renewal	42	Ea.	2	\$70,355	16542
The Mechanical / HVAC Piping / System Is Beyond Its Useful Life	Capital Renewal	158,000	SF	2	\$1,217,894	16547
The Steam Condensate Receiver Requires Replacement	Capital Renewal	3	Ea.	2	\$1,055,274	16541
The Steam/Hot Water Radiant Heater Requires Replacement	Capital Renewal	4	Ea.	2	\$20,664	16545
Kitchen Air/Exhaust Is Inadequate And Should Be Repaired <b>Note:</b> Wall switch does not work and steam backs up to the kitchen	Capital Renewal	1	Ea.	3	\$1,260	12700
Testing And Balancing Required	Capital Renewal	183,300	SF	3	\$341,666	12685
The Make Up Air Equipment Requires Replacement <b>Note:</b> Original from 1965	Capital Renewal	1	Ea.	3	\$15,899	12699

Boilers

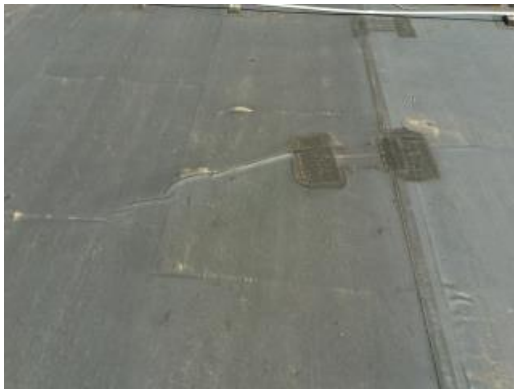
Roof Repairs

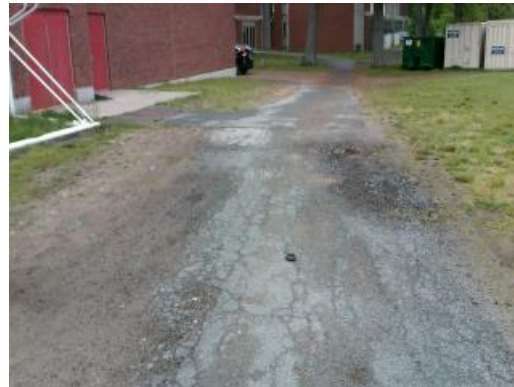
Damaged Asphalt Roadway

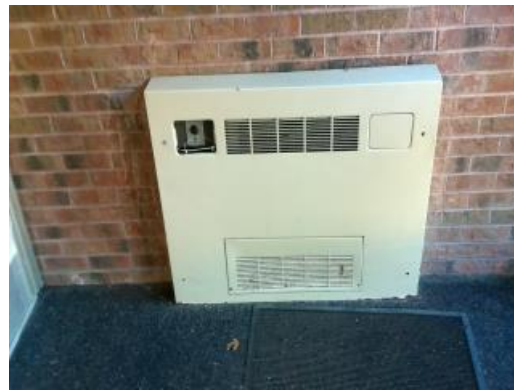
Deficiency	Category	Qty	UoM	Priority	Repair Cost	ID
Replace Unit Vent	Capital Renewal	56	Ea.	2	\$947,229	16544
The Air Handler HVAC Component Requires Replacement	Capital Renewal	19	Ea.	2	\$1,923,898	16546

Typical Unit Vent

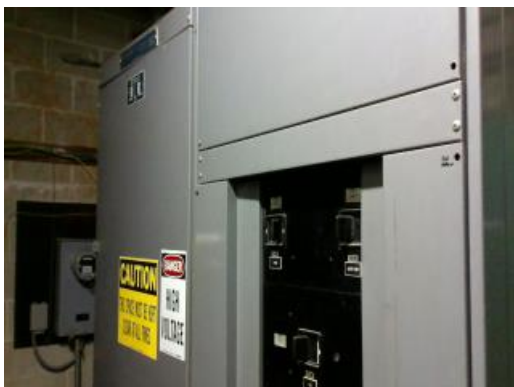
Main Switchgear

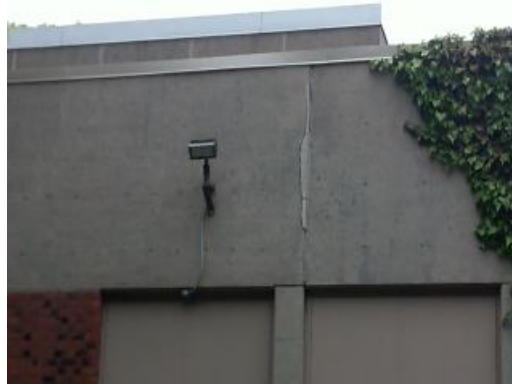
Deficiency	Category	Qty	UoM	Priority	Repair Cost	ID
The Concrete/CMU Exterior Requires Repair <b>Note:</b> Exterior wall outside the boiler room has a crack near the top	Capital Renewal	5	LF	4	\$428	12687
<b>Sub Total for System</b>		<b>1</b>	<b>items</b>		<b>\$428</b>

Cracked Concrete Wall
