# Facility Condition Assessment

East Providence - Agnes B. Hennessey School

June 2017

75 Fort Street, East Providence, RI 02914

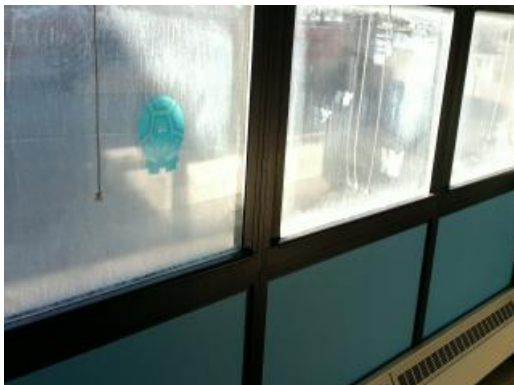
| Deficiency | Category | Qty | UoM | Priority | Repair Cost | ID |
|--|---|---|---|---|---|---|
| The Glass Pane In The Steel Exterior Window Requires Replacement | Capital Renewal | 240 | SF | 2 | \$120,165 | 9846 |

Damaged Window Panes

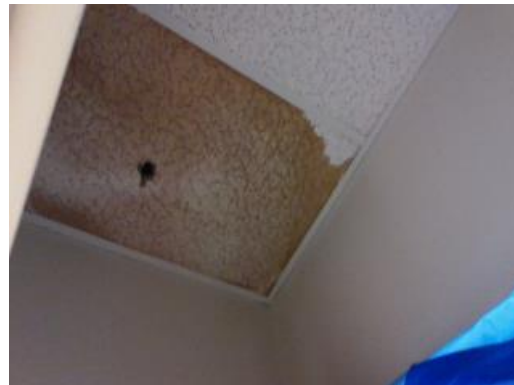
| Deficiency | Category | Qty | UoM | Priority | Repair Cost | ID |
|--|---|---|---|---|---|---|
| The Acoustical Ceiling Tiles Require Replacement | Capital Renewal | 13,825 | SF | 3 | \$131,649 | 9847 |

Stained Ceiling Tile

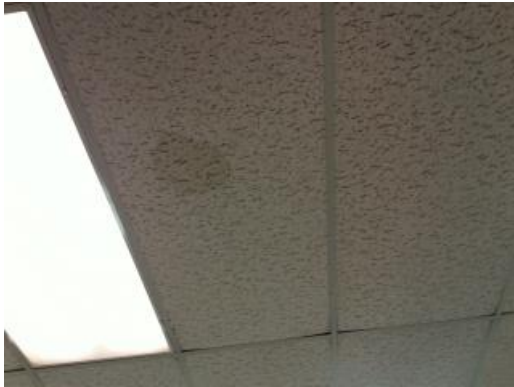
Stained And Sagging Ceiling Tiles

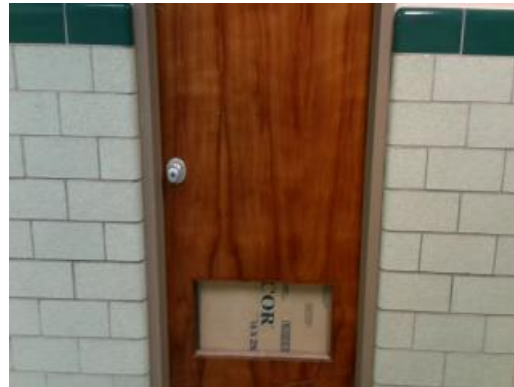
| Deficiency | Category | Qty | UoM | Priority | Repair Cost | ID |
|--|---|---|---|---|---|---|
| Interior Doors Require Replacement | Capital Renewal | 30 | Door | 3 | \$145,846 | 9848 |

Aged Interior Door With Non-Compliant Hardware

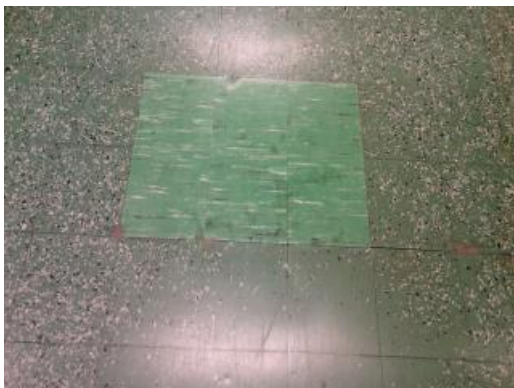
| Deficiency | Category | Qty | UoM | Priority | Repair Cost | ID |
|--|---|---|---|---|---|---|
| Light Deterioration or Damage of 9x9 Asbestos Floor Tile is Present | Hazardous Material | 15,889 | SF | 4 | \$477,802 | Rollup |

Original 9x9 Tile

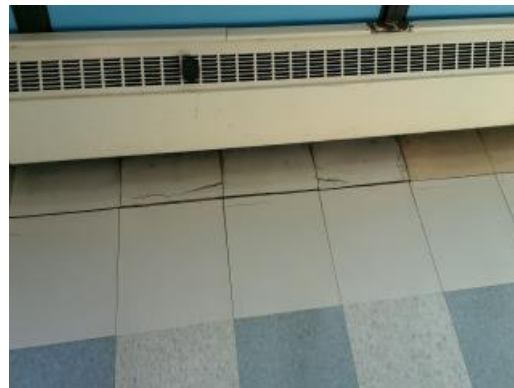
| Deficiency | Category | Qty | UoM | Priority | Repair Cost | ID |
|--|---|---|---|---|---|---|
| The Vinyl Composition Tile Requires Replacement | Functional Deficiency | 12,823 | SF | 3 | \$155,098 | 9850 |

Separating VCT Flooring

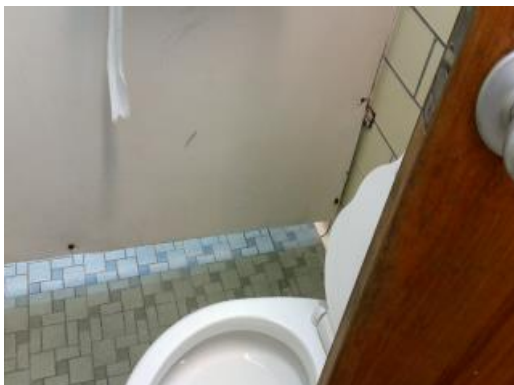
| Deficiency | Category | Qty | UoM | Priority | Repair Cost | ID |
|--|---|---|---|---|---|---|
| Interior Toilet Partition Requires Repair | Capital Renewal | 10 | Ea. | 4 | \$5,513 | 9856 |

Toilet Partition Damaged At Wall

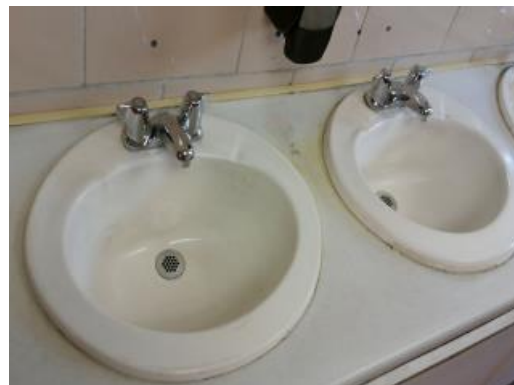
| Deficiency | Category | Qty | UoM | Priority | Repair Cost | ID |
|---|---|---|---|---|---|---|
| The Restroom Lavatories Plumbing Fixtures Require Replacement | Capital Renewal | 20 | Ea. | 4 | \$67,079 | 9853 |

Typical Restroom Lavatories

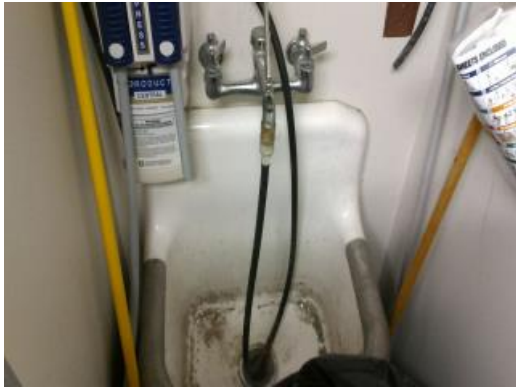
| Deficiency | Category | Qty | UoM | Priority | Repair Cost | ID |
|---|---|---|---|---|---|---|
| The Custodial Mop Or Service Sink Requires Replacement | Capital Renewal | 2 | Ea. | 4 | \$5,433 | 9859 |

Aged Service Sink

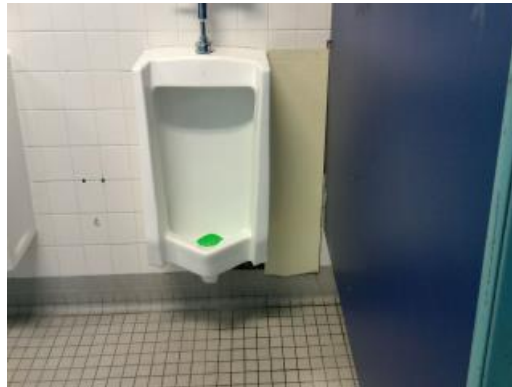
Ceramic Tiles Missing From Restroom Wall

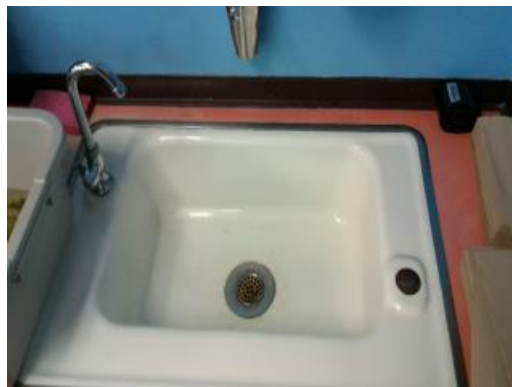
| Deficiency | Category | Qty | UoM | Priority | Repair Cost | ID |
|---|---|---|---|---|---|---|
| The Classroom Lavatories Plumbing Fixtures Require Replacement | Capital Renewal | 25 | Ea. | 4 | \$71,670 | 9843 |

Aged Classroom Lavatory

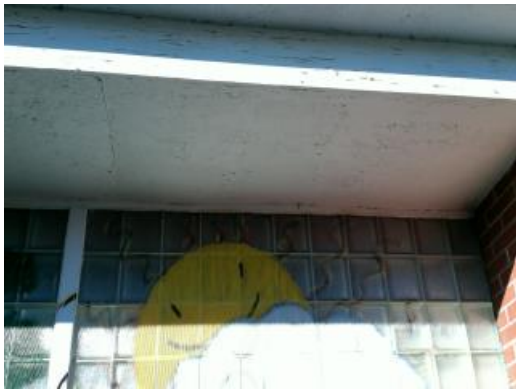
Peeling Paint At Soffit

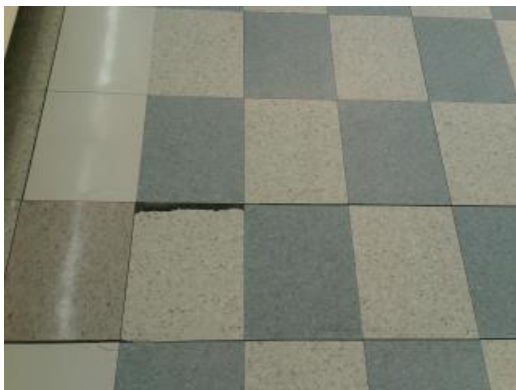
Separating VCT Flooring

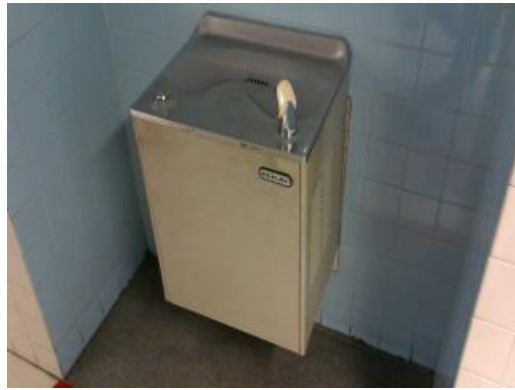
| Deficiency | Category | Qty | UoM | Priority | Repair Cost | ID |
|---|---|---|---|---|---|---|
| The Refrigerated Water Cooler Requires Replacement | Capital Renewal | 3 | Ea. | 4 | \$23,335 | 9864 |

Aged Refrigerated Drinking Fountain

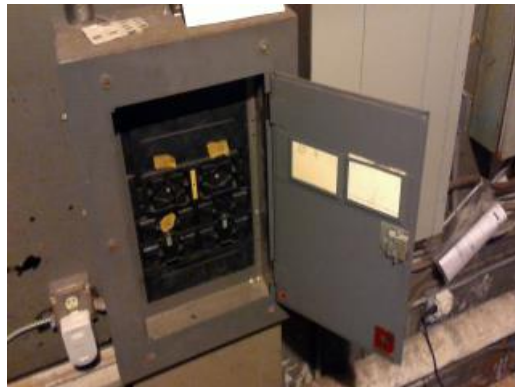
| Deficiency | Category | Qty | UoM | Priority | Repair Cost | ID |
|---|---|---|---|---|---|---|
| The Panelboard Requires Replacement | Capital Renewal | 2 | Ea. | 2 | \$10,224 | 9868 |
| The Panelboard Requires Replacement | Capital Renewal | 3 | Ea. | 2 | \$18,343 | 9869 |

Aged Panelboard

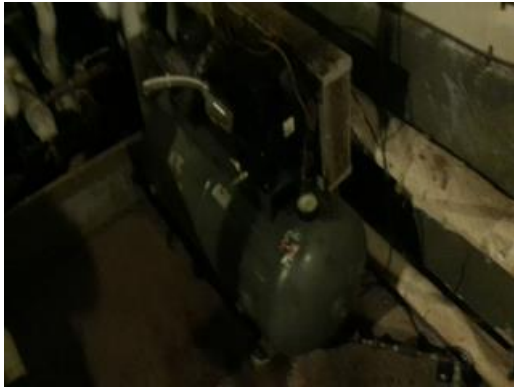
| Deficiency | Category | Qty | UoM | Priority | Repair Cost | ID |
|---|---|---|---|---|---|---|
| Air Compressor Is Inoperable And Requires Replacement | Capital Renewal | 1 | Ea. | 3 | \$6,379 | 9867 |

Aged Air Compressor

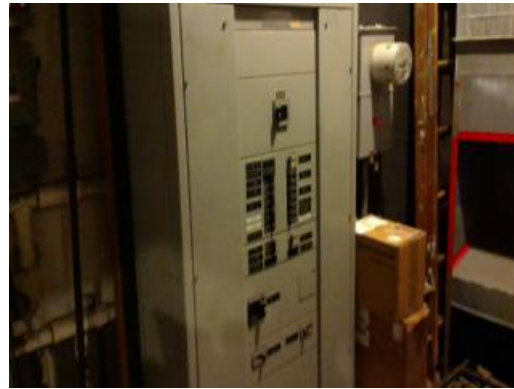
| Deficiency | Category | Qty | UoM | Priority | Repair Cost | ID |
|---|---|---|---|---|---|---|
| The Distribution Panel Requires Replacement | Capital Renewal | 1 | Ea. | 2 | \$30,713 | 9873 |

Aged Distribution Panel

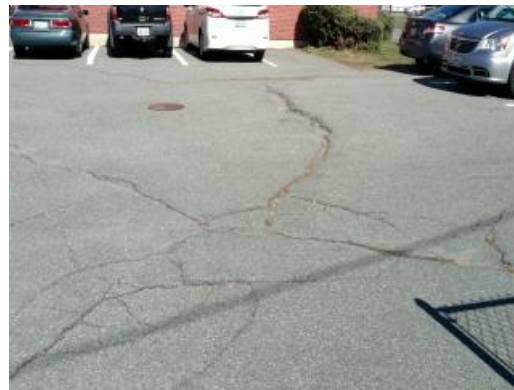
| Deficiency | Category | Qty | UoM | Priority | Repair Cost | ID |
|--|---|---|---|---|---|---|
| Asphalt Paving Requires Replacement | Capital Renewal | 35 | CAR | 4 | \$146,511 | 9838 |
| <b>Note:</b> Asphalt parking is cracked and weathered. | | | | | | |

Cracked Asphalt Parking Lot

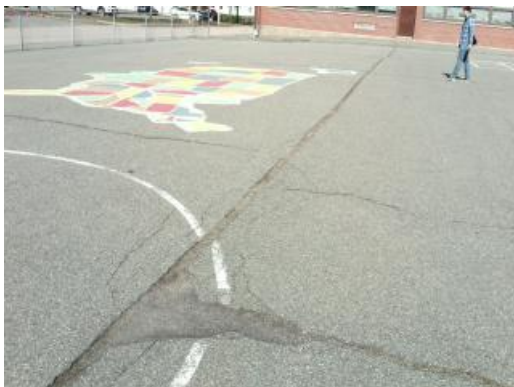
Cracks in Play Area Asphalt

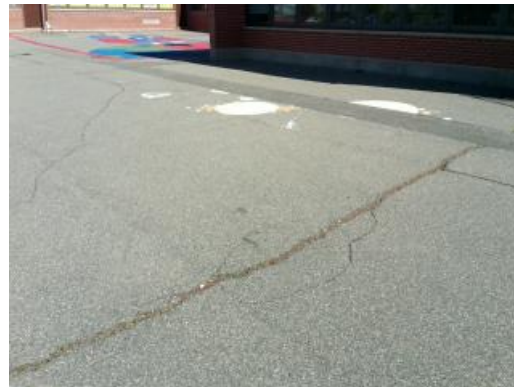
Cracks In Play Area Asphalt

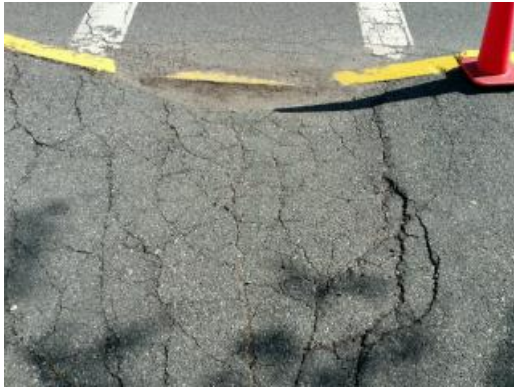
Alligatoring Asphalt Walkway

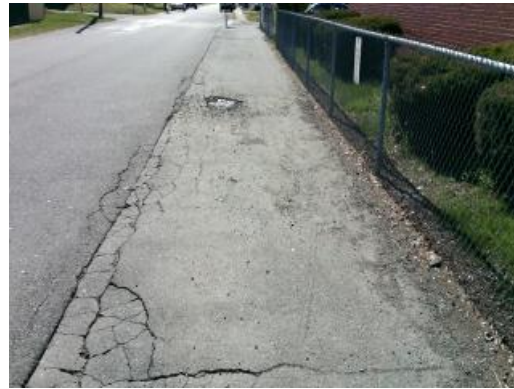
Sidewalk Cracks And Potholes

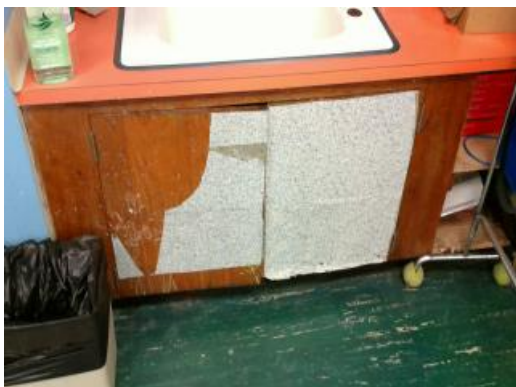
| Deficiency | Category | Qty | UoM | Priority | Repair Cost | ID |
|---|--|---|---|---|---|---|
| Replace Cabinetry In Classes/Labs | Capital Renewal | 7 | Room | 4 | \$82,572 | 9878 |
| <b>Note:</b> | Original casework in classroom is damaged, delaminating, and should be replaced. | | | | | |

Damaged Original Cabinetry

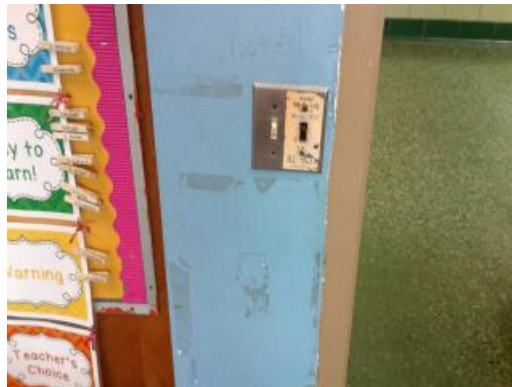
| Deficiency | Category | Qty | UoM | Priority | Repair Cost | ID |
|--|---|---|---|---|---|---|
| Paint (probable pre-1978 in base layer(s)) - damaged area < 9 sq. ft. OR overall worn AND in children-accessible area (measurement unit - square feet) | Hazardous Material | 1,115 | SF | 4 | \$11,177 | Rollup |

Chipped And Worn Interior Wall Paint

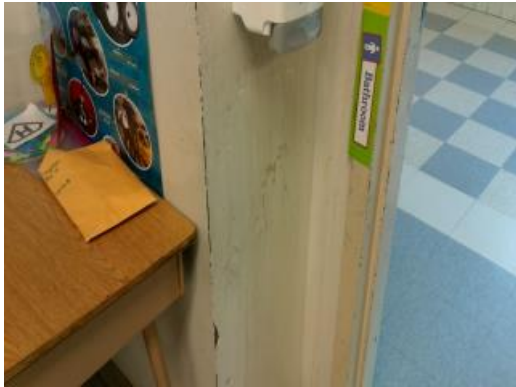
Chipped And Worn Interior Wall Paint

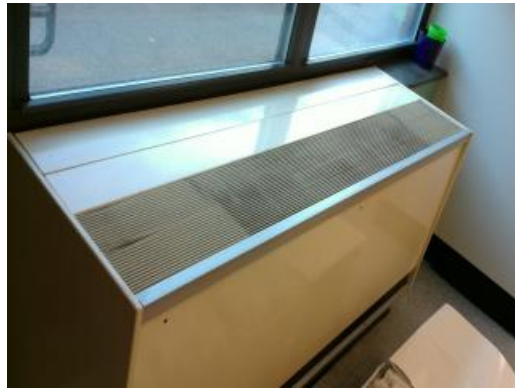
| Deficiency | Category | Qty | UoM | Priority | Repair Cost | ID |
|---|---|---|---|---|---|---|
| Replace Unit Vent | Capital Renewal | 9 | Ea. | 2 | \$160,508 | 9880 |

Aged Unit Vent

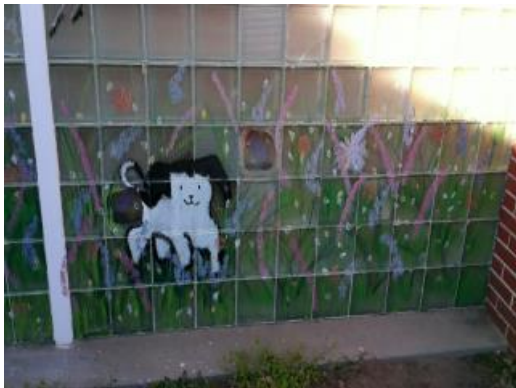
| Deficiency | Category | Qty | UoM | Priority | Repair Cost | ID |
|--|---|---|---|---|---|---|
| Glass Block Requires Replacement | Capital Renewal | 144 | SF | 2 | \$11,836 | 9881 |

Damaged Glass Block
