Facility Condition Assessment

Lincoln - Lincoln Senior High School

June 2017

135 Old River Road, Lincoln, RI 02865

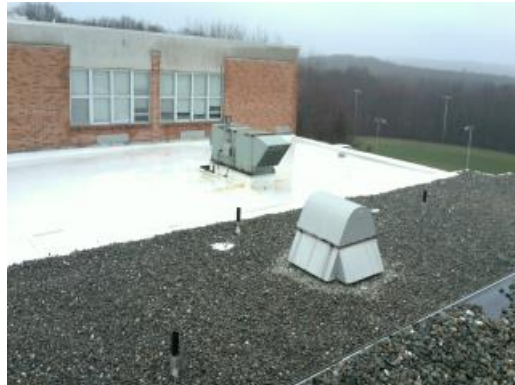
Roof

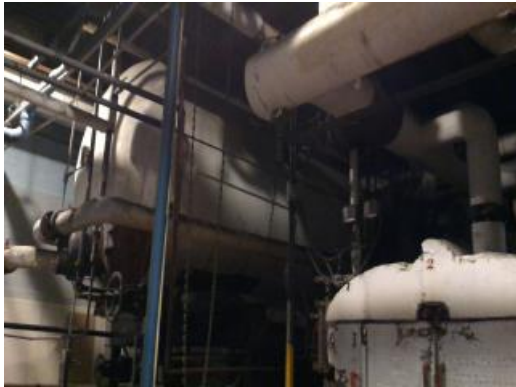
Heat Exchanger

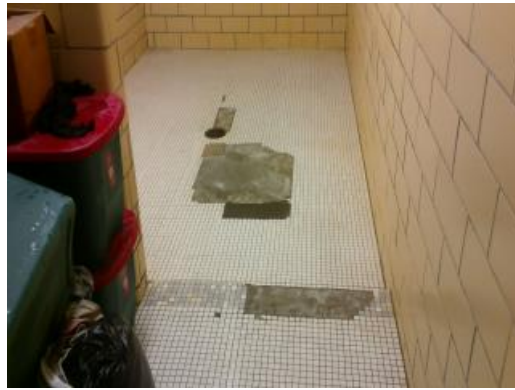
Damaged Ceramic Tile Flooring

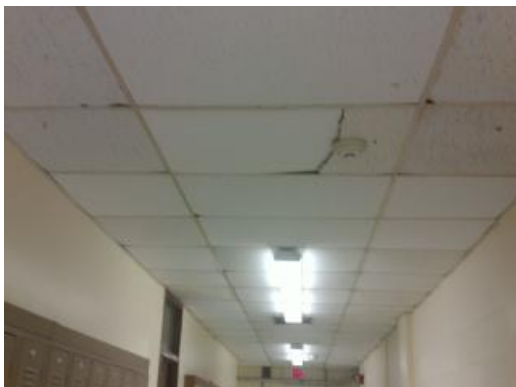
Broken Ceiling Tile

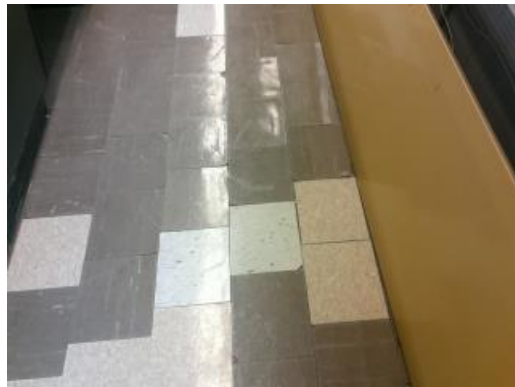
Worn And Lifting VCT Flooring

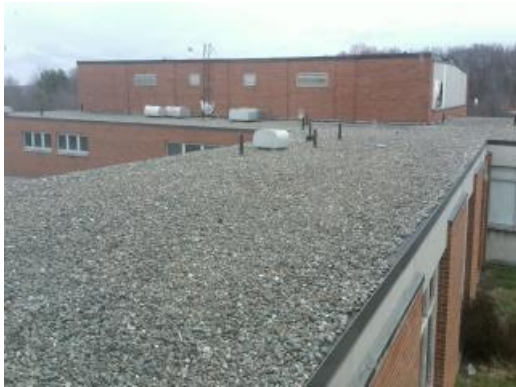
Ballasted Roof

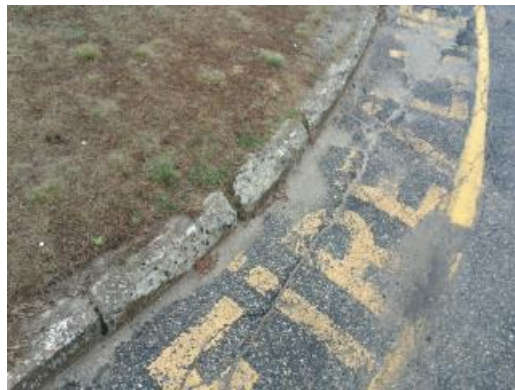
Broken Curb

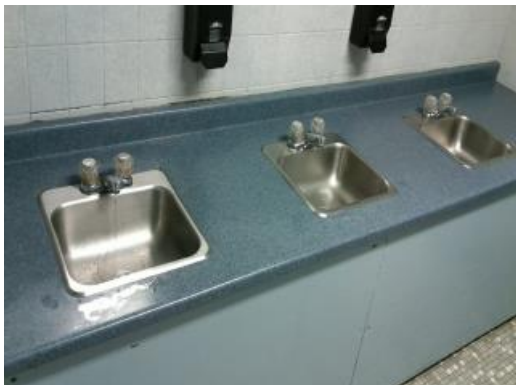
Typical Restroom Lavatories

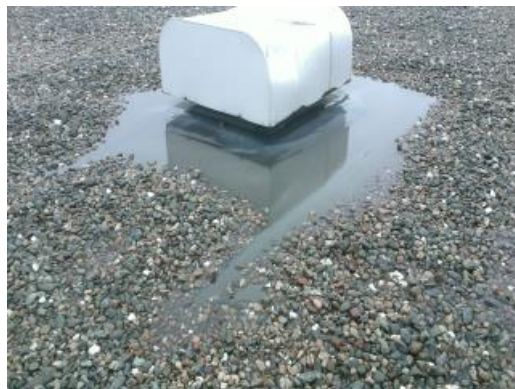
Deficiency	Category	Qty	UoM	Priority	Repair Cost	ID
The Single-Ply Membrane Roof Covering Requires Replacement	Capital Renewal	168,610	SF	2	\$6,411,881	2028
Note: Excessive ponding, edge flashing failing, drainage problems, ballast is missing in several areas.						
Awning Or Canopy Metal Roofing System Requires Replacement	Capital Renewal	320	SF	3	\$18,253	2026
Note: Canopies are rotting.						
Location: East entrances						
Sub Total for System		2 items			\$6,430,134

Roof Ponding
