# Facility Condition Assessment

New Shoreham - Block Island School

June 2017

PO Box 1890, Block Island, RI 02807

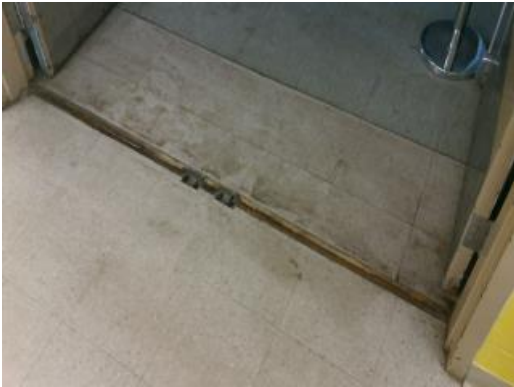
Worn VCT At Threshold

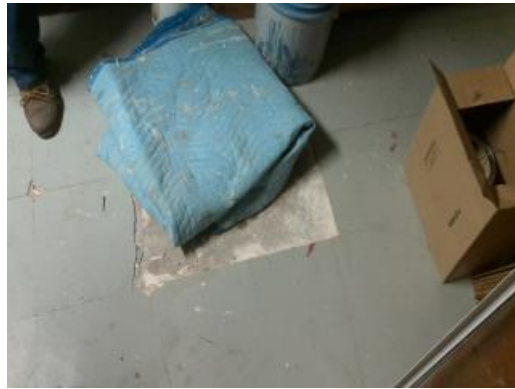
Chipped And Missing VCT

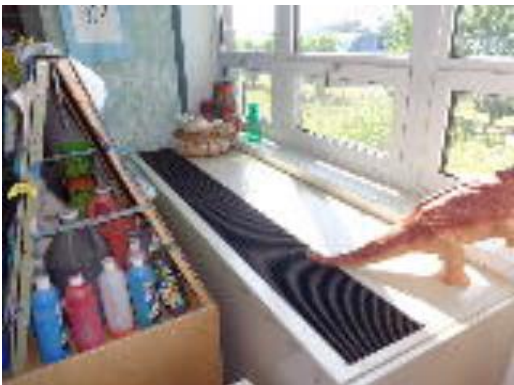
Unit Ventilator

Deficiency	Category	Qty	UoM	Priority	Repair Cost	ID
Replace Unit Ventilators	Capital Renewal	6	Ea.	2	\$45,366	24765
<b>Note:</b> Unit ventilators are extremely old and oversized for the space and occupants.						
The Cast Iron Water Boiler Requires Replacement	Capital Renewal	2	Ea.	2	\$74,491	24766
<b>Note:</b> Gymnasium boilers are out of service.						
Unit Ventilators Are Excessively Noisy	Acoustics	13	Ea.	3	\$98,294	27872
<b>Note:</b> Older Classrooms						
Lab lacks an appropriate fume hood.	Educational Adequacy	1	Ea.	4	\$21,986	Rollup
	<b>Sub Total for System</b>	<b>4</b>	<b>items</b>		<b>\$240,137</b>

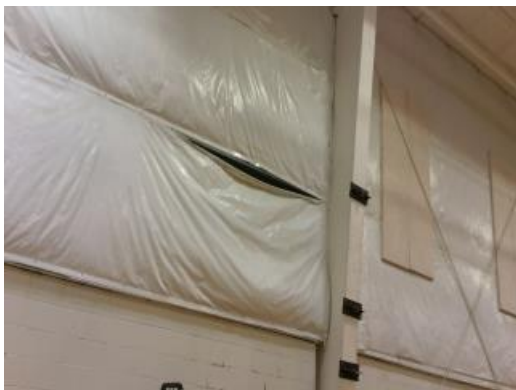
Vinyl Faced Insulation

Room Lighting Is Inadequate Or In Poor Condition.	Educational Adequacy	23,530	SF	4	\$896,586	Rollup
Vinyl Backed Insulation Requires Replacement	Capital Renewal	500	SF	4	\$2,368	24767
<b>Location:</b> Gymnasium						
Wall/ceiling materials - area < 9 sq. ft. AND in children-accessible area	Hazardous Material	33	SF	4	\$374	Rollup
Wall/ceiling materials - large areas (> 10 sq. ft.) of damage & area in active use - children	Hazardous Material	25	SF	4	\$283	Rollup
Wall/ceiling materials -large areas (> 10 sq. ft.) of damage & area in active use-adults only	Hazardous Material	10	SF	4	\$113	Rollup
Classroom Door Requires Vision Panel	Educational Adequacy	28	Ea.	5	\$63,887	Rollup
Room lacks appropriate sound control.	Educational Adequacy	100	SF	5	\$3,480	Rollup
<b>Sub Total for System</b>		<b>20 items</b>			<b>\$1,924,269</b>
