Facility Condition Assessment

Newport - Rogers High School

June 2017

15 Wickham Road, Newport, RI 02840

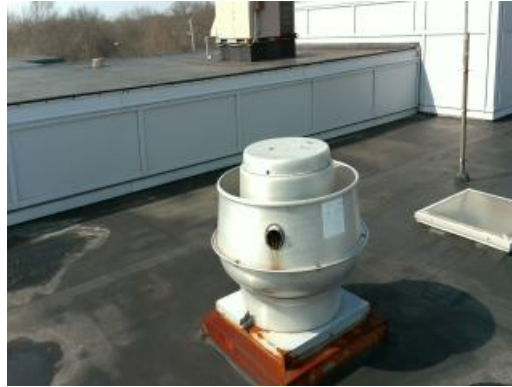
| Deficiency | Category | Qty | UoM | Priority | Repair Cost | ID |
|---|---|---|---|---|---|---|
| The Exhaust Hood Requires Replacement Note: Of the 40 total exhaust fan only 8 were running during occupied hours. | Capital Renewal | 40 | Ea. | 4 | \$208,165 | 1747 |

Roof Exhaust

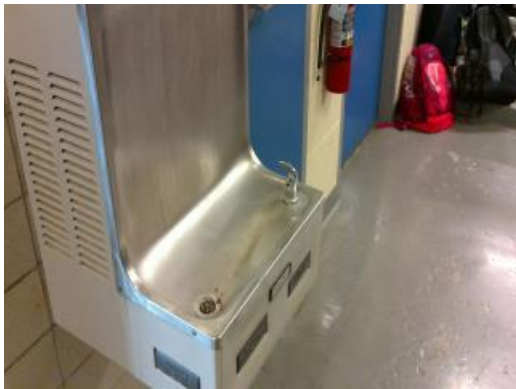
| Deficiency | Category | Qty | UoM | Priority | Repair Cost | ID |
|---|---|---|---|---|---|---|
| The Refrigerated Water Cooler Requires Replacement Note: Majority of water fountains are not functioning. | Capital Renewal | 10 | Ea. | 4 | \$73,774 | 1743 |

Typical Drinking Fountain

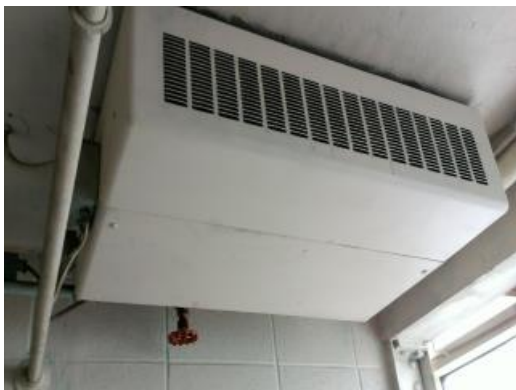
| Deficiency | Category | Qty | UoM | Priority | Repair Cost | ID |
|---|---|---|---|---|---|---|
| Steam/HW Unit Heater Requires Replacement Note: Outdated and should be replaced. Appears many of them are no longer functional. | Capital Renewal | 30 | Ea. | 2 | \$84,479 | 1462 |

Ceiling Unit Heater

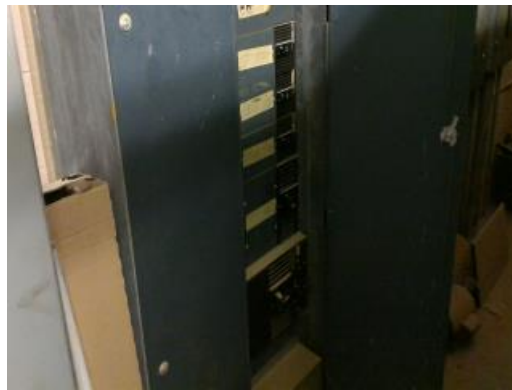
| Deficiency | Category | Qty | UoM | Priority | Repair Cost | ID |
|---|---|---|---|---|---|---|
| The Distribution Panel Requires Replacement | Capital Renewal | 1 | Ea. | 2 | \$51,908 | 1454 |

Aged Panel

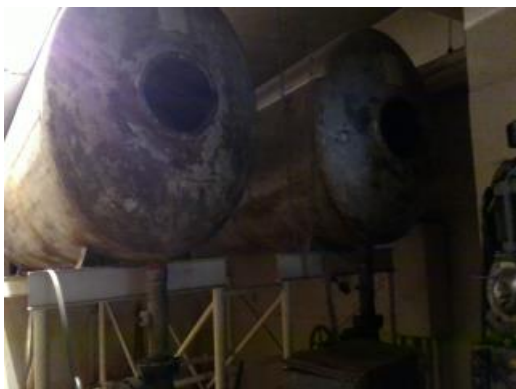
Abandoned Tanks

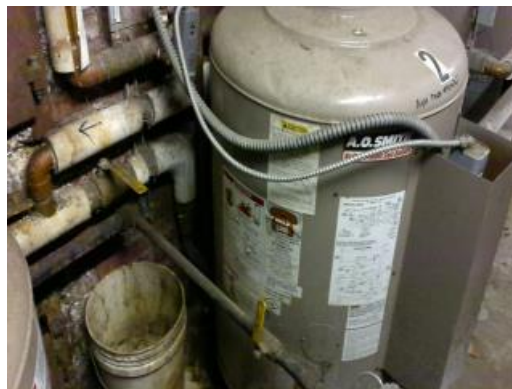
| Deficiency | Category | Qty | UoM | Priority | Repair Cost | ID |
|--|---|---|---|---|---|---|
| The Gas Water Heater Requires Replacement | Capital Renewal | 2 | Ea. | 3 | \$6,225 | 1489 |
| Note: Water heater has failed. | | | | | | |

Failed Water Heater

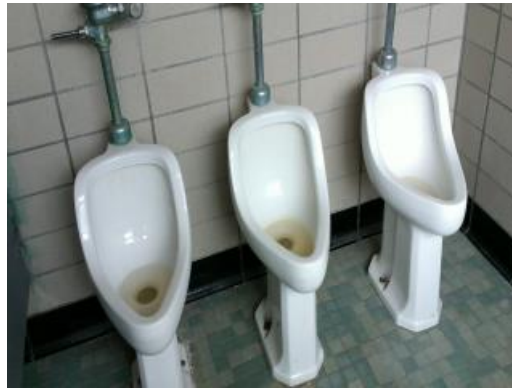
| Deficiency | Category | Qty | UoM | Priority | Repair Cost | ID |
|---|---|---|---|---|---|---|
| The Urinal Plumbing Fixtures Require Replacement Note: Original, failing. | Capital Renewal | 30 | Ea. | 3 | \$39,872 | 1474 |

Typical Urinal Fixtures

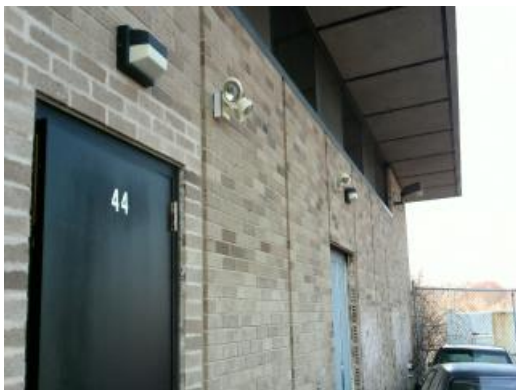
Building Mounted Lighting

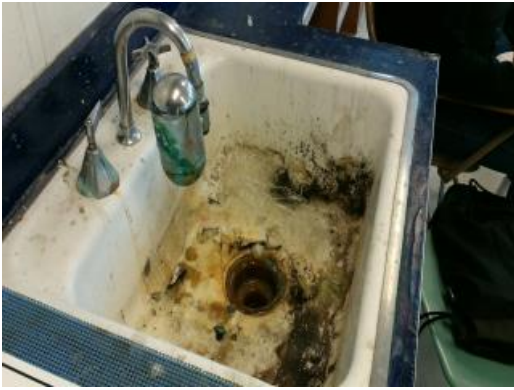
| Deficiency | Category | Qty | UoM | Priority | Repair Cost | ID |
|---|---|---|---|---|---|---|
| The Custodial Mop Or Service Sink Requires Replacement Note: Original to building. Fixtures constantly failing or inoperable per custodian. | Capital Renewal | 10 | Ea. | 4 | \$25,764 | 1745 |

Corroded Custodial Sink

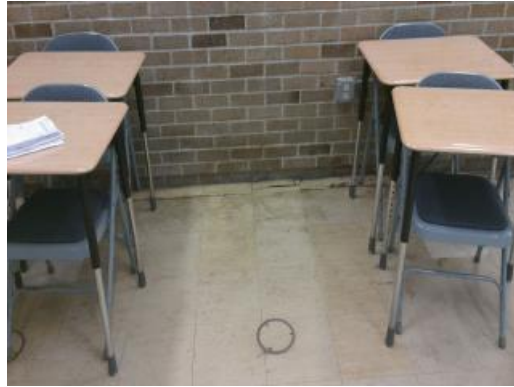
Settlement At Vocational Building

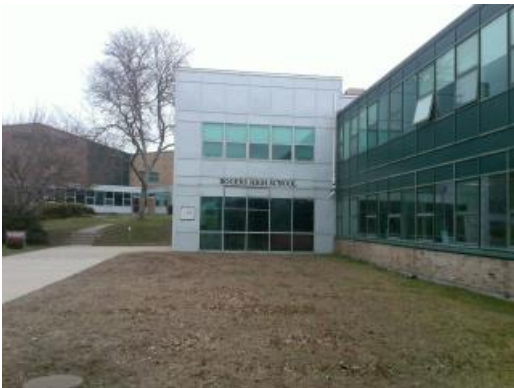
| Deficiency | Category | Qty | UoM | Priority | Repair Cost | ID |
|--|---|---|---|---|---|---|
| The Storefront/Curtain Wall Requires Replacement (Bldg SF) | Capital Renewal | 120,000 | SF | 2 | \$9,674,293 | 2991 |
| Note: Seals failing, water actively migrating into building at gym entrance and main entry. | | | | | | |

Main Entry
