Facility Condition Assessment

North Kingstown - Suzanne M. Henseler Quidnessett Elementary School

June 2017

166 Mark Drive, North Kingstown, RI 02852

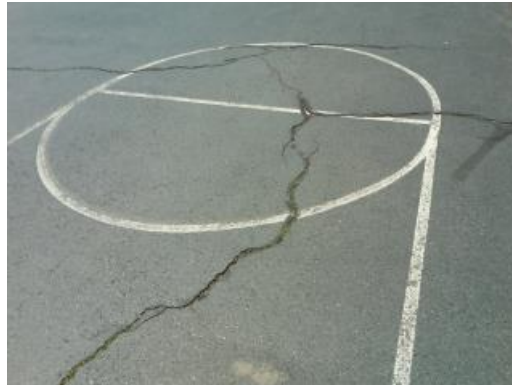
Cracked Paved Play Area

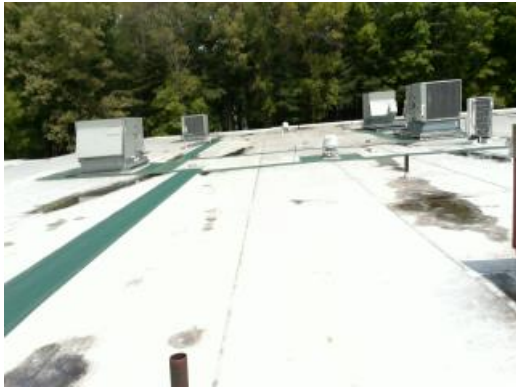
Typical Roof Condition

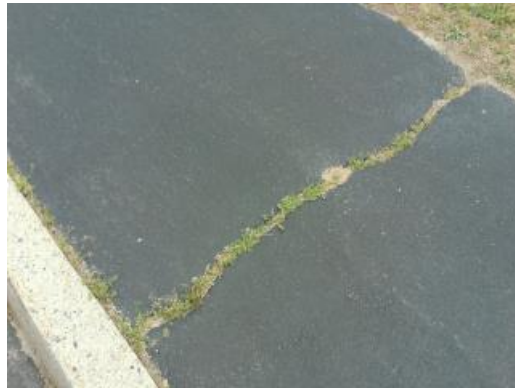
Cracked Asphalt Walkway

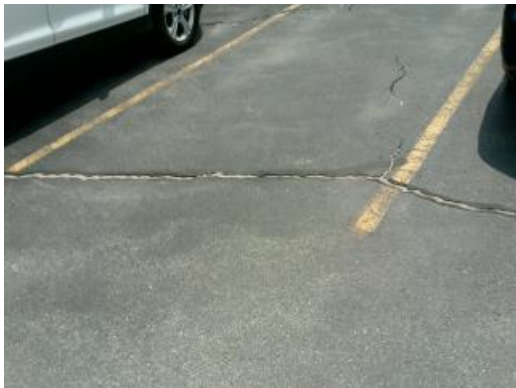
Weathered Parking Lot Paving

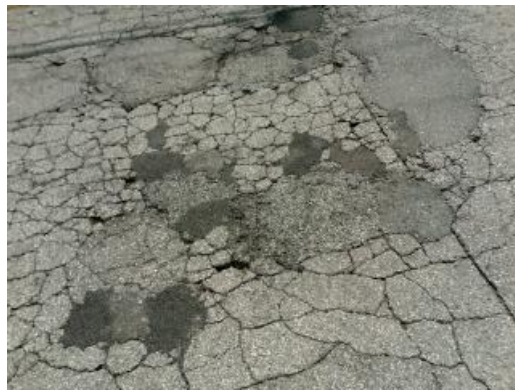
Alligatored Asphalt Paving

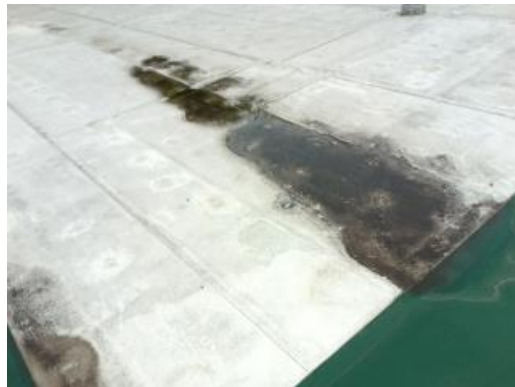
Pooling On Roof

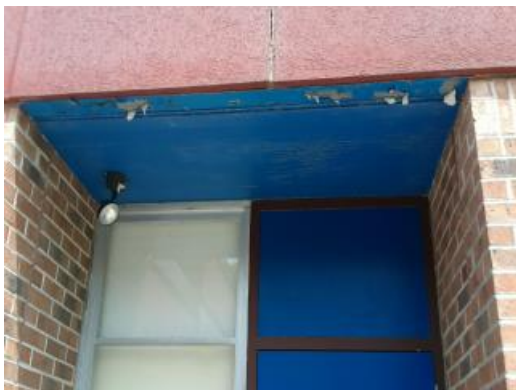
Peeling Soffit Paint

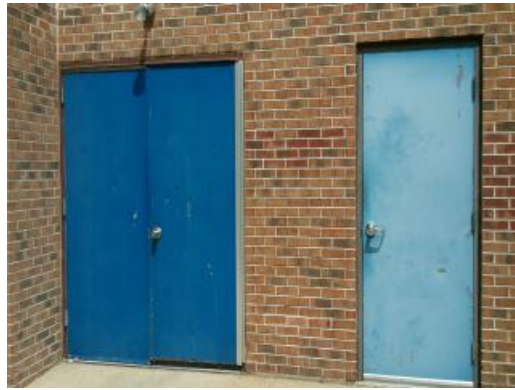
Aged Exterior Doors

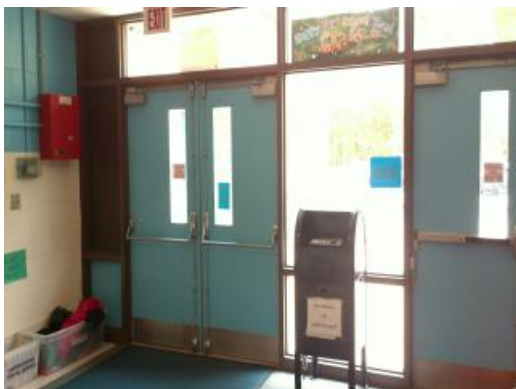
Aged Entry Doors

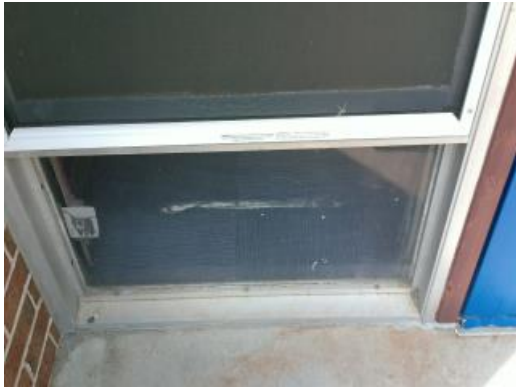
Original Single Pane Windows

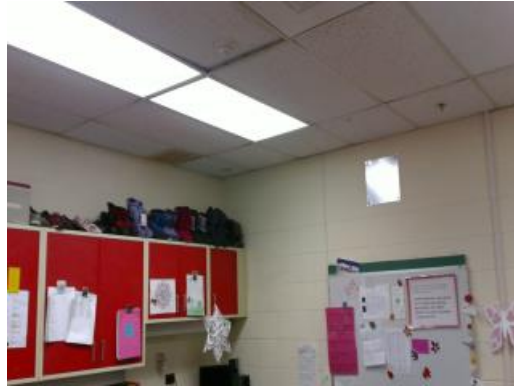
Stained And Sagging Ceiling Tiles

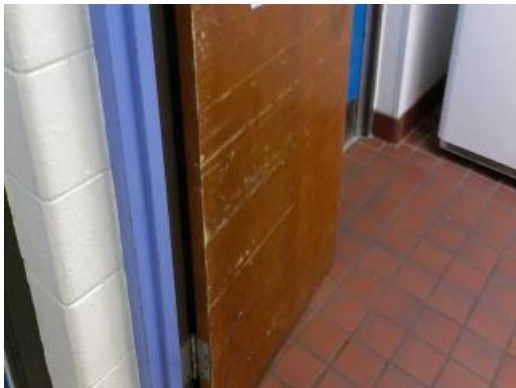
Worn Interior Wood Doors

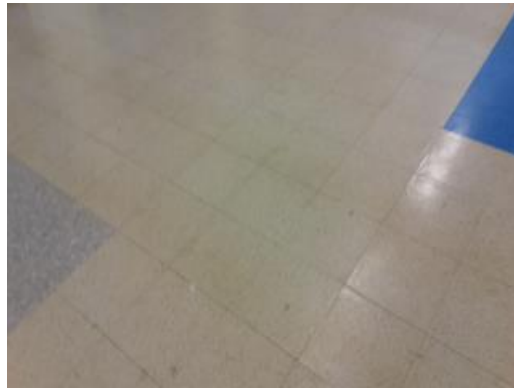
Original VCT

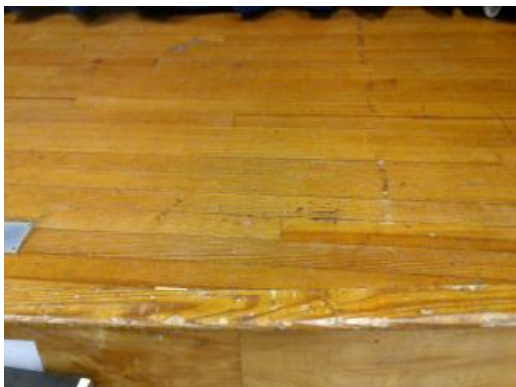
Worn Stage Floor

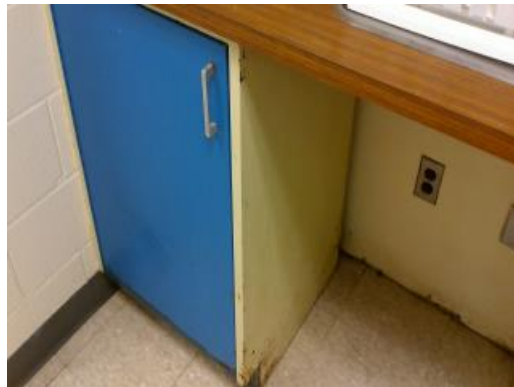
Aged Cabinetry

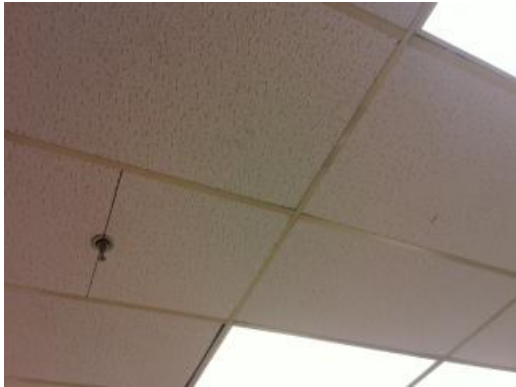
Stained Ceiling Grid

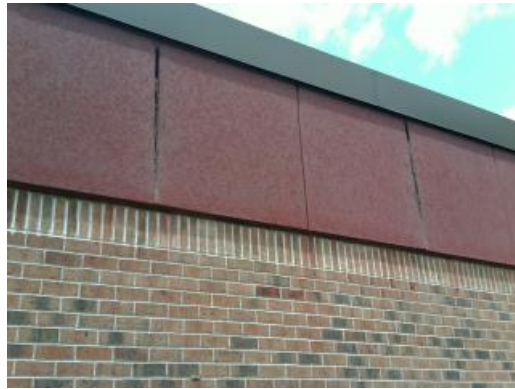
Weathered Caulking At EIFS
