# Facility Condition Assessment

North Smithfield - Dr. Harry L. Halliwell Memorial School

June 2017

358 Victory Highway, Slatersville, RI 02876

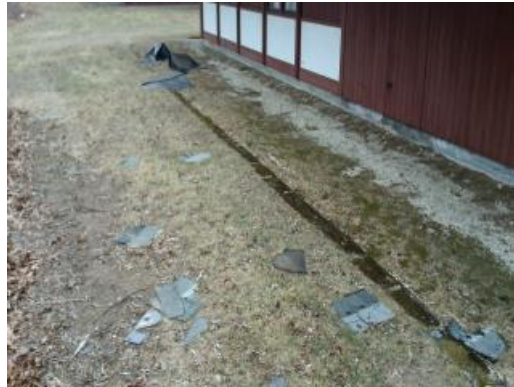
Displaced Roof Shingles

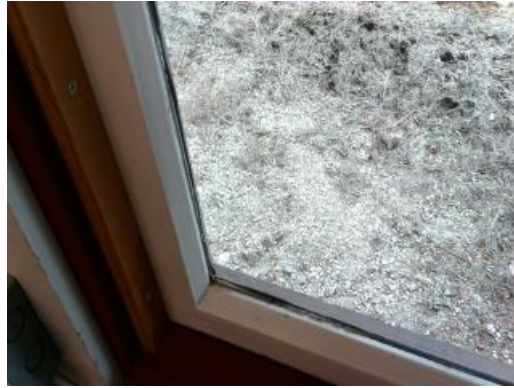
Single Pane Window

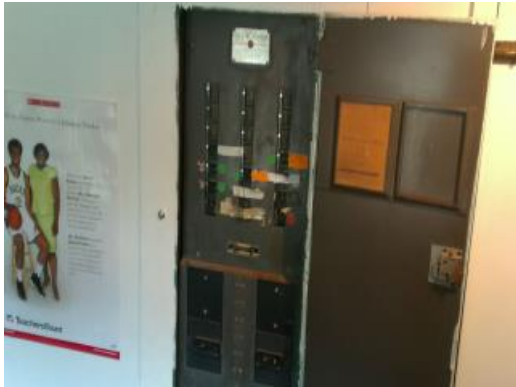
Aged Panel

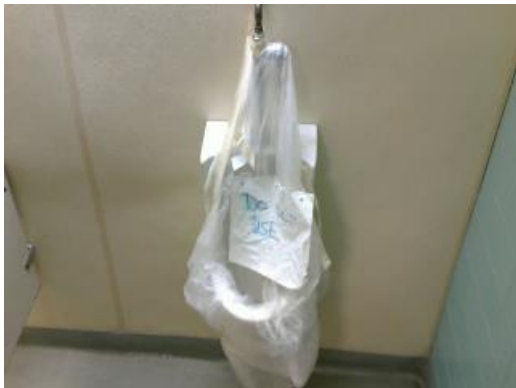
Urinal Out Of Service

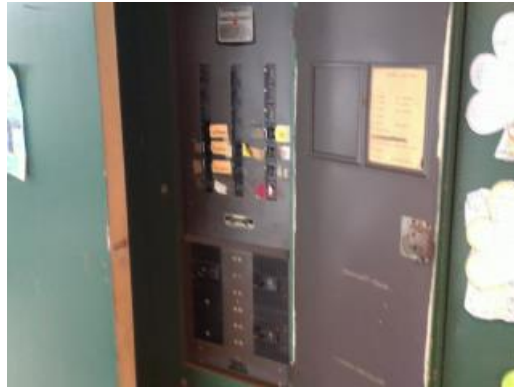
Aged Panelboard

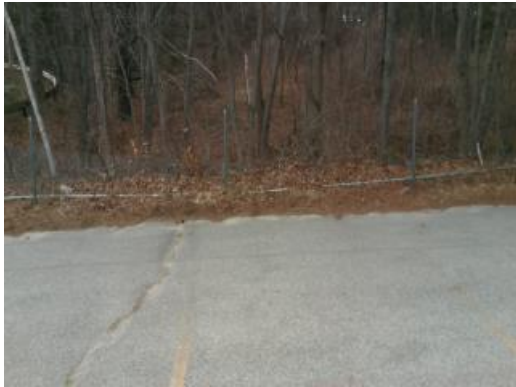
Fence Falling Down

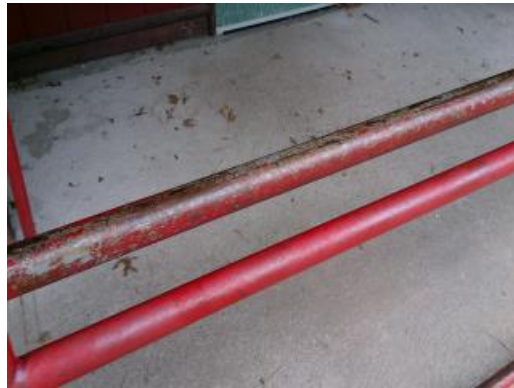
| Deficiency | Category | Qty | UoM | Priority | Repair Cost | ID |
|---|---|---|---|---|---|---|
| <b>Note:</b> Railings throughout the campus are worn and in need of repainting. | | | | | | |

Typical Worn Handrail

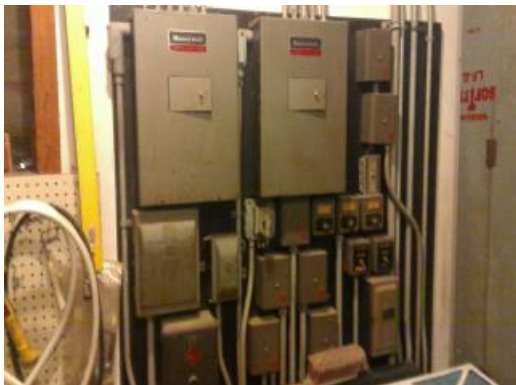
Rudimentary ECS

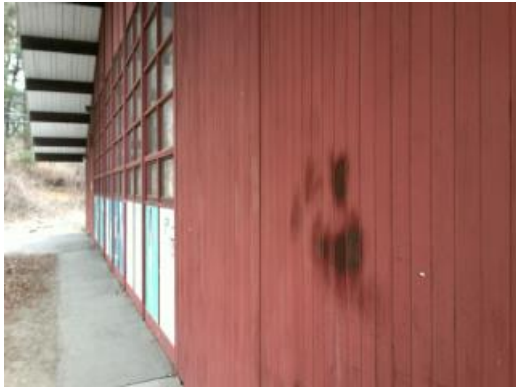
Stained Wood Exterior

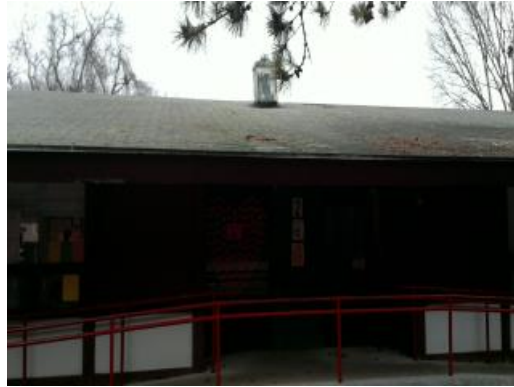
Shingles Missing From Building 2 Roof

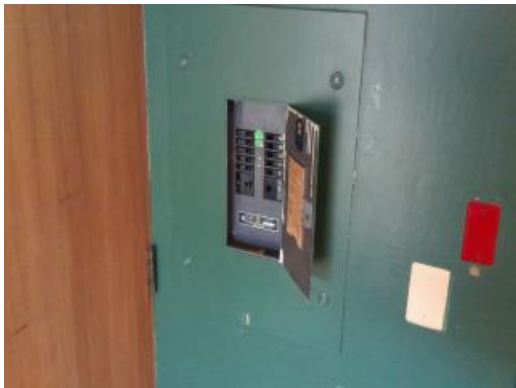
Aged Panelboard

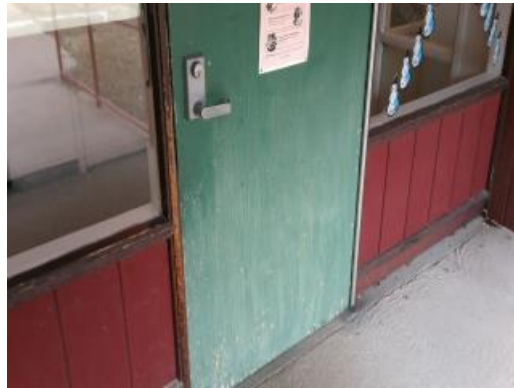
| Deficiency | Category | Qty | UoM | Priority | Repair Cost | ID |
|---|---|---|---|---|---|---|
| <b>Note:</b> Exterior door at entrance is worn, chipped, and faded. | | | | | | |

Faded Exterior Door

| Deficiency | Category | Qty | UoM | Priority | Repair Cost | ID |
|---|---|---|---|---|---|---|
| The Metal Exterior Door Requires Replacement | Capital Renewal | 1 | Door | 2 | \$6,417 | 1144 |

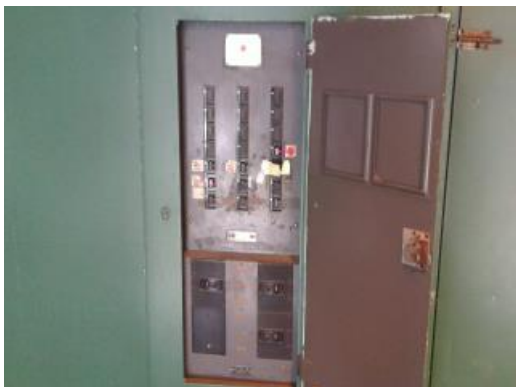
Aged Panelboard

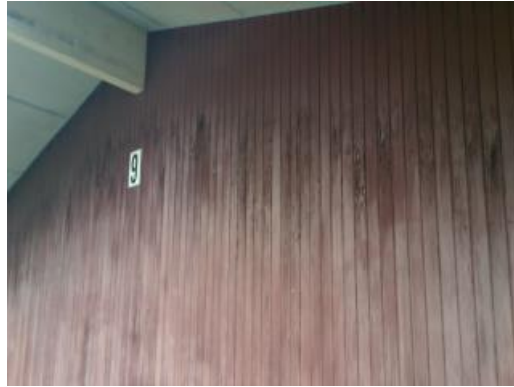
| Deficiency | Category | Qty | UoM | Priority | Repair Cost | ID |
|---|---|---|---|---|---|---|
| <b>Note:</b> Wood veneer is cracked, faded, and in need of replacement. | | | | | | |

Weathered Wood Exterior

| Deficiency | Category | Qty | UoM | Priority | Repair Cost | ID |
|---|---|---|---|---|---|---|
| The Exterior Wood Requires Replacement (Bldg SF) | Capital Renewal | 2,500 | SF | 2 | \$74,939 | 1114 |

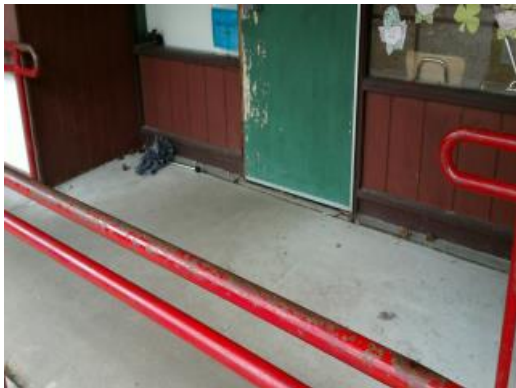
| Deficiency | Category | Qty | UoM | Priority | Repair Cost | ID |
|---|---|---|---|---|---|---|
| <b>Note:</b> Exterior door at entrance is worn, chipped, and faded. | | | | | | |

Chipped And Faded Exterior Door

| Deficiency | Category | Qty | UoM | Priority | Repair Cost | ID |
|---|---|---|---|---|---|---|
| The Metal Exterior Door Requires Replacement | Capital Renewal | 1 | Door | 2 | \$6,417 | 1130 |

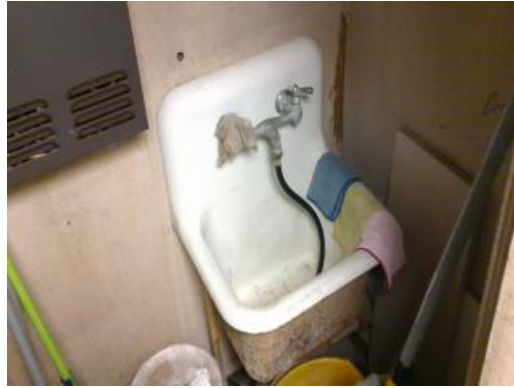
Stained Service Sink

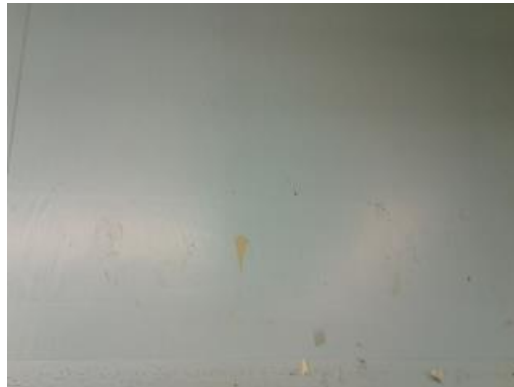
Chipped And Faded Interior Walls

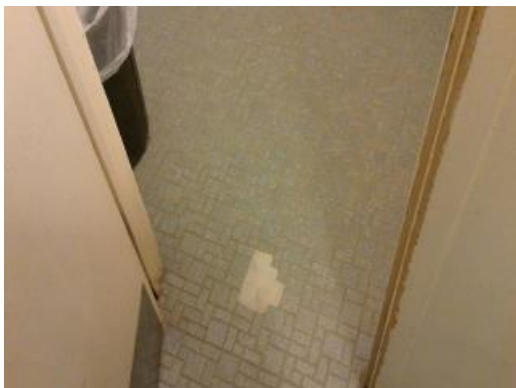
Missing Tiles

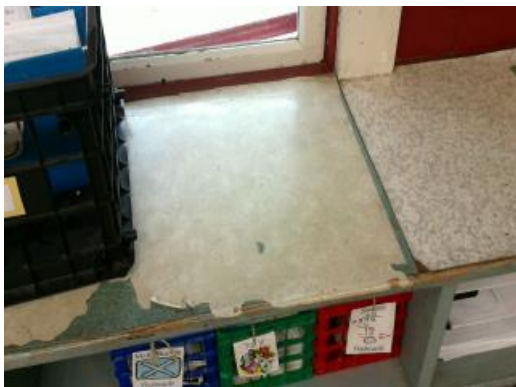
| Deficiency | Category | Qty | UoM | Priority | Repair Cost | ID |
|---|---|---|---|---|---|---|
| <b>Note:</b> Cabinetry is worn with surfaces peeling, chipped, or missing. | | | | | | |

Chipped And Worn Cabinetry

| Deficiency | Category | Qty | UoM | Priority | Repair Cost | ID |
|---|---|---|---|---|---|---|
| Replace Cabinetry In Classes/Labs | Capital Renewal | 2 | Room | 4 | \$22,376 | 1119 |

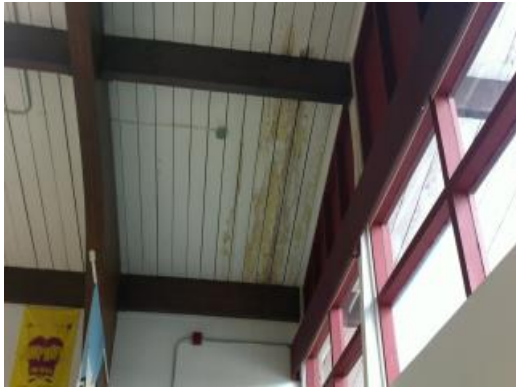
Stained Wood Decking

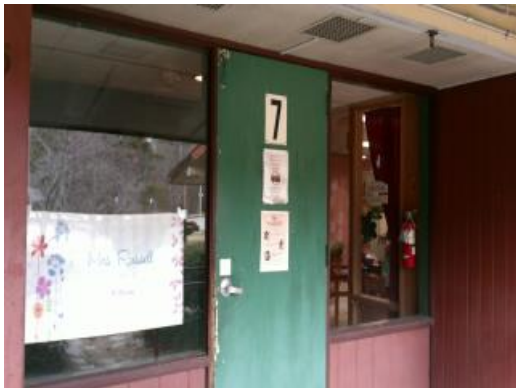
Faded Exterior Door

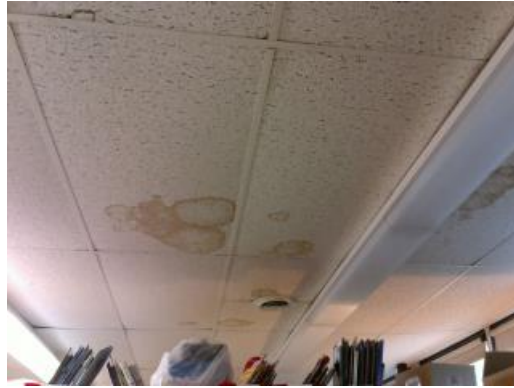
| Deficiency | Category | Qty | UoM | Priority | Repair Cost | ID |
|---|---|---|---|---|---|---|
| <b>Note:</b> Grid system is original to the building and in need of replacement. | | | | | | |

Original Grid System

| Deficiency | Category | Qty | UoM | Priority | Repair Cost | ID |
|---|---|---|---|---|---|---|
| Ceiling Grid Requires Replacement | Capital Renewal | 2,500 | SF | 4 | \$29,651 | 1116 |

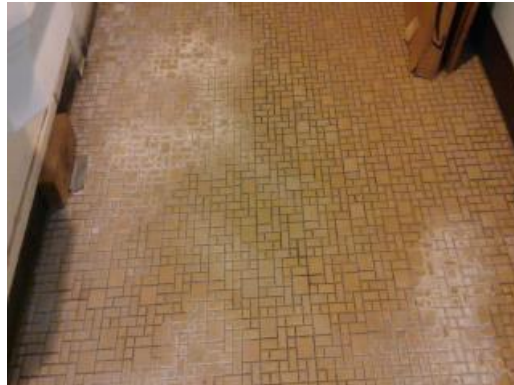
Stained And Faded VCT

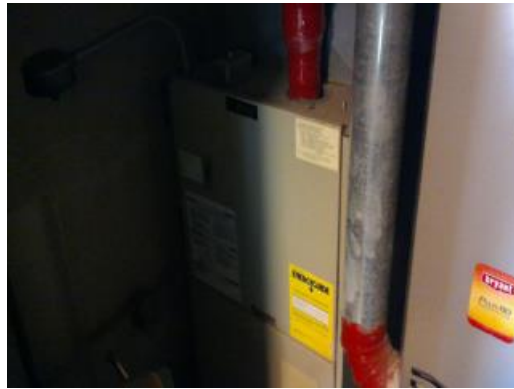
Corroding Furnace

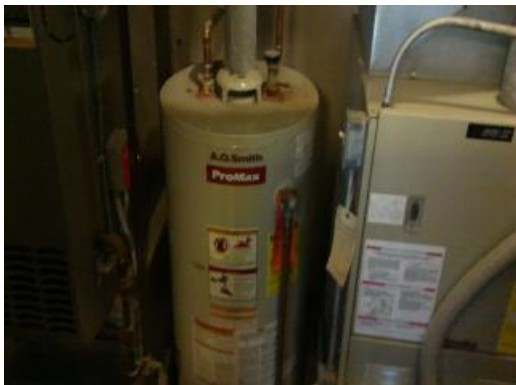
| Deficiency | Category | Qty | UoM | Priority | Repair Cost | ID |
|---|---|---|---|---|---|---|
| <b>Note:</b> Water heater is rusted and corroded. | | | | | | |

Rusted Water Heater

| Deficiency | Category | Qty | UoM | Priority | Repair Cost | ID |
|---|---|---|---|---|---|---|
| The Gas Water Heater Requires Replacement | Capital Renewal | 1 | Ea. | 3 | \$3,160 | 1079 |

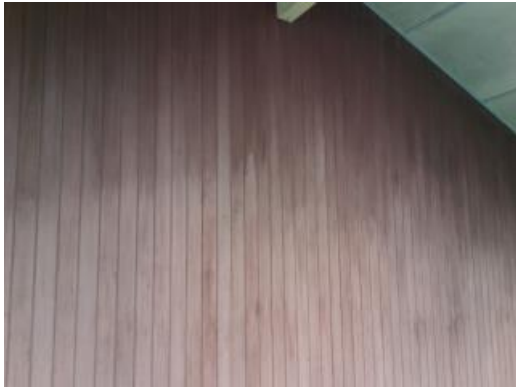
| Deficiency | Category | Qty | UoM | Priority | Repair Cost | ID |
|---|---|---|---|---|---|---|
| <b>Note:</b> Wood veneer is cracked, faded, and in need of replacement. | | | | | | |

Typical Wood Veneer Fading

| Deficiency | Category | Qty | UoM | Priority | Repair Cost | ID |
|---|---|---|---|---|---|---|
| The Exterior Wood Requires Replacement (Bldg SF) | Capital Renewal | 2,500 | SF | 2 | \$74,939 | 1128 |

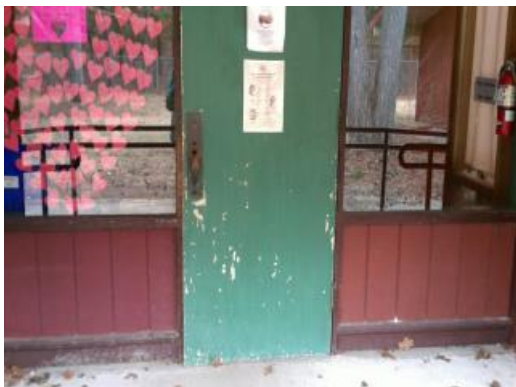
Chipped And Faded Exterior Door
