Facility Condition Assessment

Pawtucket - Charles E. Shea Senior High School

June 2017

485 East Avenue, Pawtucket, RI 02860

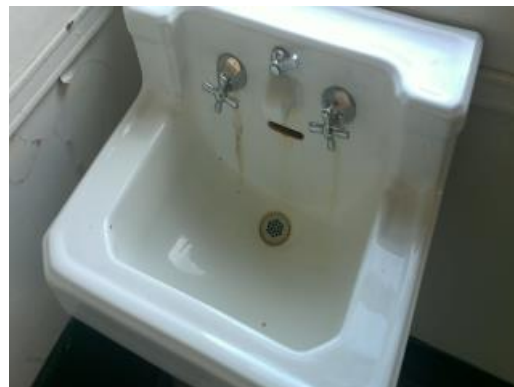
Aged Restroom Lavatory

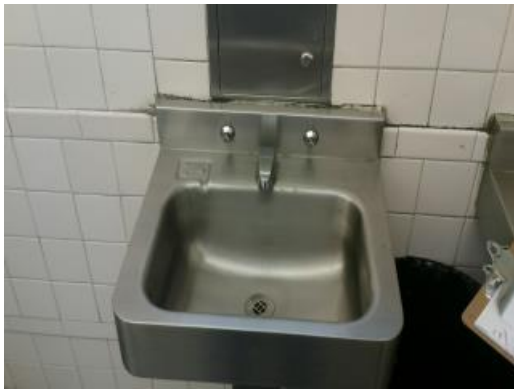
Rusted Restroom Lavatory

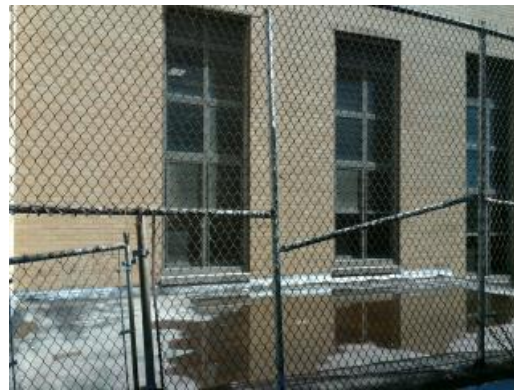
Damaged Fencing

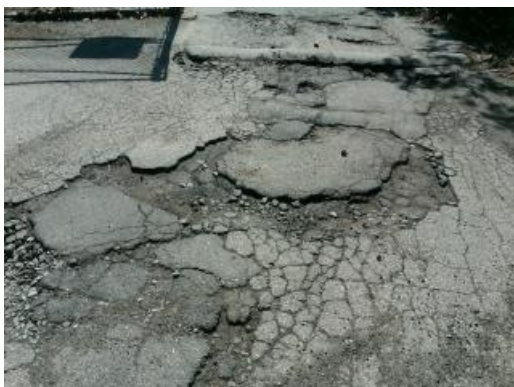
Deteriorated Parking Lot Asphalt

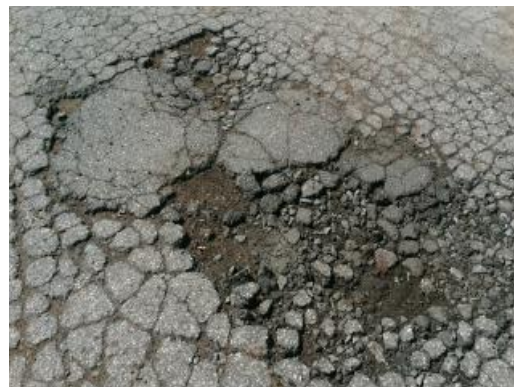
Alligatored Asphalt

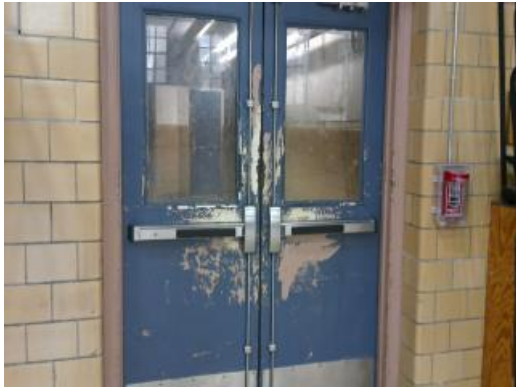
Worn Door Paint

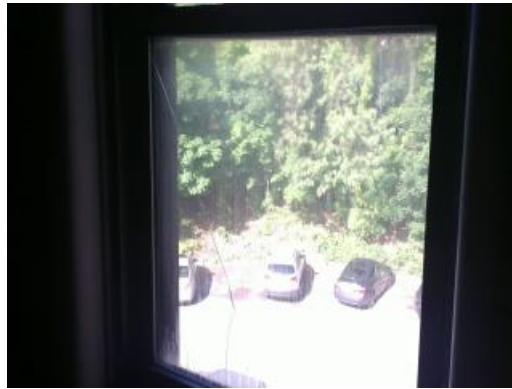
Aged Window

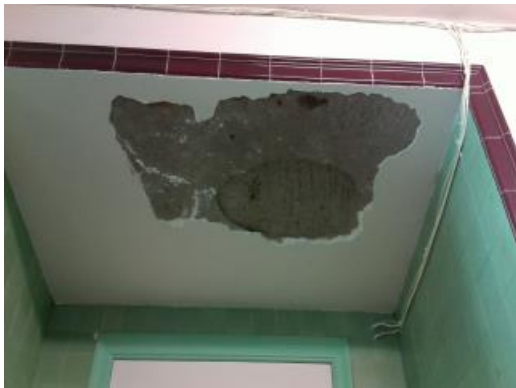
Damaged Ceiling

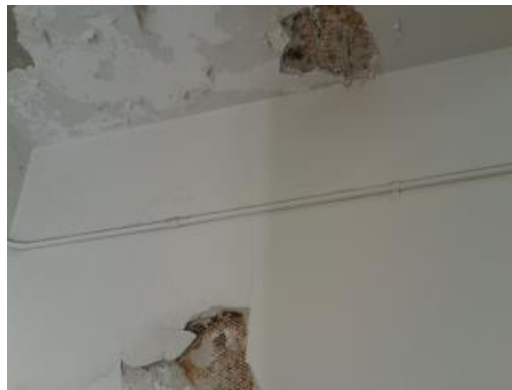
Damaged Ceiling

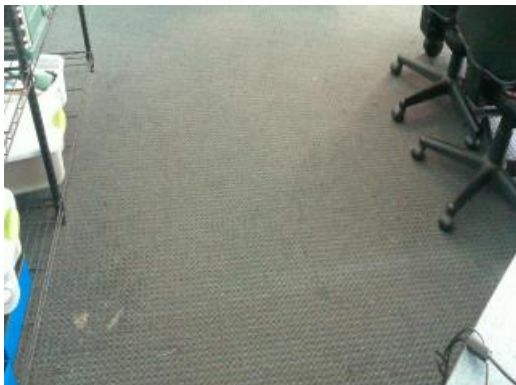
Worn Carpet

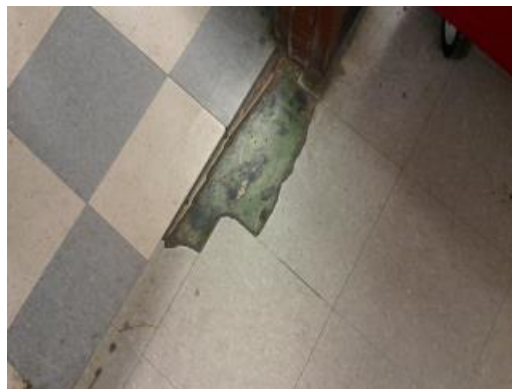
Chipped VCT

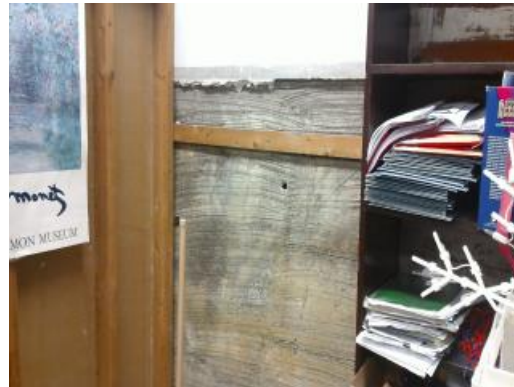
Missing Ceramic Tile

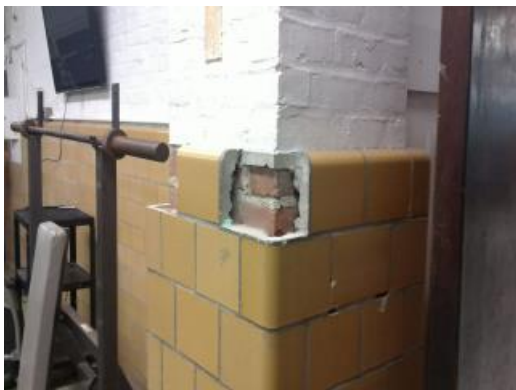
Broken And Missing Tile

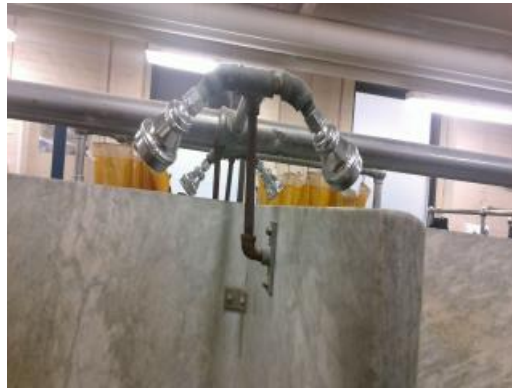
Aged Shower Fixtures

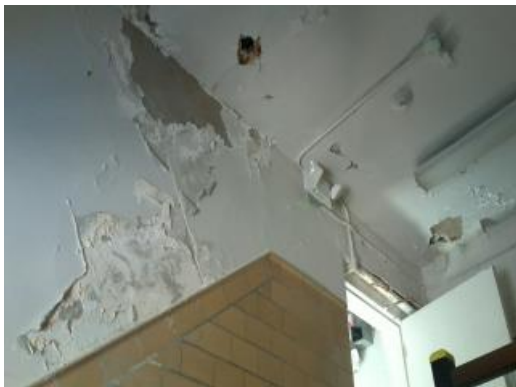
Peeling Wall Paint

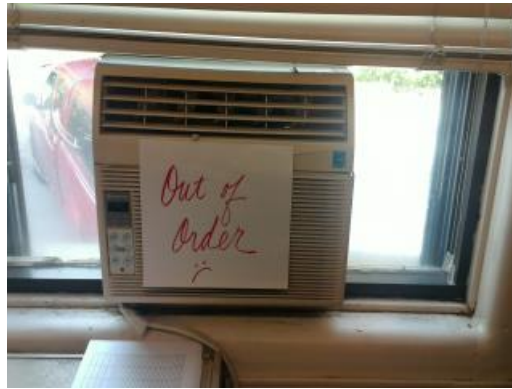
Non-Functional Window Unit

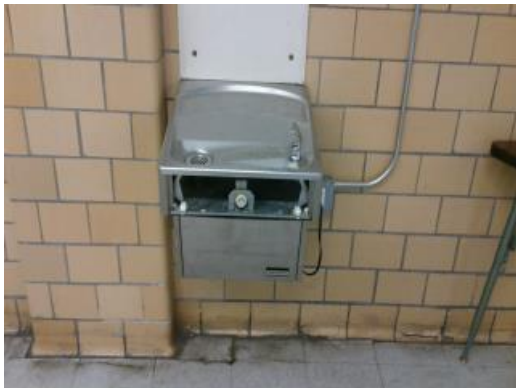
Deficiency	Category	Qty	UoM	Priority	Repair Cost	ID
The Refrigerated Water Cooler Requires Replacement Note: The drinking fountains are damaged and in need of replacement.	Capital Renewal	3	Ea.	4	\$23,977	12638
The Restroom Lavatories Plumbing Fixtures Require Replacement Note: Sinks are original to the building and should be replaced.	Capital Renewal	2	Ea.	4	\$6,892	12626
The Restroom Lavatories Plumbing Fixtures Require Replacement Note: The restroom lavatories are aged and rusted.	Capital Renewal	24	Ea.	4	\$82,707	12627
Room lacks a drinking fountain.	Educational Adequacy	3	Ea.	5	\$3,308	Rollup
Room lacks a private shower area.	Educational Adequacy	1	Ea.	5	\$10,235	Rollup
The Class Room Lavatories Plumbing Fixtures Are Missing And Should Be Installed	Educational Adequacy	27	Ea.	5	\$40,813	Rollup
Sub Total for System		13	items		\$805,339

Broken Drinking Fountain

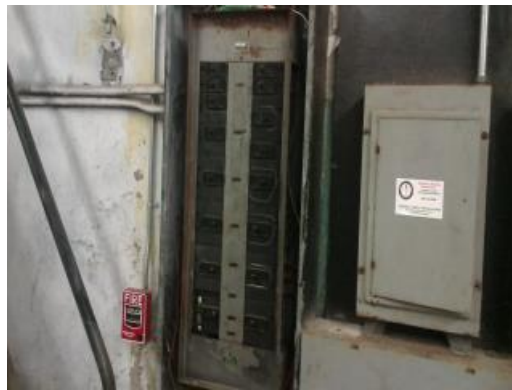
Aged Panelboard

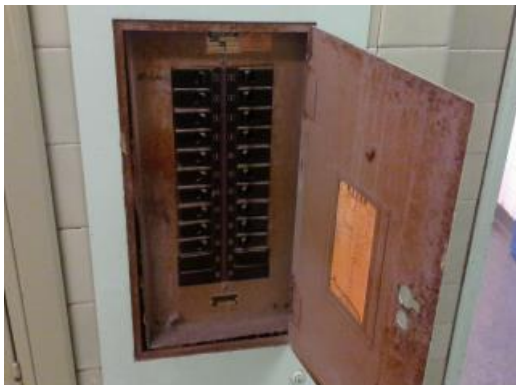
Rusted Panelboard

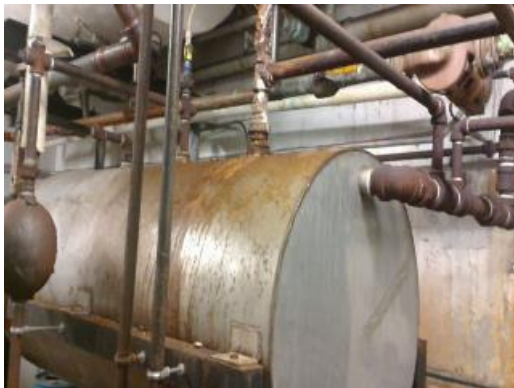
Rusted Condensate Tank

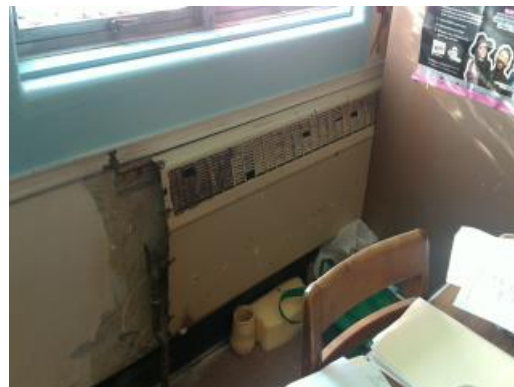
Broken Fin Tube Heater

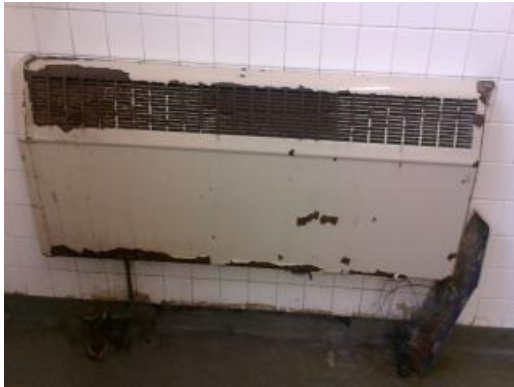
Rusted Fin Tube Heater

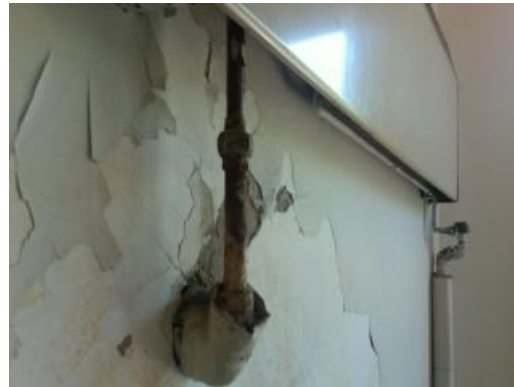
Rusted Piping

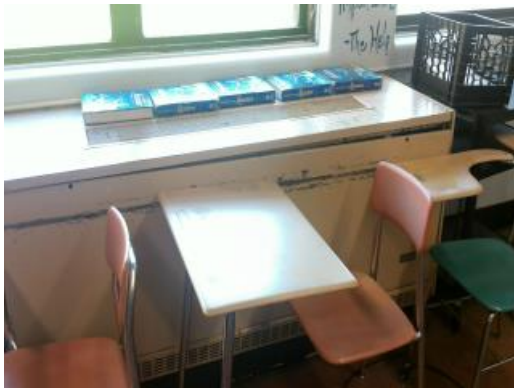
Deficiency	Category	Qty	UoM	Priority	Repair Cost	ID
Replace Unit Vent	Capital Renewal	55	Ea.	2	\$1,007,840	12653
The Air Handler HVAC Component Requires Replacement Note: Air handling units do not function correctly.	Capital Renewal	2	Ea.	2	\$93,463	12641
The Cast Iron Water Boiler Requires Replacement	Capital Renewal	1	Ea.	2	\$33,860	12646
The Fin Tube Water Radiant Heater Requires Replacement Note: The fin tube heaters are broken or rusted.	Capital Renewal	69	Ea.	2	\$125,216	12648
The Mechanical / HVAC Piping / System Is Beyond Its Useful Life Note: Piping is rusted with evidence of leaks.	Capital Renewal	118,281	SF	2	\$987,710	12649
The Steam Condensate Receiver Requires Replacement	Capital Renewal	1	Ea.	2	\$381,071	12647
The Window AC Unit Component Requires Replacement Note: Window units are aged and damaged. Many are non-functional.	Capital Renewal	12	Ea.	2	\$43,405	12640
Exhaust Fan Ventilation Requires Replacement	Capital Renewal	4	Ea.	4	\$11,603	12625

Non-Functional Unit Vent

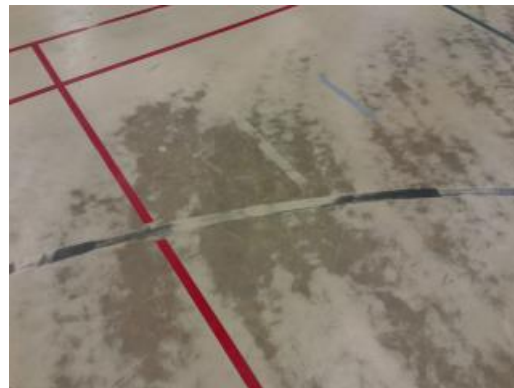
Deficiency	Category	Qty	UoM	Priority	Repair Cost	ID
Classroom Entry Doors Provide Insufficient Sound Isolation Note: All classrooms	Acoustics	52	Ea.	3	\$495,392	19828
The Athletic Sport Flooring Requires Replacement Note: The gymnasium floor shows signs of extensive wear and tear.	Capital Renewal	5,914	SF	3	\$219,274	12634
The Carpet Flooring Requires Replacement Note: The carpet is stained and worn and should be replaced.	Capital Renewal	4,731	SF	3	\$111,506	12620
The Ceramic Tile Flooring Requires Replacement Note: The ceramic tile flooring is original to the building and should be replaced.	Capital Renewal	8,280	SF	3	\$240,878	12622
The Interior Door Hardware Requires Replacement Note: Door hardware is not ADA compliant.	Barrier to Accessibility	208	Door	3	\$706,938	12636
The Vinyl Composition Tile Requires Replacement Note: VCT flooring is chipped and worn with pieces missing.	Capital Renewal	40,381	SF	3	\$501,844	12621

Worn Gymnasium Floor

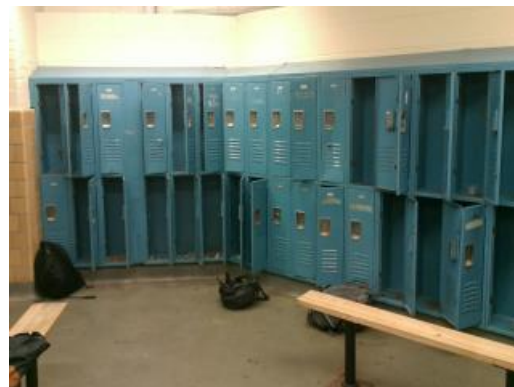
Aged Lockers

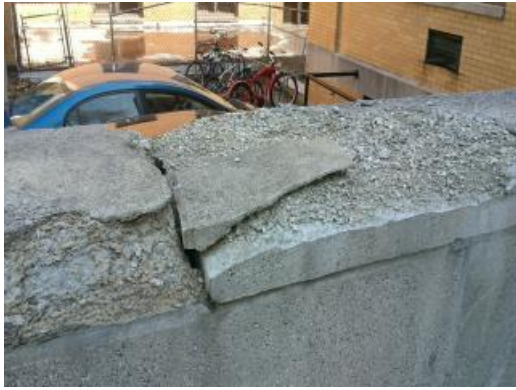
Cracked Concrete Wall

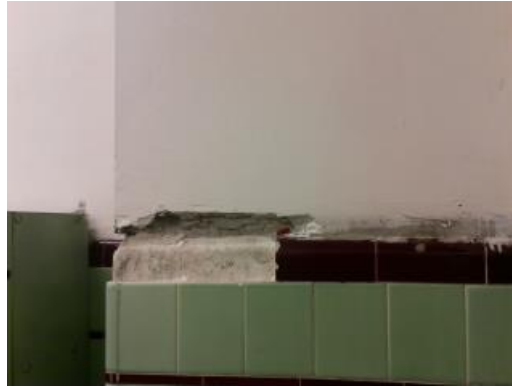
Damaged Tile

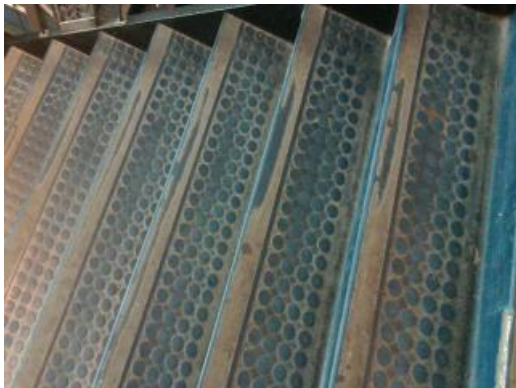
Worn Stair Tread

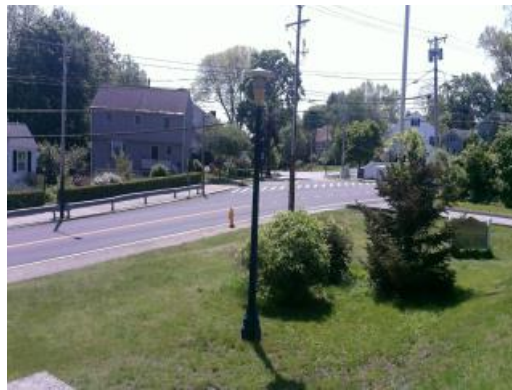
Deficiency	Category	Qty	UoM	Priority	Repair Cost	ID
The Pole Lighting Requires Replacement Note: The pole lights are not functional.	Capital Renewal	3	Ea.	3	\$29,973	12607
Sub Total for System		1	items		\$29,973	
Sub Total for School and Site Level		16	items		\$2,244,328

Non-Functional Pole Light
