# Facility Condition Assessment

Pawtucket - M. Virginia Cunningham School

June 2017

40 Baldwin Street, Pawtucket, RI 02860

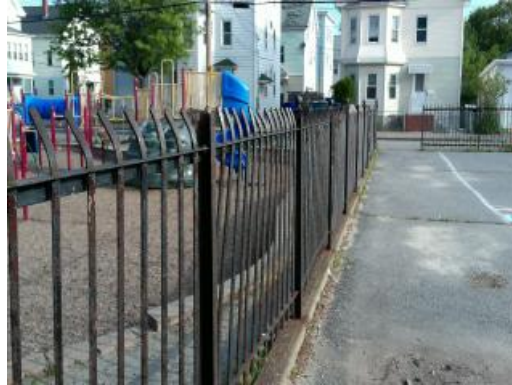
Rusted Ornamental Fencing

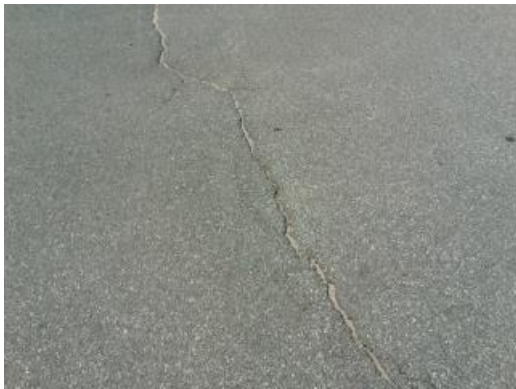
Weathered Parking Lot Pavement

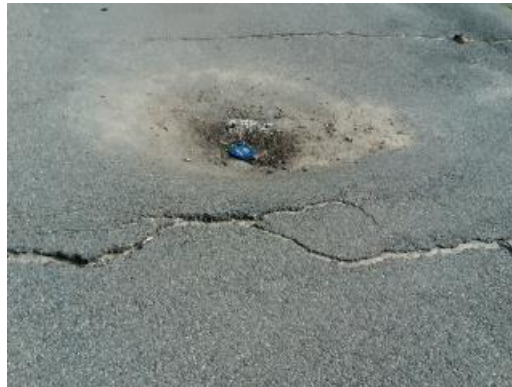
Cracks And Pothole In Parking Lot

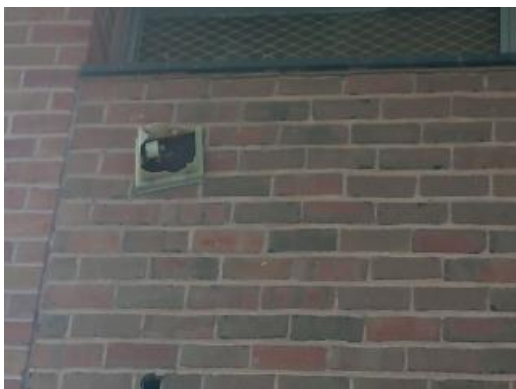
Broken Building Mounted Fixture

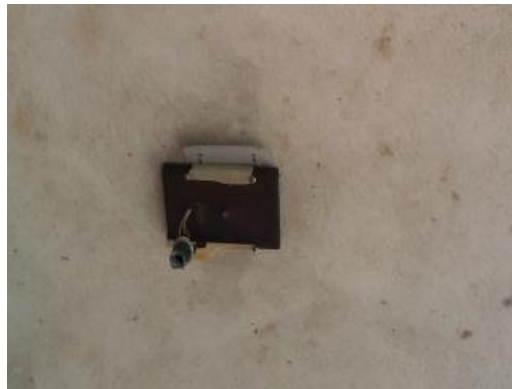
Broken Canopy Fixture

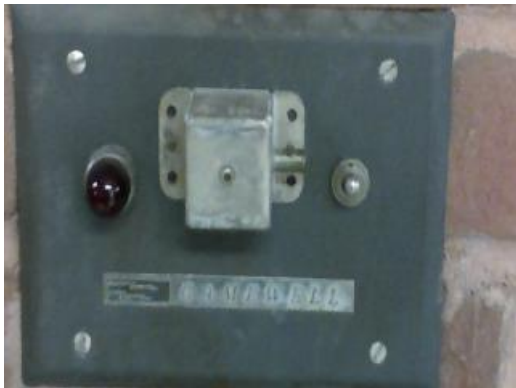
Damaged Controls

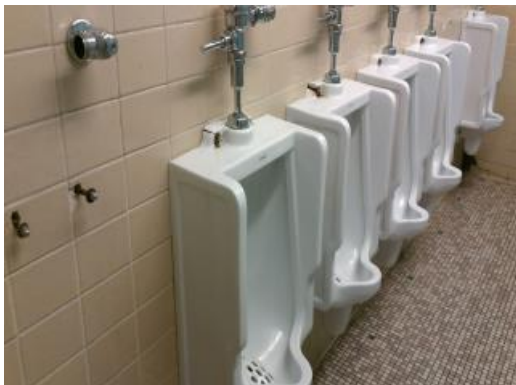
Broken And Missing Urinals

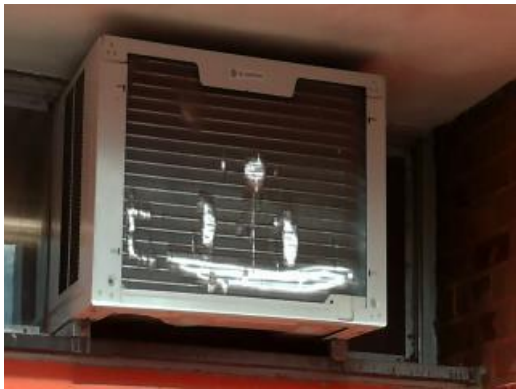
Aged Window Unit

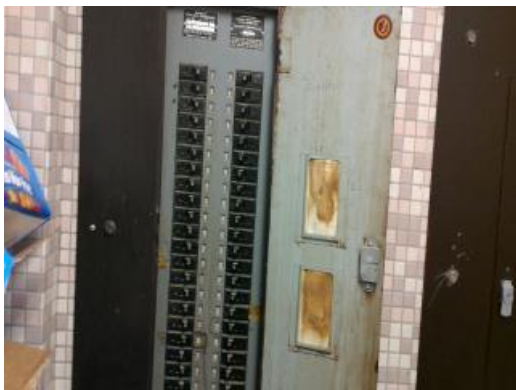
Aged Panelboard

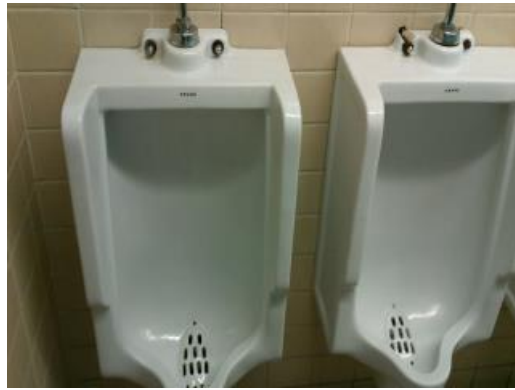
Typical And Broken Urinal

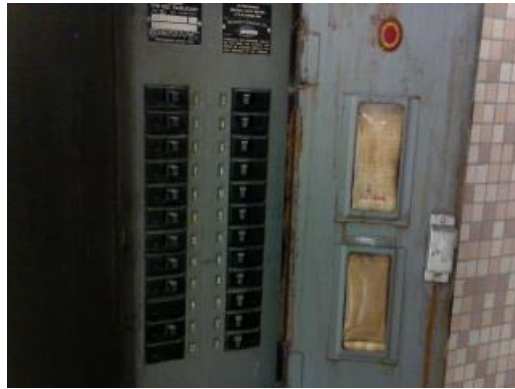
Rusted Panelboard

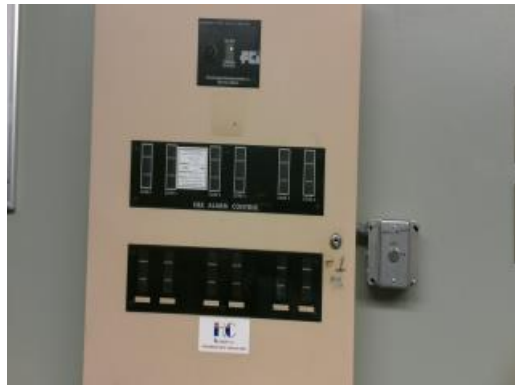
Deficiency	Category	Qty	UoM	Priority	Repair Cost	ID
Fire Alarm Is Missing Or Inadequate (NFPA 72 and NFPA 101, Section 9.6)	Code Compliance	41,744	SF	1	\$127,450	12787
<b>Note:</b> Fire alarm system is aged and is scheduled to be replaced according to site staff.

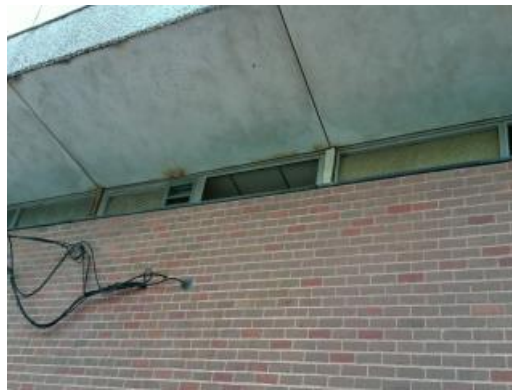
Deficiency	Category	Qty	UoM	Priority	Repair Cost	ID
The Aluminum Window Requires Replacement <b>Note:</b> 206 @ 1'x5' windows are aged and rusted.	Capital Renewal	1,030	SF	2	\$181,563	12771
The Aluminum Window Requires Replacement <b>Note:</b> 147 @ 5'x5' windows are aged and rusted.	Capital Renewal	3,675	SF	2	\$647,811	12772
The Brick Exterior Requires Replacement (Bldg SF) <b>Note:</b> Replace cracked bricks.	Capital Renewal	50	SF	2	\$2,377	12798
The Exterior Requires Cleaning <b>Note:</b> Pressure wash brick to remove graffiti and paint covering it.	Capital Renewal	34,230	SF Wall	5	\$96,610	12797
<b>Sub Total for System</b>		<b>4</b>	<b>items</b>		<b>\$928,361</b>

Aged And Rusted Windows

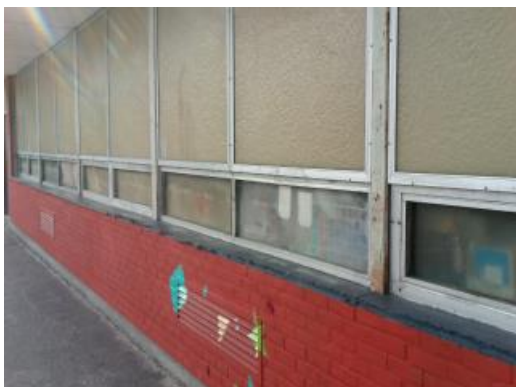
Aged Aluminum Windows

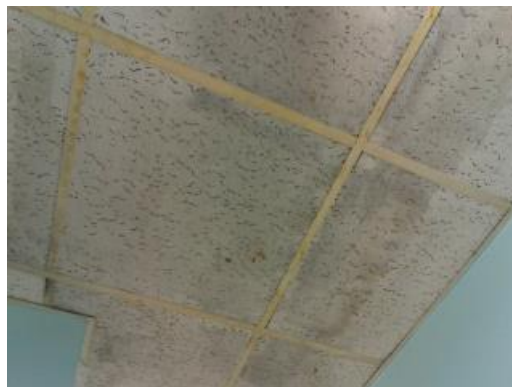
Stained Ceiling Tiles

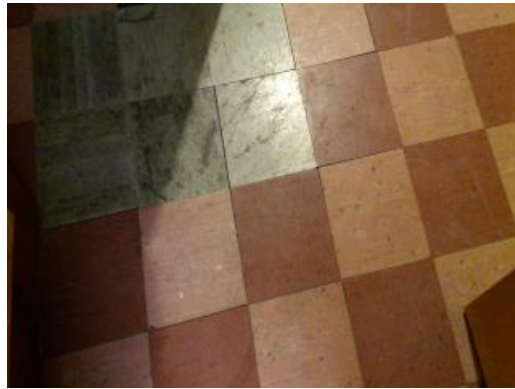
Worn VCT

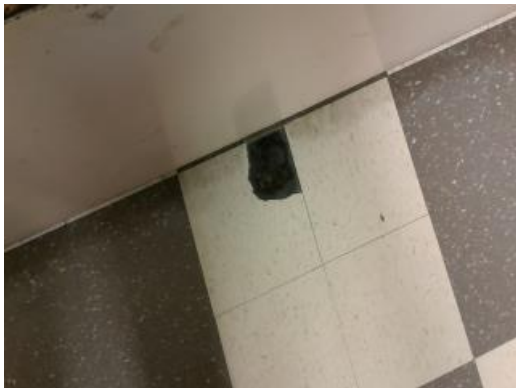
Chipped VCT

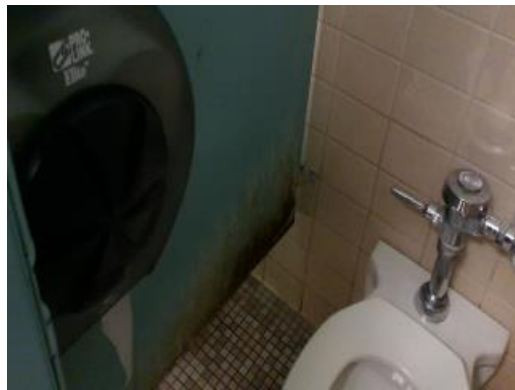
Classroom Door Requires Vision Panel	Educational Adequacy	4	Ea.	5	\$9,127	Rollup
Interior Toilet Partition Requires Repainting	Capital Renewal	1,200	SF Wall	5	\$23,767	12782
<b>Note:</b> Toilet partitions are rusting.						
<b>Sub Total for System</b>		<b>19</b>	<b>items</b>		<b>\$2,467,952</b>

Rusted Toilet Partition

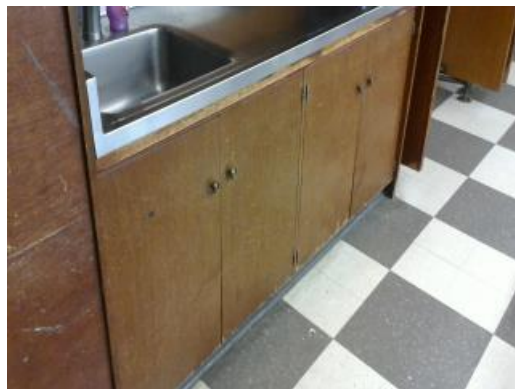
Aged Cabinetry

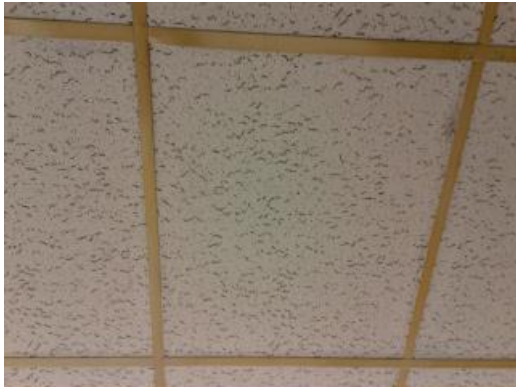
Ceiling Grid Requires Replacement <b>Note:</b> Ceiling grid is aged and stained.	Capital Renewal	36,735	SF	4	\$453,850	12800
Light Deterioration or Damage of 9x9 Asbestos Floor Tile is Present	Hazardous Material	150	SF	4	\$4,456	Rollup
Paint (probable pre-1978 in base (layers(s)) - large areas (> 10 sq. ft.) of peeling/damage & area in active use - children (measurement unit - each)	Hazardous Material	84	Ea.	4	\$24,956	Rollup
Paint (probable pre-1978 in base layer(s)) - large areas (> 10 sq. ft.) of peeling/damage & area in active use - children (measurement unit - linear feet)	Hazardous Material	320	LF	4	\$7,606	Rollup

Stained Ceiling Grid

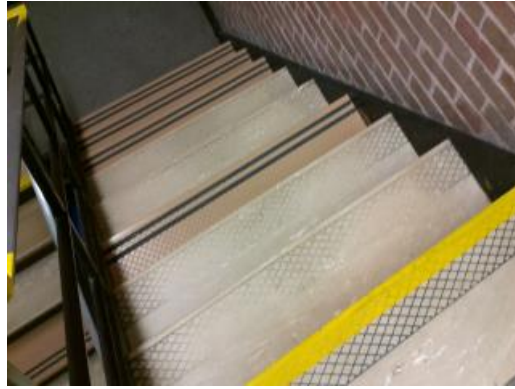
Worn Or Missing Stair Tread
