# Facility Condition Assessment

Providence - Alan Shawn Feinstein Elementary at Broad Street

*June 2017*

1450 Broad Street, Providence, RI 02905

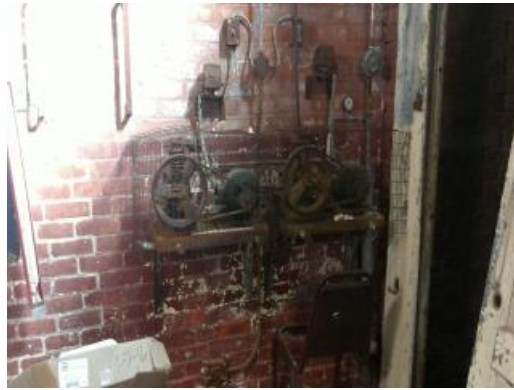
Abandoned Equipment

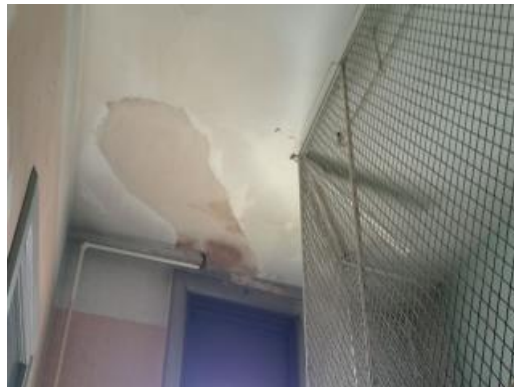
Ceiling Damage

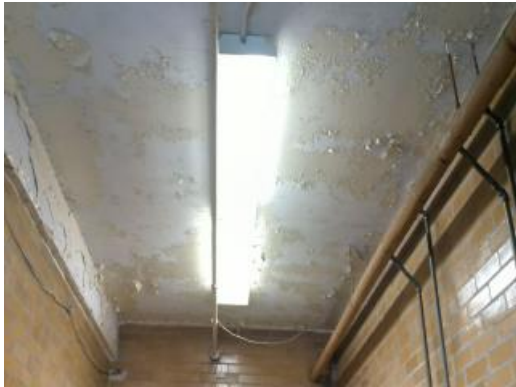
Basement Ceiling Damage

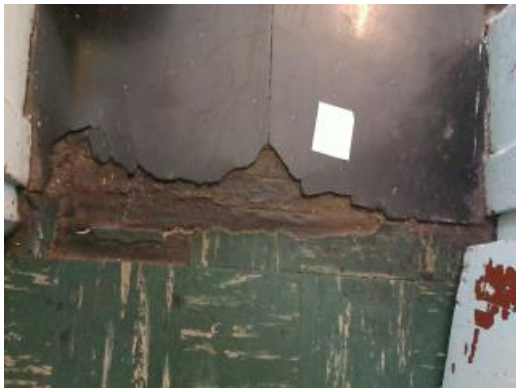
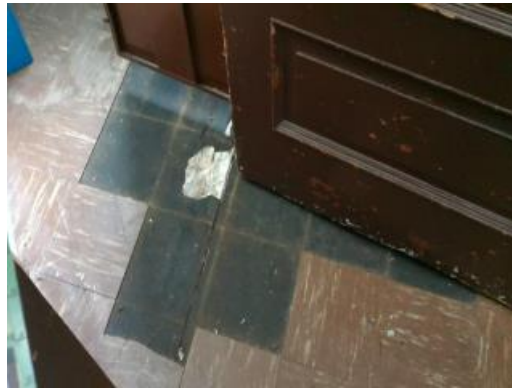
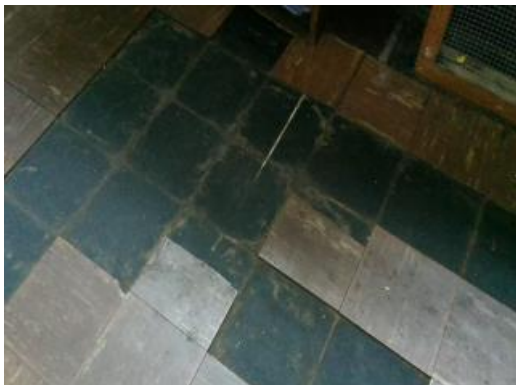
Missing 9x9 Tiles

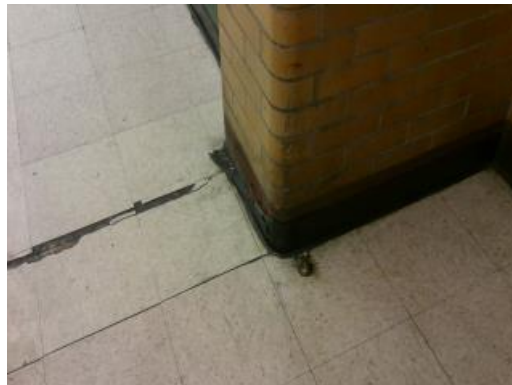
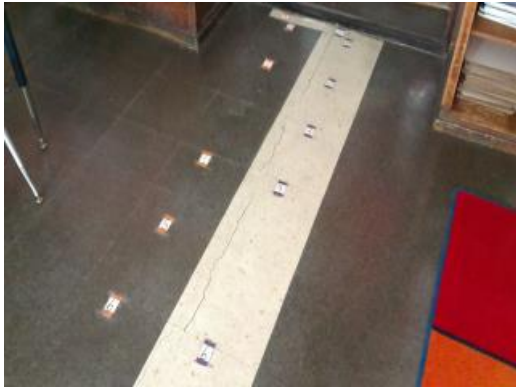
Damaged VCT

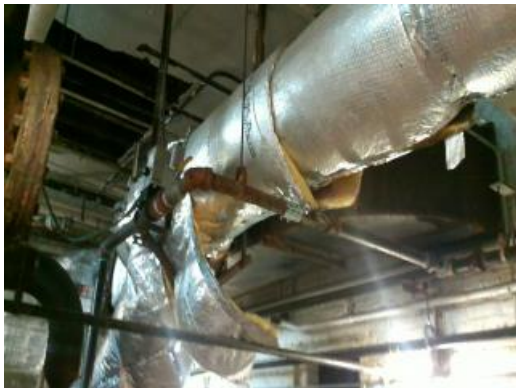
Damaged Insulation

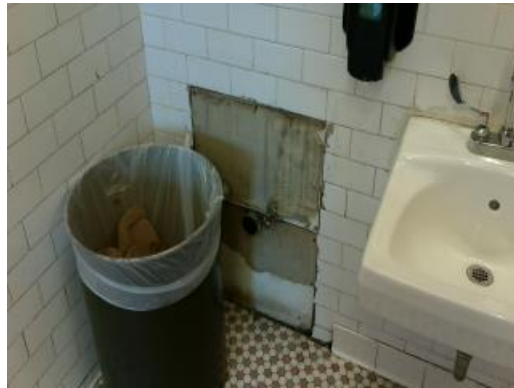
Missing Tile

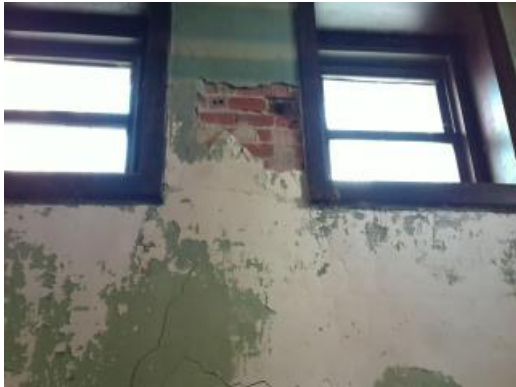
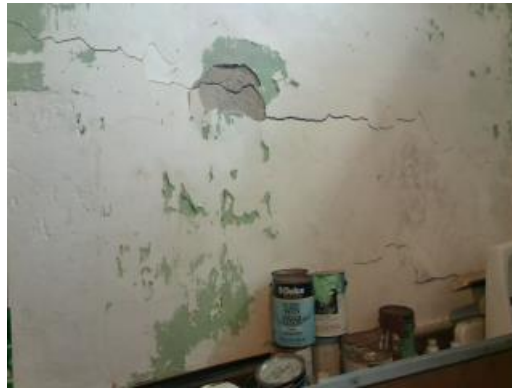
Damaged CMU
