# Facility Condition Assessment

Providence - Mount Pleasant High School / Evolutions HS

June 2017

434 Mt. Pleasant Avenue, Providence, RI 02908

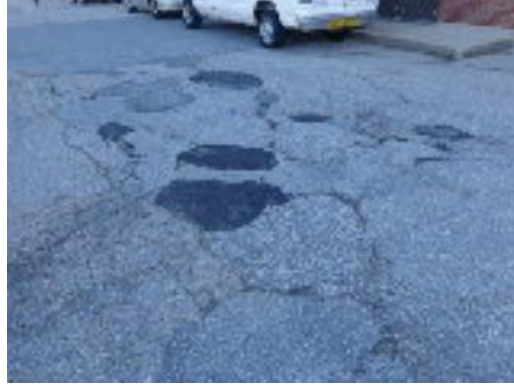
Patched Roadway

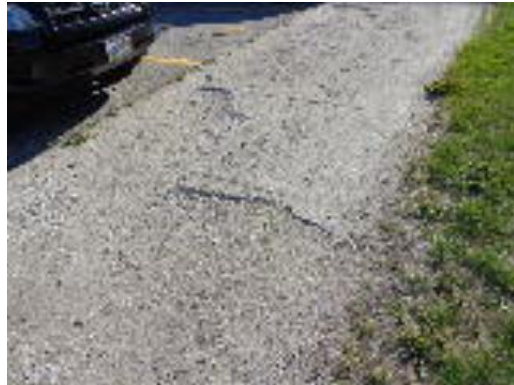
Deteriorated Sidewalk

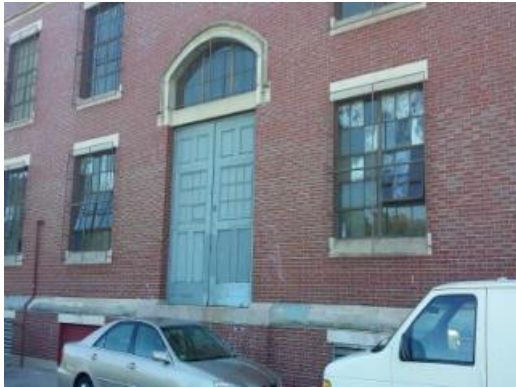
Weathered Exterior Wood Doors

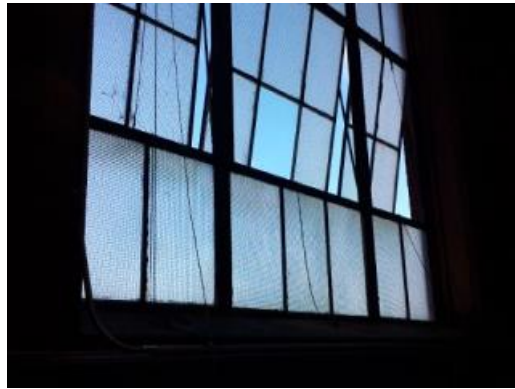
Aged Steel Frame Windows

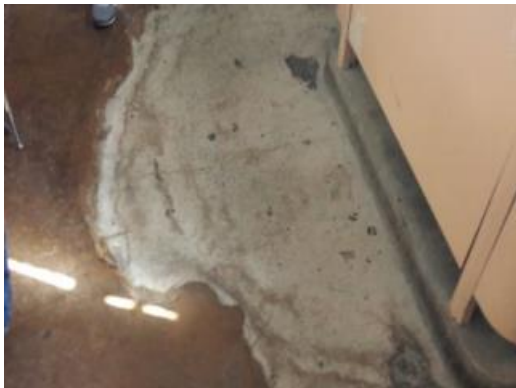
Worn Linoleum Flooring

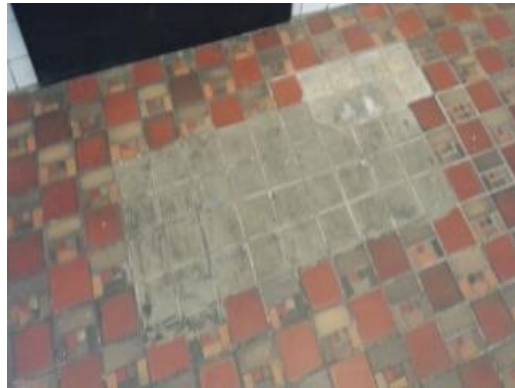
Worn And Missing Tiles

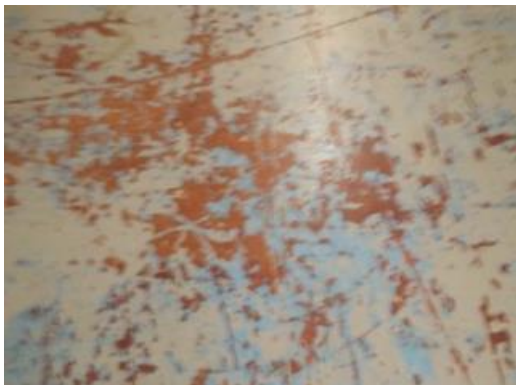
Peeling Concrete Floor Finish

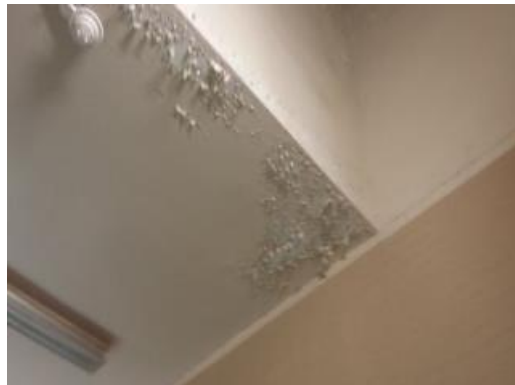
Peeling Ceiling Paint

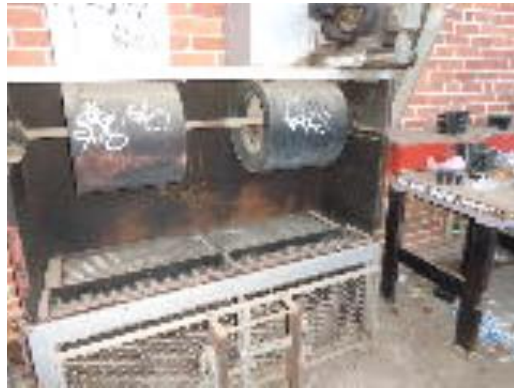
Abandoned AHU

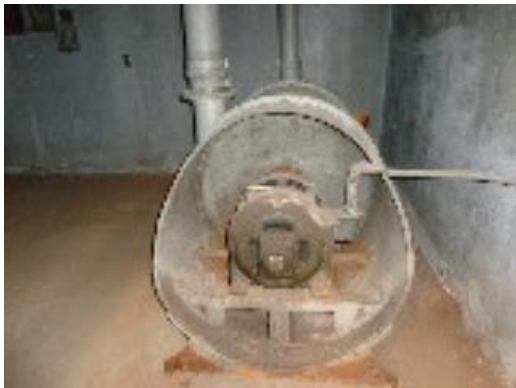
Abandoned Vacuum System

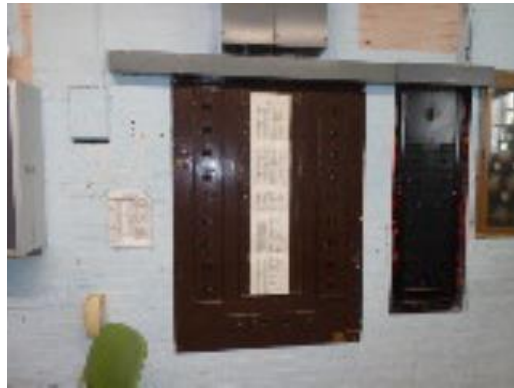
Aged Electrical Panel

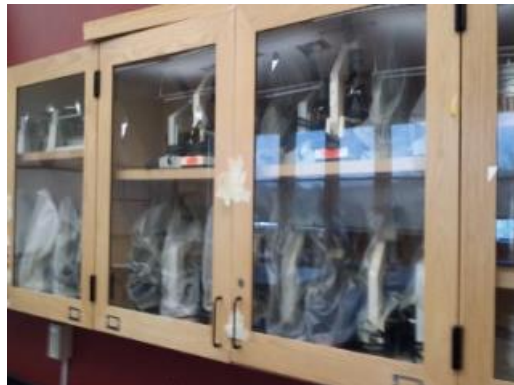
Worn And Peeling Cabinets

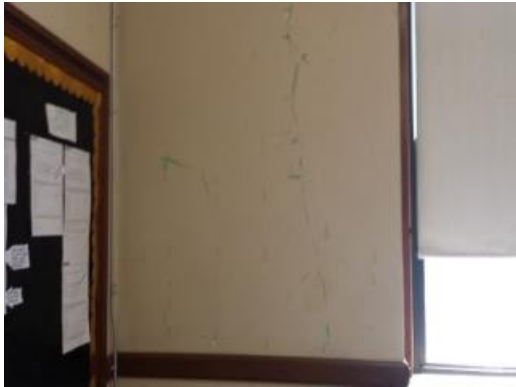
Peeling Wall Paint

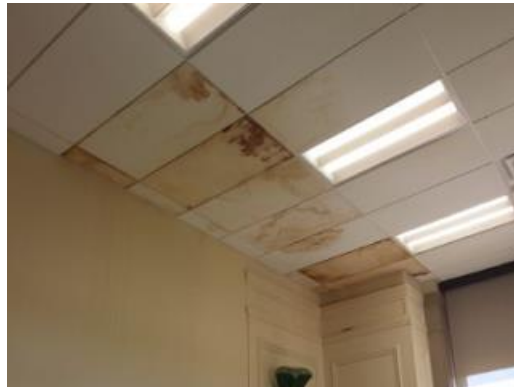
Stained Ceiling Grid And Tiles
