# Facility Condition Assessment

Scituate - Scituate Middle School & High School

June 2017

94 Trimtown Road, North Scituate, RI 02857

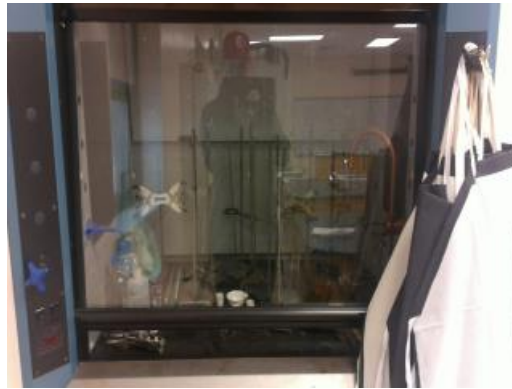
Lab lacks an appropriate fume hood.	Educational Adequacy	4	Ea.	4	\$87,943	Rollup
Small HVAC Circulating Pump Requires Replacement <b>Note:</b> Pump bodies are showing signs of corrosion and poor seals. According to the building manager the water quality is very poor.	Capital Renewal	3	Ea.	4	\$28,589	4549
Small HVAC Circulating Pump Requires Replacement <b>Note:</b> Pump bodies are showing signs of corrosion and poor seals. According to the building manager the water quality is very poor.	Capital Renewal	6	Ea.	4	\$45,770	4557
The Chemistry Lab Fume Hood(s) Require Replacement <b>Note:</b> Fume hoods are outdated, obsolete, and should be replaced.	Capital Renewal	3	Ea.	4	\$85,563	4539
<b>Sub Total for System</b>		<b>11 items</b>			<b>\$2,308,104</b>

Outdated Fume Hood

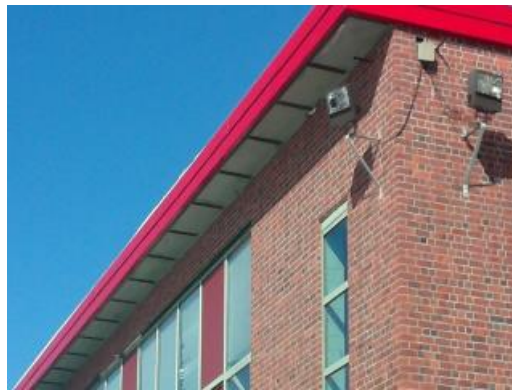
Deficiency	Category	Qty	UoM	Priority	Repair Cost	ID
The Exterior Soffit Requires Repainting <b>Location:</b> NE corner	Capital Renewal	3,000	SF	5	\$9,982	4541
<b>Sub Total for System</b>		<b>1 items</b>			<b>\$9,982</b>

Worn Soffit Paint

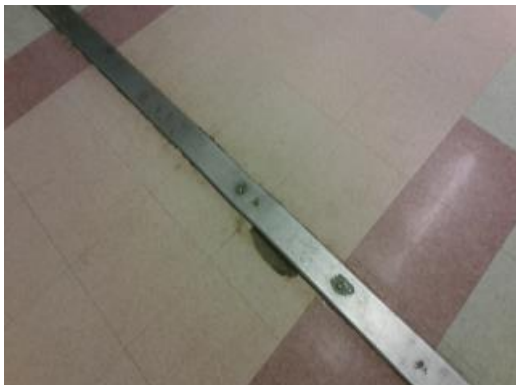
Lifted Joint Cover With Damaged VCT

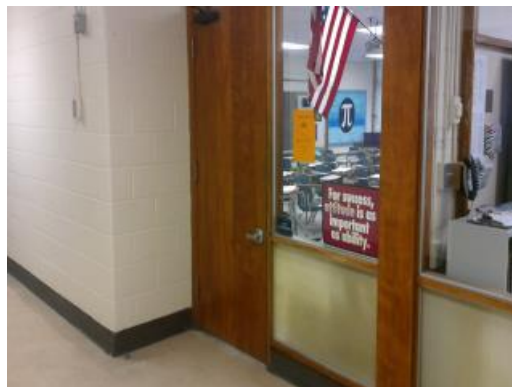
Deficiency	Category	Qty	UoM	Priority	Repair Cost	ID
Existing Door Hardware Is Not ADA Compliant <b>Note:</b> Lever handle is less than 34" above the floor in middle school classrooms 401-420. <b>Location:</b> Middle school classrooms 401-420	Barrier to Accessibility	15	Door	3	\$42,781	4543
The Vinyl Composition Tile Requires Replacement <b>Note:</b> Joint cover is lifted and flooring is damaged. <b>Location:</b> Outside Room 209	Capital Renewal	25	SF	3	\$287	4545
Caulking - significant areas of broken pieces &/or deteriorating caulk	Hazardous Material	585	LF	4	\$11,123	Rollup
Light Deterioration or Damage of 9x9 Asbestos Floor Tile is Present	Hazardous Material	702	SF	4	\$20,022	Rollup
Paint (probable pre-1978 in base (layer(s)) - large areas (> 10 sq. ft.) of peeling/damage & area in active use - children (measurement unit - each)	Hazardous Material	113	Ea.	4	\$32,229	Rollup
Paint (probable pre-1978 in base layer(s)) - large areas (> 10 sq. ft.) of peeling/damage & area in active use - children (measurement unit - linear feet)	Hazardous Material	74	LF	4	\$1,688	Rollup

Non-Compliant Door Hardware

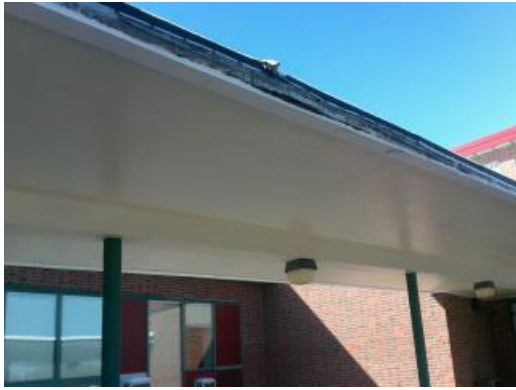
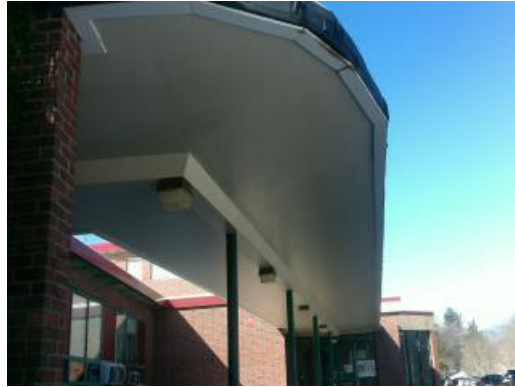
Damaged Canopy Roof Edge

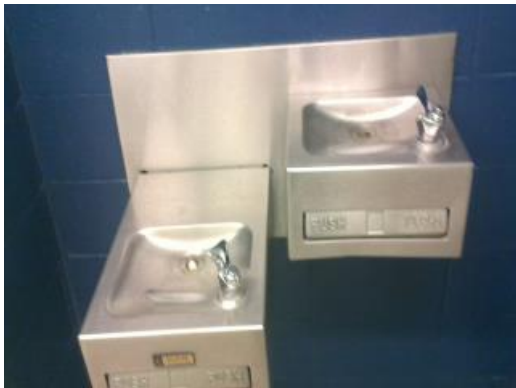
Damaged Drinking Fountains

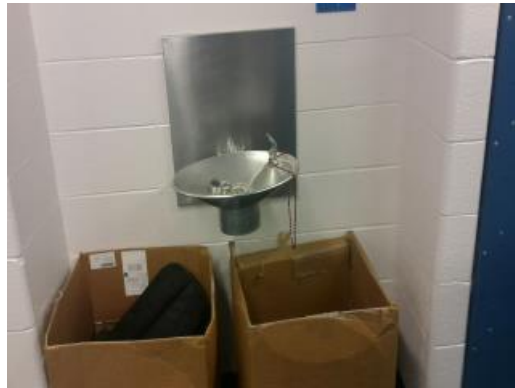
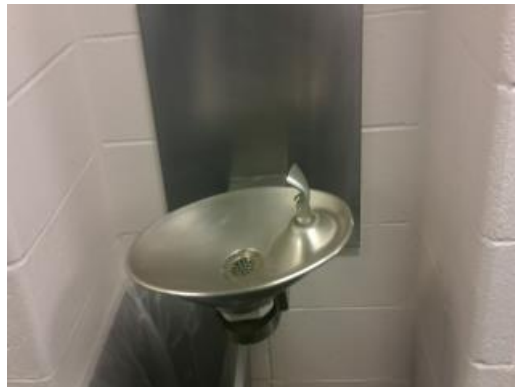
Deficiency	Category	Qty	UoM	Priority	Repair Cost	ID
Emergency Eyewash Requires Replacement <b>Note:</b> Identified as a high priority item by RGB Architects in LEA Review - Replace HS Shop eye wash	Capital Renewal	1	Ea.	3	\$4,753	53532
Sump Pump Requires Replacement	Capital Renewal	2	Ea.	3	\$2,898	4550
The Plumbing / Domestic Water Piping System Is Beyond Its Useful Life <b>Note:</b> Domestic hot water piping in high school appears to be original to the building. According to the building manager, water has high pH levels which can lead to premature failure.	Capital Renewal	50,000	SF	3	\$402,294	4548
Water Storage Tank Requires Replacement <b>Note:</b> Tanks appear to be original to 1956 install and should be replaced.	Capital Renewal	2	Ea.	3	\$69,211	4556
The Refrigerated Water Cooler Requires Replacement <b>Note:</b> Water fountains in the boy's locker room, girl's locker room, and hallway outside of auxiliary gym are non-functional.	Capital Renewal	3	Ea.	4	\$22,132	4547

Non-Functional Drinking Fountain

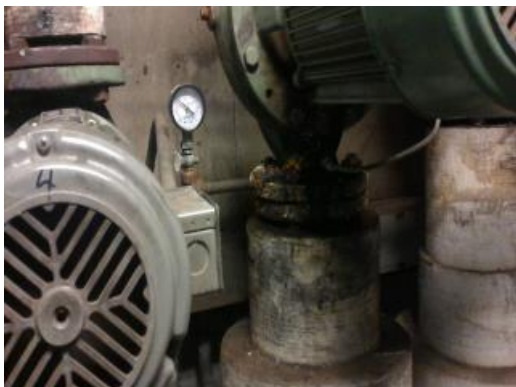
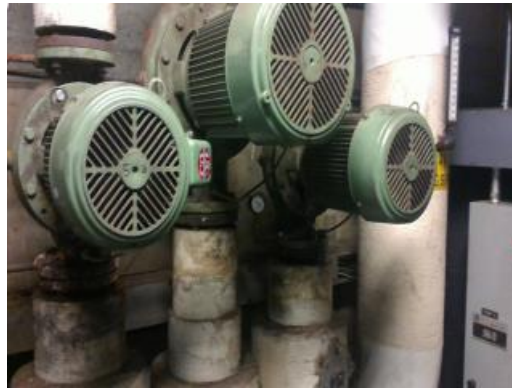
Corroded Pumps

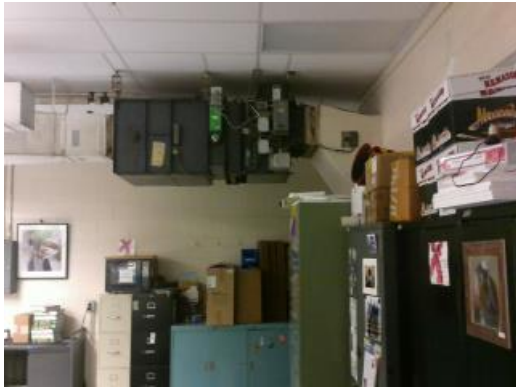
Deficiency	Category	Qty	UoM	Priority	Repair Cost	ID
The Air Handler HVAC Component Requires Replacement <b>Note:</b> AHUs are aged, obsolete, and should be replaced.	Capital Renewal	4	Ea.	2	\$172,548	4551

Aged Air Handler

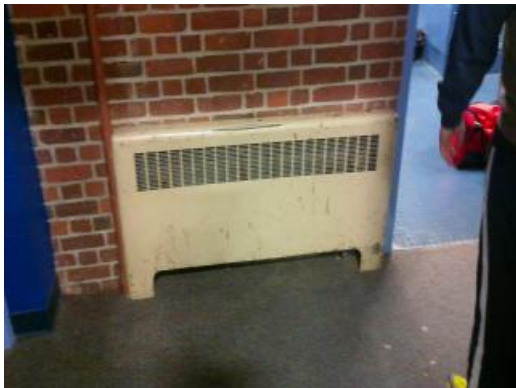
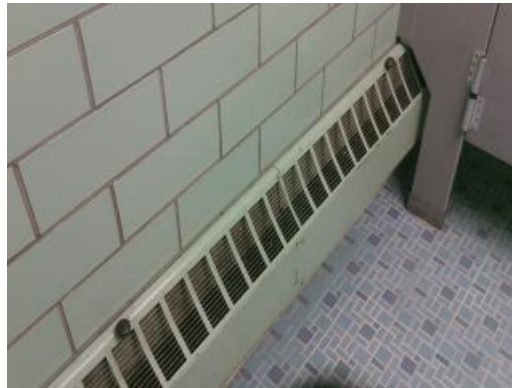
Deficiency	Category	Qty	UoM	Priority	Repair Cost	ID
The Fin Tube Water Radiant Heater Requires Replacement <b>Note:</b> Fin tube radiation is outdated, deteriorating, and should be replaced.	Capital Renewal	117	Ea.	2	\$195,990	4552
The Mechanical / HVAC Piping / System Is Beyond Its Useful Life <b>Note:</b> Hot water piping is original to 1956. Water is not treated and is highly corrosive. Damage can be seen at pumps.	Capital Renewal	144,756	SF	2	\$1,115,807	4553
Energy Recover Unit Requires Replacement <b>Note:</b> Per RGB Architects in LEA Review - The units that service the gym are currently not working.	Capital Renewal	4	Ea.	3	\$94,667	53522
Unit Ventilators Are Excessively Noisy <b>Note:</b> All classrooms	Acoustics	50	Ea.	3	\$317,248	19723
Unit Ventilators Are Excessively Noisy <b>Note:</b> All classrooms	Acoustics	25	Ea.	3	\$158,624	19724
Exhaust Fan Ventilation Requires Replacement <b>Note:</b> Greenhouse supply fans.	Capital Renewal	2	Ea.	4	\$5,355	4542

Typical Deteriorating Radiant Heater

Typical Aged Radiant Heater

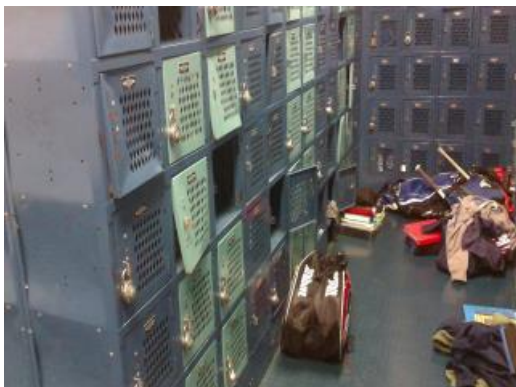
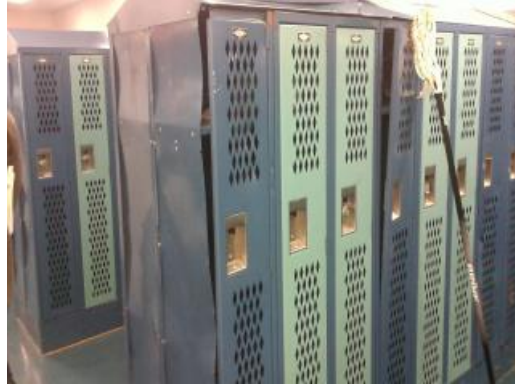
Deficiency	Category	Qty	UoM	Priority	Repair Cost	ID
Room has insufficient writing area.	Educational Adequacy	4	Ea.	3	\$18,253	Rollup
The Metal Student Lockers Require Replacement <b>Note:</b> Lockers are dented with broken doors. <b>Location:</b> Locker rooms	Capital Renewal	300	Ea.	4	\$147,596	4555
Room lacks an appropriate refrigerator.	Educational Adequacy	8	Ea.	5	\$68,450	Rollup
<b>Sub Total for System</b>		<b>3</b>	<b>items</b>		<b>\$234,299</b>	
<b>Sub Total for Building 01 - Main Building</b>		<b>75</b>	<b>items</b>		<b>\$8,118,867</b>	
<b>Total for Campus</b>		<b>79</b>	<b>items</b>		<b>\$8,397,935</b>

Damaged Lockers

Dented Lockers

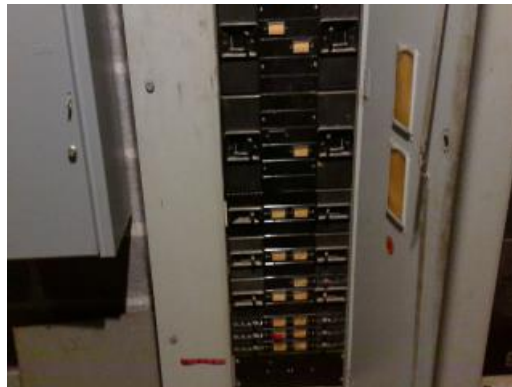
Deficiency	Category	Qty	UoM	Priority	Repair Cost	ID
Room last power shut-off valves for utilities	Educational Adequacy	4	Ea.	1	\$5,649	Rollup
The Distribution Panel Requires Replacement <b>Location:</b> Old electrical room	Capital Renewal	2	Ea.	2	\$58,335	4554
The Electrical Receptacles Are Inadequate And More are Needed <b>Note:</b> Inadequate receptacles throughout building. More are needed.	Functional Deficiency	150	Ea.	3	\$85,563	4558
Room Has Insufficient Electrical Outlets	Educational Adequacy	240	Ea.	5	\$119,104	Rollup
<b>Sub Total for System</b>		<b>4 items</b>			<b>\$268,650</b>

Aged Distribution Panel
