Facility Condition Assessment

Smithfield - Smithfield Senior High School

June 2017

90 Pleasant View Avenue, Smithfield, RI 02917

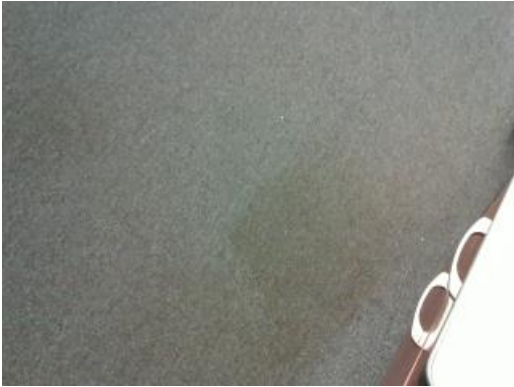
Stained And Worn Carpet

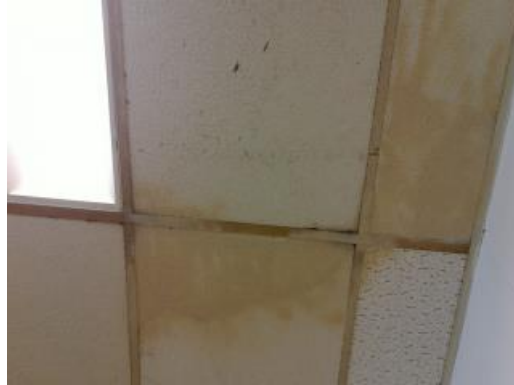
Stained Ceiling Tiles And Grid

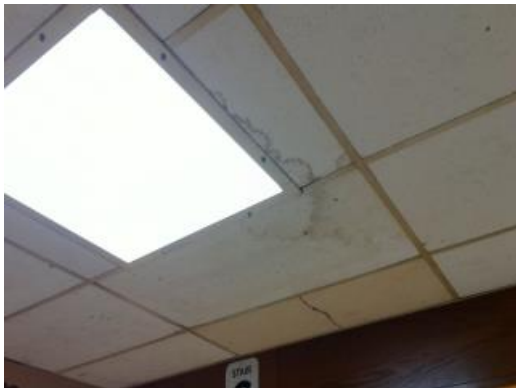
Aged And Stained Ceiling Grid And Tiles

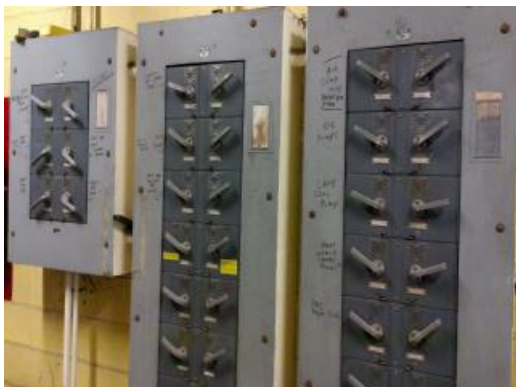
Deficiency	Category	Qty	UoM	Priority	Repair Cost	ID
Room last power shut-off valves for utilities	Educational Adequacy	4	Ea.	1	\$5,718	Rollup
Switchgear Is Needed Or Requires Replacement Note: Switchgears aged and rusted.	Capital Renewal	3	Ea.	2	\$350,722	11917
The Panelboard Requires Replacement	Capital Renewal	3	Ea.	2	\$23,383	11906
The Panelboard Requires Replacement	Capital Renewal	21	Ea.	2	\$103,060	11907
The Panelboard Requires Replacement	Capital Renewal	14	Ea.	2	\$82,179	11908
The Panelboard Requires Replacement	Capital Renewal	6	Ea.	2	\$38,106	11909
The Panelboard Requires Replacement	Capital Renewal	5	Ea.	2	\$60,527	11910
Room Has Insufficient Electrical Outlets	Educational Adequacy	64	Ea.	5	\$32,148	Rollup
Sub Total for System		8	items		\$695,844

Switchgear

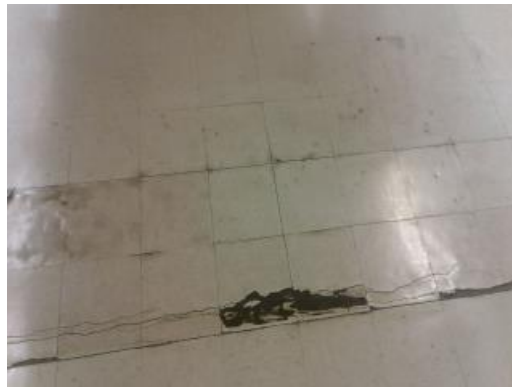
Cracked And Worn VCT

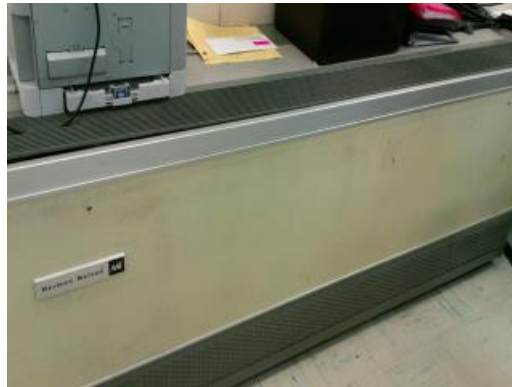
Typical Aged Heating Unit

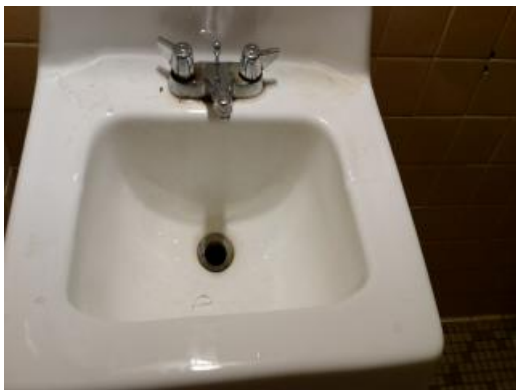
Cracked Restroom Lavatory

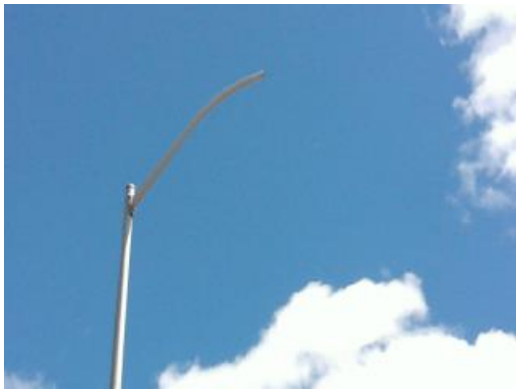
Deficiency	Category	Qty	UoM	Priority	Repair Cost	ID
The Pole Lighting Requires Repair Note: Pole is missing lighting fixture.	Functional Deficiency	1	Ea.	3	\$3,680	11890
Sub Total for System		1	items		\$3,680	
Sub Total for School and Site Level		6	items		\$1,159,905

Missing Pole Light Fixture

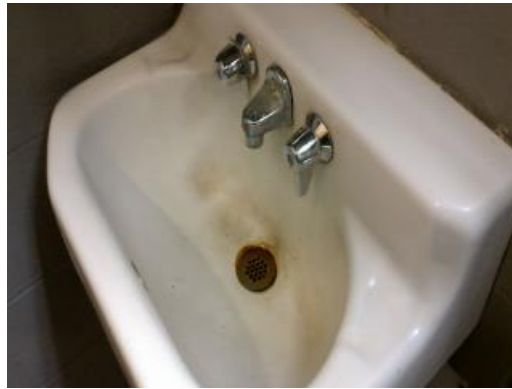
Stained Restroom Lavatory

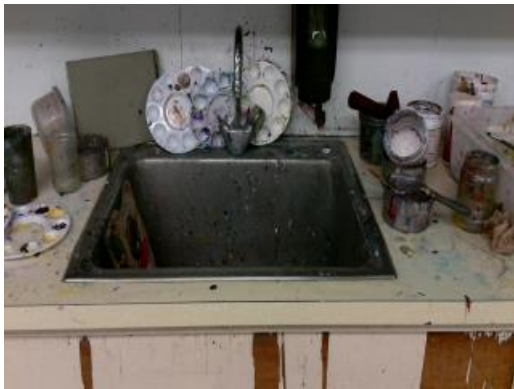
Stained Classroom Lavatory

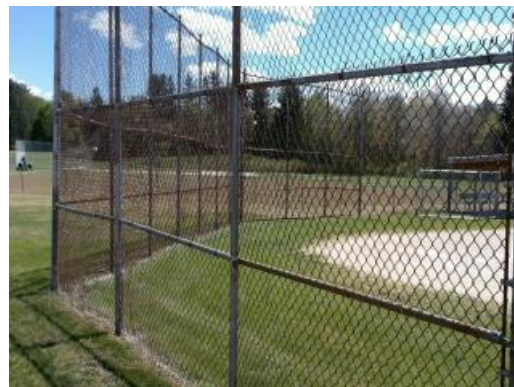
Rusted Fencing

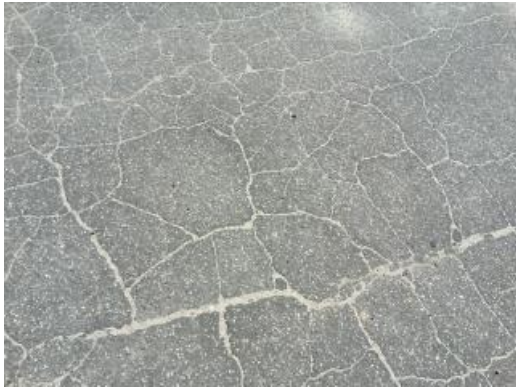
Alligatored Asphalt Pavement

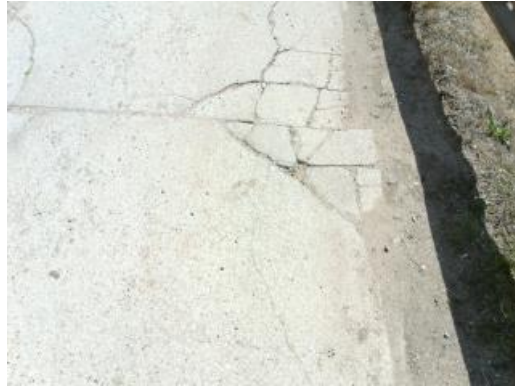
Cracked Sidewalks

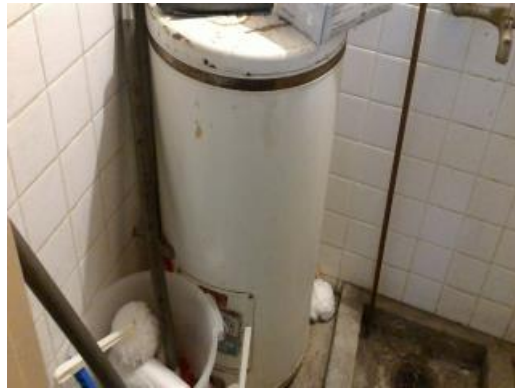
Deficiency	Category	Qty	UoM	Priority	Repair Cost	ID
The Electric Water Heater Requires Replacement Note: Water heaters are rusted and show signs of leaks.	Functional Deficiency	4	Ea.	2	\$14,334	11905
The Showers Plumbing Fixtures Require Replacement Note: Shower fixtures leak and are missing controls. Shower heads are rusted. Location: Locker room and gym office	Capital Renewal	27	Ea.	3	\$207,852	11900
The Urinal Plumbing Fixtures Require Replacement	Capital Renewal	26	Ea.	3	\$34,977	11904
Non-Refrigerated Drinking Fountain Requires Replacement	Capital Renewal	8	Ea.	4	\$82,756	11901
The Classroom Lavatories Plumbing Fixtures Require Replacement	Functional Deficiency	24	Ea.	4	\$66,051	11891
The Custodial Mop Or Service Sink Requires Replacement Note: Mop sinks are rusted with poor drainage.	Capital Renewal	9	Ea.	4	\$23,470	11902
The Restroom Lavatories Plumbing Fixtures Require Replacement Note: Restroom lavatories are aged and stained with some cracking.	Functional Deficiency	32	Ea.	4	\$103,033	11898

Typical Rusted Water Heater

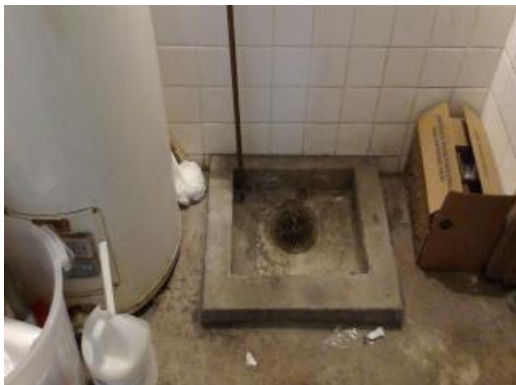
Corroded Mop Sink

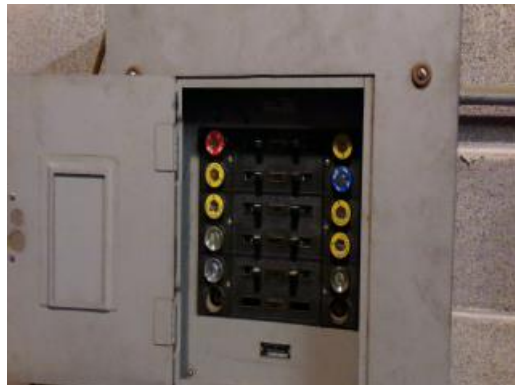
Aged Panelboard

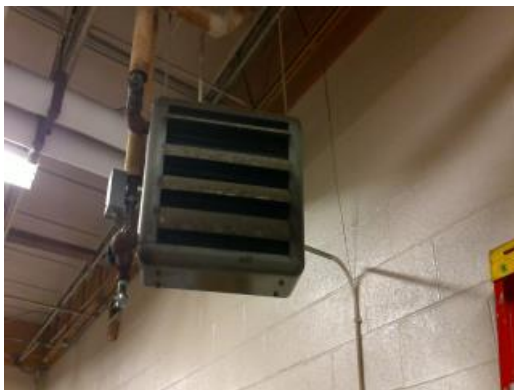
Aged Unit Heater

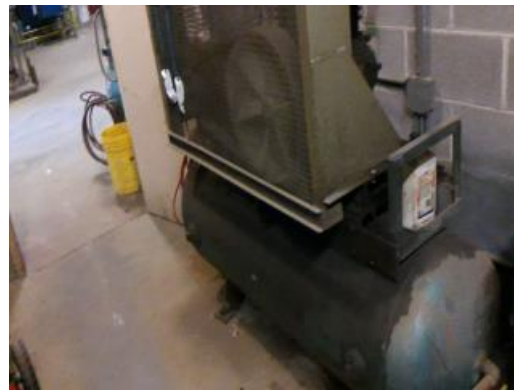
Abandoned Air Compressor
