Facility Condition Assessment

South Kingstown - South Kingstown High School

June 2017

215 Columbia Street, Wakefield, RI 02879

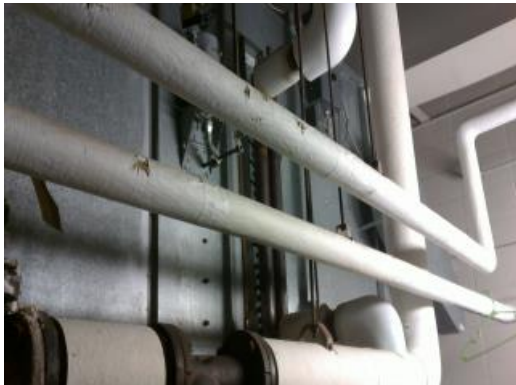
Auditorium AHU

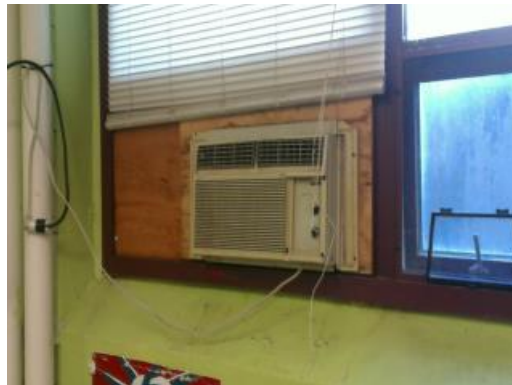
Failing Window Unit

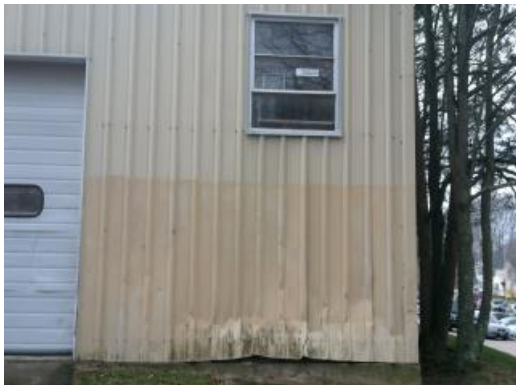
Damaged Metal Panel Wall

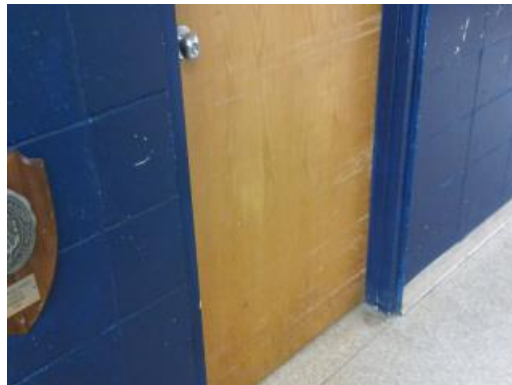
Worn Wood Door

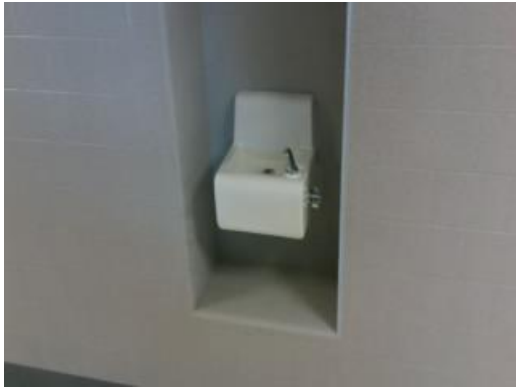
Deficiency	Category	Qty	UoM	Priority	Repair Cost	ID
Non-Refrigerated Drinking Fountain Requires Replacement Note: Units are aged, corroded, and non-functional.	Capital Renewal	9	Ea.	4	\$91,980	8471
The Custodial Mop Or Service Sink Requires Replacement Note: Service sinks are stained and rusting.	Capital Renewal	13	Ea.	4	\$33,493	8472
Room lacks a drinking fountain.	Educational Adequacy	3	Ea.	5	\$3,308	Rollup
The Class Room Lavatories Plumbing Fixtures Are Missing And Should Be Installed	Educational Adequacy	107	Ea.	5	\$161,742	Rollup
Sub Total for System		4	items		\$290,524

Non-Functional Drinking Fountain

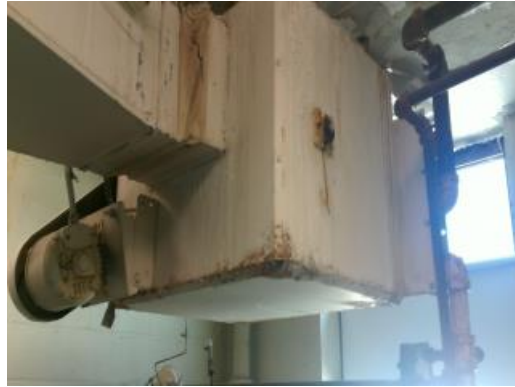
Corroded Make-Up Air Unit

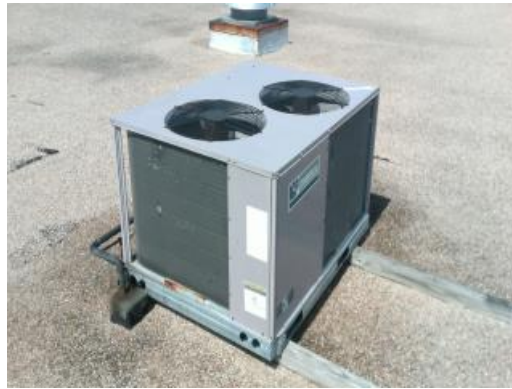
The Exterior Condenser Requires Replacement Note: Condenser is old and the heat exchanger is rusted.	Capital Renewal	1	Ea.	2	\$16,342	8481
The Steam Condensate Receiver Requires Replacement Note: Pumps and seals are rusted and leaking.	Capital Renewal	3	Ea.	2	\$1,055,274	8486
The Window AC Unit Component Requires Replacement Note: Units are aged and beginning to fail. Plastic casing is cracked and coils are clogged.	Capital Renewal	3	Ea.	2	\$10,017	8479

Condenser

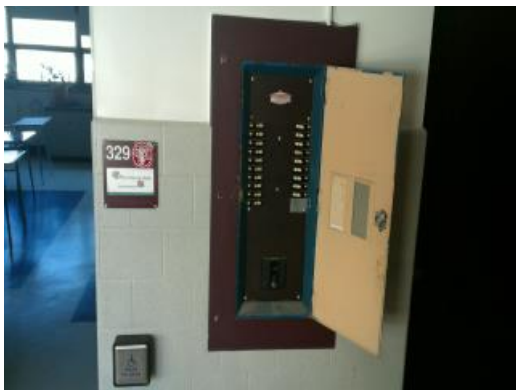
Aged Panelboard

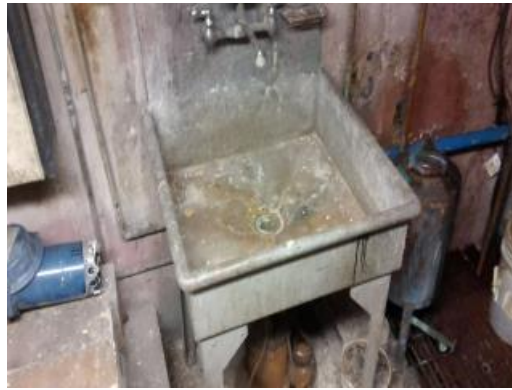
Corroded Utility Sink

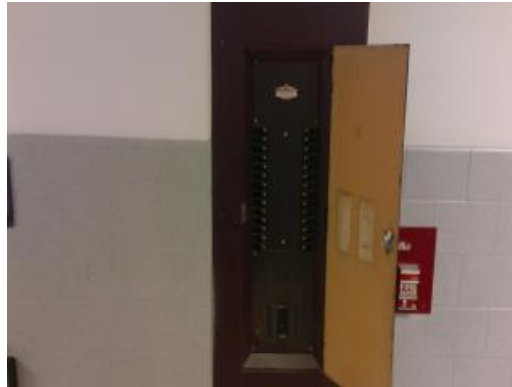
Aged 225 Amp Panelboard

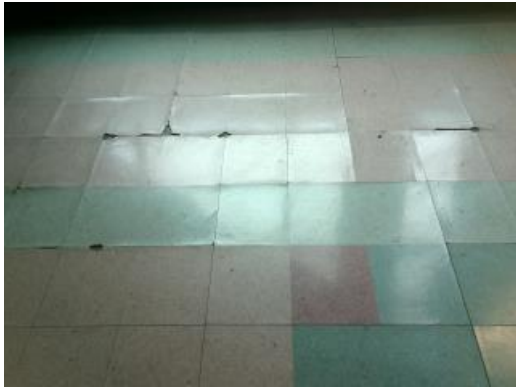
Chipped And Curling VCT

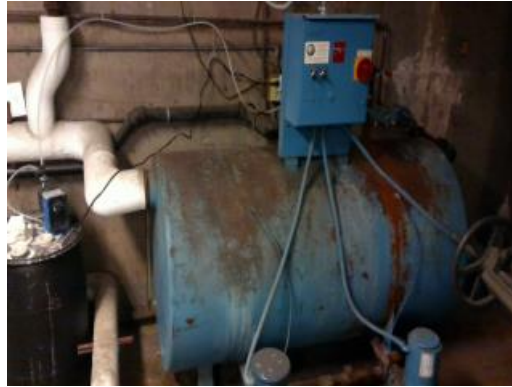
Rusted Condensate Receiver

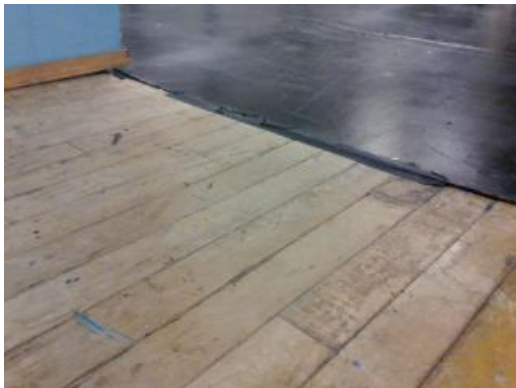
Worn Wood Floor

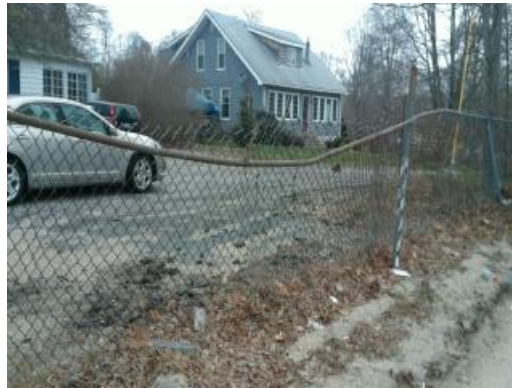
Rusted And Falling Fence

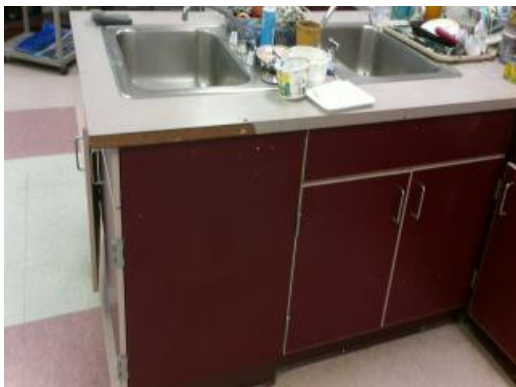
Deficiency	Category	Qty	UoM	Priority	Repair Cost	ID
Room has insufficient writing area.	Educational Adequacy	4	Ea.	3	\$18,253	Rollup
Replace Cabinetry In Classes/Labs	Capital Renewal	27	Room	4	\$302,071	8490
Note: Laminate chipped or faded on main building cabinetry.						
Walk In Cooler/Freezer Is Required	Educational Adequacy	1	Ea.	4	\$90,316	Rollup
Welding Bays Are Required	Educational Adequacy	2	Ea.	4	\$10,838	Rollup
Work Tables Are Required	Educational Adequacy	1	Ea.	4	\$3,585	Rollup
Room lacks an appropriate refrigerator.	Educational Adequacy	15	Ea.	5	\$128,344	Rollup
Sub Total for System		6	items		\$553,407	
Sub Total for Building 01 - Main Building		79	items		\$17,074,765	
Total for Campus		89	items		\$19,397,032

Chipped Art Classroom Cabinetry

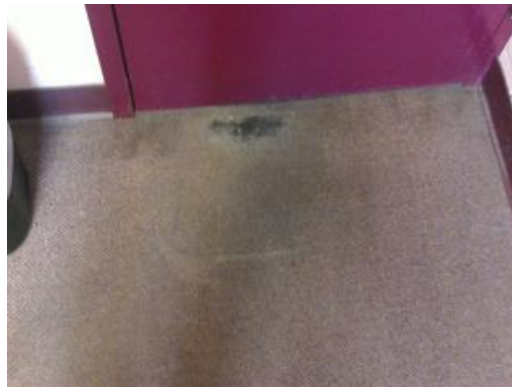
Worn And Stained Carpet

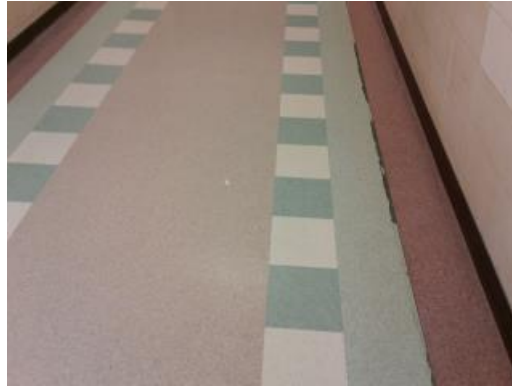
Chipped VCT

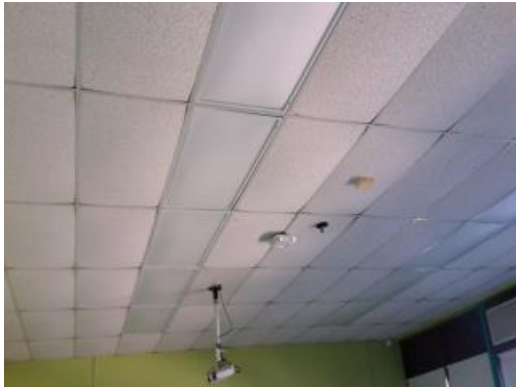
Stained And Sagging Ceiling Tiles

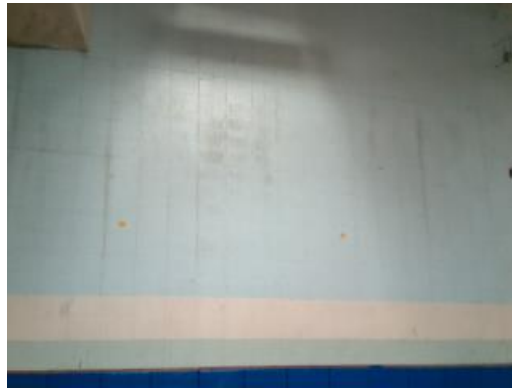
Worn Gym Paint

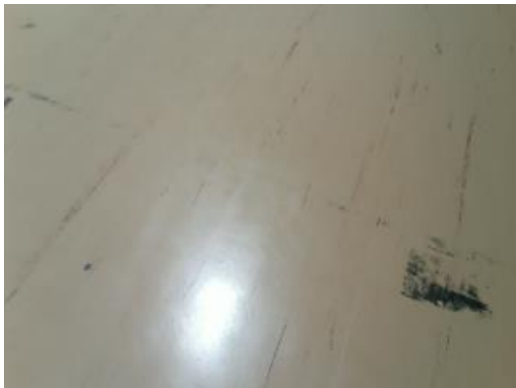
Worn Athletic Flooring

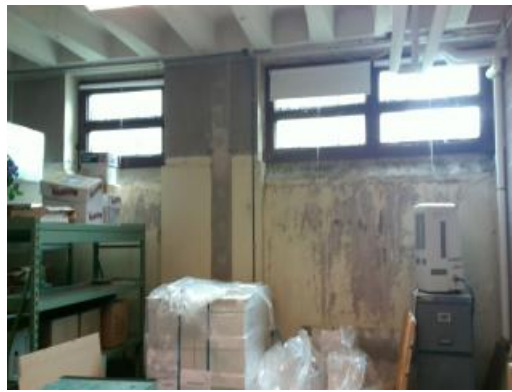
Peeling Paint In Storage
