Facility Condition Assessment

Tiverton - Tiverton High School

June 2017

100 North Brayton Road, Tiverton, RI 02878

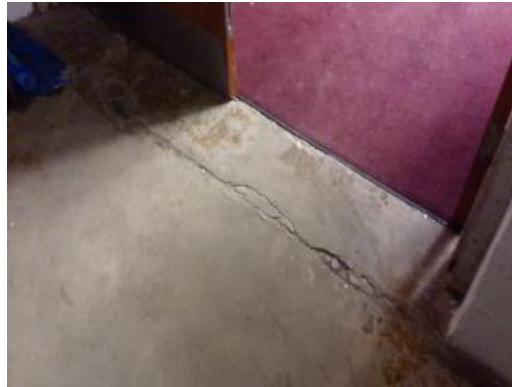
Cracked Concrete Flooring

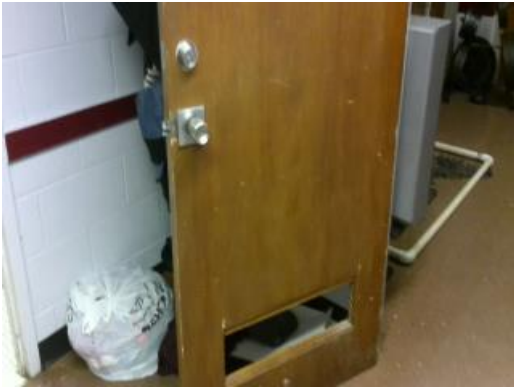
Chipped And Worn Wood Door

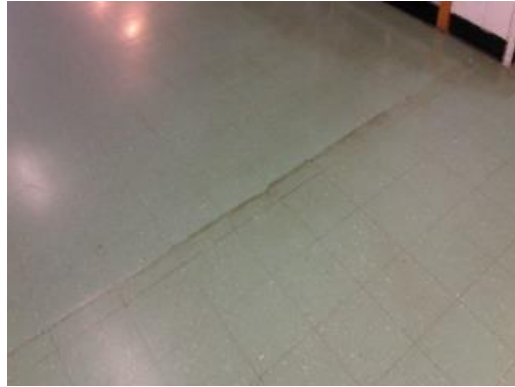
Cracked 9X9 Tile

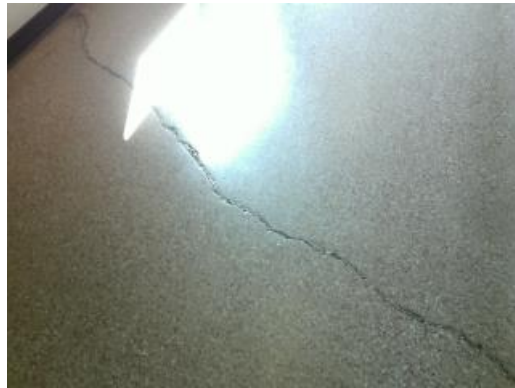
Cracked Terrazzo Flooring

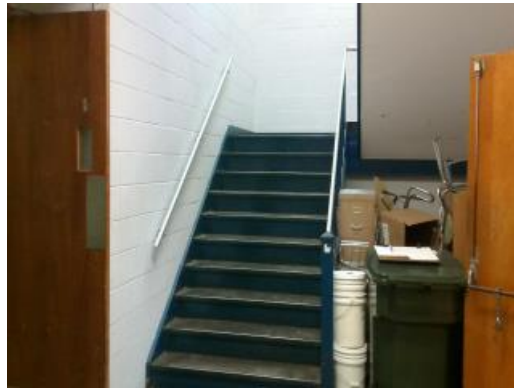
The Handrails In The Stair Area Are Not ADA Compliant Note: No hand rail extension at top or bottom.	Barrier to Accessibility	1,000	LF	4	\$129,295	1702
Vinyl/Fabric Wall Covering Requires Replacement Note: Wall covering has been painted and is peeling.	Capital Renewal	4,000	SF	4	\$28,521	1620
Wall/ceiling materials - area < 9 sq. ft. AND in children-accessible area	Hazardous Material	20	SF	4	\$190	Rollup
Wall/ceiling materials - large areas (> 10 sq. ft.) of damage & area in active use - children	Hazardous Material	290	SF	4	\$2,757	Rollup
Wall/ceiling materials - large areas (> 10 sq. ft.) of damage & area in active use - adults only	Hazardous Material	250	SF	4	\$2,377	Rollup
Classroom Door Requires Vision Panel	Educational Adequacy	1	Ea.	5	\$2,282	Rollup
Room lacks appropriate sound control.	Educational Adequacy	200	SF	5	\$6,959	Rollup
The Concrete Flooring Requires Repair Or Repainting Location: Girls locker room	Capital Renewal	1,600	SF	5	\$12,169	1577

No Handrail Extension At Top Or Bottom

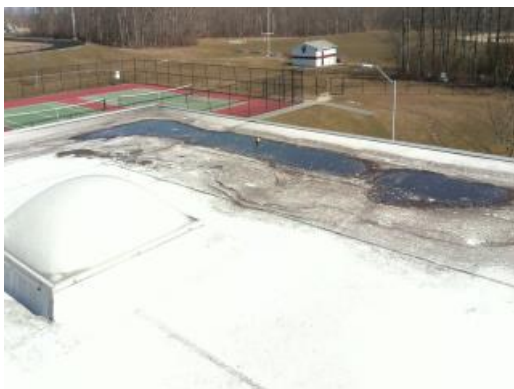
Deficiency	Category	Qty	UoM	Priority	Repair Cost	ID
The Single-Ply Membrane Roof Covering Requires Replacement Note: Roof is holding substantial amounts of water.	Capital Renewal	102,500	SF	2	\$1,315,527	1700
Sub Total for System		1 items			\$1,315,527

Ponding At Gym Roof Edge

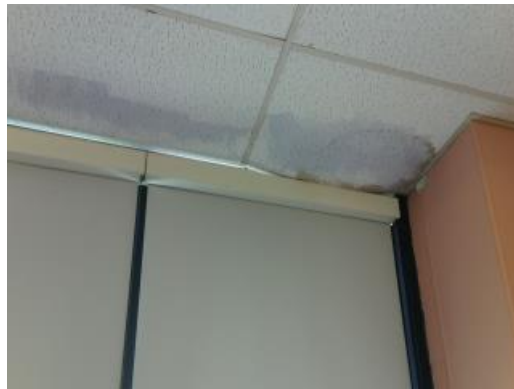
Stained Ceiling Tiles

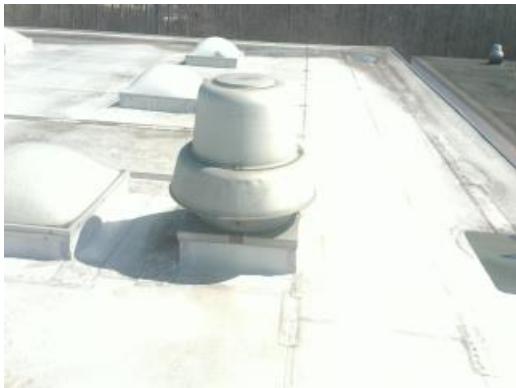
Non-Functional Exhaust Fan

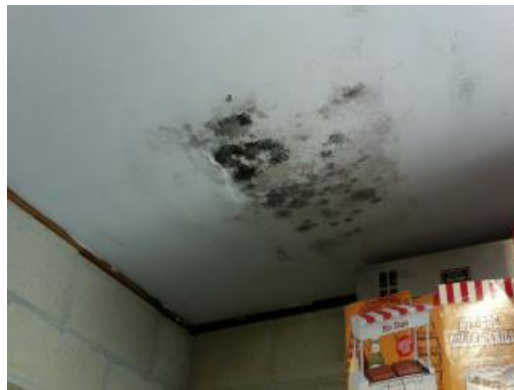
Building 3 Stained Concession Ceiling

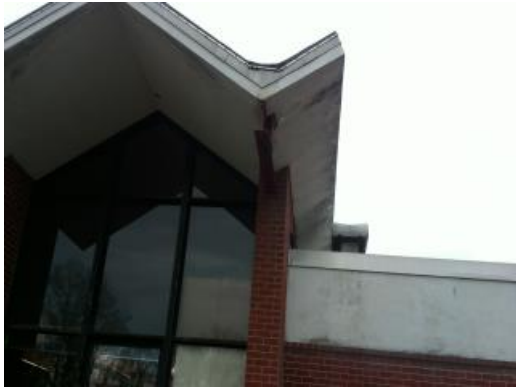
Damaged Library Roof Soffit

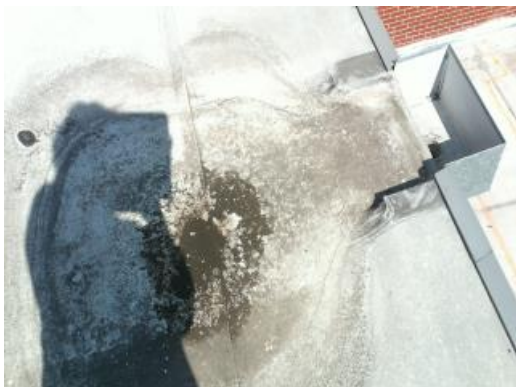
Staining At Drain

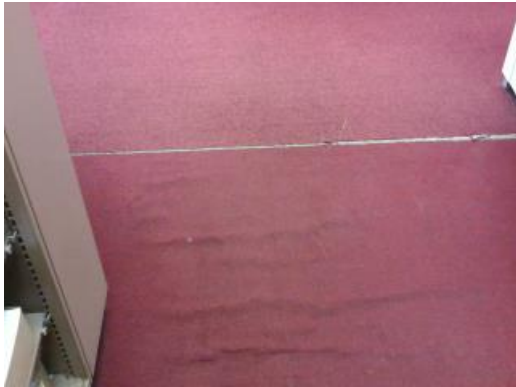
Bubbled Carpet

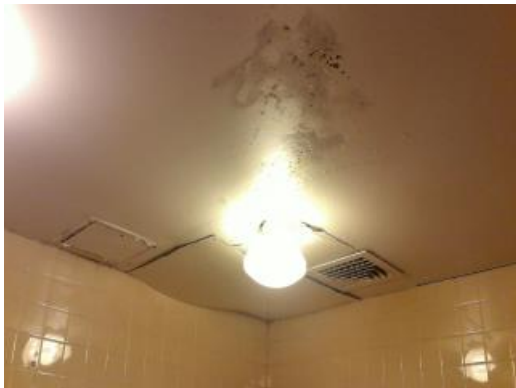
Stained Gypsum Ceiling

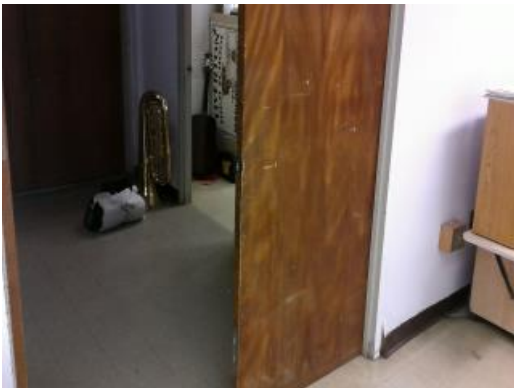
Chipped And Worn Wood Door

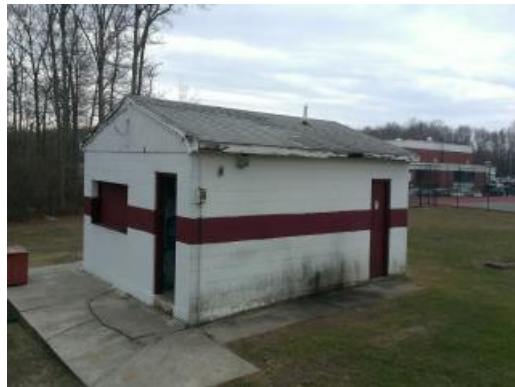
Building 3 Decaying Roof

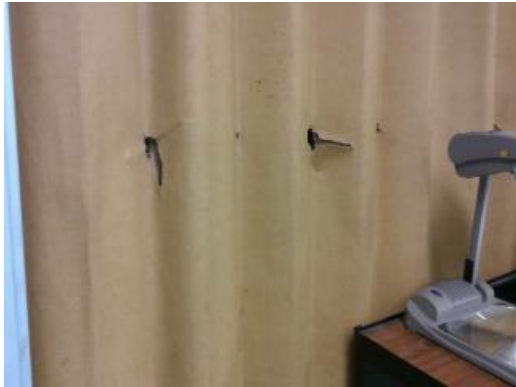
Typical Stained And Torn Partition

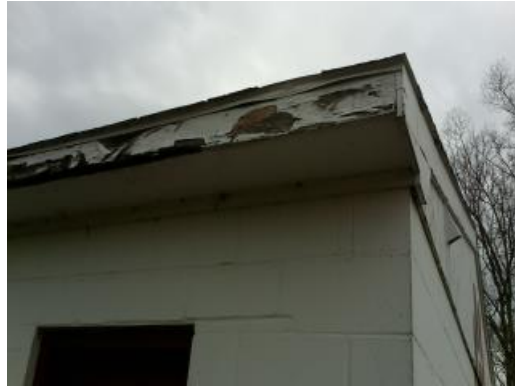
Building 3 Damaged Roof Fascia

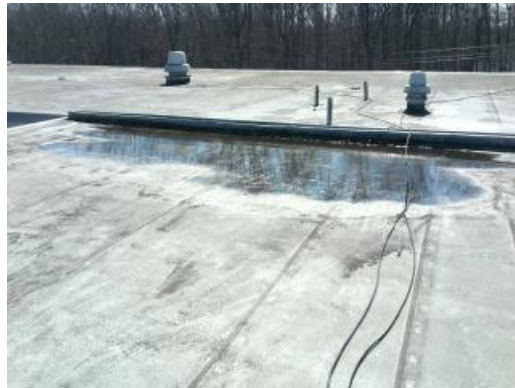
Ponding At Expansion Joint

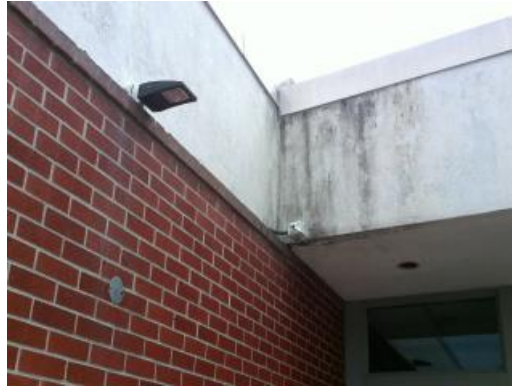
Stained And Weathered Stucco

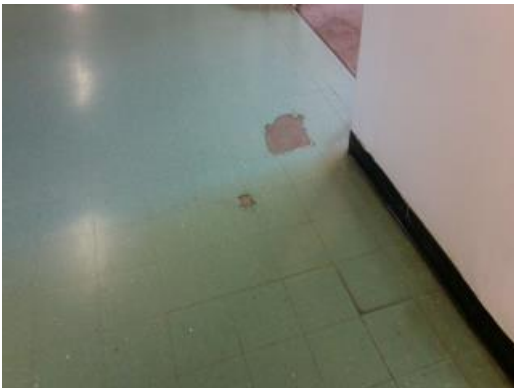
Chipped 9X9 Tile

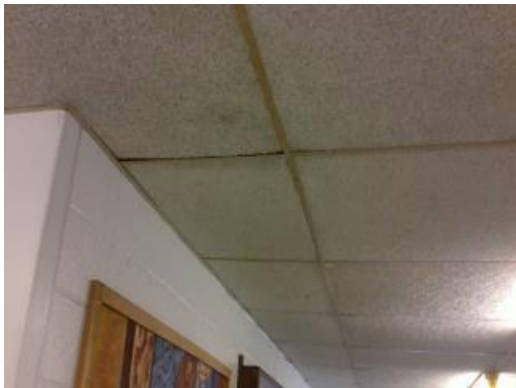
Stained Ceiling Grid

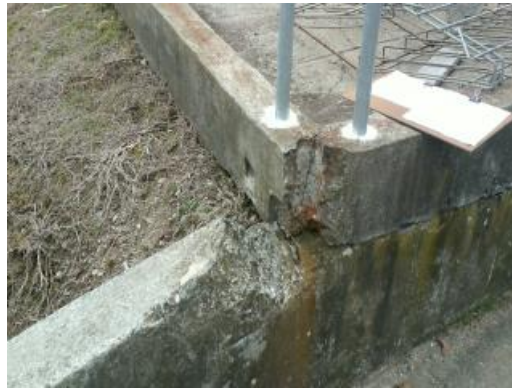
Broken Concrete Retaining Wall

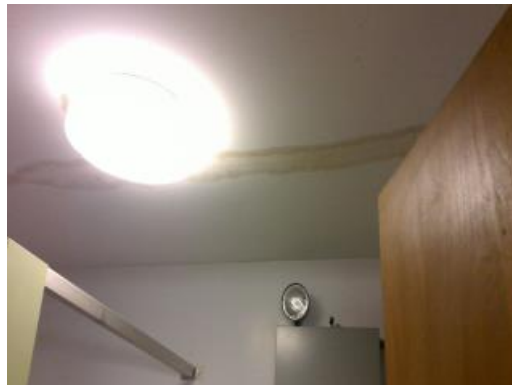
Stained Gypsum Ceiling

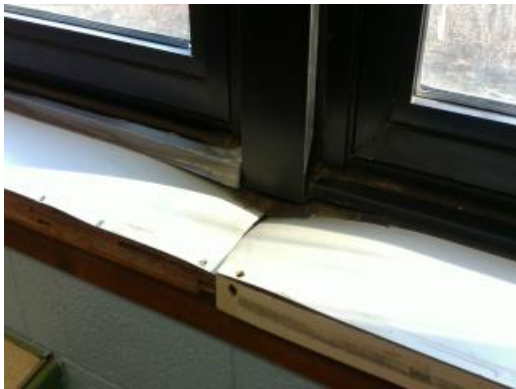
Deficiency	Category	Qty	UoM	Priority	Repair Cost	ID
The Aluminum Window Requires Replacement Note: Windows leak when it rains, sills are water damaged, and ceiling tiles at window heads are water stained.	Capital Renewal	5,808	SF	2	\$982,853	1696
The Metal Exterior Door Requires Replacement Note: Exterior doors don't operate well, hardware is nonfunctional and gaps are visible.	Capital Renewal	35	Door	2	\$224,602	1694
The Storefront/Curtain Wall Requires Replacement (Bldg SF) Note: Glass is broken and wood frame is deteriorating.	Capital Renewal	567	SF	2	\$45,711	1684
The Stucco Exterior Wall Requires Replacement (Bldg SF) Note: Stucco is peeling off in large pieces and is stained.	Capital Renewal	32,657	SF	2	\$1,092,603	1699
Sub Total for System		4 items			\$2,345,769

Water Damaged Sill

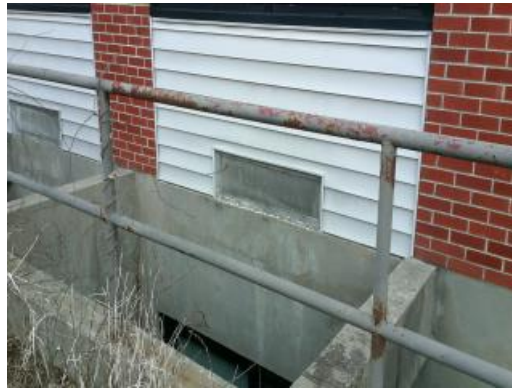
Chipped Paint Window Well Railing

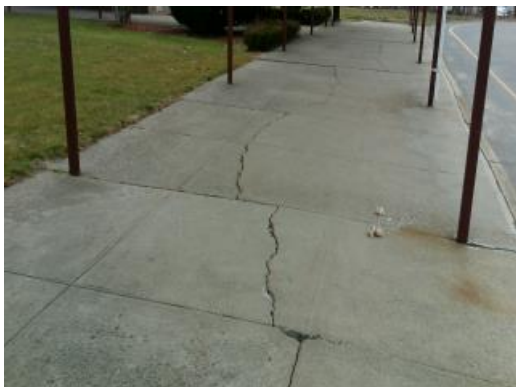
Front Entry Cracked Sidewalk

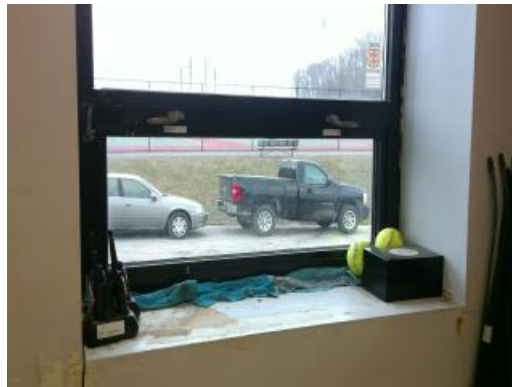
Evidence Of Water Damage At Window

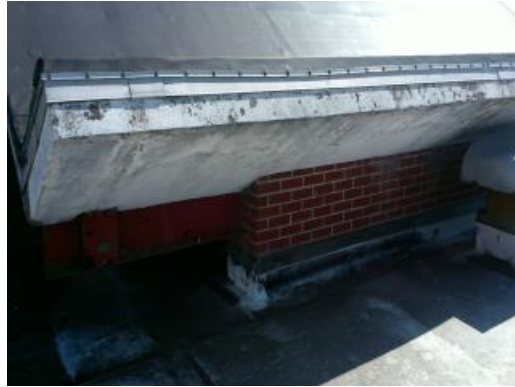
Damaged Soffit At Library

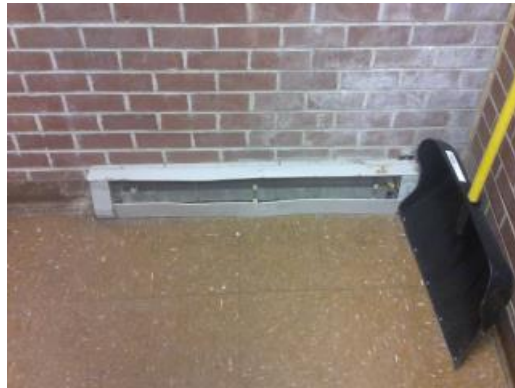
Original Radiant Heaters

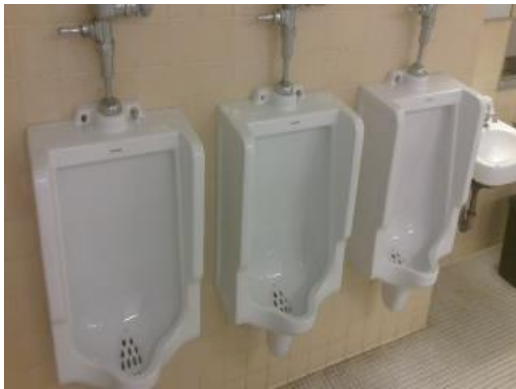
Original Urinals

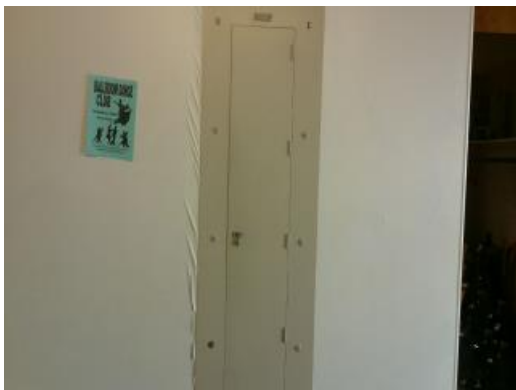
Peeling Wall Covering

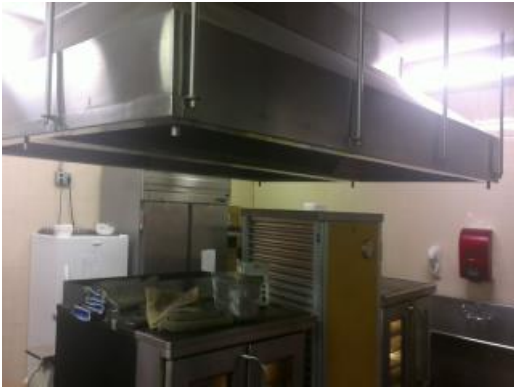
Deficiency	Category	Qty	UoM	Priority	Repair Cost	ID
Replace Kitchen Exhaust Hood	Capital Renewal	2	Ea.	1	\$31,928	1579
Note: No fire suppression on the kitchen hoods. This is a full size kitchen that should have a built in fire suppression system in the hood.						
Room lacks shut-off valves for utilities. (International Fuel Gas Code, Section 409.6)	Educational Adequacy	7	Ea.	1	\$79,859	Rollup
Sub Total for System		2	items		\$111,787

Kitchen Hood
