Facility Condition Assessment

Tiverton - Tiverton Middle School

June 2017

10 Quintal Drive, Tiverton, RI 02878

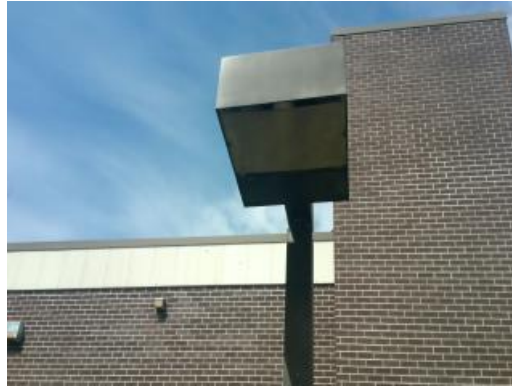
Deficiency	Category	Qty	UoM	Priority	Repair Cost	ID
The Pole Lighting Requires Replacement Note: Mercury vapor lights with broken or clouded lenses.	Capital Renewal	33	Ea.	3	\$253,532	2680
Sub Total for System		1 items			\$253,532	
Sub Total for School and Site Level		8 items			\$2,061,706

Aged Pole Mounted Lights

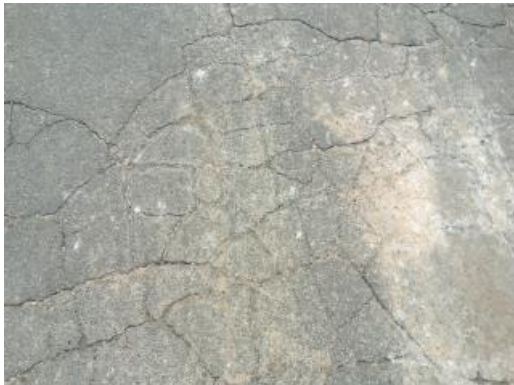
Alligatoring Parking Lot Pavement

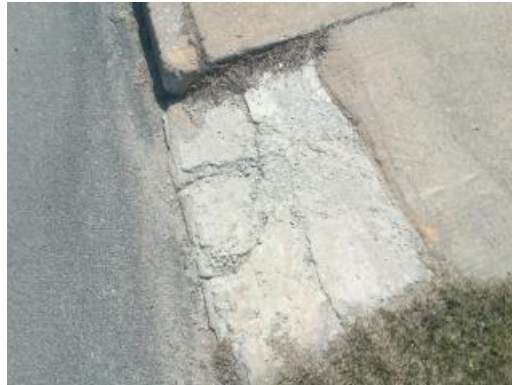
Deficiency	Category	Qty	UoM	Priority	Repair Cost	ID
Concrete Walks Require Replacement Note: Sidewalks are splitting and cracking and steps are settling.	Capital Renewal	11,346	SF	3	\$230,346	2685
Install New Paving Note: Construct exit further down Quintal Road	Traffic	1,920	SF	3	\$39,887	4492
Asphalt Paving Requires Replacement Note: Alligating, cracking, and splitting throughout.	Capital Renewal	128	CAR	4	\$420,639	2682
Asphalt Paving Requires Replacement Note: Cracking, splitting, and ponding throughout.	Capital Renewal	230	CAR	4	\$755,835	2684
Fencing Requires Replacement (4' Chain Link Fence) Note: Fencing is falling and poles and chain link are rusting.	Capital Renewal	480	LF	4	\$30,822	2681
Exterior Basketball Goals are Required Note: Exterior Basketball Goals are Required	Educational Adequacy	1	Ea.	5	\$5,807	28813
School lacks a competition track. Note: School lacks a competition track.	Educational Adequacy	1	Ea.	5	\$324,837	28276

Cracked Concrete Walkway

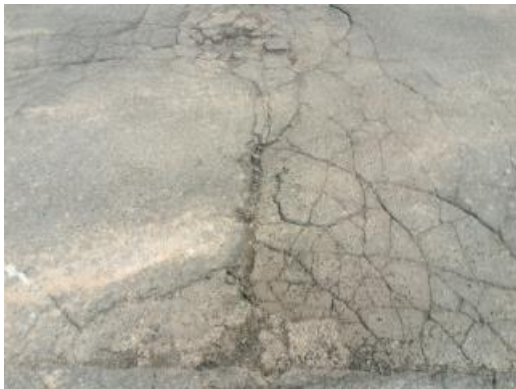
Cracked Roadway Asphalt

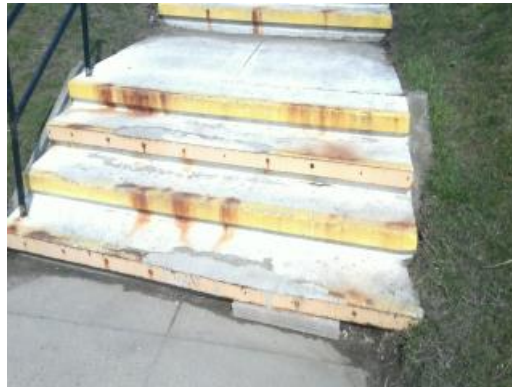
Concrete Stairs Settling

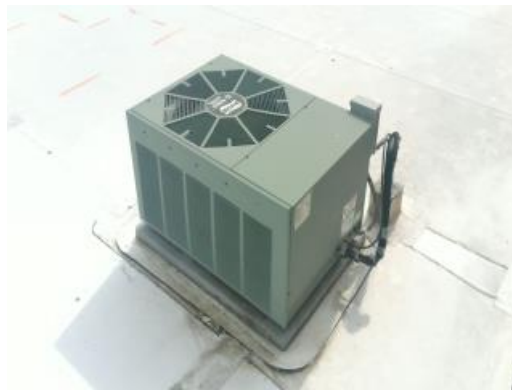
Condenser With Collapsed Coils

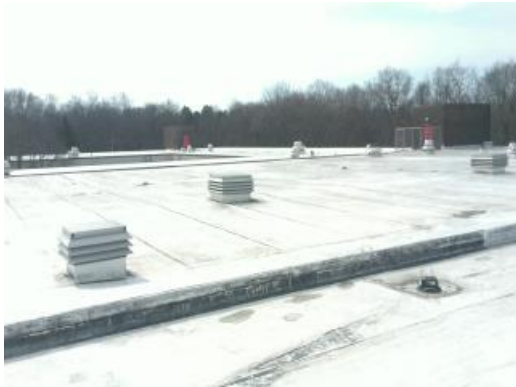
Deficiency	Category	Qty	UoM	Priority	Repair Cost	ID
EPDM Roofing Requires Replacement (Bldg SF) Note: The roof has ongoing issues. There are bubbles throughout and there is evidence of water infiltration.	Capital Renewal	75,300	SF	2	\$945,702	2946
The Tectum Decking Requires Replacement Note: Tectum is aged, with warping and general wear.	Capital Renewal	35,500	SF	2	\$2,616,094	2948
Sub Total for System		2 items			\$3,561,796

Roof General Condition

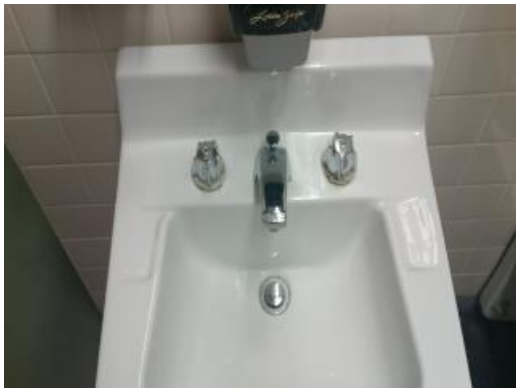
The Restroom Lavatories Plumbing Fixtures Require Replacement Note: Restroom lavatories are aged and stained.	Capital Renewal	47	Ea.	4	\$148,502	2700
The Restroom Lavatories Plumbing Fixtures Require Replacement Note: Lavatories aged, stained, and drains are clogged.	Capital Renewal	23	Ea.	4	\$72,671	2707
Above Ground Fuel/Oil Storage Tank Requires Replacement Note: There is no tank gauging system and the concrete protection is cracked with damaged insulation.	Capital Renewal	1	Ea.	5	\$56,658	2745
Room lacks a drinking fountain.	Educational Adequacy	6	Ea.	5	\$6,572	Rollup
Room lacks a private shower area.	Educational Adequacy	1	Ea.	5	\$10,166	Rollup
The Class Room Lavatories Plumbing Fixtures Are Missing And Should Be Installed	Educational Adequacy	8	Ea.	5	\$12,011	Rollup
Sub Total for System		13	items		\$1,093,261

Typical Restroom Lavatory Fixture

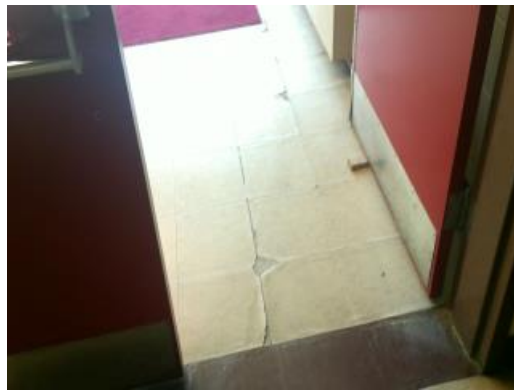
Peeling VCT Flooring

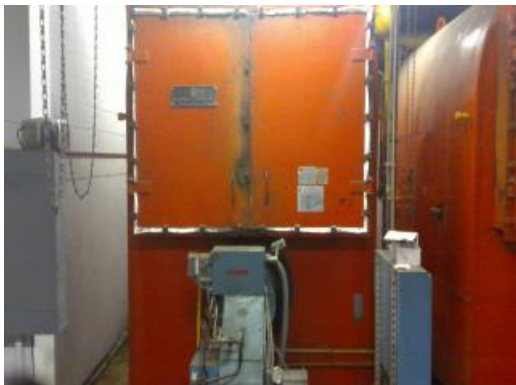
Aged Boilers

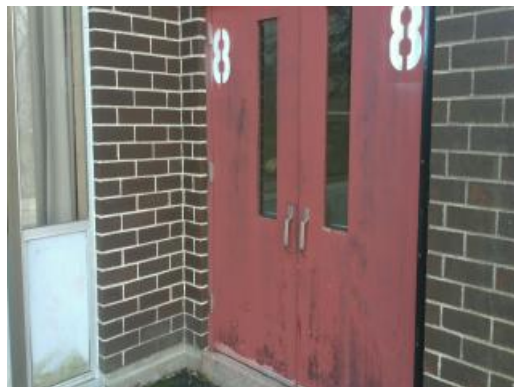
The Aluminum Window Requires Replacement Note: 5 @ 4x18 - Windows are aged with many not operational.	Capital Renewal	360	SF	2	\$60,510	2945
The Metal Exterior Door Requires Replacement Note: Original exterior doors are worn with some not fully operation. They should be replaced.	Capital Renewal	30	Door	2	\$191,220	2716

Original Exterior Doors

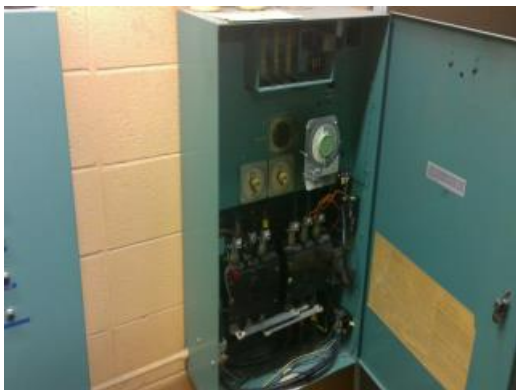
Transfer Switch With Burned Contacts

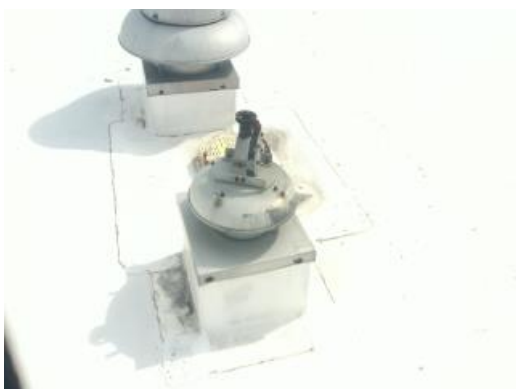
Damaged Small Exhaust Fan

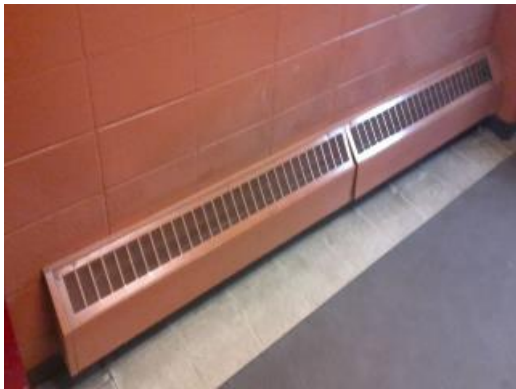
Aged Radiant Heaters

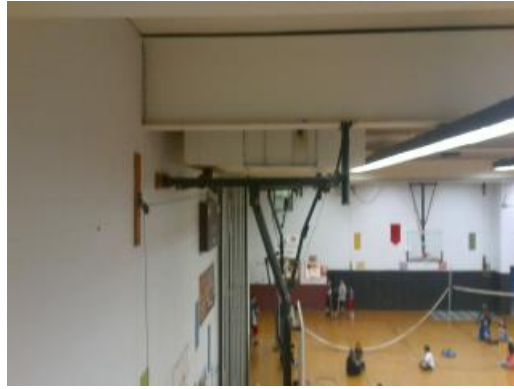
Note: Units are rusted and damaged, missing hoods and/or belts.						
The Make Up Air Equipment Requires Replacement	Capital Renewal	4	Ea.	3	\$63,170	2720
Note: Gym units are non-functional. Locker room units do not heat.						
Location: 2 in gym, 2 in locker rooms						
The Small Diameter Exhausts/Hoods Require Replacement	Capital Renewal	22	Ea.	3	\$57,628	2708
Note: Units are rusted and damaged, missing hoods and/or belts.						
Unit Ventilators Are Excessively Noisy	Acoustics	56	Ea.	3	\$352,925	4742
Note: All classrooms						
Exhaust Fan Ventilation Requires Replacement	Capital Renewal	2	Ea.	4	\$5,319	2723
Note: Units are aged and blades and louvers are packed with dirt.						
Existing Controls Are Inadequate And Should Be Replaced With DDC Controls	Capital Renewal	142,000	SF	4	\$952,709	2744
Note: System has leaks throughout.						
Small HVAC Circulating Pump Requires Replacement	Capital Renewal	8	Ea.	4	\$75,725	2713

Non-Functional Make-up Air Unit

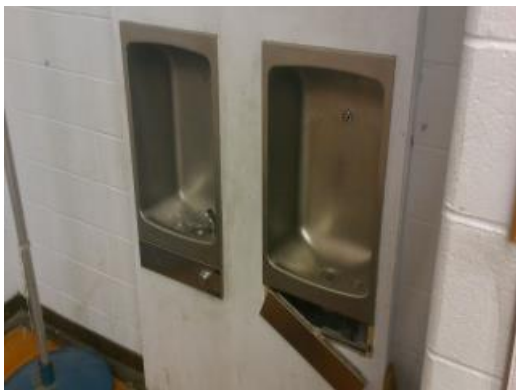
Damaged Drinking Fountain

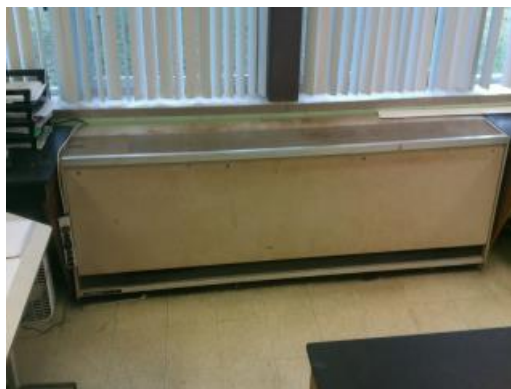
Aged Heating Unit

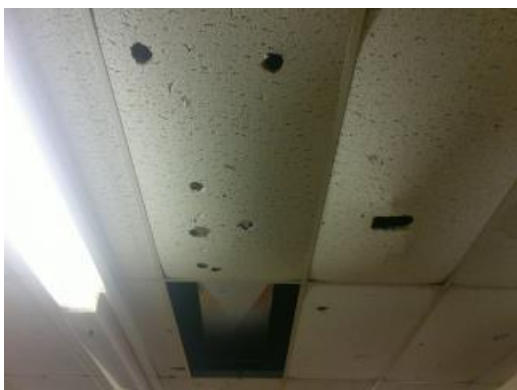
Damaged And Missing Ceiling Tiles

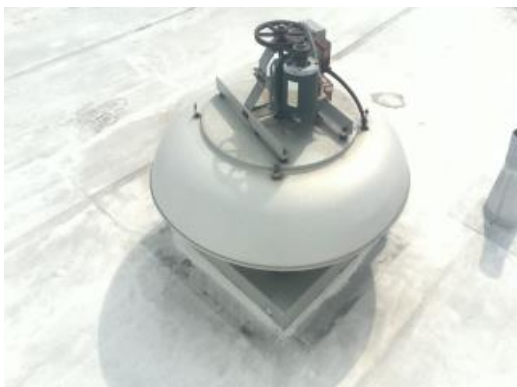
Exhaust Fan Missing Hood

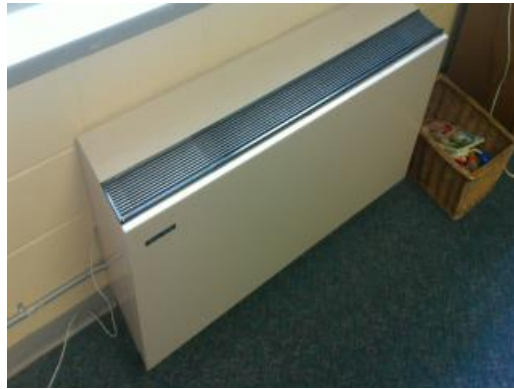
Non-Functional Heating Unit

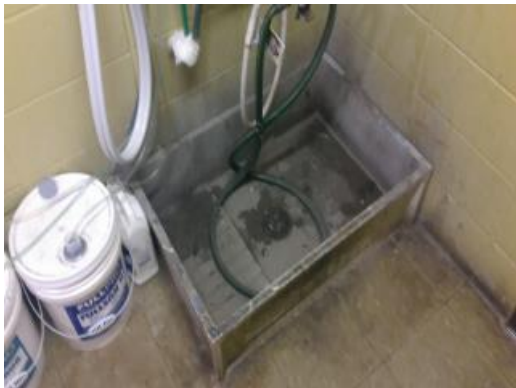
Stained Mop Sink

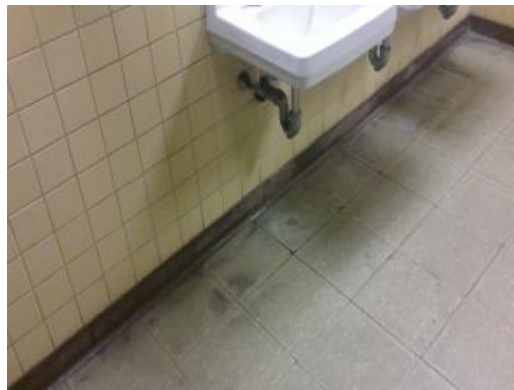
Curling VCT Flooring In Restroom

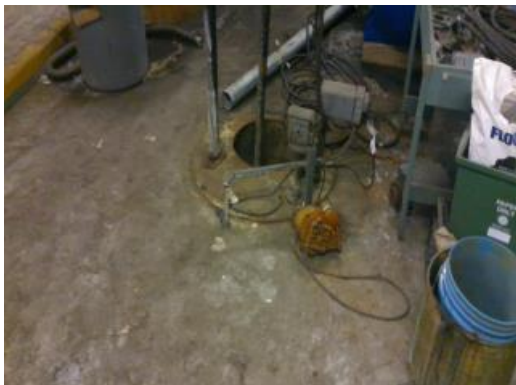
Failing Sump Pump

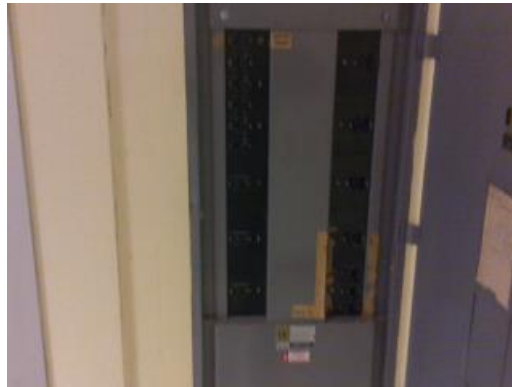
225A Panel With Corroded Connections

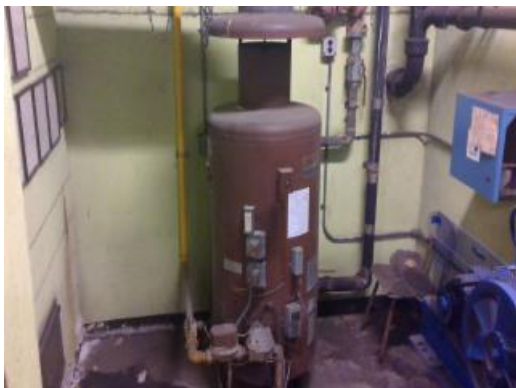
Aged Boiler For Hot Water

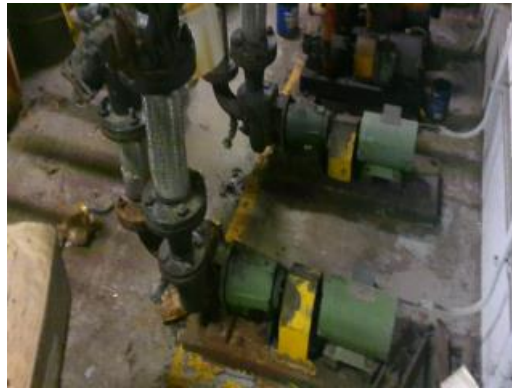
Note: Pumps leak.						
Sub Total for System		14	items		\$4,485,996

Aged Water Pumps

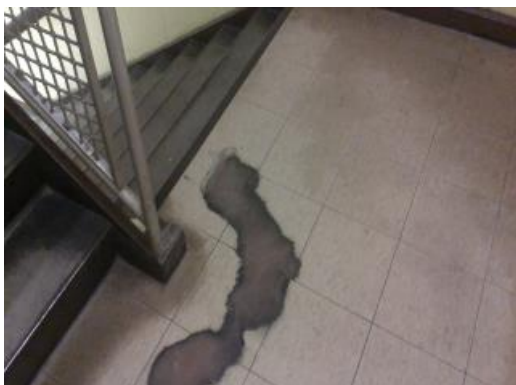
Worn VCT Flooring

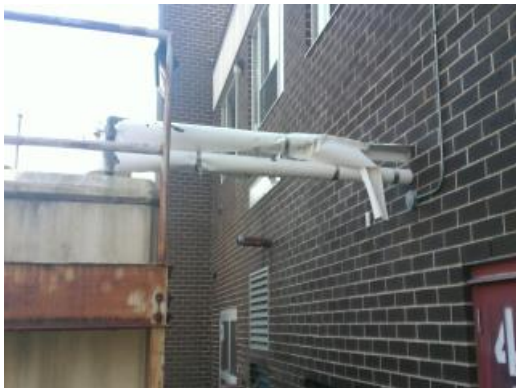
Damaged Insulation At Fuel Tank

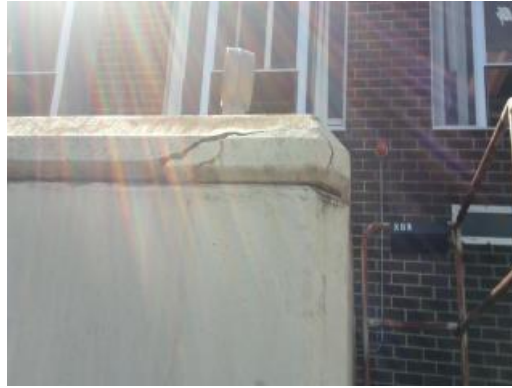
Cracked Concrete On Fuel Tank

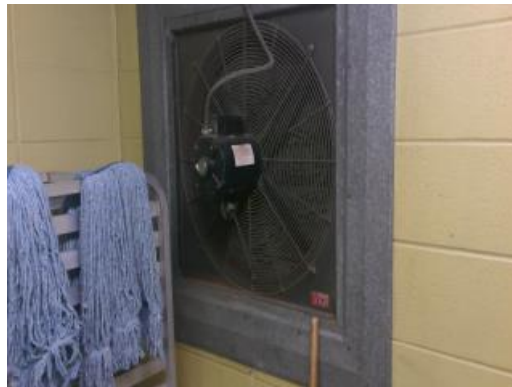
Aged Wall Exhaust

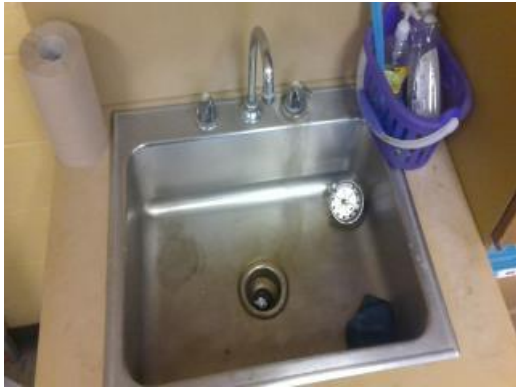
Stained Lavatory

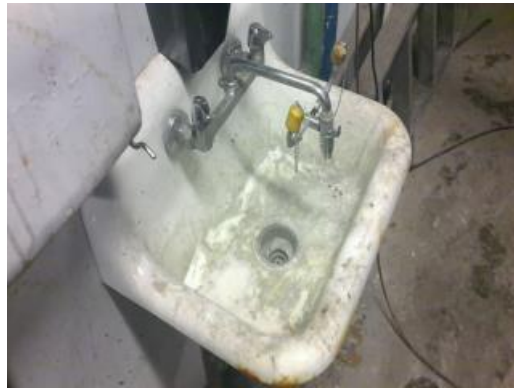
Stained And Corroded Service Sink

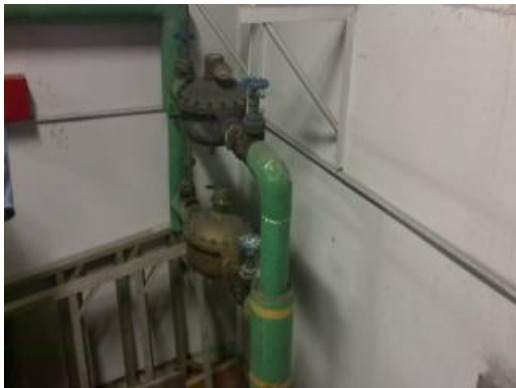
Deficiency	Category	Qty	UoM	Priority	Repair Cost	ID
Backflow Preventer Requires Replacement Note: Backflow preventer is aged and connections are rusted.	Capital Renewal	3	Ea.	2	\$27,547	2731
Sump Pump Requires Replacement Note: Pumps are failing. Sump is full.	Capital Renewal	2	Ea.	3	\$2,878	2729
The Showers Plumbing Fixtures Require Replacement	Capital Renewal	56	Ea.	3	\$423,044	2699
The Urinal Plumbing Fixtures Require Replacement Note: Aged urinals are stained and cracking.	Capital Renewal	26	Ea.	3	\$34,323	2703
The Classroom Lavatories Plumbing Fixtures Require Replacement Note: Classroom lavatories are stained and rusted and the science units are non-functional.	Capital Renewal	67	Ea.	4	\$180,946	2692
The Custodial Mop Or Service Sink Requires Replacement Note: Sinks are corroded and stained.	Capital Renewal	6	Ea.	4	\$15,354	2718
The Refrigerated Water Cooler Requires Replacement Note: Units are aged and rusted. Some have missing parts or are broken.	Capital Renewal	14	Ea.	4	\$102,588	2710

Aged Backflow Preventer

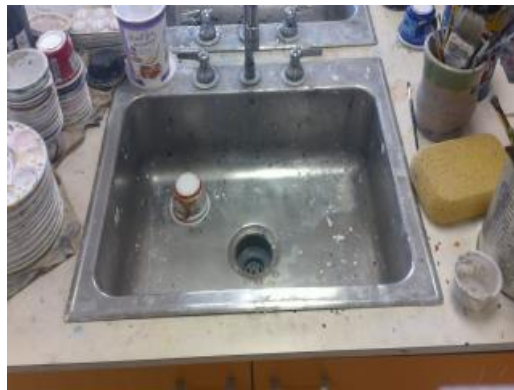
Stained And Worn Classroom Lavatory
