# Facility Condition Assessment

Warwick - Norwood School

June 2017

266 Norwood Avenue, Warwick, RI 02888

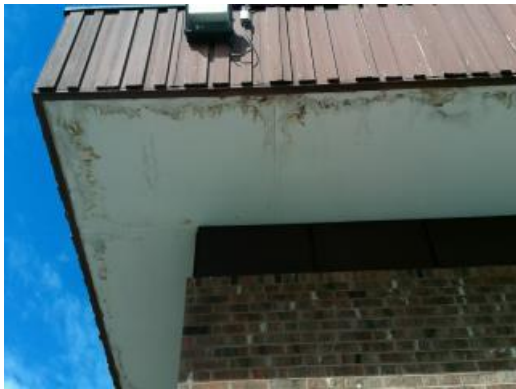
Damaged Soffit

The Exterior Soffit Requires Replacement <b>Note:</b> Soffits are water damaged.	Capital Renewal	8,623	SF	4	\$1,110,127	12307
<b>Sub Total for System</b>		<b>7</b>	<b>items</b>		<b>\$1,494,896</b>

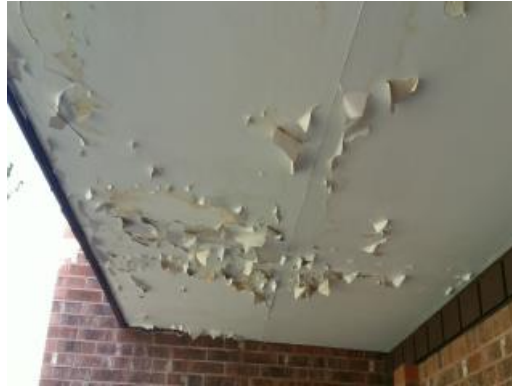
Water Damaged Soffit

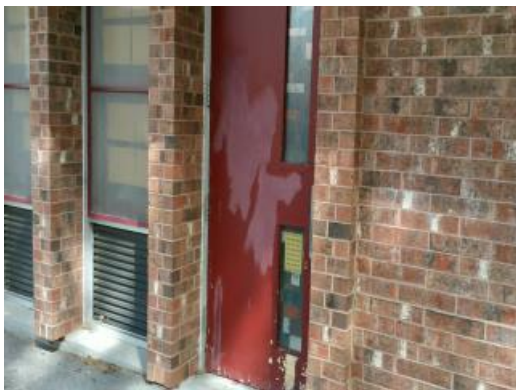
Weathered And Rusted Exterior Door

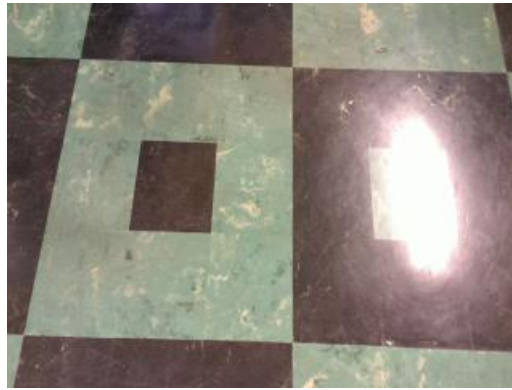
Worn VCT

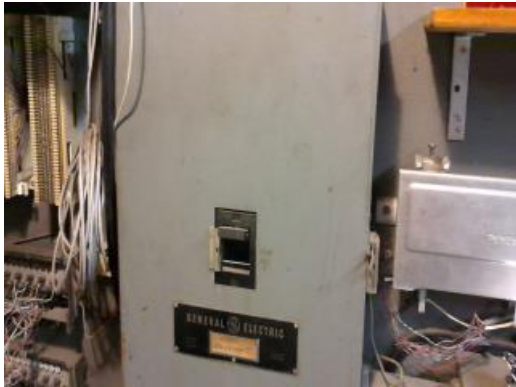
Electrical Disconnect

Deficiency	Category	Qty	UoM	Priority	Repair Cost	ID
The Electrical Disconnect Requires Replacement <b>Note:</b> Disconnect is aged and rusted.	Capital Renewal	1	Ea.	2	\$1,909	12316
The Panelboard Requires Replacement	Capital Renewal	3	Ea.	2	\$18,123	12328
The Panelboard Requires Replacement	Capital Renewal	1	Ea.	2	\$11,913	12329
The Panelboard Requires Replacement <b>Note:</b> Panelboards are rusted and corroded.	Capital Renewal	4	Ea.	2	\$24,164	12330
The Mounted Building Lighting Requires Replacement <b>Note:</b> Building mounted lights are broken or missing.	Capital Renewal	18	Ea.	3	\$27,986	12315
The Canopy Lighting Requires Replacement <b>Note:</b> Canopy lights are not functioning.	Functional Deficiency	5	Ea.	4	\$7,180	12314
Room Has Insufficient Electrical Outlets	Educational Adequacy	76	Ea.	5	\$37,462	Rollup
<b>Sub Total for System</b>		<b>7</b>	<b>items</b>		<b>\$128,737</b>

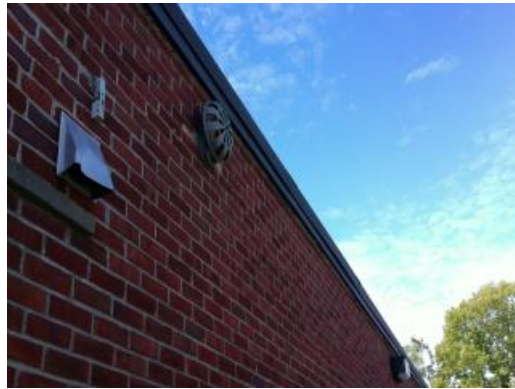
Wall Exhaust

Deficiency	Category	Qty	UoM	Priority	Repair Cost	ID
Gas Unit Heater Requires Replacement <b>Note:</b> Aged unit heaters should be replaced.	Capital Renewal	2	Ea.	2	\$6,077	12331
Replace Unit Vent <b>Note:</b> Unit vents are aged and leaking with dirty coils.	Capital Renewal	18	Ea.	2	\$317,153	12338
The Air Handler HVAC Component Requires Replacement <b>Note:</b> AHU is corroded and leaking.	Capital Renewal	1	Ea.	2	\$105,477	12327
The Boiler HVAC Component Requires Replacement <b>Note:</b> Boilers are aged and showing signs of leaks.	Capital Renewal	2	Ea.	2	\$47,634	12339
The Fin Tube Water Radiant Heater Requires Replacement <b>Note:</b> Fin tube heaters are aged and rusted.	Capital Renewal	12	Ea.	2	\$20,939	12332
The Window AC Unit Component Requires Replacement <b>Note:</b> Window units are aged with damaged coils.	Capital Renewal	2	Ea.	2	\$6,956	12326
Exhaust Fan Ventilation Requires Replacement <b>Note:</b> Wall mounted exhaust fan does not work.	Capital Renewal	1	Ea.	4	\$2,789	12317

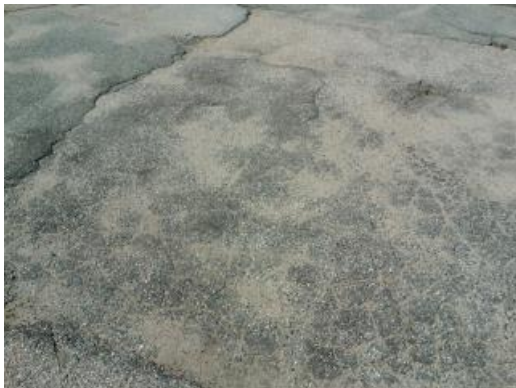
Weathered Asphalt Parking Lot

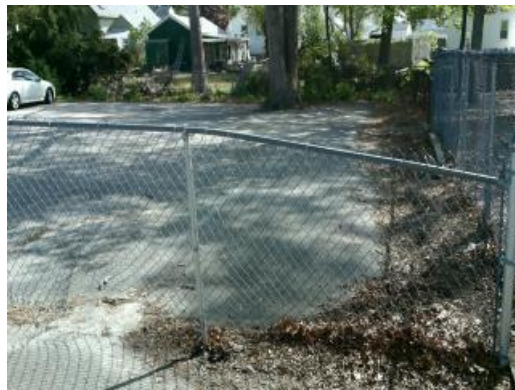
Damaged Fencing

Deficiency	Category	Qty	UoM	Priority	Repair Cost	ID
Asphalt Walks Require Replacement <b>Note:</b> There are several large cracks and pot holes in sidewalk.	Capital Renewal	300	SF	3	\$3,204	12304
Crosswalk Requires Repainting <b>Note:</b> Repaint crosswalks on Norwood Avenue.	Traffic	2	Ea.	3	\$1,901	16920
Sidewalk Requires Replacement <b>Note:</b> Replace sidewalk on edge of school property on Norwood Ave (500' long x 6' wide)	Traffic	3,000	SF	3	\$85,563	16921
Asphalt Paving Requires Replacement <b>Note:</b> Asphalt parking is weathered and should be replaced.	Capital Renewal	71	CAR	4	\$293,631	12302
Asphalt Paving Requires Replacement <b>Note:</b> Roadway asphalt has cracks, alligating, and pot holes.	Capital Renewal	10	CAR	4	\$41,357	12303
Backstops Require Replacement <b>Note:</b> Backstops Require Replacement	Educational Adequacy	1	Ea.	4	\$35,651	28613
Fencing Requires Replacement (4' Chain Link Fence)	Capital Renewal	330	LF	4	\$26,667	12301

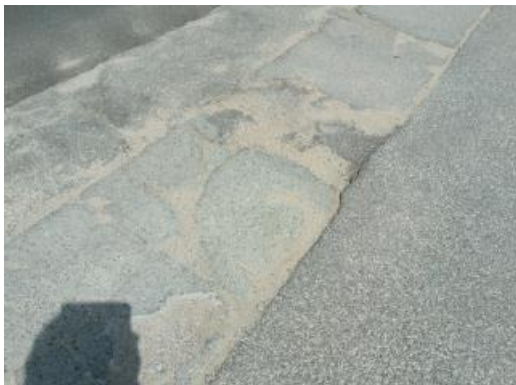
Damaged Asphalt Sidewalk

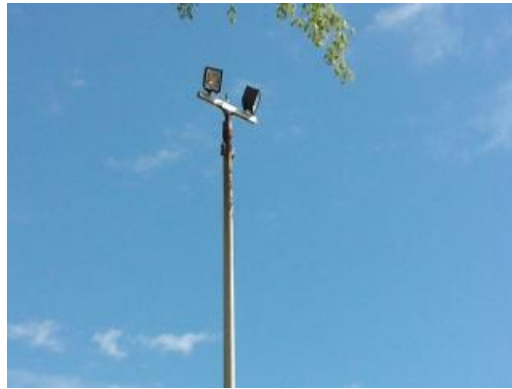
Pole Lights

Deficiency	Category	Qty	UoM	Priority	Repair Cost	ID
The Pole Lighting Requires Replacement <b>Note:</b> Pole lights are rusted.	Capital Renewal	2	Ea.	3	\$19,337	12305
<b>Sub Total for System</b>		<b>1</b>	<b>items</b>		<b>\$19,337</b>	
<b>Sub Total for School and Site Level</b>		<b>8</b>	<b>items</b>		<b>\$507,312</b>

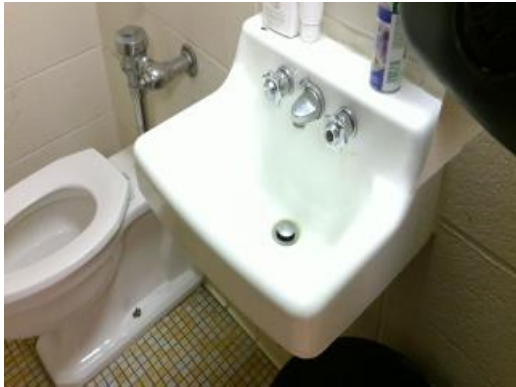
Aged Restroom Lavatory

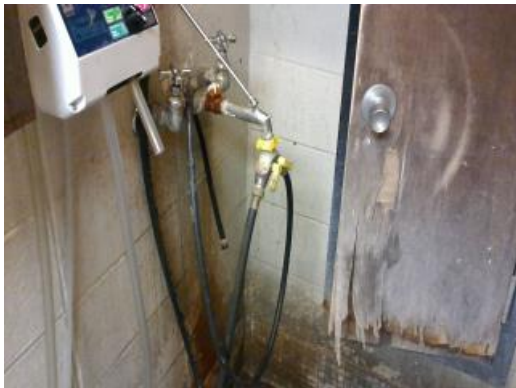
Leaking Service Sink Faucet

Deficiency	Category	Qty	UoM	Priority	Repair Cost	ID
The Custodial Mop Or Service Sink Requires Replacement	Functional Deficiency	2	Ea.	4	\$5,367	12322
<b>Note:</b> Service sinks are rusted and leaking.						
The Restroom Lavatories Plumbing Fixtures Require Replacement	Capital Renewal	2	Ea.	4	\$6,627	12318
The Restroom Lavatories Plumbing Fixtures Require Replacement	Capital Renewal	21	Ea.	4	\$69,585	12319
<b>Note:</b> Restroom lavatories are aged with some rust and corrosion present.						
Room lacks a drinking fountain.	Educational Adequacy	6	Ea.	5	\$6,572	Rollup
The Class Room Lavatories Plumbing Fixtures Are Missing And Should Be Installed	Educational Adequacy	7	Ea.	5	\$8,576	Rollup
	<b>Sub Total for System</b>	<b>8</b>	<b>items</b>		<b>\$171,719</b>

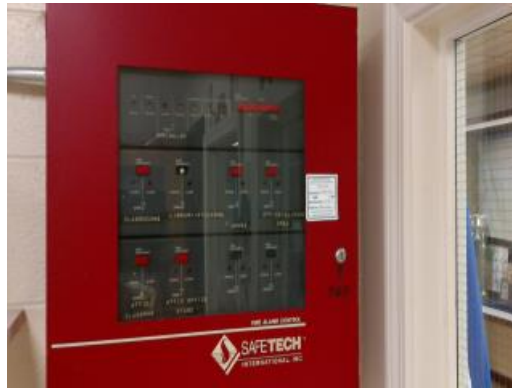
Deficiency	Category	Qty	UoM	Priority	Repair Cost	ID
Fire Alarm Is Missing Or Inadequate (NFPA 72 and NFPA 101, Section 9.6)	Capital Renewal	34,492	SF	1	\$105,308	12324
	<b>Sub Total for System</b>	<b>1</b>	<b>items</b>		<b>\$105,308</b>

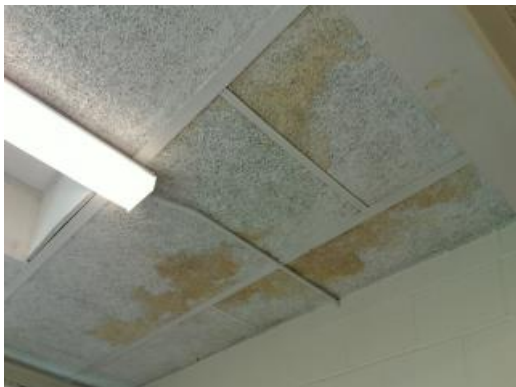
Stained Tectum

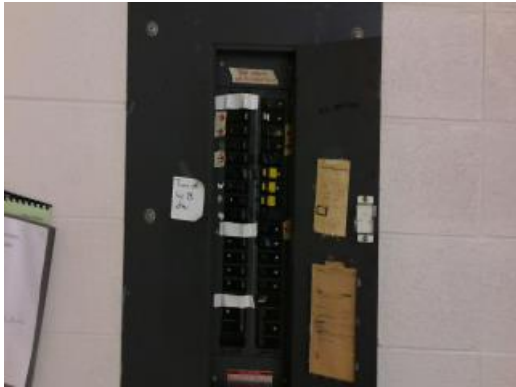
Aged Panelboard

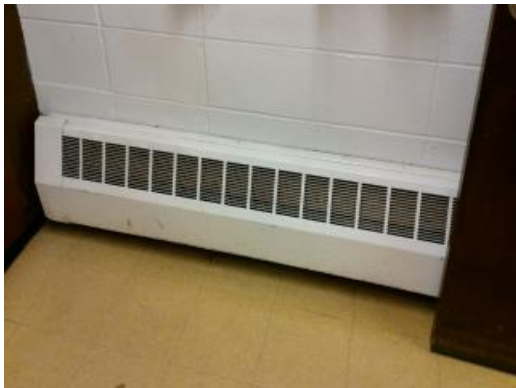
Aged Finned Wall Radiator

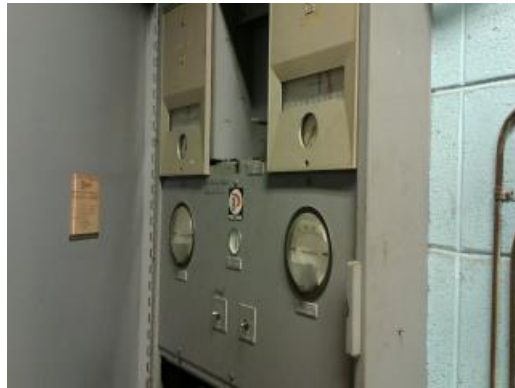
Existing Controls Are Inadequate And Should Be Replaced With DDC Controls <b>Note:</b> System is aged with leaks in the air lines.	Capital Renewal	34,492	SF	4	\$242,691	12333
<b>Sub Total for System</b>		<b>8</b>	<b>items</b>		<b>\$749,715</b>

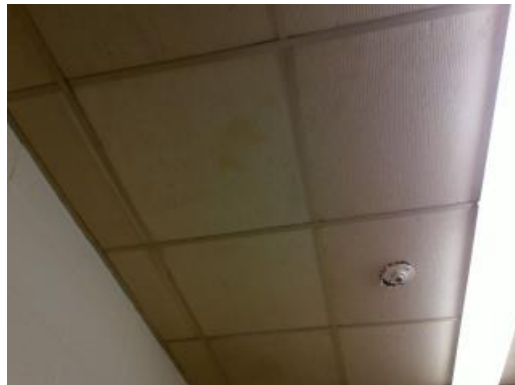
Stained Ceiling Grid
