Facility Condition Assessment

Warwick - Warwick Veterans Memorial Junior HS

June 2017

2401 West Shore Road, Warwick, RI 02889

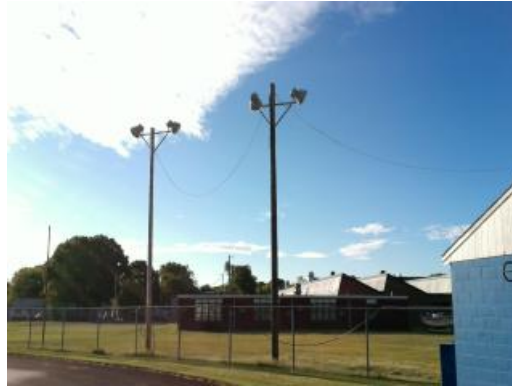
Deficiency	Category	Qty	UoM	Priority	Repair Cost	ID
The Pole Lighting Requires Replacement Note: One pole light located by the field snack bar does not work. Possible circuit issue.	Capital Renewal	1	Ea.	3	\$9,669	16776
Sub Total for System		1	items		\$9,669	
Sub Total for School and Site Level		13	items		\$5,512,496

Pole Light Aged And Weathered

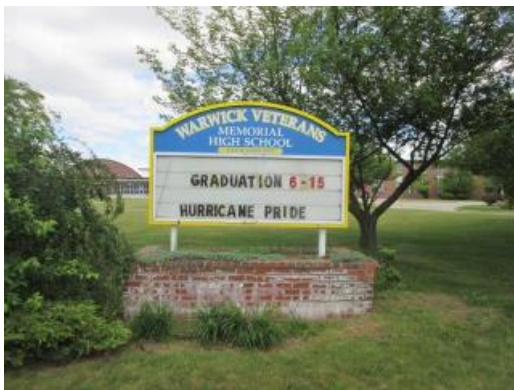
Site Marquee Requires Replacement Note: The marquee sign is in poor condition.	Capital Renewal	1	Ea.	4	\$35,651	16775
Tennis Courts, Nets, And Equipment Require Replacement Note: Tennis courts are deteriorated.	Capital Renewal	6	Ea.	4	\$1,426,046	16772
School has insufficient # of tennis courts. Note: School has insufficient # of tennis courts.	Educational Adequacy	1	Ea.	5	\$203,366	29049
School has insufficient football/soccer fields. Note: School has insufficient football/soccer fields.	Educational Adequacy	1	Ea.	5	\$118,837	28201
Sub Total for System		12	items		\$5,502,827

Marquee Sign

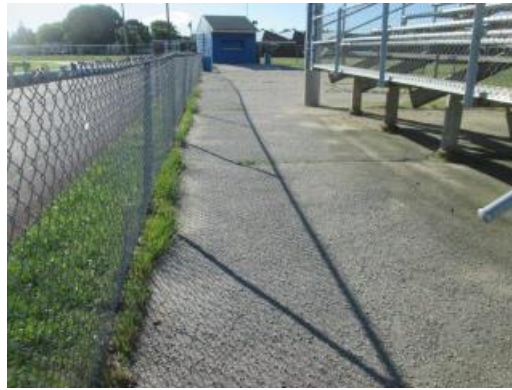
Deficiency	Category	Qty	UoM	Priority	Repair Cost	ID
Asphalt Walks Require Replacement Note: The pedestrian paving at the football field bleachers and circulation area is deteriorated.	Capital Renewal	35,000	SF	3	\$373,857	16773
Concrete Walks Require Replacement	Capital Renewal	15,000	SF	3	\$383,242	16774
New Sidewalk Is Required Note: Add sidewalk along Fletcher St adjacent to tennis courts (720' long x 6' wide)	Traffic	4,320	SF	3	\$123,210	22007
Asphalt Paving Requires Replacement	Capital Renewal	70	CAR	4	\$289,496	16769
Asphalt Paving Requires Replacement	Capital Renewal	540	CAR	4	\$2,233,251	16770
Asphalt Paving Requires Replacement Note: The basketball court pavement is severely deteriorated.	Capital Renewal	10	CAR	4	\$41,357	16771
Fencing Requires Replacement (4' Chain Link Fence) Note: The fencing is rusted and damaged.	Capital Renewal	2,400	LF	4	\$193,942	16767
Fencing Requires Replacement (Ornamental Fence) Note: The ornamental fencing at the main entry is corroded.	Capital Renewal	60	LF	4	\$80,572	16768

Bleacher Pavement

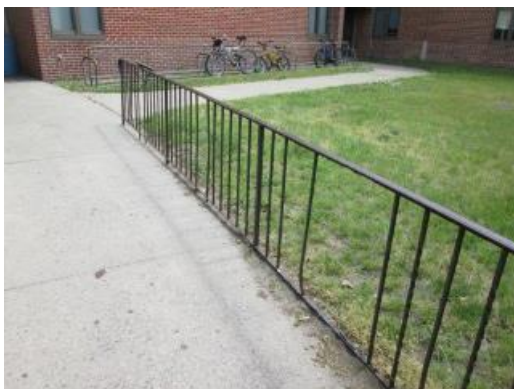
Main Entry Ornamental Fence

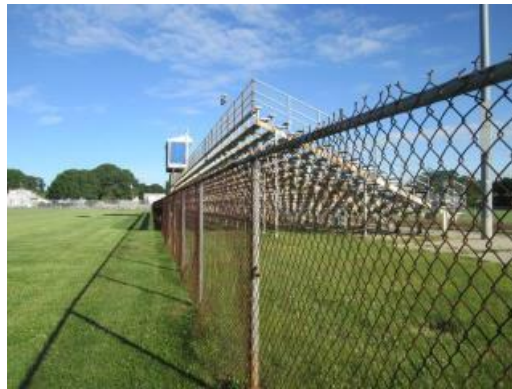
Rusted Fencing

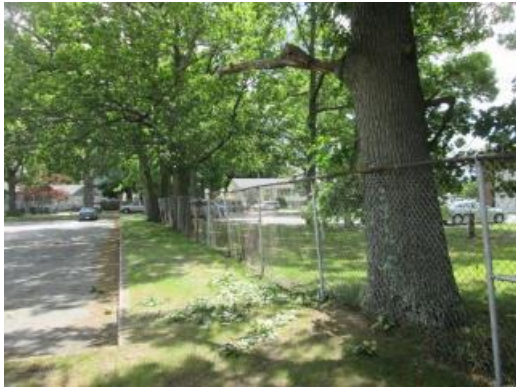
Damaged Fencing

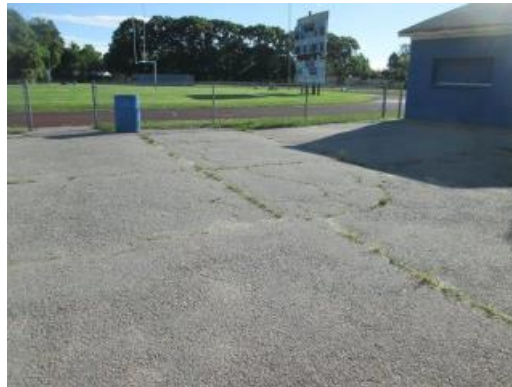
Asphalt Pedestrian Pavement

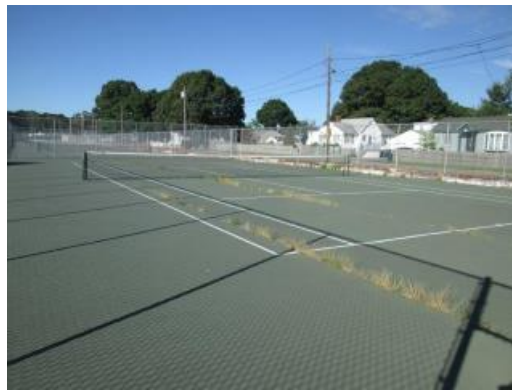
Tennis Court Paving

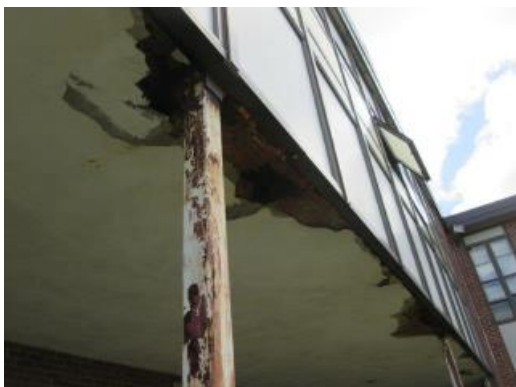
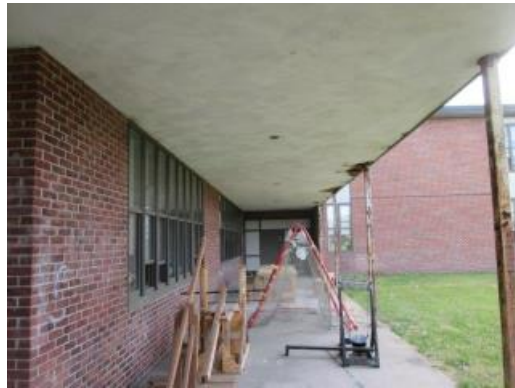
Deficiency	Category	Qty	UoM	Priority	Repair Cost	ID
The Aluminum Window Requires Replacement Location: Windows at gym entry vestibule	Capital Renewal	160	SF	2	\$28,204	16784
The Metal Exterior Door Requires Replacement Note: The steel doors are corroded and damaged.	Capital Renewal	28	Door	2	\$187,168	16781
The Overhead Door Requires Replacement Note: The overhead shop doors are deteriorated and damaged.	Capital Renewal	2	Door	2	\$76,650	16783
The Overhead Door Requires Replacement	Capital Renewal	4	Door	2	\$153,300	18976
The Steel Window Requires Replacement Note: The original steel windows are deteriorated. Location: Windows at shop clerestory, boiler room and adjacent to corridor exit doors	Capital Renewal	3,526	SF	2	\$785,662	16785
The Exterior Soffit Requires Replacement Note: The plaster soffit at G-wing is severely damaged.	Capital Renewal	1,100	SF	4	\$141,614	16779

G-Wing Soffit

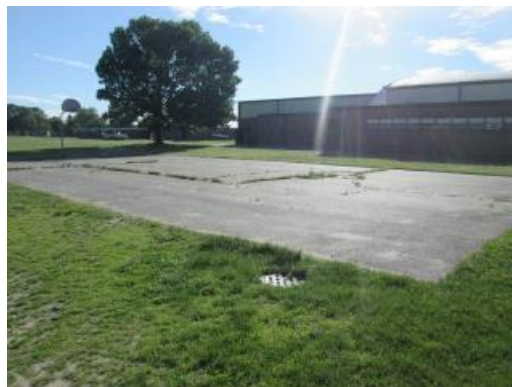
Deteriorated Basketball Court

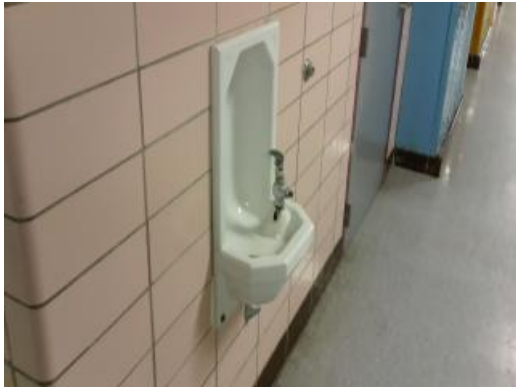
Non-Refrigerated Water Fountain

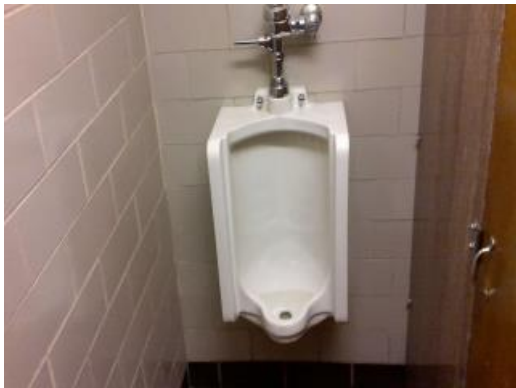
The Urinal Plumbing Fixtures Require Replacement	Capital Renewal	30	Ea.	3	\$41,534	16803
Note: Urinals are corroding and past life expectancy.						
Non-Refrigerated Drinking Fountain Requires Replacement	Capital Renewal	10	Ea.	4	\$106,458	16797
Note: Low flow, past life expectancy and rusting.						
The Classroom Lavatories Plumbing Fixtures Require Replacement	Capital Renewal	32	Ea.	4	\$90,633	16778
Note: Most sinks are in bad condition and past life expectancy. Low flow and corroding.						
The Custodial Mop Or Service Sink Requires Replacement	Capital Renewal	5	Ea.	4	\$13,419	16800
Note: Sinks are corroding and rusting.						
The Restroom Lavatories Plumbing Fixtures Require Replacement	Capital Renewal	55	Ea.	4	\$182,247	16794
Note: Most need to be replaced because they are in poor condition. Some restrooms have gravity sinks.						
Room lacks a drinking fountain.	Educational Adequacy	7	Ea.	5	\$7,720	Rollup

Urinals

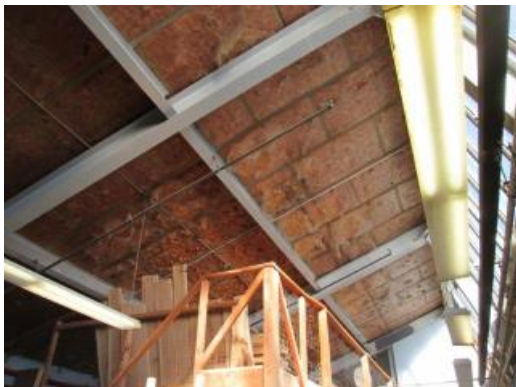
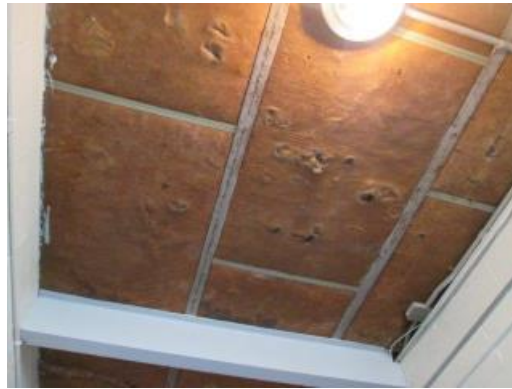
Deficiency	Category	Qty	UoM	Priority	Repair Cost	ID
The Tectum Decking Requires Replacement Note: The exposed panel insulation ceilings are deteriorated, stained and damaged.	Capital Renewal	18,520	SF	2	\$1,431,295	16804
Gutters Require Replacement Note: The gutter at the north wall of the shop classroom wing is deteriorated and damaged.	Capital Renewal	250	LF	3	\$12,379	16801
Sub Total for System		2	items		\$1,443,674

Exposed Insulated Panel Ceiling

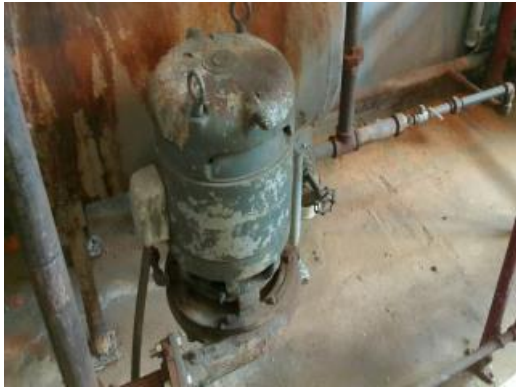
Deficiency	Category	Qty	UoM	Priority	Repair Cost	ID
Note: Pumps are old and corroding. Past life expectancy and in bad condition.						
Sub Total for System		7	items		\$4,849,015

5HP Pump

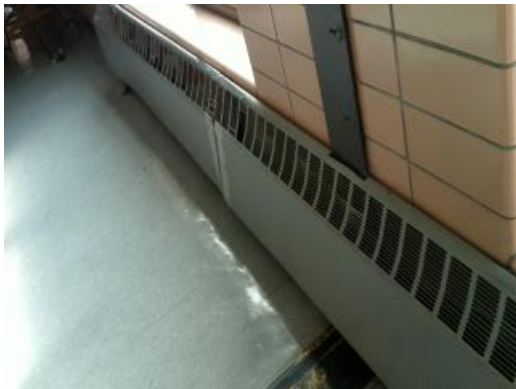
Fin Tube Radiator

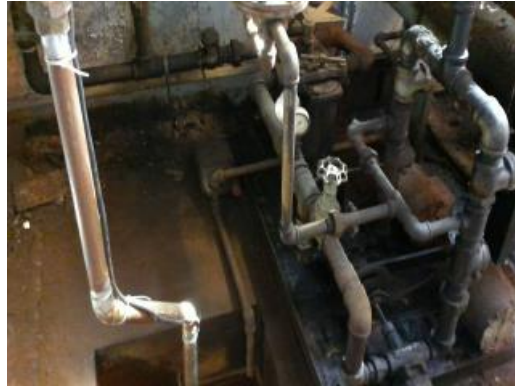
Deficiency	Category	Qty	UoM	Priority	Repair Cost	ID
Backflow Preventer Requires Replacement	Capital Renewal	1	Ea.	2	\$4,084	16811
Note: Pipes are old and corroding, past life expectancy also. Need to be replaced.						
The Electric Water Heater Requires Replacement	Capital Renewal	2	Ea.	2	\$7,376	16808
Note: Water heaters are old and past life expectancy. In bad condition. Need to add additional water heater dedicated to locker rooms.						
Sump Pump Requires Replacement	Capital Renewal	1	Ea.	3	\$1,509	16807
Note: Sump pump is in poor condition and needs to be replaced. Past life expectancy and rusting.						
The Plumbing / Domestic Water Piping System Is Beyond Its Useful Life	Capital Renewal	210,520	SF	3	\$1,764,395	16805
Note: Piping is in poor condition and past life expectancy.						
The Showers Plumbing Fixtures Require Replacement	Capital Renewal	38	Ea.	3	\$301,054	16796
Note: Almost all showers are past life expectancy and in poor condition.

Backflow Preventer

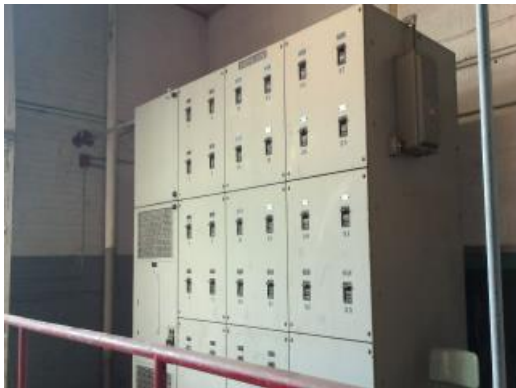
Deficiency	Category	Qty	UoM	Priority	Repair Cost	ID
Room last power shut-off valves for utilities	Educational Adequacy	4	Ea.	1	\$5,649	Rollup
Switchgear Is Needed Or Requires Replacement	Capital Renewal	1	Ea.	2	\$71,936	16814
Note: Replace original switchgear in boiler room. In poor condition and past life expectancy.						
The Panelboard Requires Replacement	Capital Renewal	23	Ea.	2	\$116,163	16809
The Panelboard Requires Replacement	Capital Renewal	9	Ea.	2	\$54,368	16810
Note: Missing breakers and corroding.						
The Mounted Building Lighting Requires Replacement	Capital Renewal	30	Ea.	3	\$46,644	16792
Note: Lights are old and do not illuminate clearly.						
Room Has Insufficient Electrical Outlets	Educational Adequacy	340	Ea.	5	\$168,730	Rollup
Sub Total for System		6	items		\$463,490

Switchgear

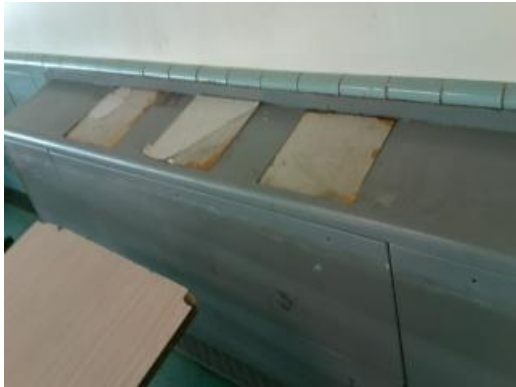
Deficiency	Category	Qty	UoM	Priority	Repair Cost	ID
Replace Unit Vent	Capital Renewal	16	Ea.	2	\$235,931	16820
Note: In poor condition, corroding, do not heat efficiently, and past life expectancy.						
The Fin Tube Water Radiant Heater Requires Replacement	Capital Renewal	300	Ea.	2	\$523,478	16812
Note: About 80% of the radiators need to be replaced, in bad condition, fins not in good shape, do not heat properly, and past life expectancy.						
The Mechanical / HVAC Piping / System Is Beyond Its Useful Life	Capital Renewal	210,520	SF	2	\$1,690,342	16813
Note: Pipes are the main issue with the heating system for the school. Pipes are old and leak. Need to be completely replaced.						
The Steel Tube Boiler Requires Replacement	Capital Renewal	2	Ea.	2	\$768,377	16822
Note: Boilers are past life expectancy and need to be replaced. In poor condition, rusting and corroding. One boiler doesn't work anymore.

Boarded Up Unit Ventilator Out Of Service

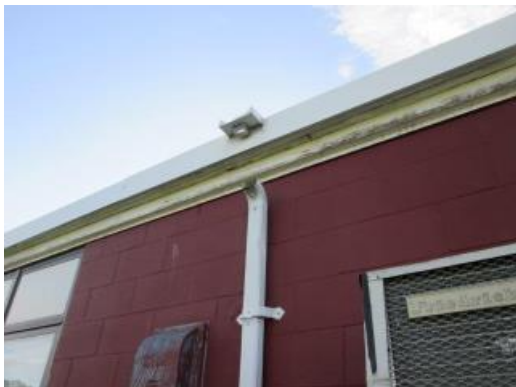
Damaged Downspout

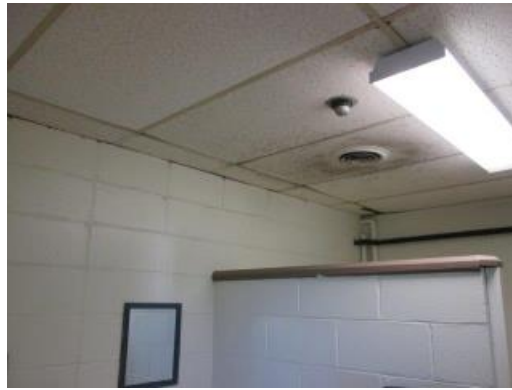
Deteriorated Acoustical Ceiling
