Facility Condition Assessment

Westerly - Springbrook Elementary School

June 2017

39 Springbrook Road, Westerly, RI 02891

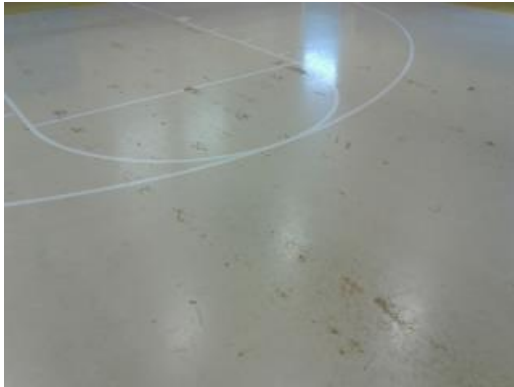
Worn Gym Floor

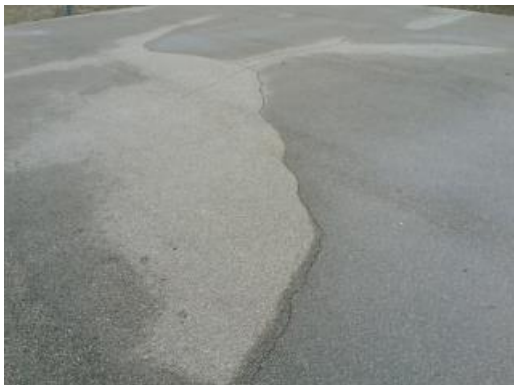
Cracked Paved Play Area

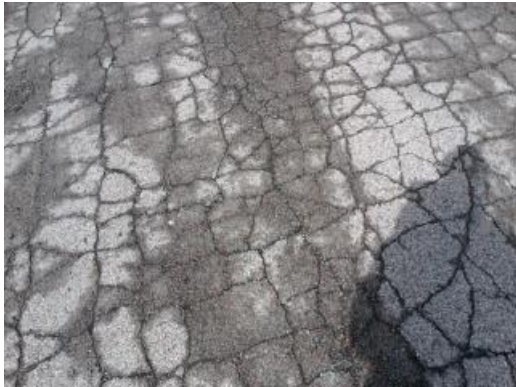
Alligatored Roadway Pavement

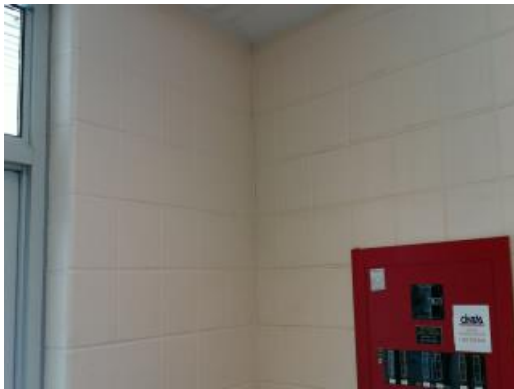
Cracked CMU

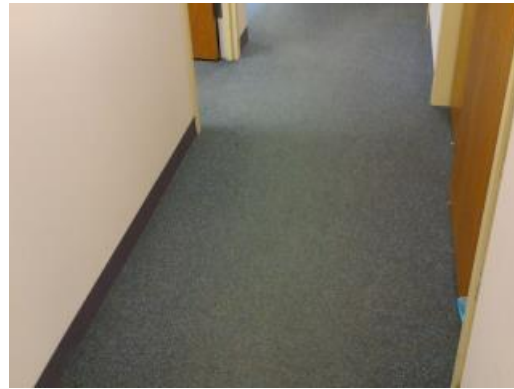
Worn Carpet

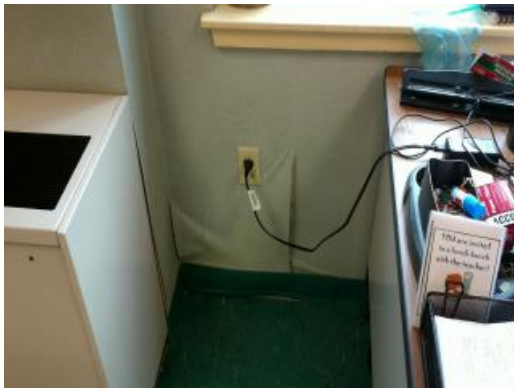
Peeling Wall Covering

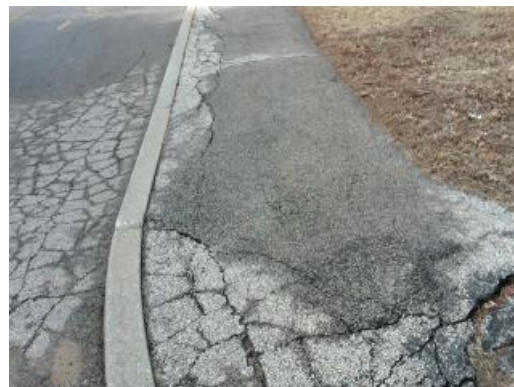
Cracked Asphalt Pavement

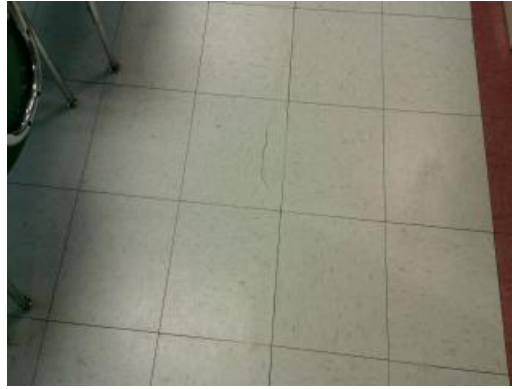
VCT Flooring Separation

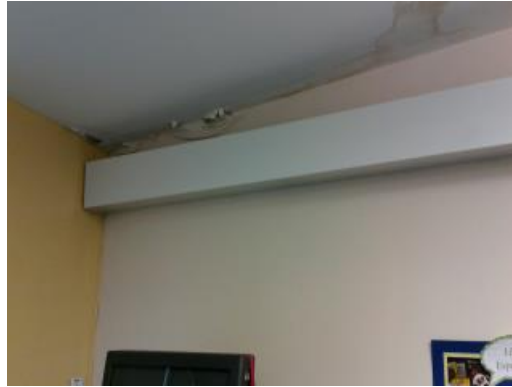
Damaged Gypsum Board Ceiling

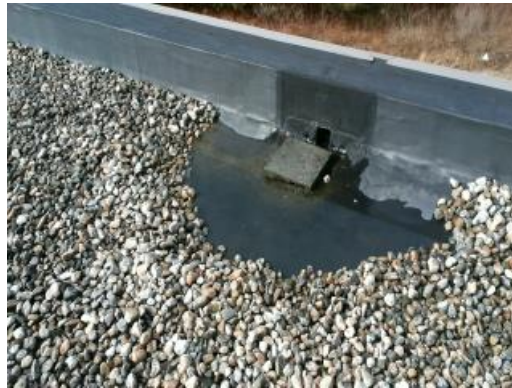
Clogged Roof Drain

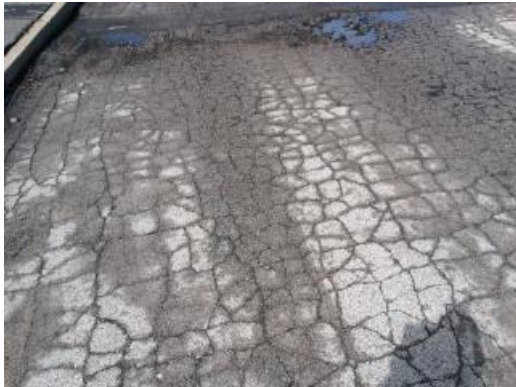
Alligatoring Asphalt Paving

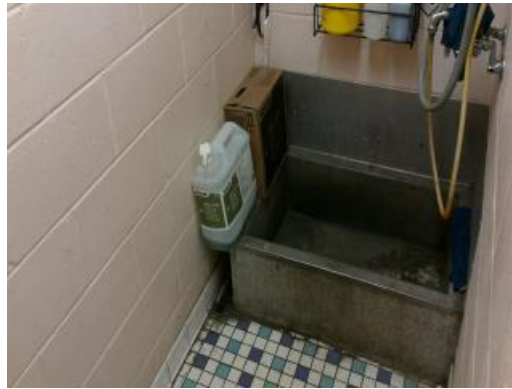
Stained Service Sink

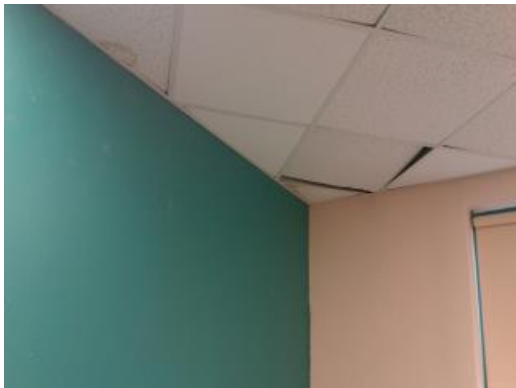
Displaced Ceiling Tiles

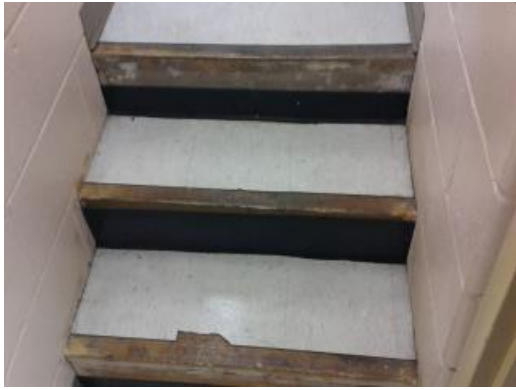
Chipped VCT On Stairs

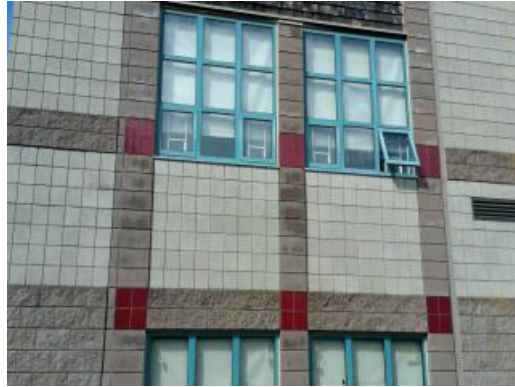
Deficiency	Category	Qty	UoM	Priority	Repair Cost	ID
The Aluminum Window Requires Repair Note: Windows on the south side needs to be replaced as the seal is broken with moisture getting in the panes.	Capital Renewal	1	Ea.	3	\$1,039	844
Sub Total for System		1	items		\$1,039

Upper Windows Seals Broken
