# Facility Condition Assessment

Westerly - Westerly High School

June 2017

23 Ward Avenue, Westerly, RI 02891

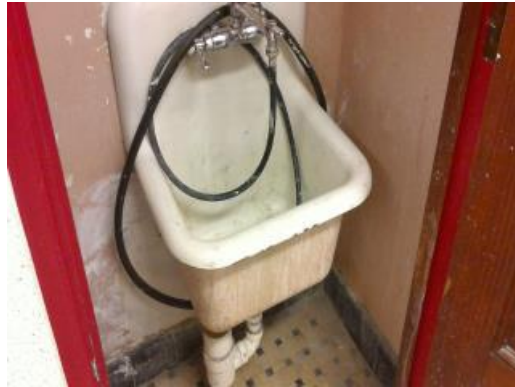
Main Building - Mop Sink

Deficiency	Category	Qty	UoM	Priority	Repair Cost	ID
The Showers Plumbing Fixtures Require Replacement	Capital Renewal	30	Ea.	3	\$237,674	1922
The Custodial Mop Or Service Sink Requires Replacement <b>Note:</b> Mop sinks are beginning to fail per custodians.	Capital Renewal	6	Ea.	4	\$16,102	2318
The Refrigerated Water Cooler Requires Replacement <b>Note:</b> Water fountains in locker rooms no longer work. <b>Location:</b> Locker Rooms	Capital Renewal	2	Ea.	4	\$15,370	1924
Room lacks a drinking fountain.	Educational Adequacy	9	Ea.	5	\$9,925	Rollup
Room lacks a private shower area.	Educational Adequacy	1	Ea.	5	\$10,235	Rollup
The Class Room Lavatories Plumbing Fixtures Are Missing And Should Be Installed	Educational Adequacy	13	Ea.	5	\$19,651	Rollup
<b>Sub Total for System</b>		<b>6</b>	<b>items</b>		<b>\$308,958</b>

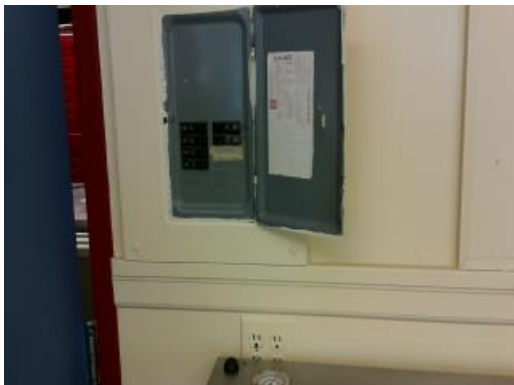
Main Building - Obsolete Panelboard

Deficiency	Category	Qty	UoM	Priority	Repair Cost	ID
The Panelboard Requires Replacement <b>Note:</b> Replace original panel; equipment is obsolete.	Capital Renewal	1	Ea.	2	\$5,051	1925
The Panelboard Requires Replacement <b>Note:</b> Panels outdated and should be updated to newer equipment.	Capital Renewal	4	Ea.	2	\$40,009	2316
The Panelboard Requires Replacement <b>Note:</b> Electrical panels in kitchen are outdated and obsolete.	Capital Renewal	4	Ea.	2	\$20,202	2317
Remove Abandoned Equipment <b>Note:</b> Remove abandoned electrical equipment in attic and HVAC equipment on roof.	Capital Renewal	2	Ea.	5	\$6,920	2190
Room Has Insufficient Electrical Outlets	Educational Adequacy	196	Ea.	5	\$97,268	Rollup
<b>Sub Total for System</b>		<b>5</b>	<b>items</b>		<b>\$169,449</b>

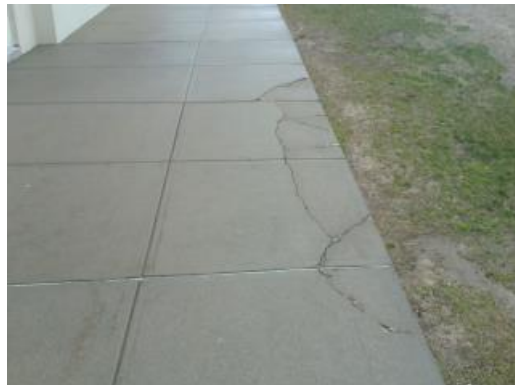
Cracked Concrete Walkway

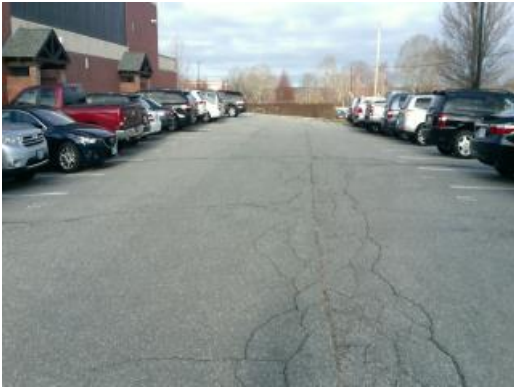
Cracked Asphalt Paving

Deficiency	Category	Qty	UoM	Priority	Repair Cost	ID
Asphalt Paving Requires Replacement <b>Note:</b> Asphalt in the faculty, employee and visitors parking areas should be replaced.	Capital Renewal	64	CAR	4	\$210,319	2105
Backstops Require Replacement <b>Note:</b> Backstops Require Replacement	Educational Adequacy	1	Ea.	4	\$28,329	28625
Concrete Sidewalks Require Repair <b>Note:</b> Cracking in concrete walkways.	Capital Renewal	150	LF	4	\$259,209	2108
School has insufficient # of tennis courts. <b>Note:</b> School has insufficient # of tennis courts.	Educational Adequacy	1	Ea.	5	\$161,597	29054
School has insufficient baseball fields. <b>Note:</b> School has insufficient baseball fields.	Educational Adequacy	1	Ea.	5	\$207,745	28333
School has insufficient softball fields. <b>Note:</b> School has insufficient softball fields.	Educational Adequacy	1	Ea.	5	\$151,087	28376
<b>Sub Total for System</b>		<b>6</b>	<b>items</b>		<b>\$1,018,287</b>

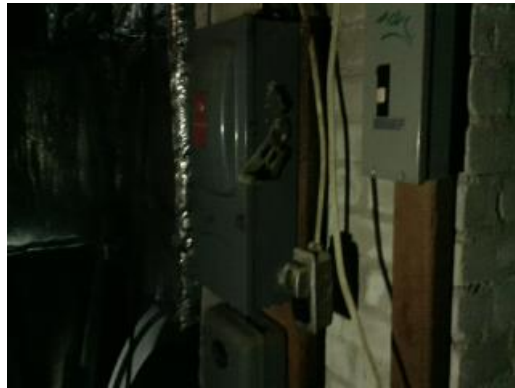
Main Building - Electrical Equipment In Attic

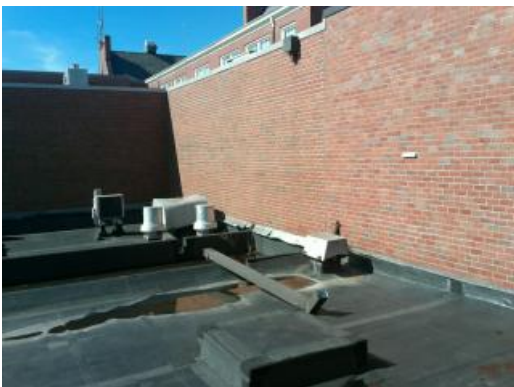
Main Building - Clogged Roof Drain

Deficiency	Category	Qty	UoM	Priority	Repair Cost	ID
The Roof Drains Require Cleaning <b>Note:</b> The roof drain on the east side is clogged and needs to be cleaned.	Capital Renewal	1	Ea.	3	\$41	2188
<b>Sub Total for System</b>		<b>1</b>	<b>items</b>		<b>\$41</b>

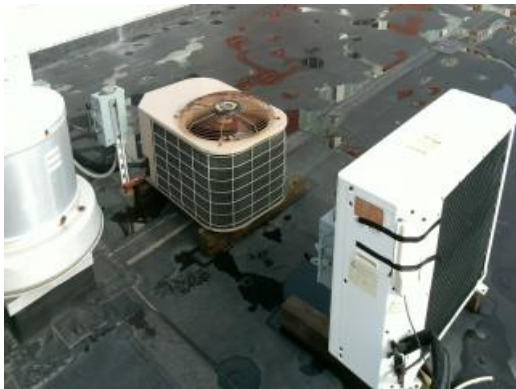
Main Building - Abandoned Equipment

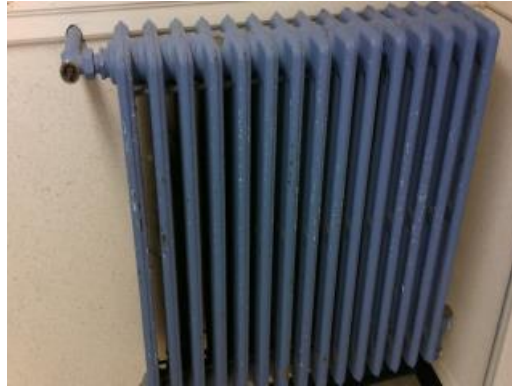
Main Building - Original Radiant Heater

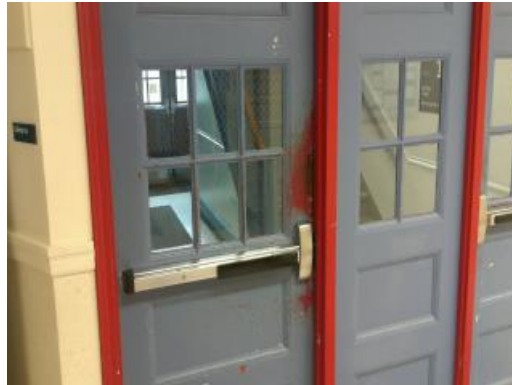
Main Building - Worn Interior Metal Doors

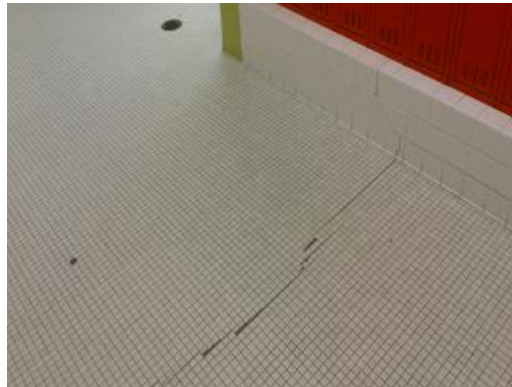
Main Building - Cracked Ceramic Tile Floor

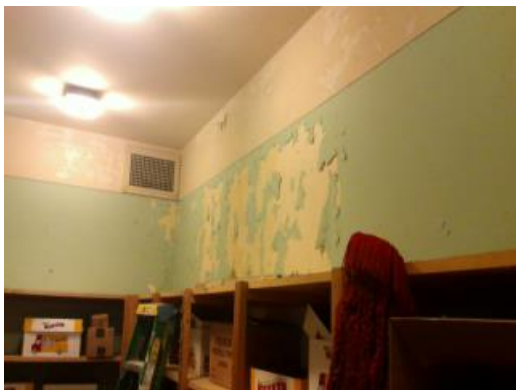
Main Building - Paint Peeling

Paint (probable pre-1978 in base layer(s)) - large areas (> 10 sq. ft.) of peeling/damage & area in active use - children (measurement unit - square feet)	Hazardous Material	17,000	SF	4	\$168,353	Rollup
Paint (probable pre-1978 in base layer(s)) -large areas (> 10 sq. ft.)of peeling/damage & area in active use-adults only (measurement unit - square feet)	Hazardous Material	3,100	SF	4	\$30,700	Rollup
Paint (probable pre-1978 in base layer(s)) -large areas(> 10 sq. ft.)of peeling/damage & area in active use-adults only (measurement unit - linear feet)	Hazardous Material	30	LF	4	\$713	Rollup
Room Is Excessively Reverberant <b>Location:</b> Gym	Acoustics	10,800	SF	4	\$251,341	27977
Room Is Excessively Reverberant <b>Location:</b> Cafeteria	Acoustics	2,756	SF	4	\$64,138	27978
Room Lighting Is Inadequate Or In Poor Condition.	Educational Adequacy	944	SF	4	\$35,970	Rollup
The Plaster Ceilings Require Replacement <b>Note:</b> Cafeteria ceiling requires repair where plywood is located.	Capital Renewal	100	SF	4	\$693	1945

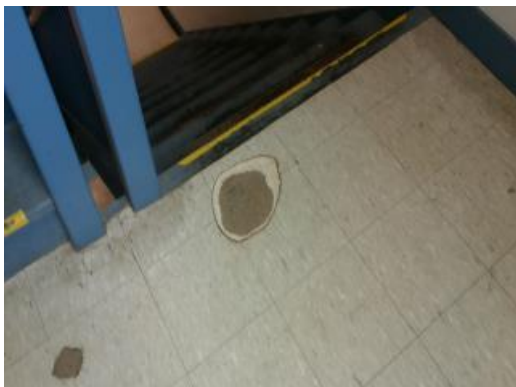
Main Building - Damaged VCT

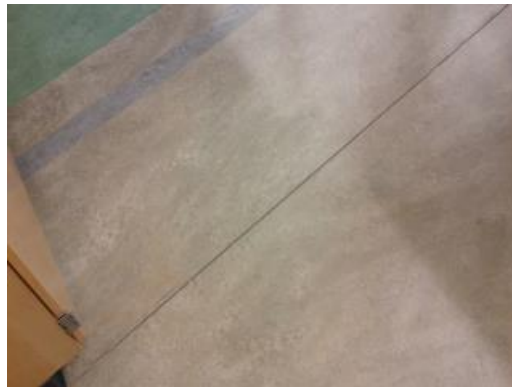
Main Building - Curling Floor Seam

Deficiency	Category	Qty	UoM	Priority	Repair Cost	ID
Rubber Flooring Requires Replacement <b>Note:</b> Seam in rubber tiled floor failing. <b>Location:</b> 1st W103 Science Room	Capital Renewal	100	SF	3	\$1,946	1944
The Ceramic Tile Flooring Requires Replacement <b>Note:</b> The ceramic tile floor in the 2010 girl's locker room is severely cracked.	Capital Renewal	100	SF	3	\$2,797	2033
The Vinyl Composition Tile Requires Replacement <b>Location:</b> Hallway staircase	Capital Renewal	1,000	SF	3	\$11,950	2032
Asbestos 9x9 Tile is Present. Limited Areas of Lifting or Broken Tiles Exist	Hazardous Material	140	SF	4	\$4,159	Rollup
Paint (probable pre-1978 in base (layers(s)) - large areas (> 10 sq. ft.) of peeling/damage & area in active use - children (measurement unit - each)	Hazardous Material	775	Ea.	4	\$230,247	Rollup
Paint (probable pre-1978 in base layer(s)) - large areas (> 10 sq. ft.) of peeling/damage & area in active use - children (measurement unit - linear feet)	Hazardous Material	950	LF	4	\$22,579	Rollup

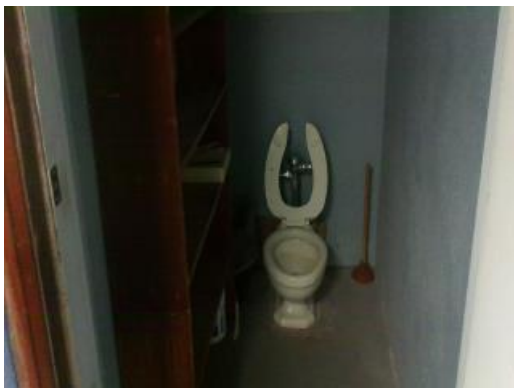
Main Building - Abandoned Restroom

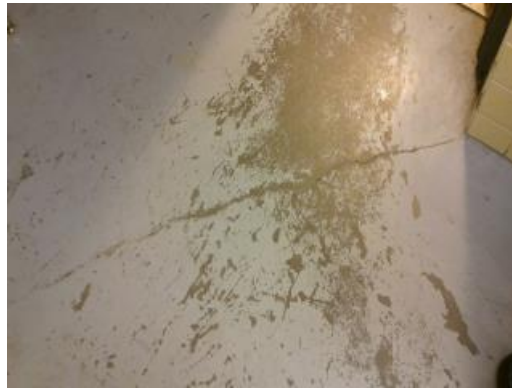
Main Building - Crack In Concrete Floor

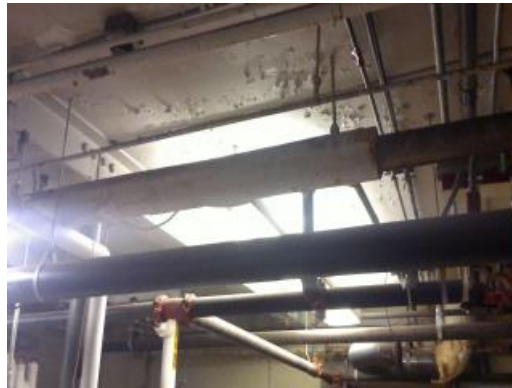
Main Building - Damaged Ceiling In Boiler Room

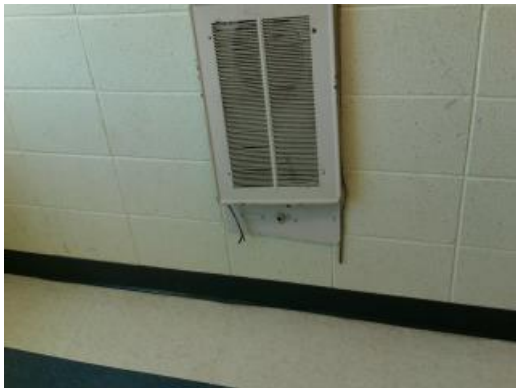
Main Building - Electric Unit Heater

Deficiency	Category	Qty	UoM	Priority	Repair Cost	ID
Electric Unit Heater Requires Replacement <b>Location:</b> Stair F, Floor 123	Capital Renewal	3	Ea.	2	\$12,683	2213
Electric Unit Heater Requires Replacement <b>Location:</b> Stair F, Floors 1-3	Capital Renewal	3	Ea.	2	\$12,683	2319
Outdoor Air Handler HVAC Component Required Replacement <b>Note:</b> Reznor units are breaking down and should be replaced. Unit on the middle roof has had fuses removed. Side panel is open which causes potential bird/rodent problem and heat loss.	Capital Renewal	5	Ea.	2	\$742,732	2194
Outdoor Air Handler HVAC Component Required Replacement <b>Note:</b> Trane units are breaking down.	Capital Renewal	3	Ea.	2	\$445,639	2195
Steam/HW Unit Heater Requires Replacement <b>Location:</b> Locker Rooms	Capital Renewal	6	Ea.	2	\$17,600	1923
The Steam/Hot Water Radiant Heater Requires Replacement <b>Note:</b> Original to building; recommend replacing.	Capital Renewal	6	Ea.	2	\$32,288	2204

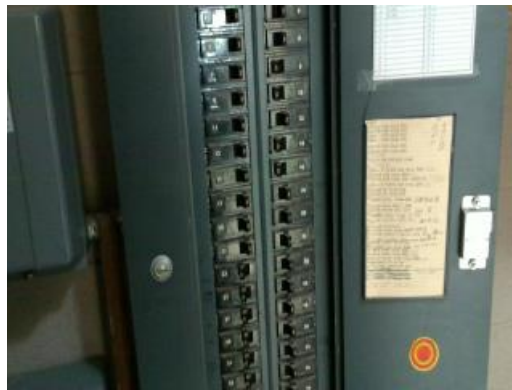
Main Building - Aged Panelboard

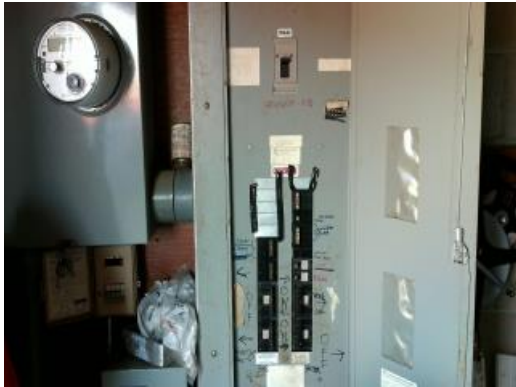
Building 02 - Outdated Panelboard

Deficiency	Category	Qty	UoM	Priority	Repair Cost	ID
The Lighting Fixtures Require Replacement <b>Note:</b> Update incandescent lights to LED.	Capital Renewal	500	SF	2	\$3,095	2441
The Panelboard Requires Replacement <b>Note:</b> Panelboard is outdated.	Capital Renewal	1	Ea.	2	\$6,536	2313
<b>Sub Total for System</b>		<b>3 items</b>			<b>\$11,488</b>	
<b>Sub Total for Building 02 - Field Light Shed</b>		<b>3 items</b>			<b>\$11,488</b>
