School Type by Count

School Type	SqFt
Elementary School	311,777
Middle School	297,353
High School	293,081
Total:	902,211

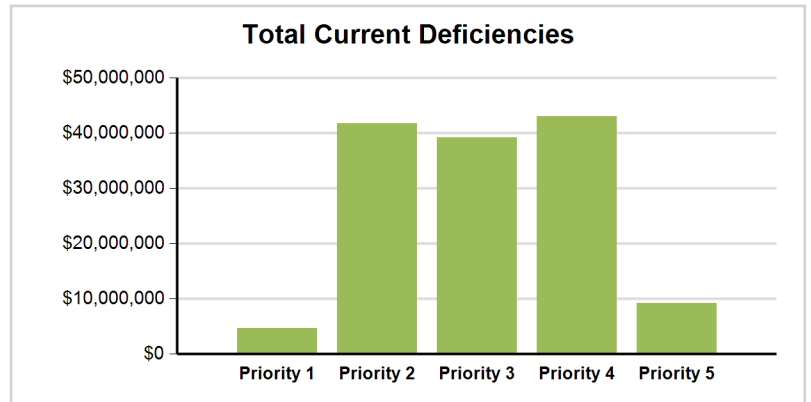
Five Year Need Summary

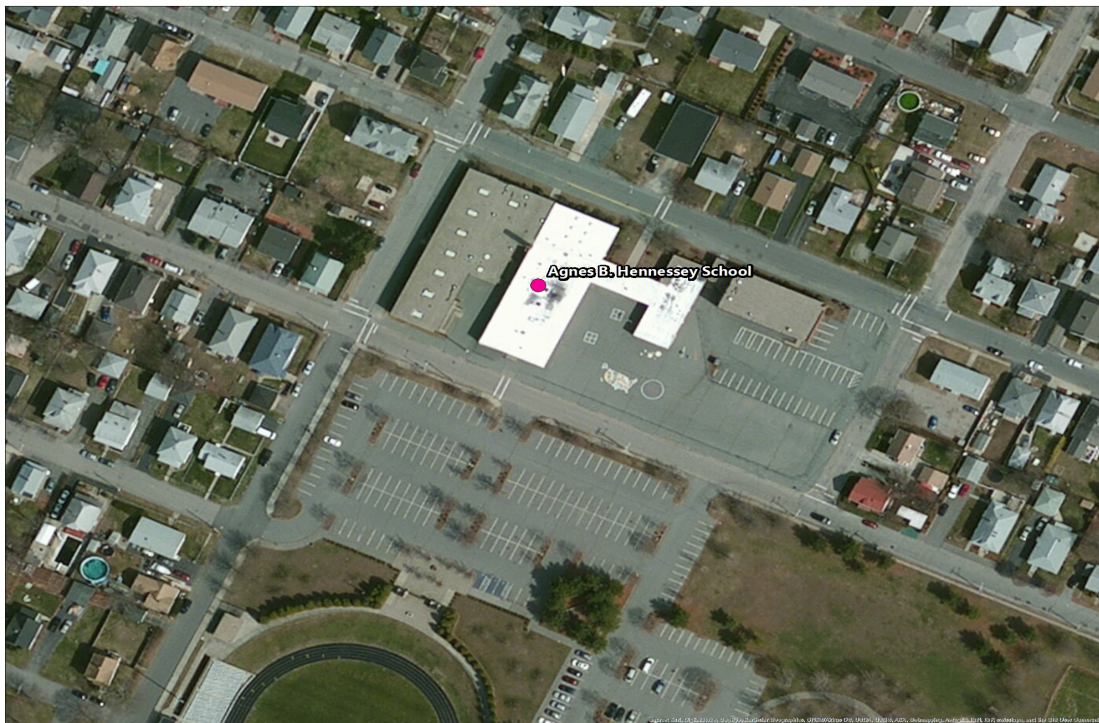
Figure 1: Aerial view of Agnes B. Hennessey School

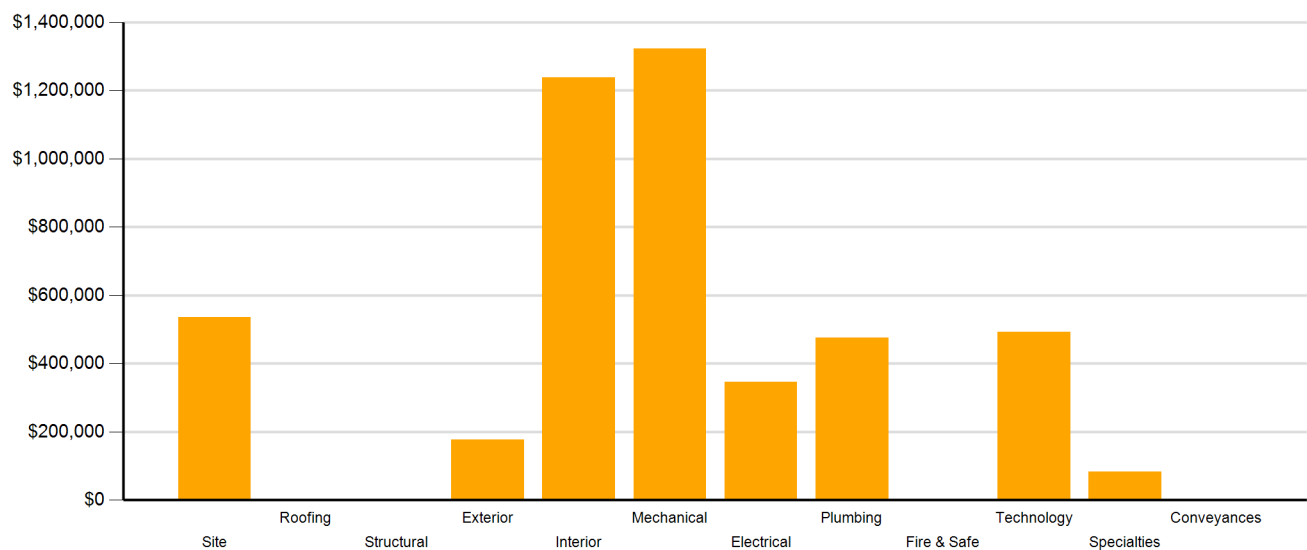
Figure 2: System Deficiencies

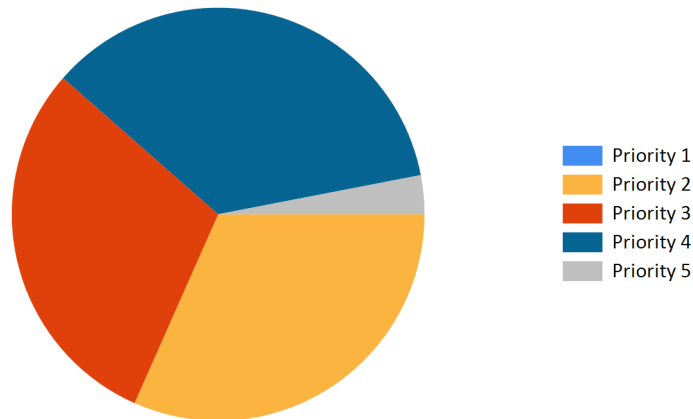
Figure 3: Current deficiencies by priority

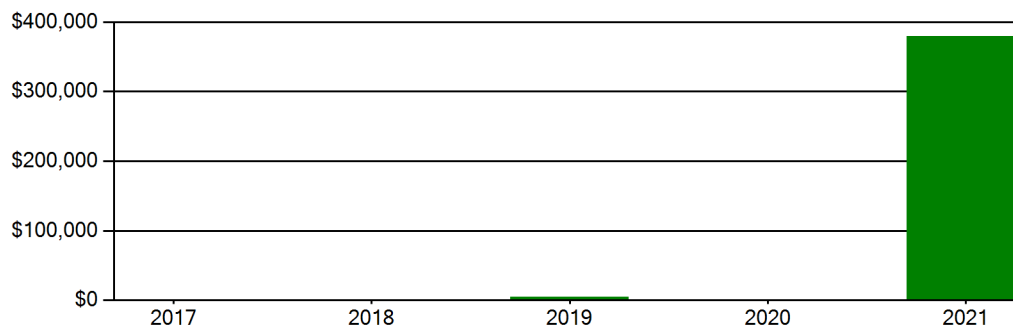
Figure 4: Life Cycle Capital Renewal Forecast

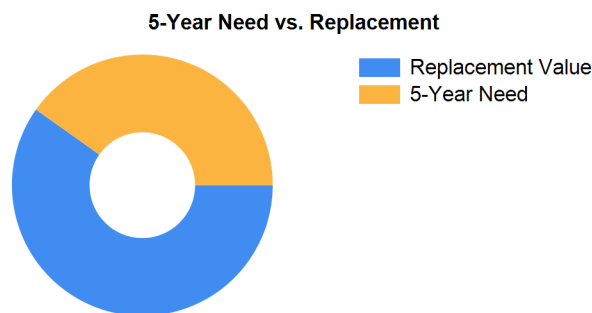
Figure 5: 5-Year FCI

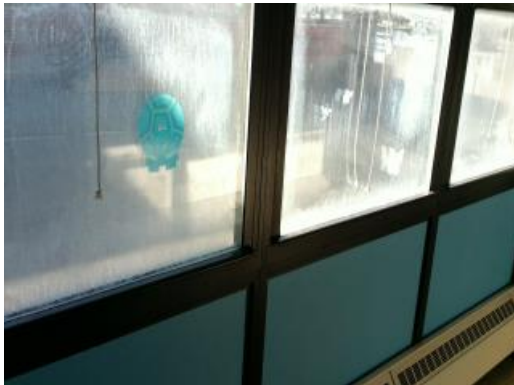
Damaged Window Panes

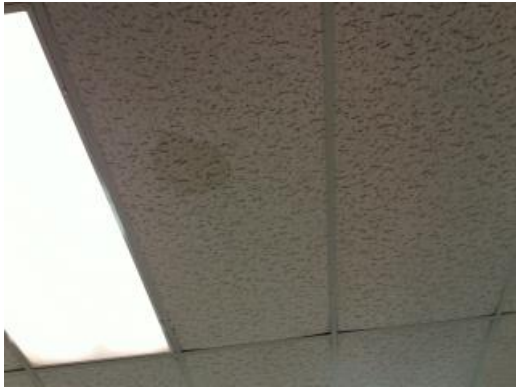
Stained And Sagging Ceiling Tiles

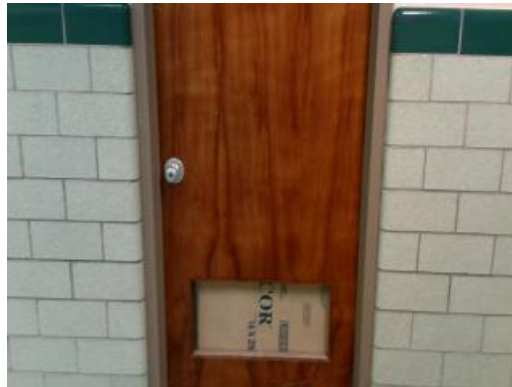
Aged Interior Door With Non-Compliant Hardware

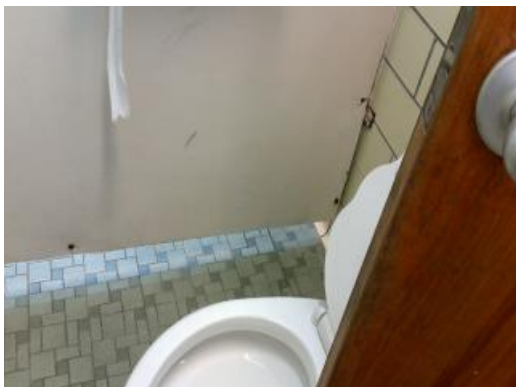
Toilet Partition Damaged At Wall

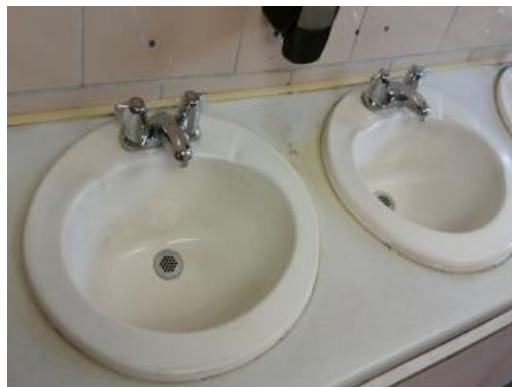
Typical Restroom Lavatories

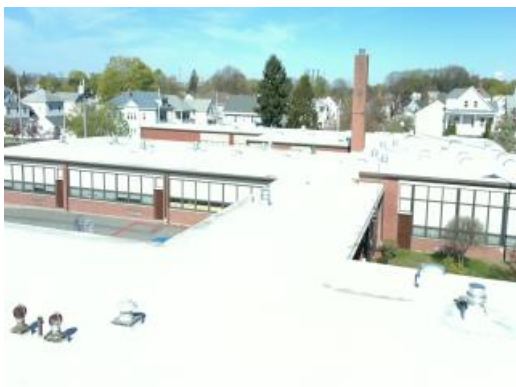
Roof General Condition

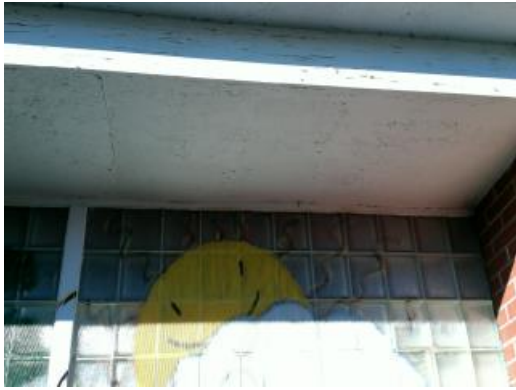
Peeling Paint At Soffit

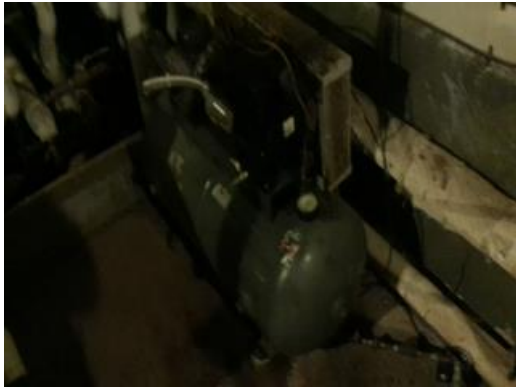
East Providence - Agnes B. Hennessey School

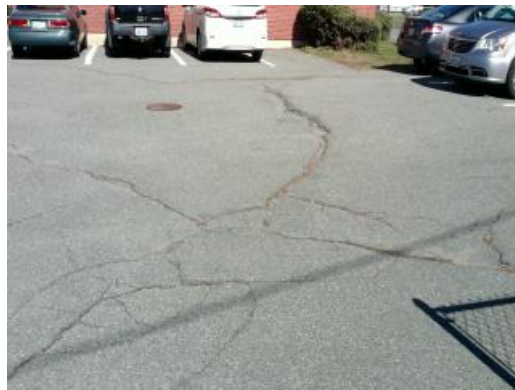
Cracked Asphalt Parking Lot

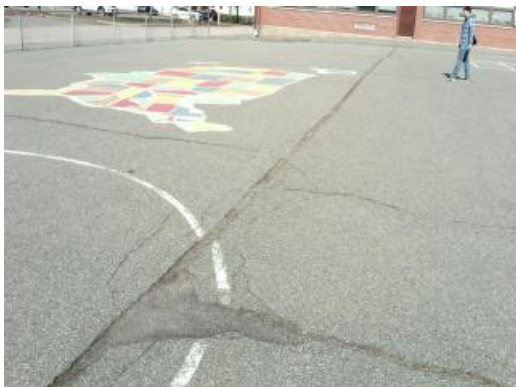
Cracks in Play Area Asphalt

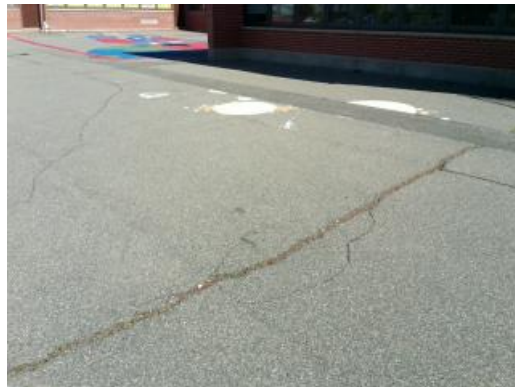
Cracks In Play Area Asphalt

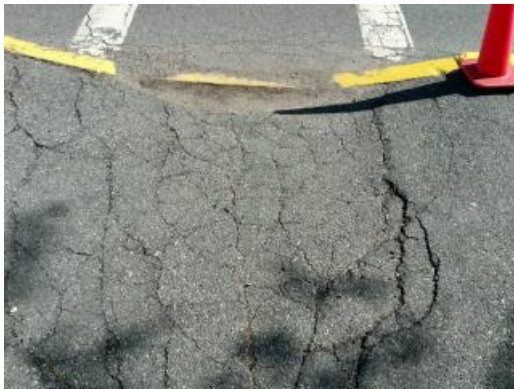
Alligatoring Asphalt Walkway

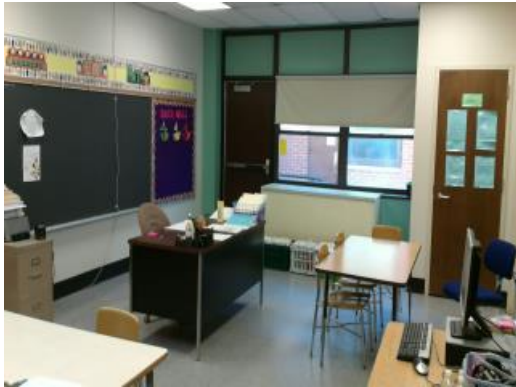
Typical Classroom 1957 Wing

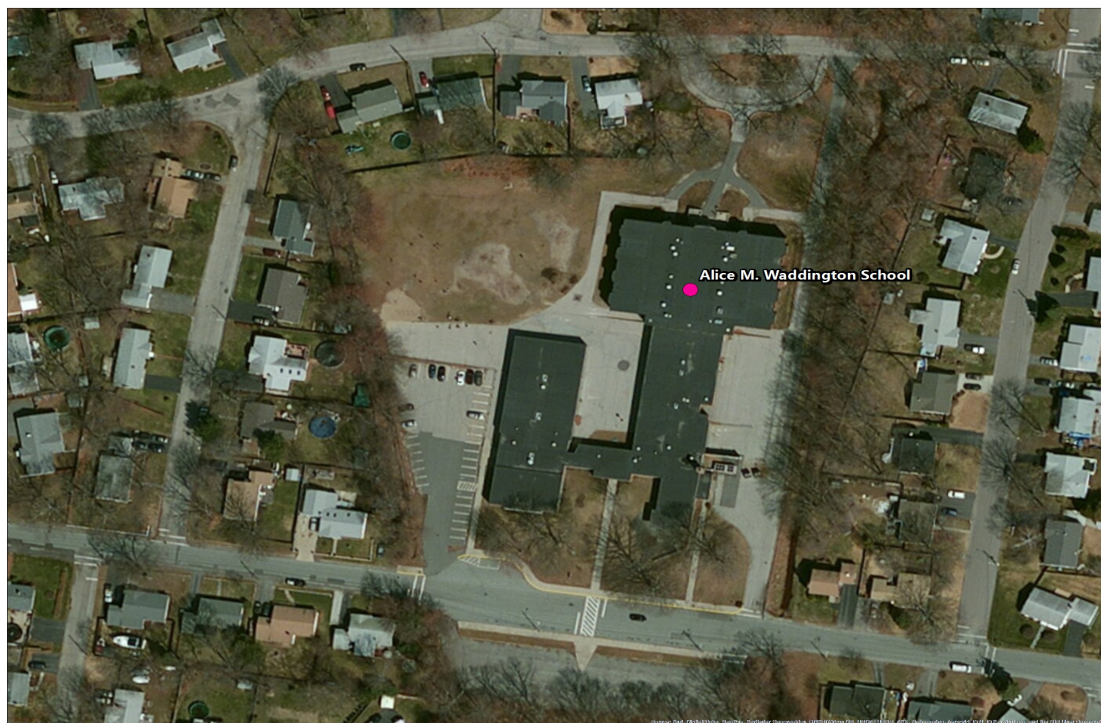
Figure 1: Aerial view of Alice M. Waddington School

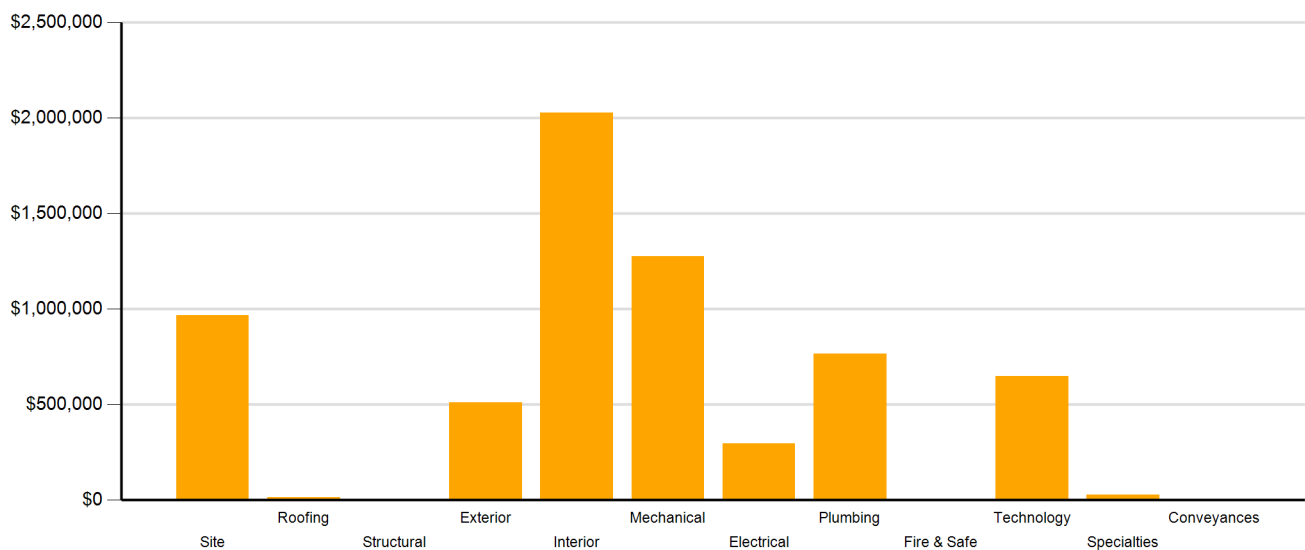
Figure 2: System Deficiencies

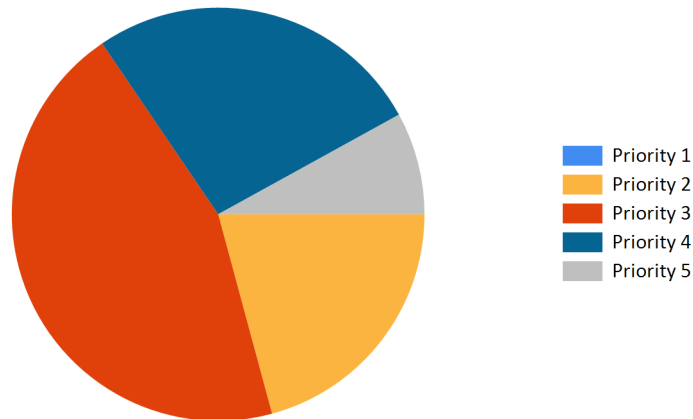
Figure 3: Current deficiencies by priority

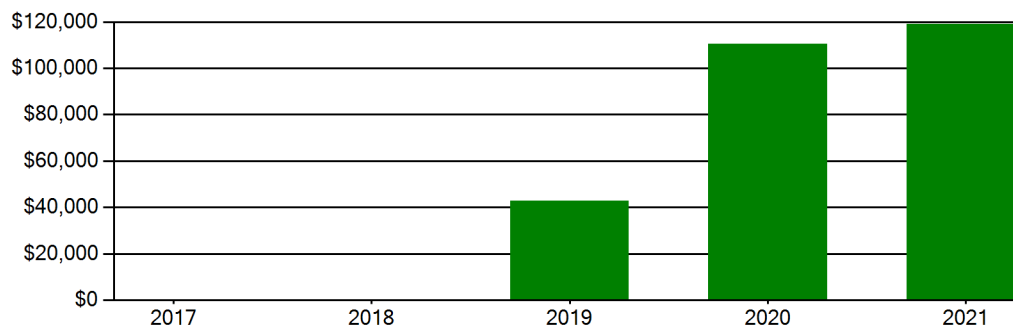
Figure 4: Life Cycle Capital Renewal Forecast

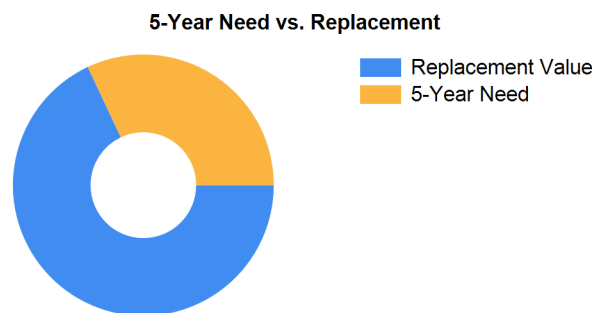
Figure 5: 5-Year FCI

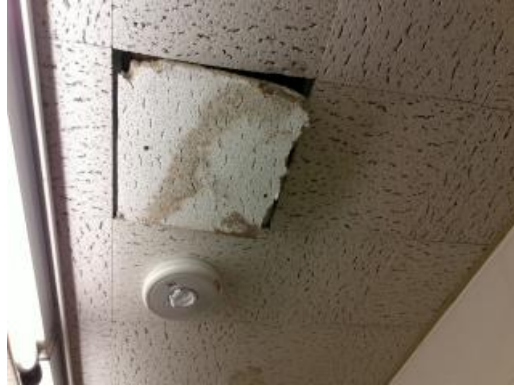
Damaged Ceiling Tiles

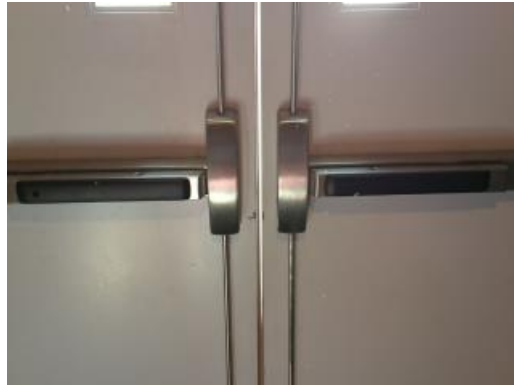
Repair Weatherstripping

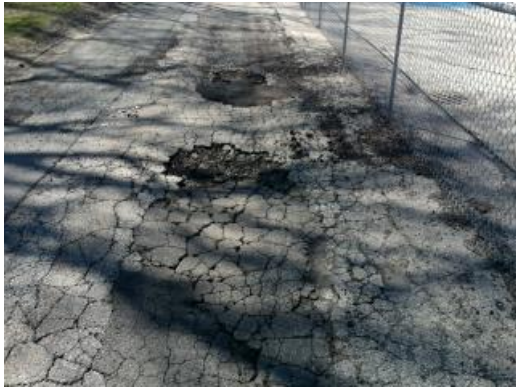
East Providence - Alice M. Waddington School

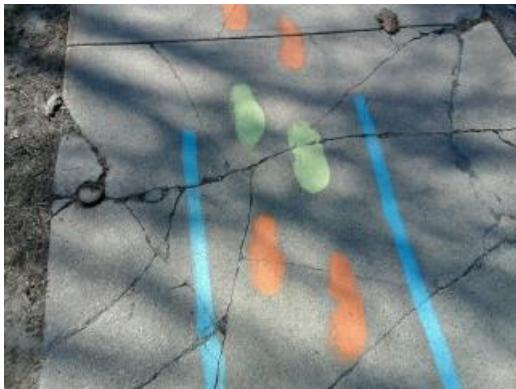
East Providence - Alice M. Waddington School

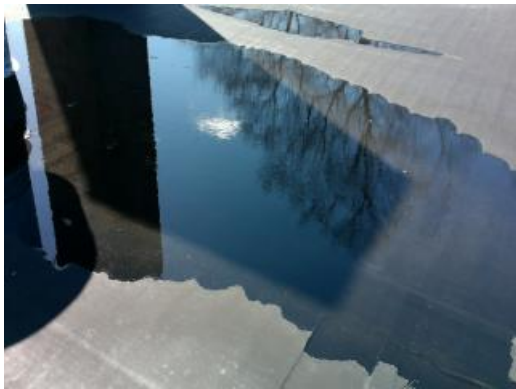
East Providence - Alice M. Waddington School

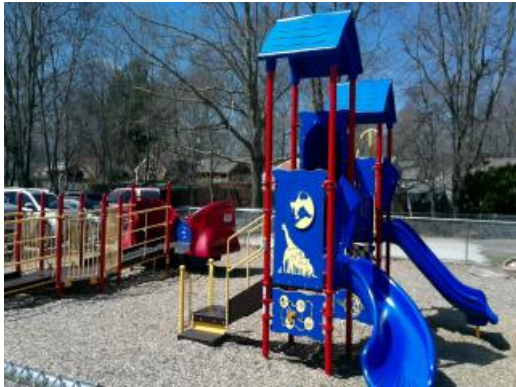
East Providence - Alice M. Waddington School

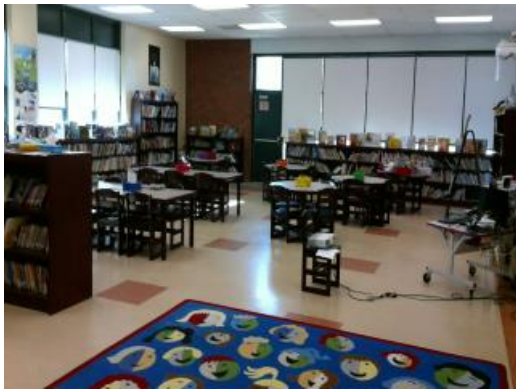
East Providence - Alice M. Waddington School

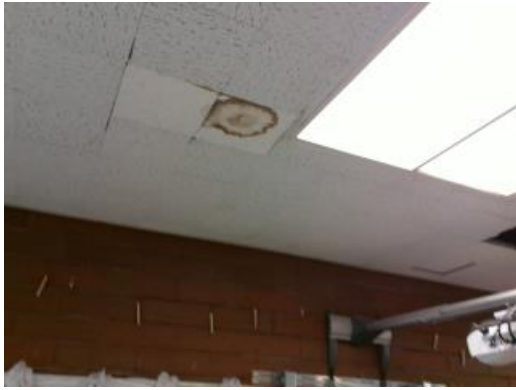
East Providence - Alice M. Waddington School

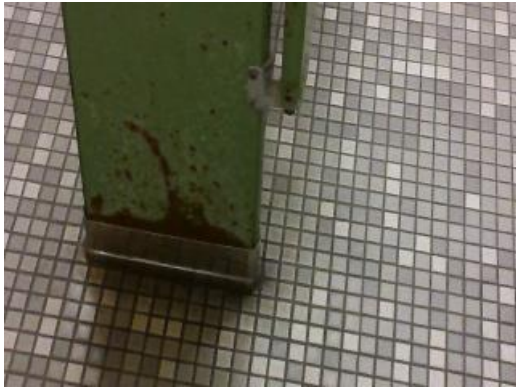
Toilet Partition Damage

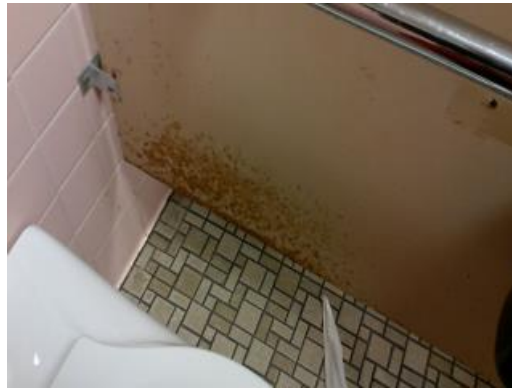
Toilet Partition Damage

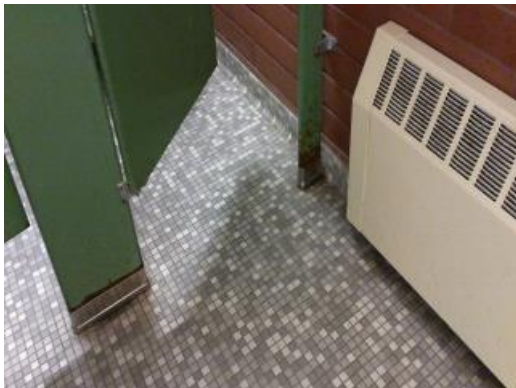
Toilet Partition Damage

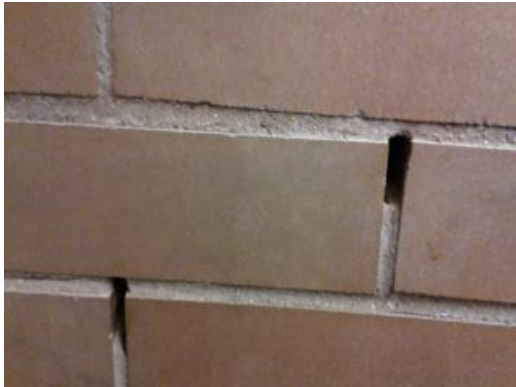
Brick Repointing Required

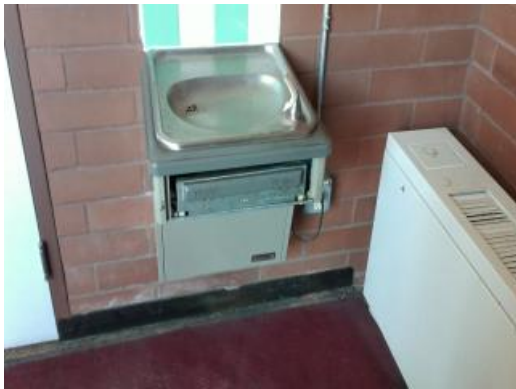
East Providence - Alice M. Waddington School

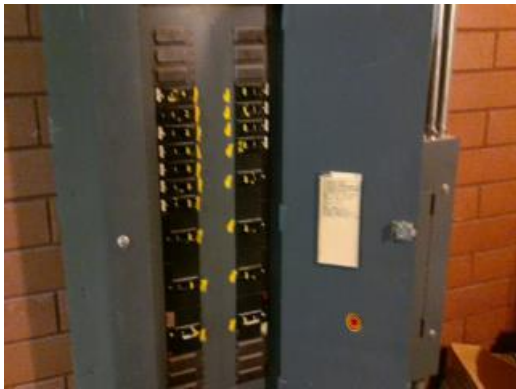
East Providence - Alice M. Waddington School

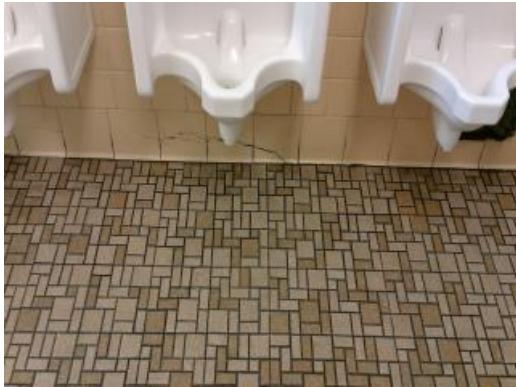
Ceramic Tile Wall Crack

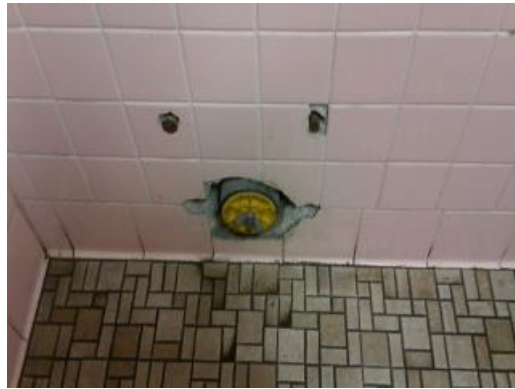
Missing Drinking Fountain

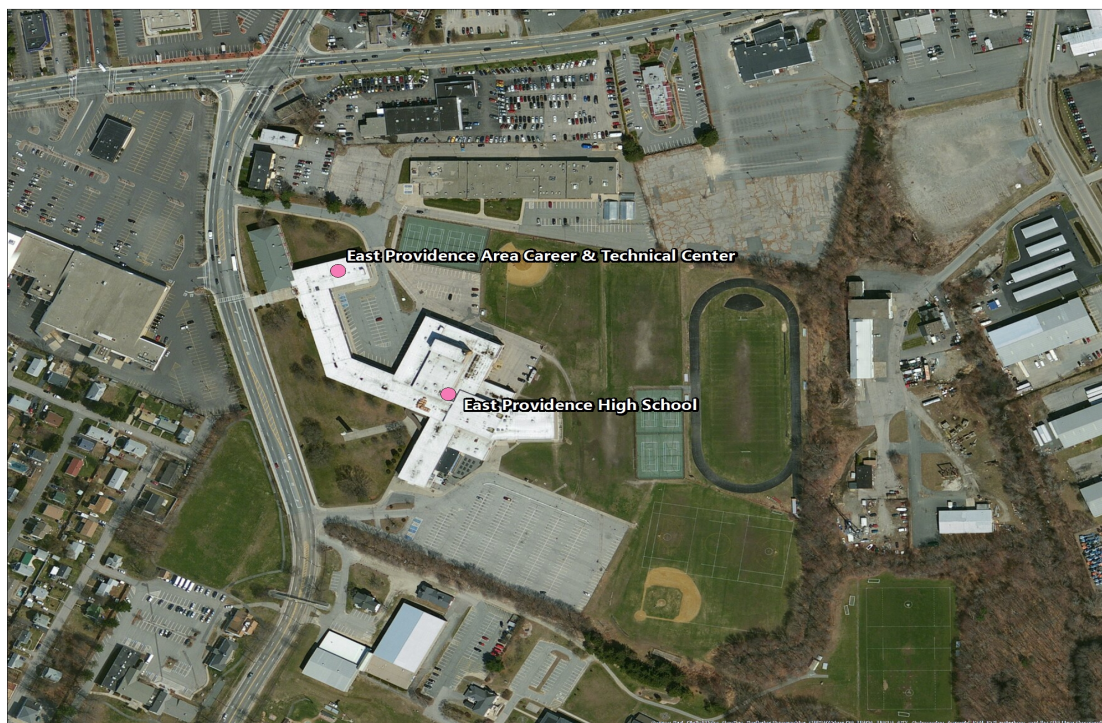
Figure 1: Aerial view of East Providence Career & Technical Center

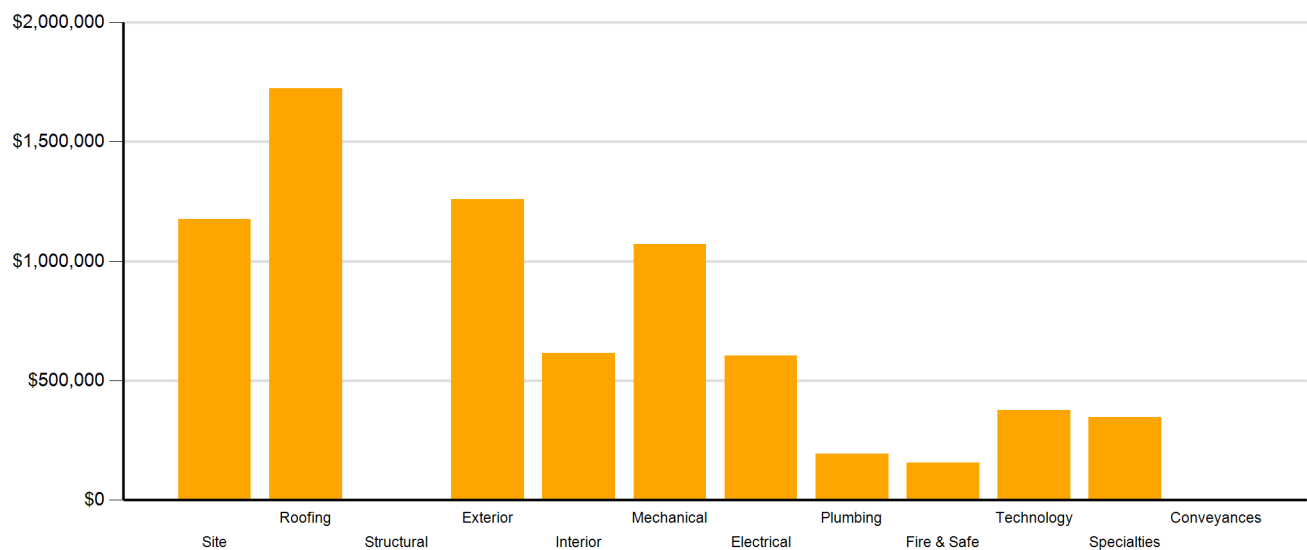
Figure 2: System Deficiencies

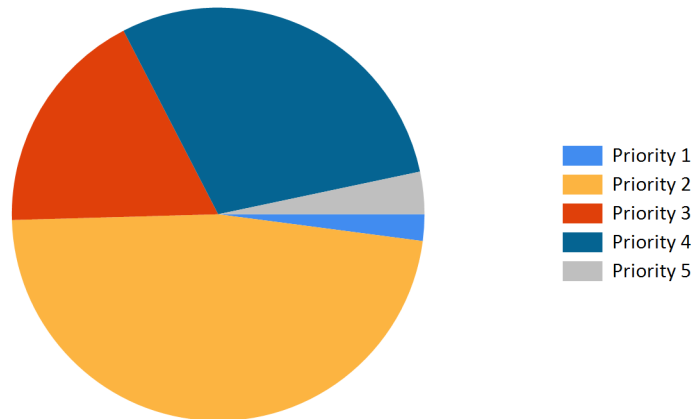
Figure 3: Current deficiencies by priority

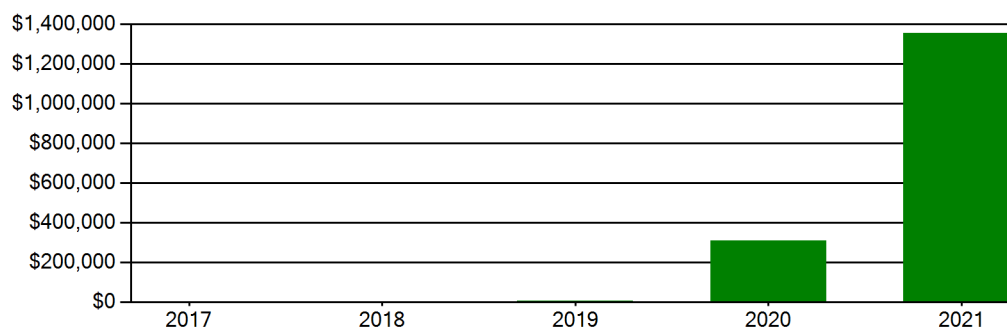
Figure 4: Life Cycle Capital Renewal Forecast

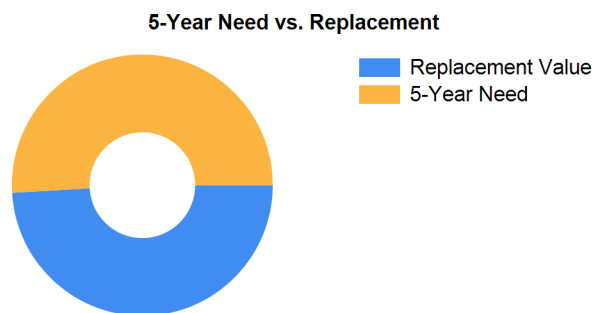
Figure 5: 5-Year FCI

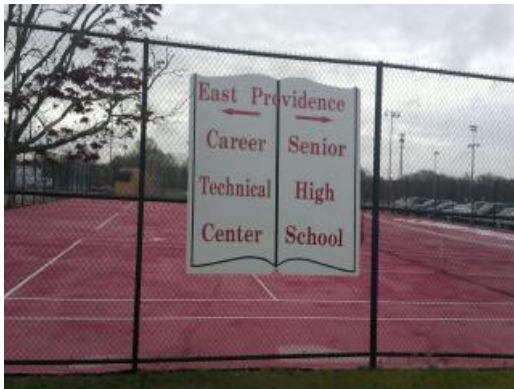
East Providence - East Providence Career & Technical Center

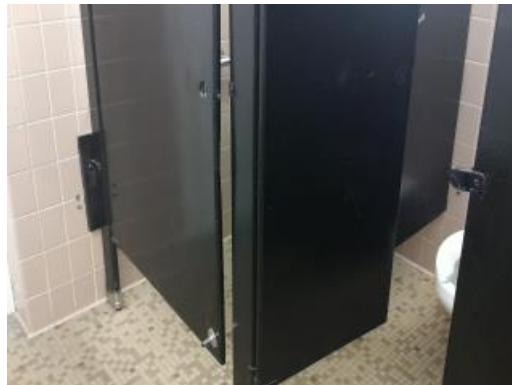
Damaged Restroom Partition

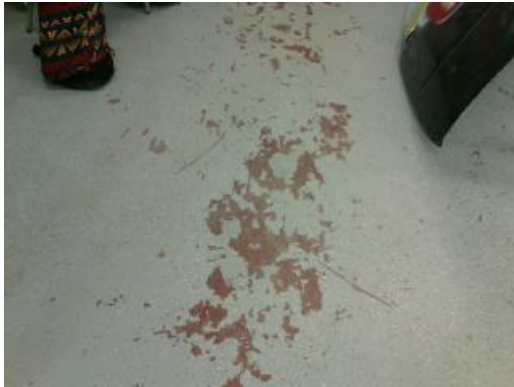
Chipped Concrete Paint

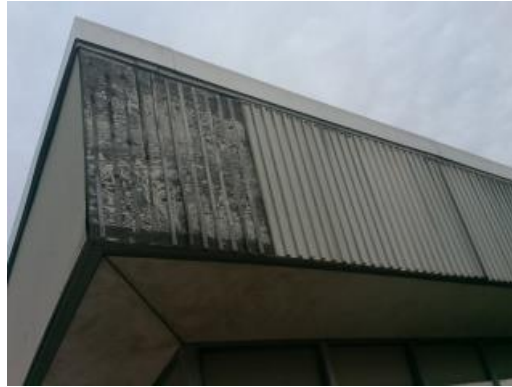
Missing And Damaged Concrete Panels

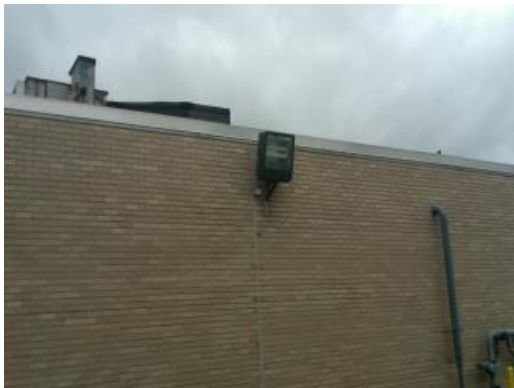
Building Mounted Light

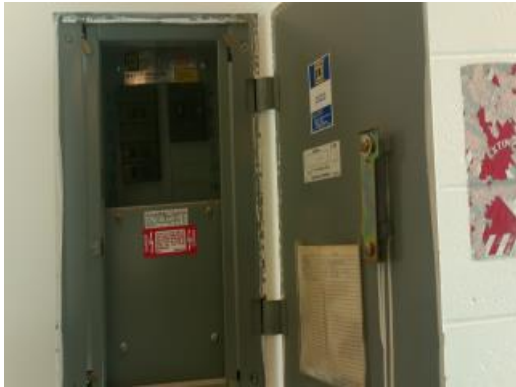
East Providence - East Providence Career & Technical Center

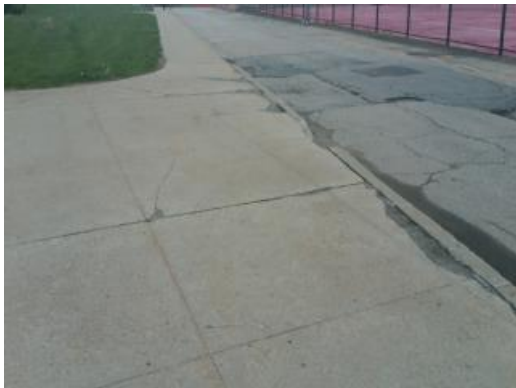
Cracked Concrete Walkway

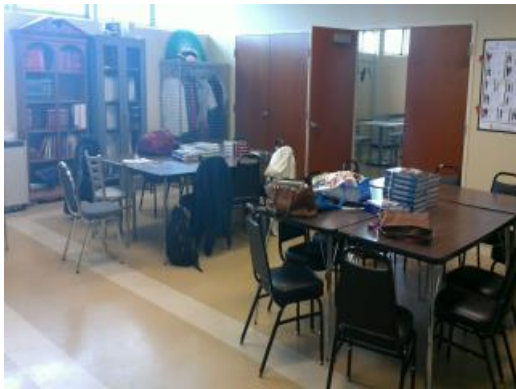
East Providence - East Providence Career & Technical Center

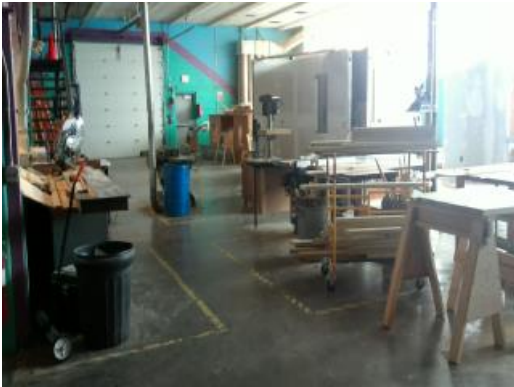
East Providence - East Providence Career & Technical Center

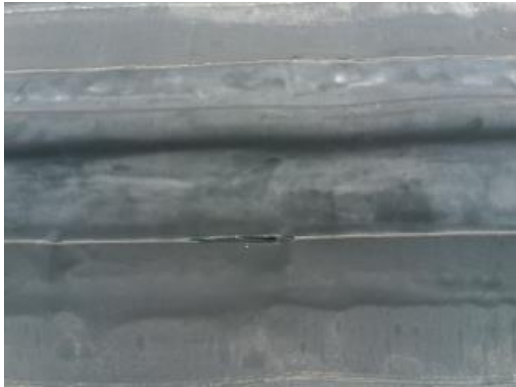
East Providence - East Providence Career & Technical Center

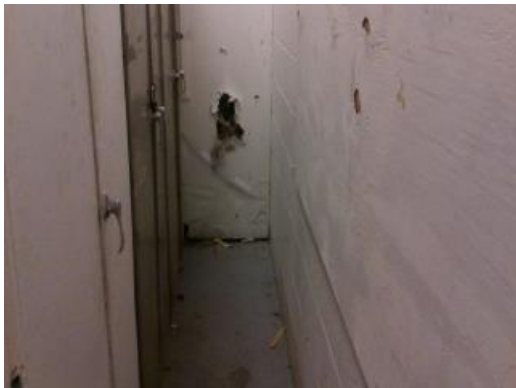
Damaged Gypsum Board Wall

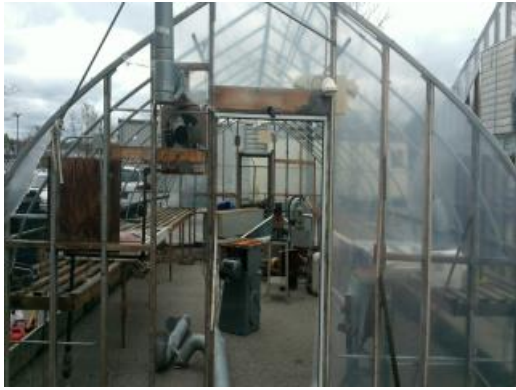
East Providence - East Providence Career & Technical Center

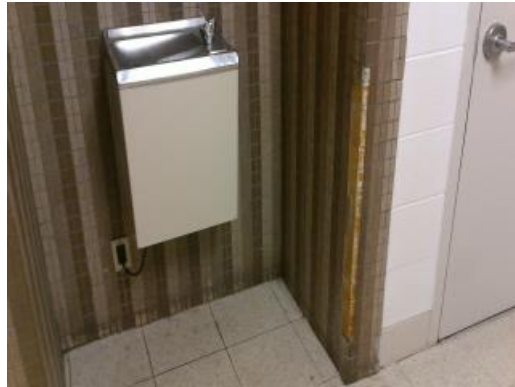
Damaged Ceramic Wall

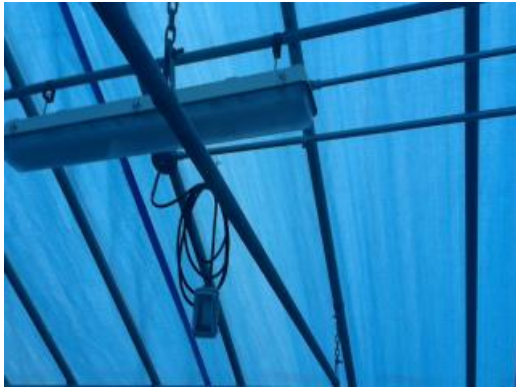
East Providence - East Providence Career & Technical Center

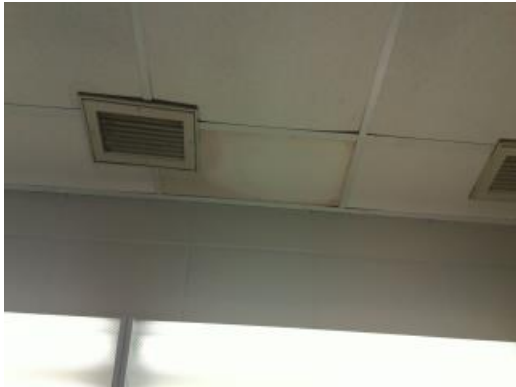
Stained Ceiling Tiles

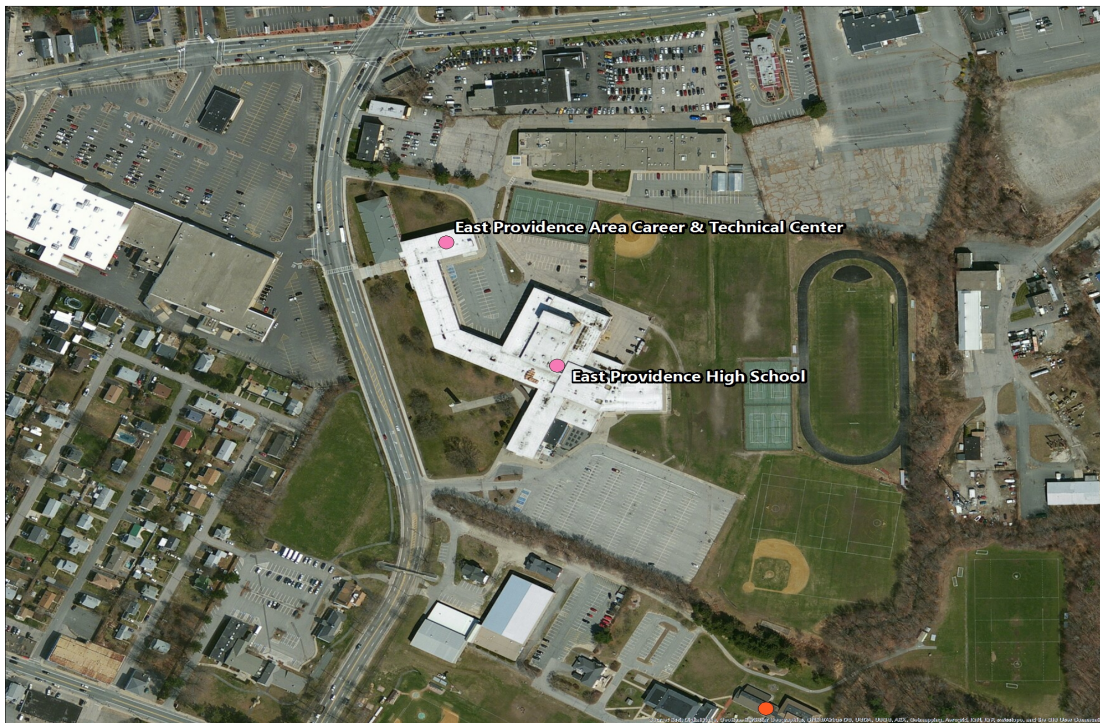
Figure 1: Aerial view of East Providence High School

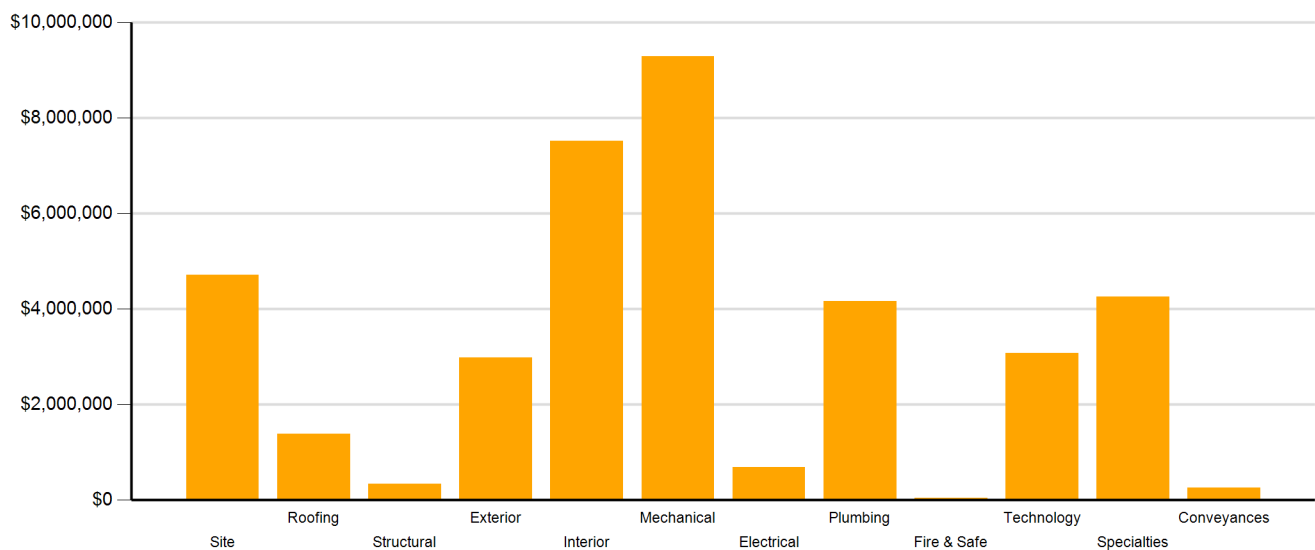
Figure 2: System Deficiencies

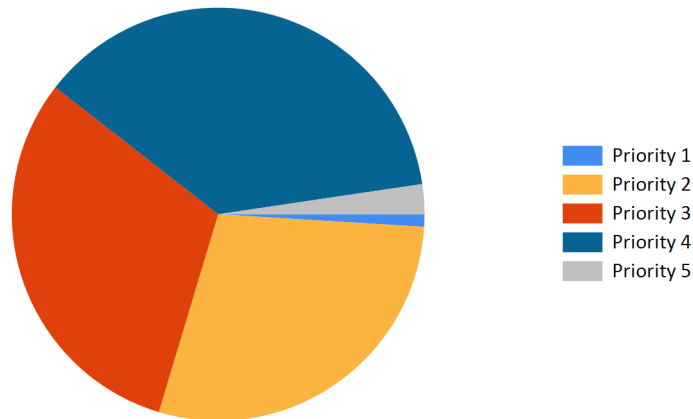
Figure 3: Current deficiencies by priority

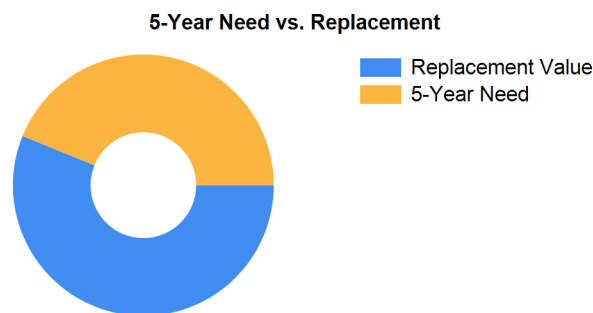
Figure 5: 5-Year FCI

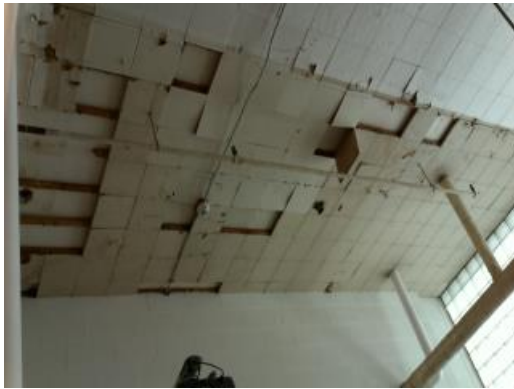
Failing Ceiling Tiles

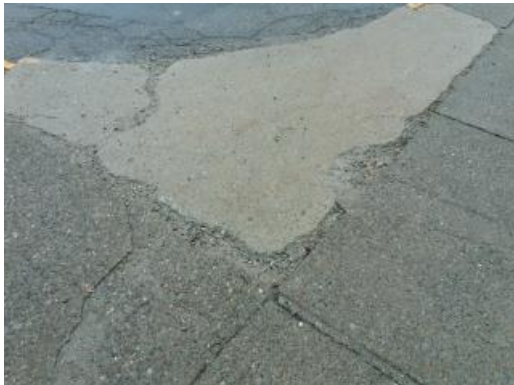
Damaged Concrete Walkways

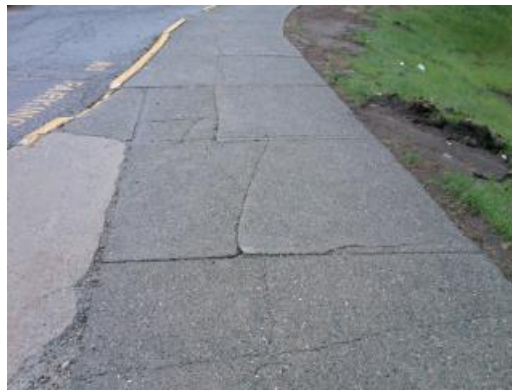
Cracked Concrete Walkway

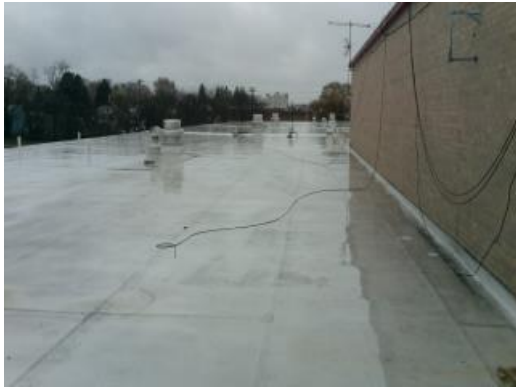
General Roof Condition

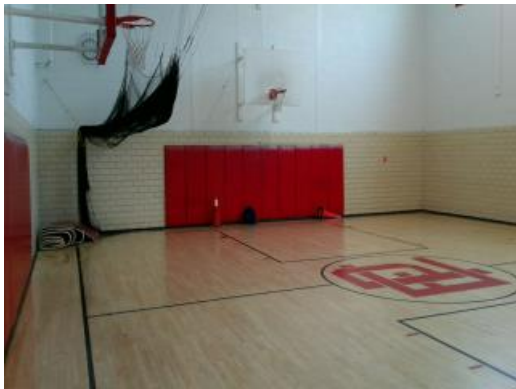
East Providence - East Providence High School

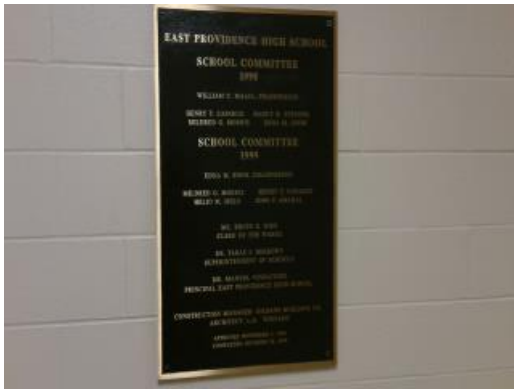
East Providence - East Providence High School

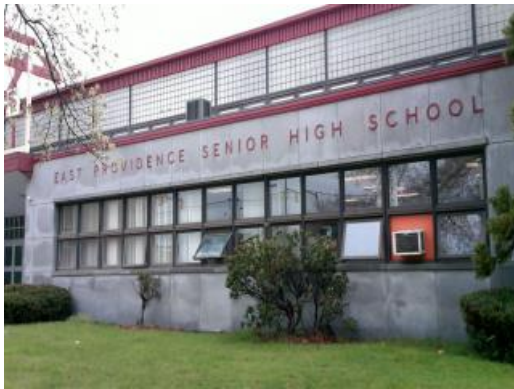
East Providence - East Providence High School

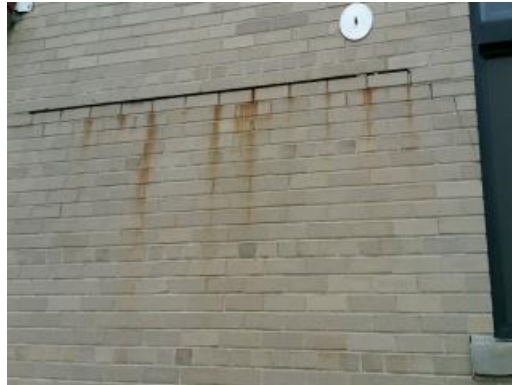
Cracked Exterior Brick

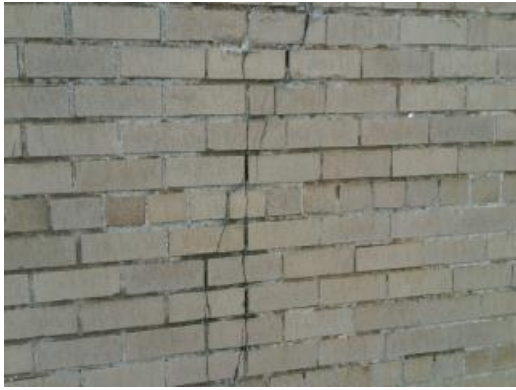
Cracked Exterior Brick

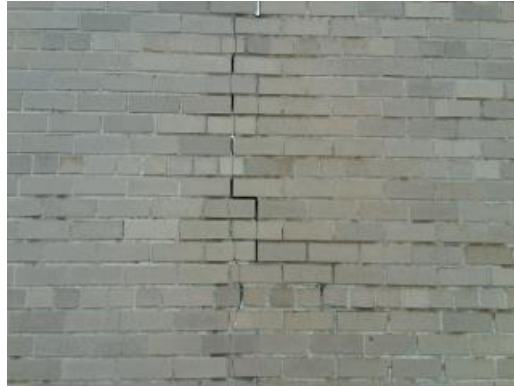
Cracked Exterior Brick

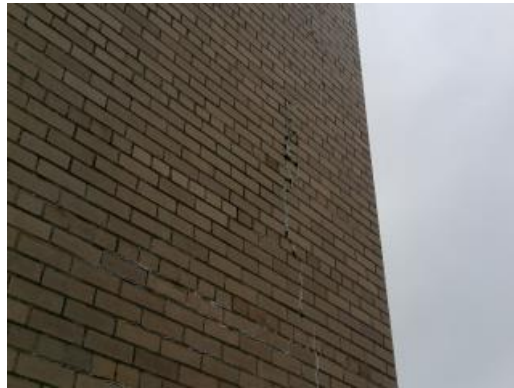
Cracked Exterior Brick

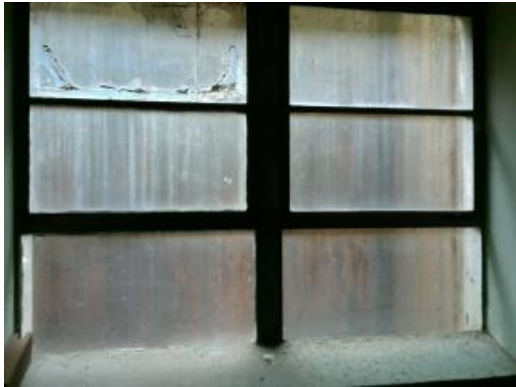
Original Basement Windows

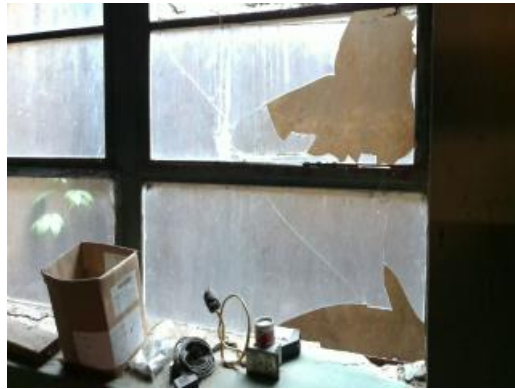
Broken Basement Windows

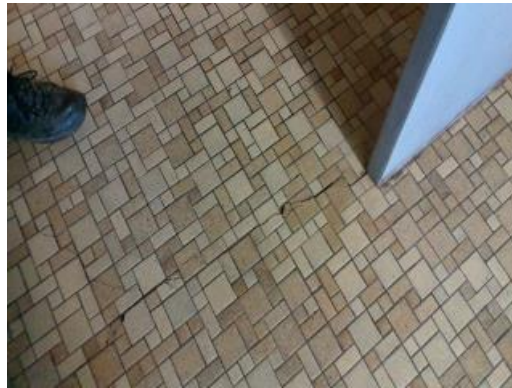
Cracked Ceramic Floor

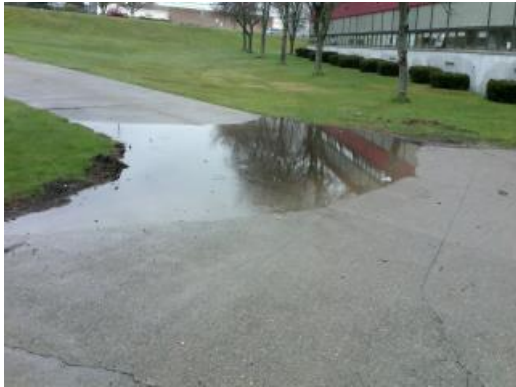
Front Entry Drainage

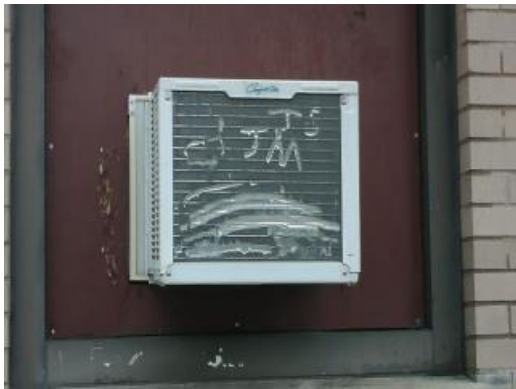
East Providence - East Providence High School

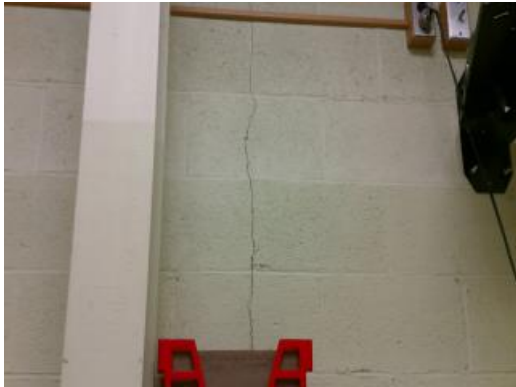
East Providence - East Providence High School

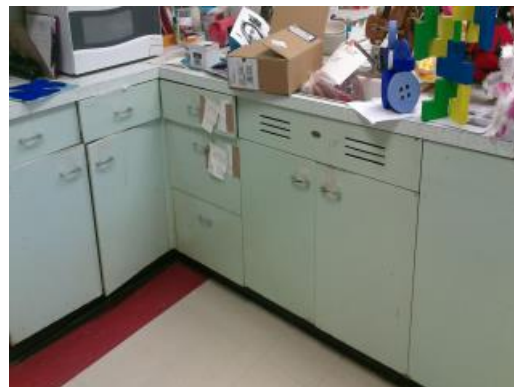
Typical Aged Cabinetry

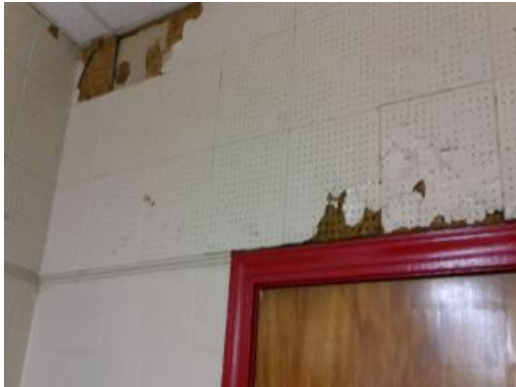
Broken Acoustic Wall Panel

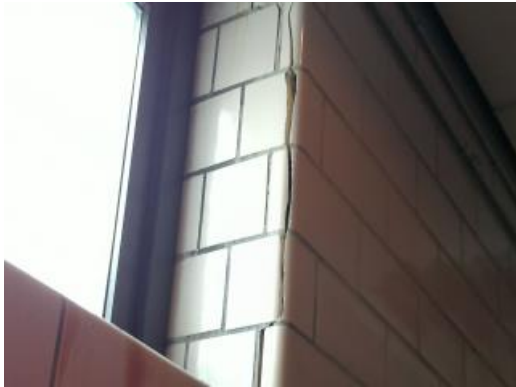
East Providence - East Providence High School

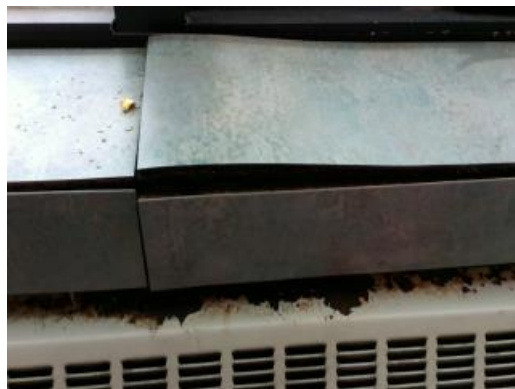
Delaminating Window Ledge

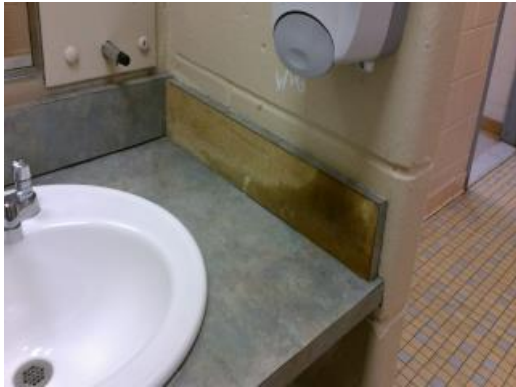
Delaminating Countertop
