School Type by Count

School Type	SqFt
Elementary School	311,777
Middle School	297,353
High School	293,081
Total:	902,211

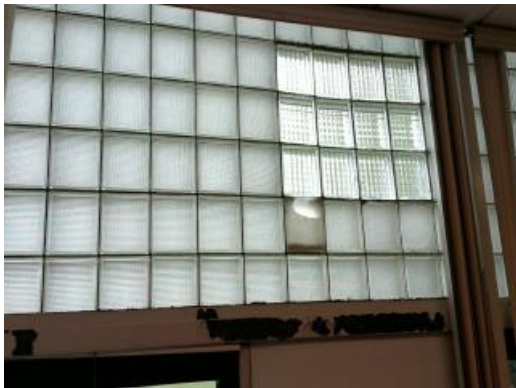
Leaking Glass Block Wall

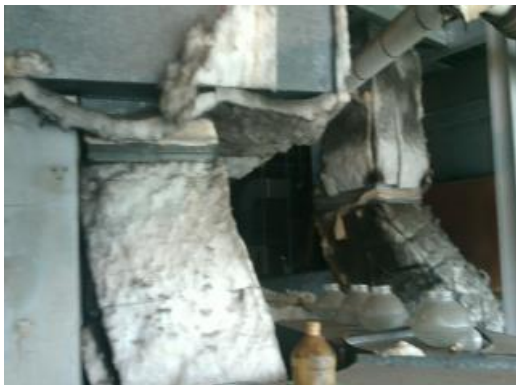
Failing AHU Insulation

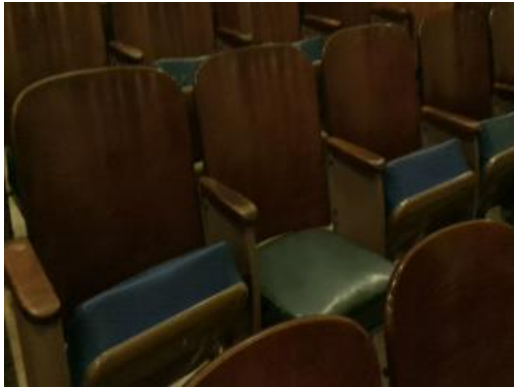
Typical Theater Seats

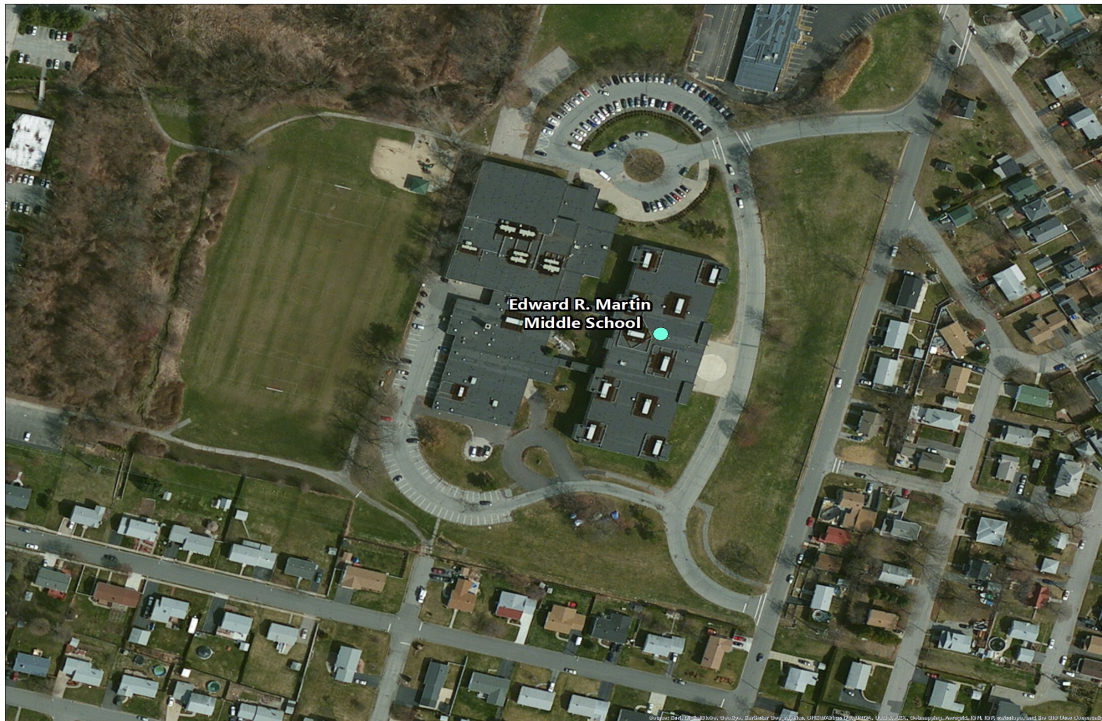
Figure 1: Aerial view of Edward R. Martin Middle School

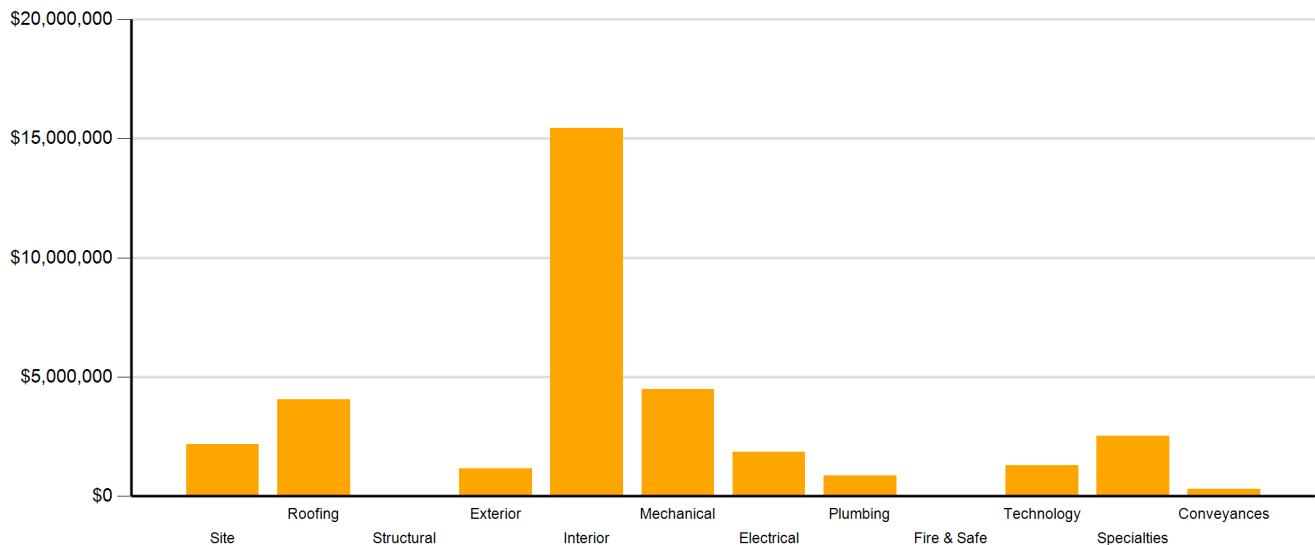
Figure 2: System Deficiencies

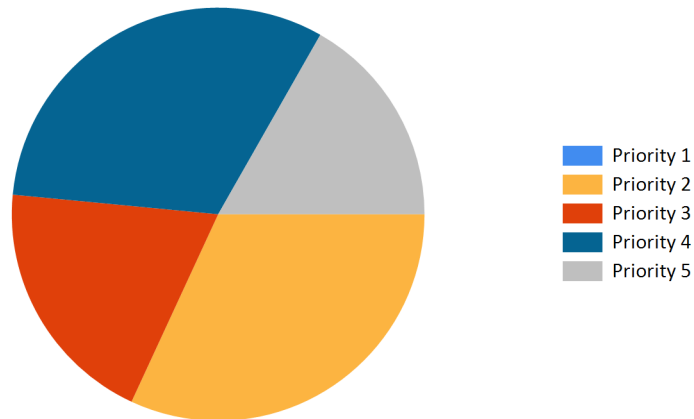
Figure 3: Current deficiencies by priority

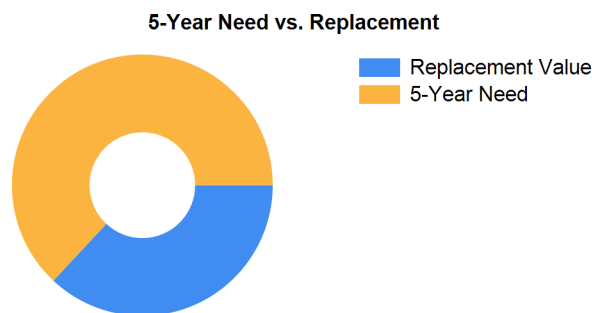
Figure 5: 5-Year FCI

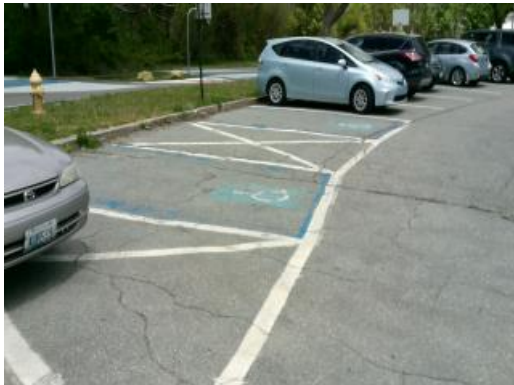
Cracked Parking Lot Pavement

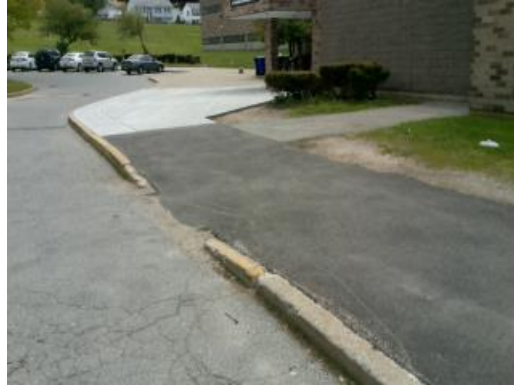
Weathered Roadway Asphalt

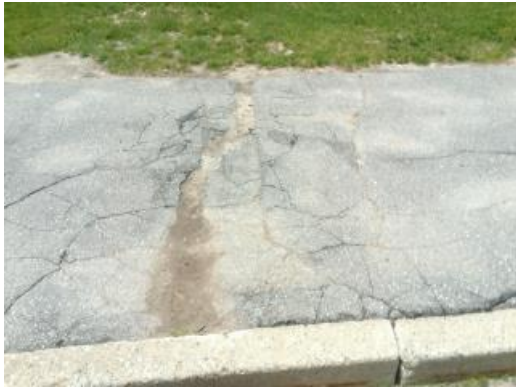
Alligatoring Asphalt Walkway

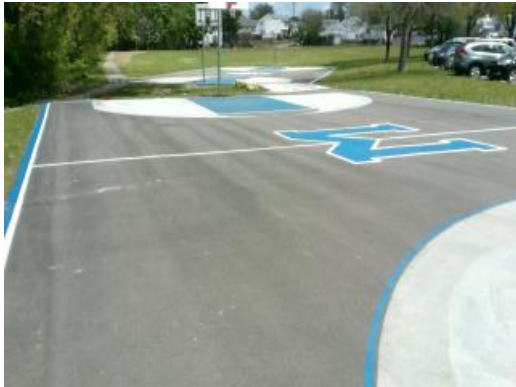
East Providence - Edward R. Martin Middle School

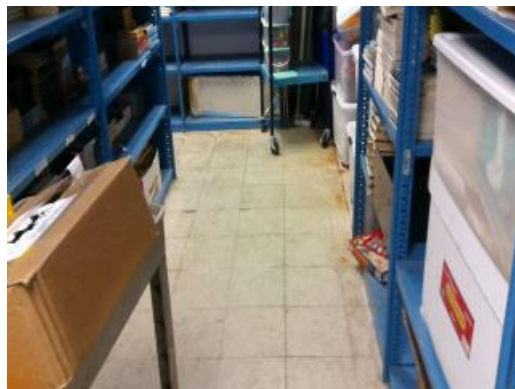
Stained And Separated VCT

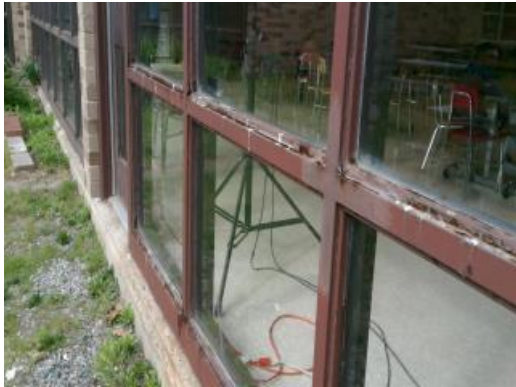
Leaking Steel Windows

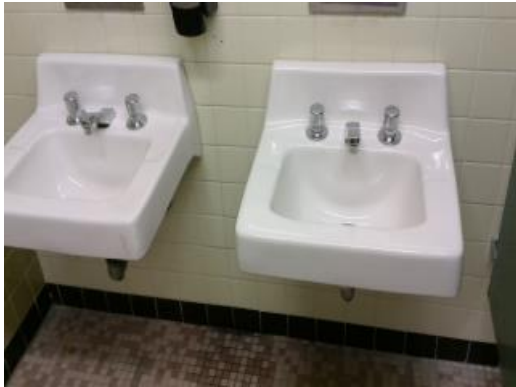
East Providence - Edward R. Martin Middle School

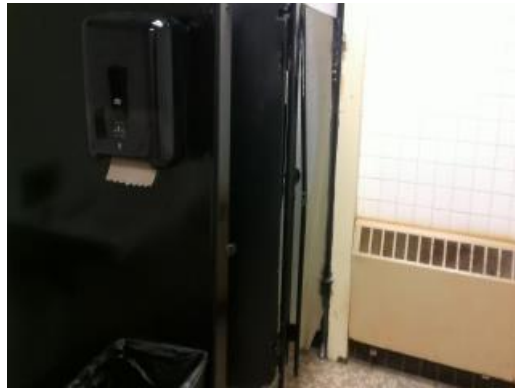
Damaged Toilet Partition

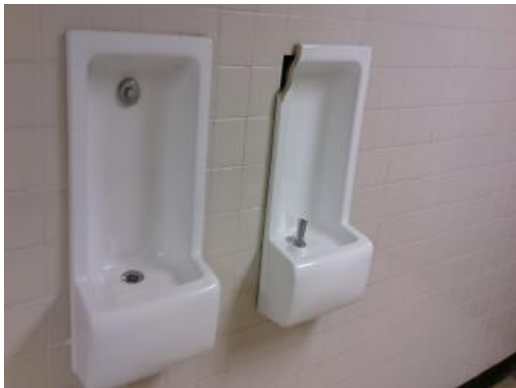
Damaged Drinking Fountain

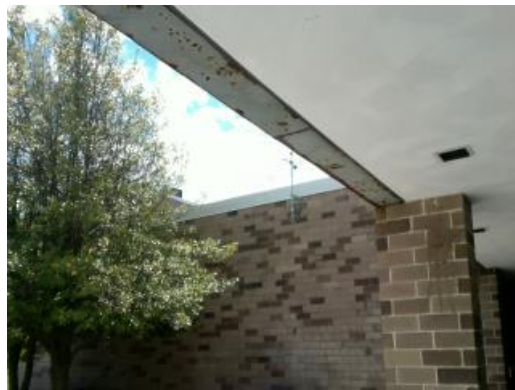
Corroded Soffit Lintel

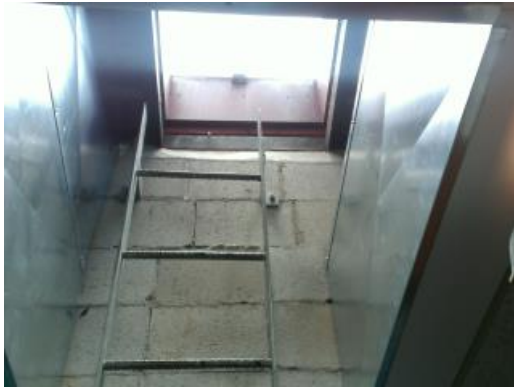
East Providence - Edward R. Martin Middle School

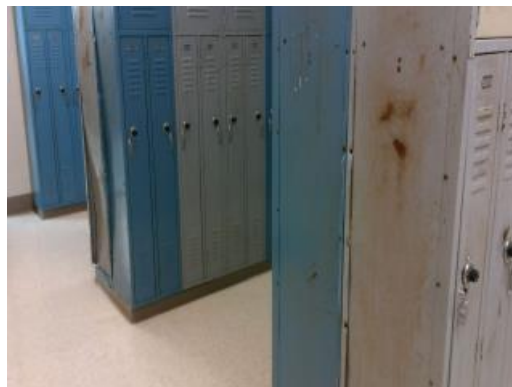
Damaged And Rusted Lockers

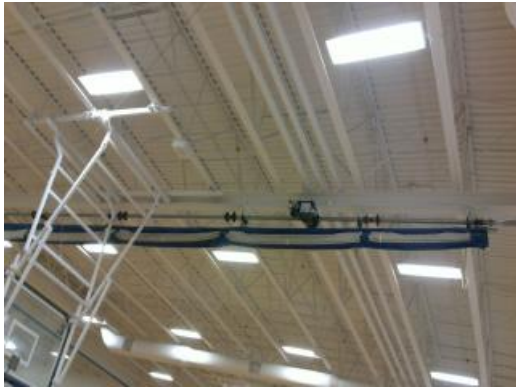
East Providence - Edward R. Martin Middle School

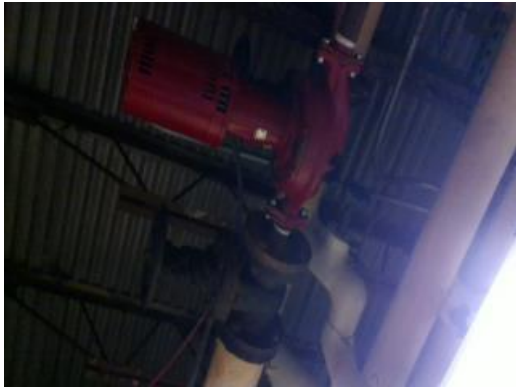
East Providence - Edward R. Martin Middle School

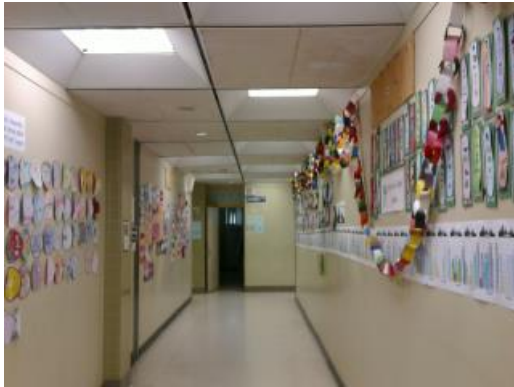
East Providence - Edward R. Martin Middle School

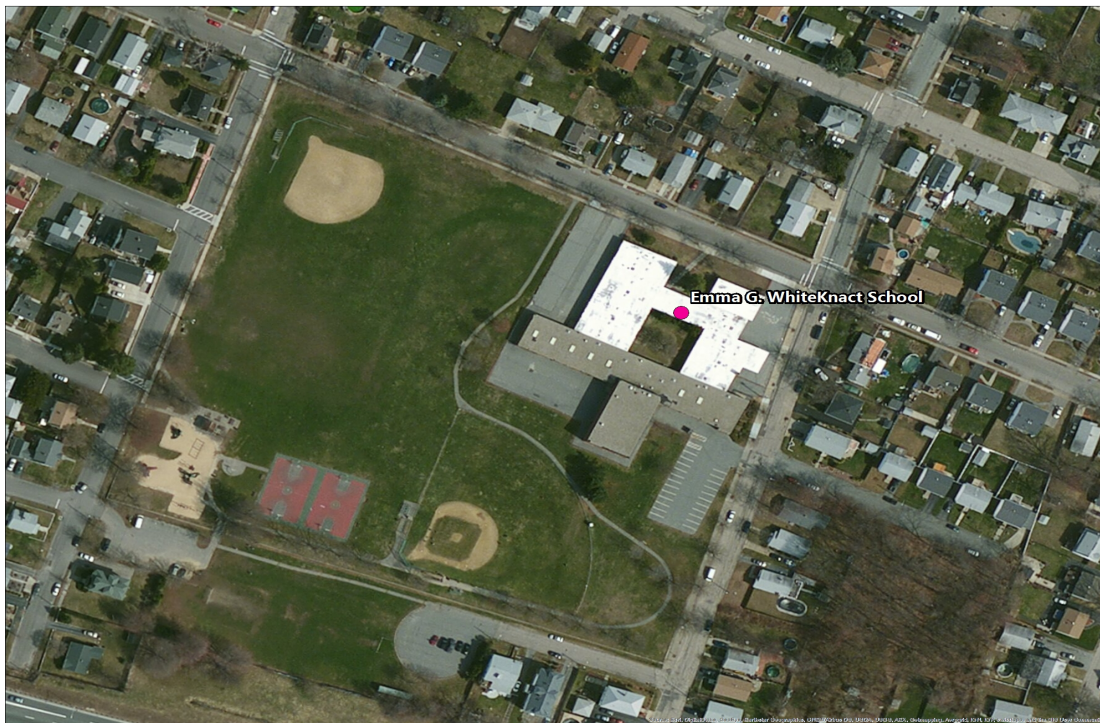
Figure 1: Aerial view of Emma G. Whiteknact School

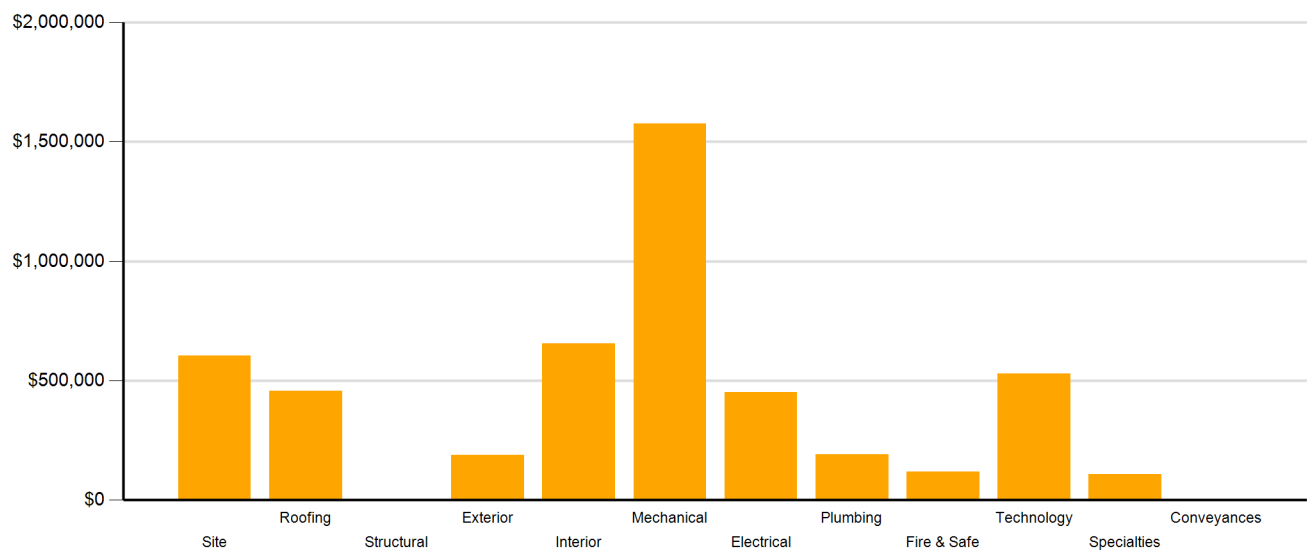
Figure 2: System Deficiencies

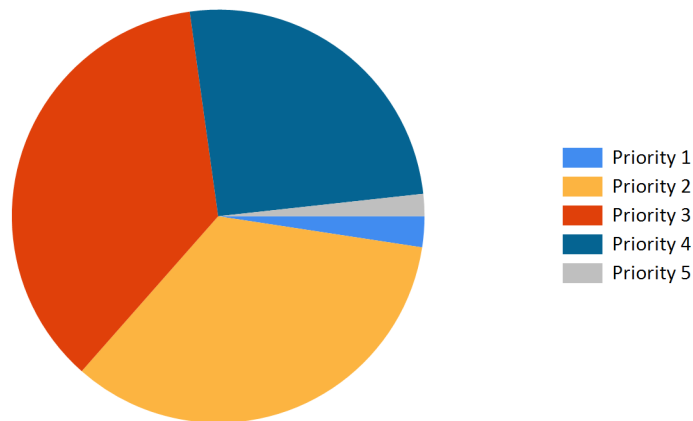
Figure 3: Current deficiencies by priority

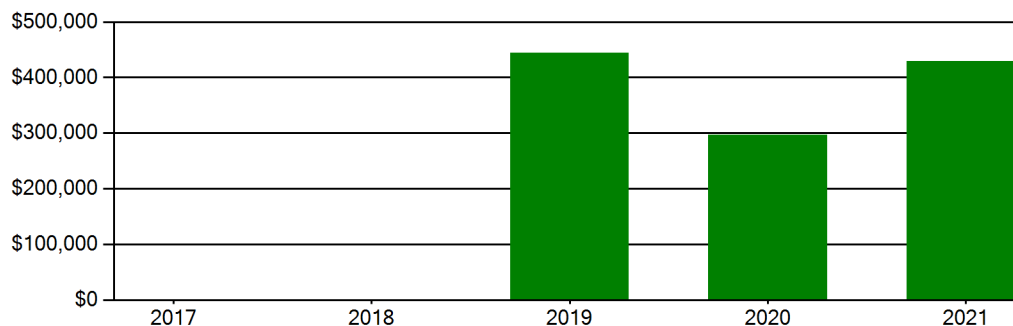
Figure 4: Life Cycle Capital Renewal Forecast

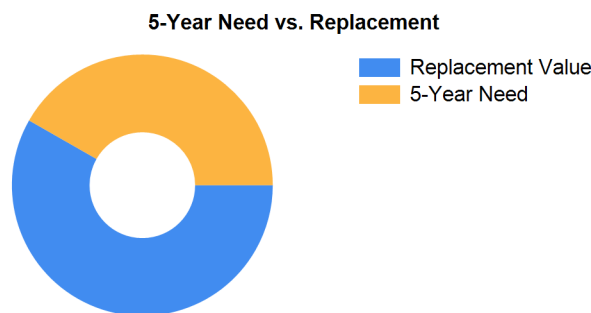
Figure 5: 5-Year FCI

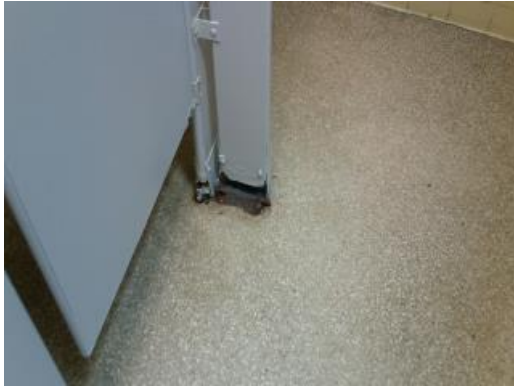
Damaged Toilet Partition

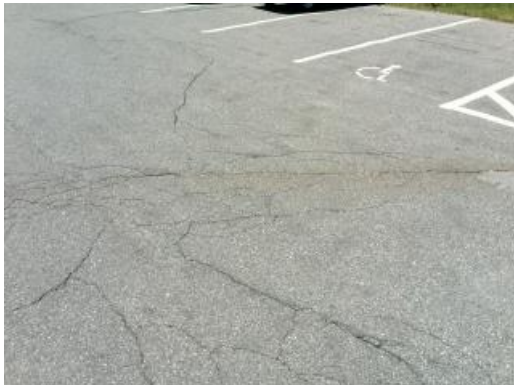
Cracked Asphalt Parking

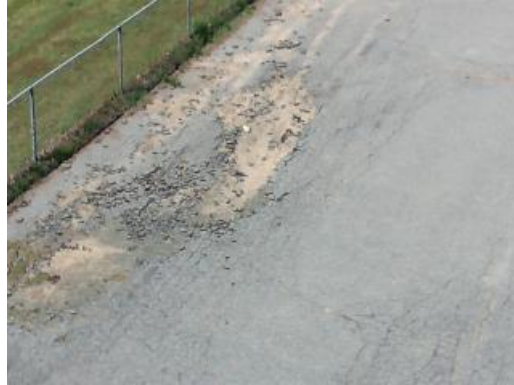
Deteriorated Roadway Asphalt

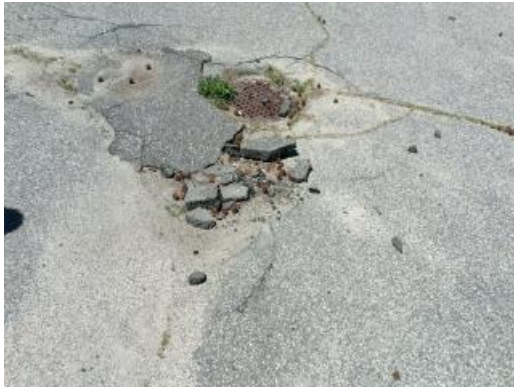
Damaged Asphalt Paving

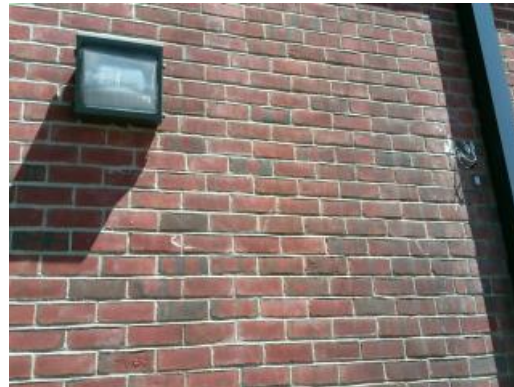
Building Mounted Light

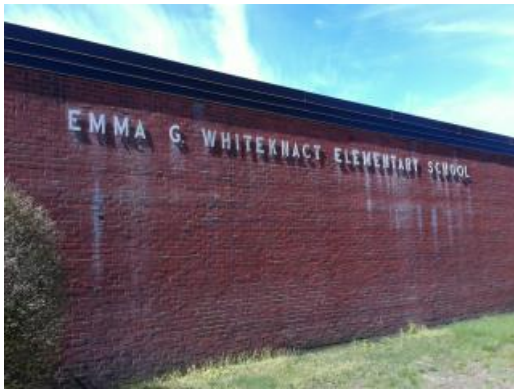
East Providence - Emma G. Whiteknact School

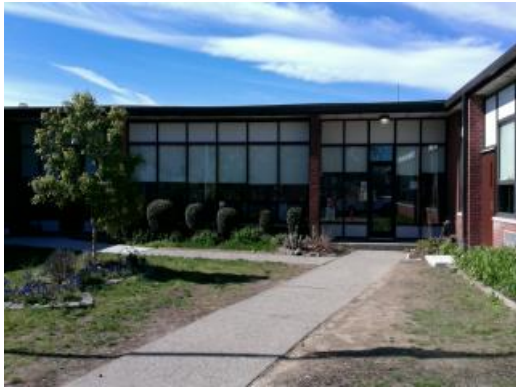
East Providence - Emma G. Whiteknact School

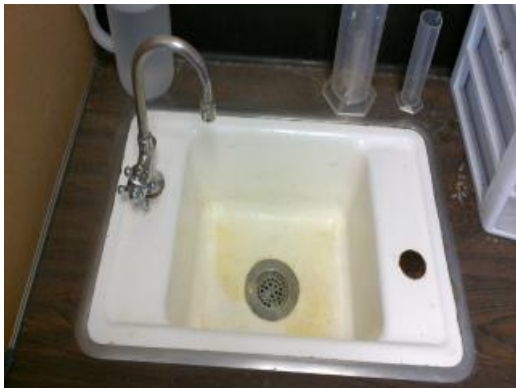
Stained Classroom Sink

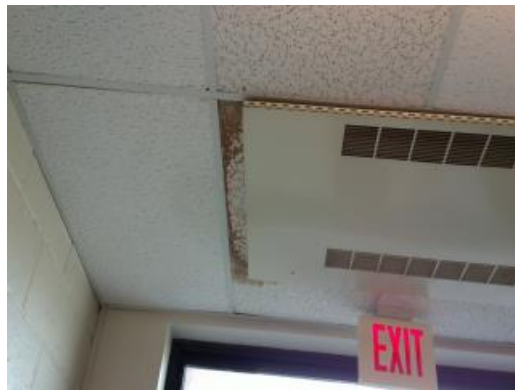
Stained Ceiling Tile

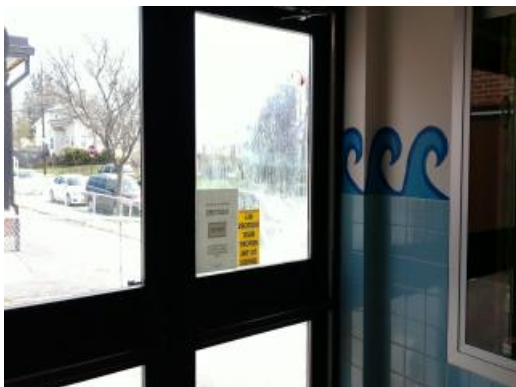
Damaged Storefront Doors

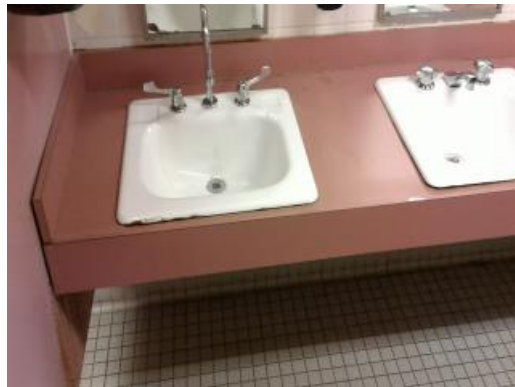
Typical Restroom Lavatories

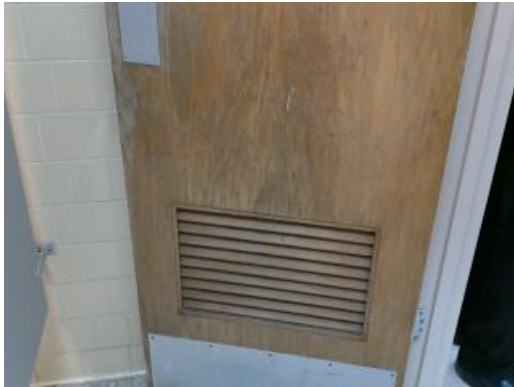
East Providence - Emma G. Whiteknact School

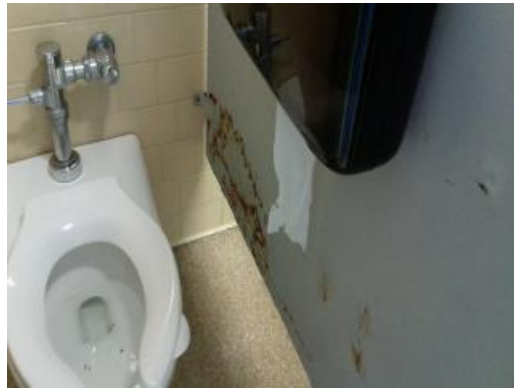
Rusted Toilet Partition

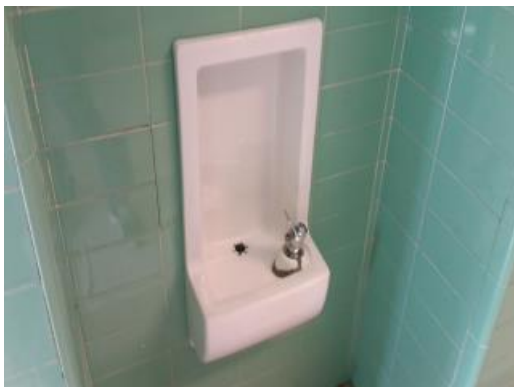
Non-Refrigerated Drinking Fountain

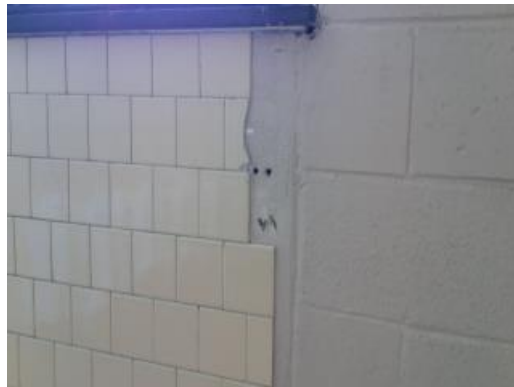
Chipped And Missing Ceramic Tiles

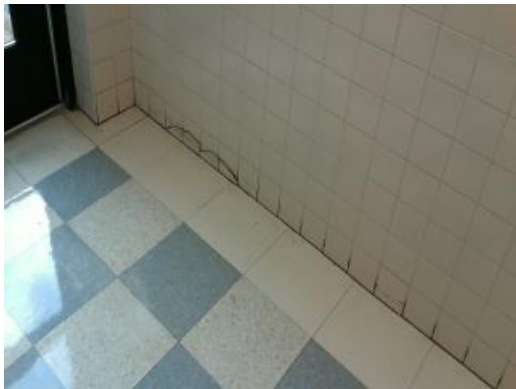
Cracked Ceramic Tile Wall

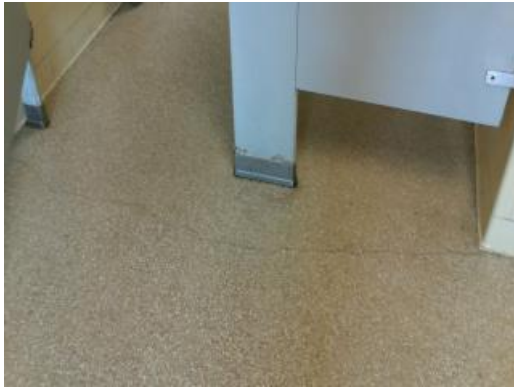
Cracked And Worn Terazzo

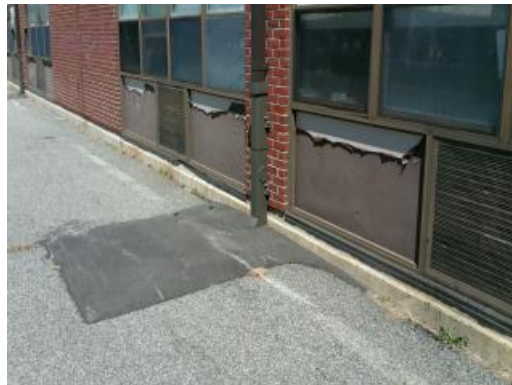
Damaged Metal Panels

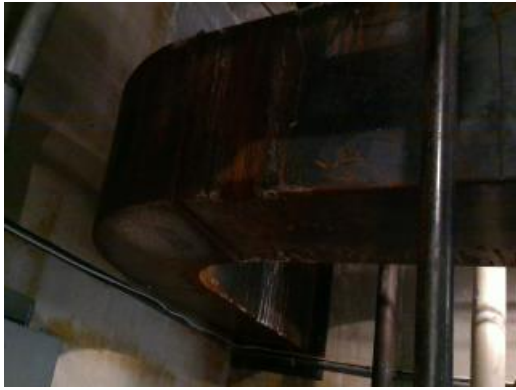
Aged Rusted Ductwork

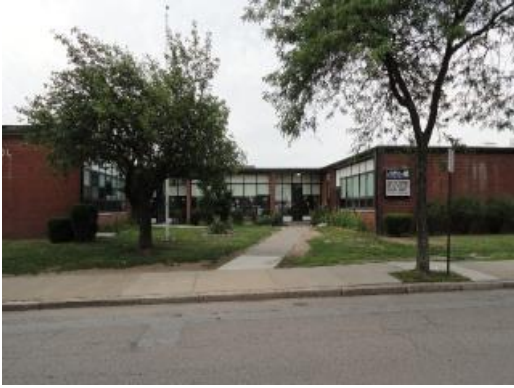
East Providence - Emma G. Whiteknact School

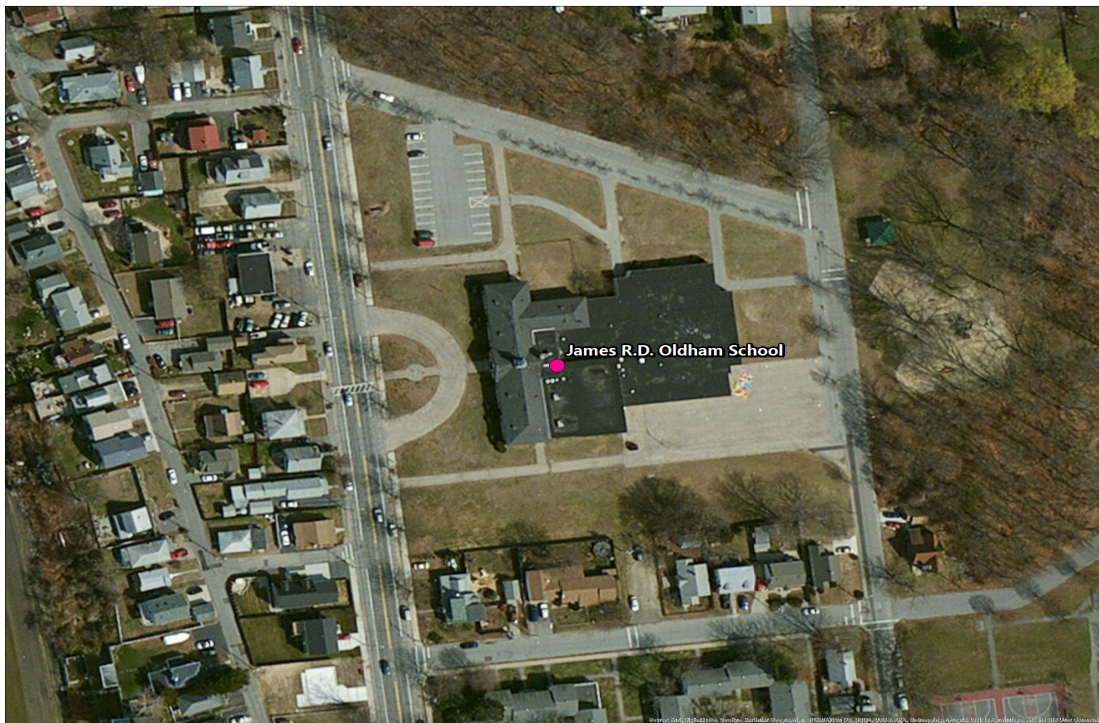
Figure 1: Aerial view of James R. D. Oldham School

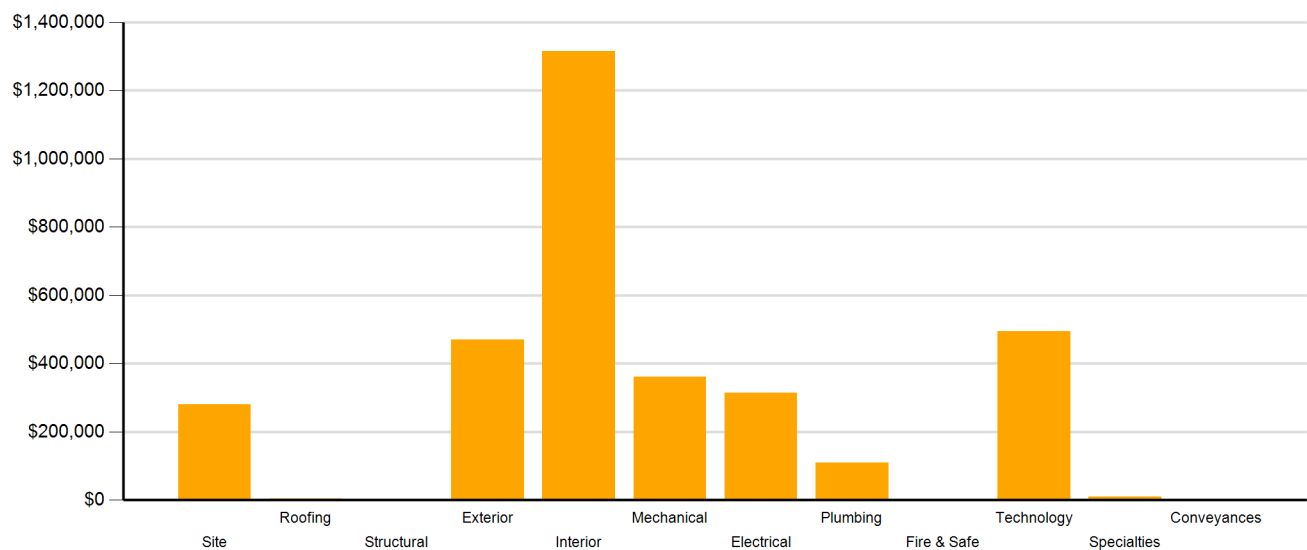
Figure 2: System Deficiencies

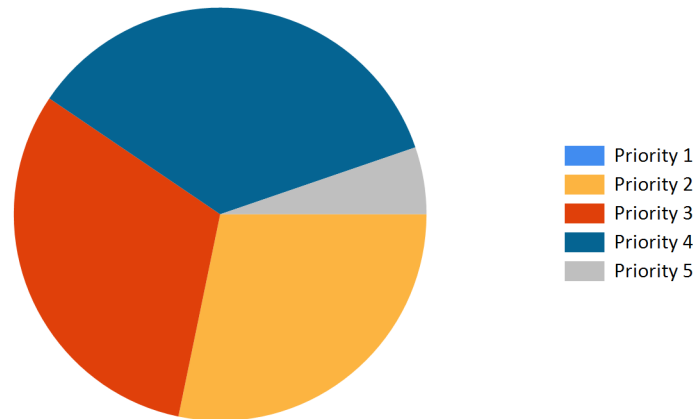
Figure 3: Current deficiencies by priority

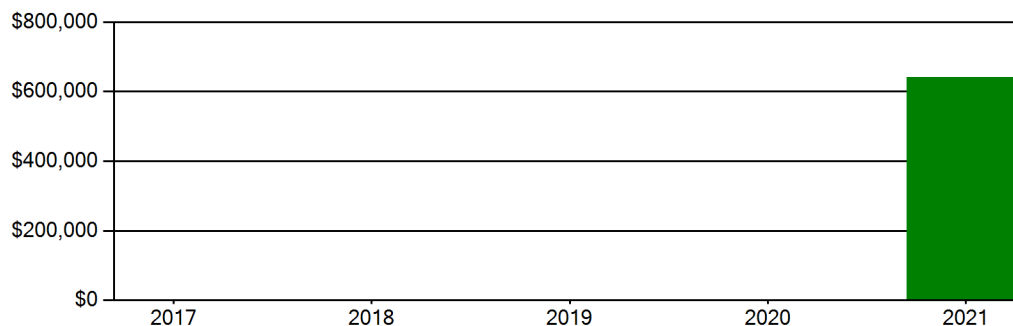
Figure 4: Life Cycle Capital Renewal Forecast

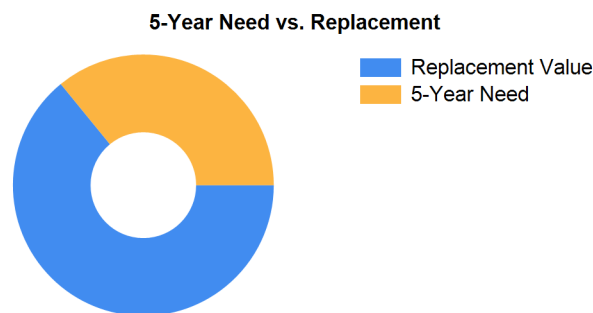
Figure 5: 5-Year FCI

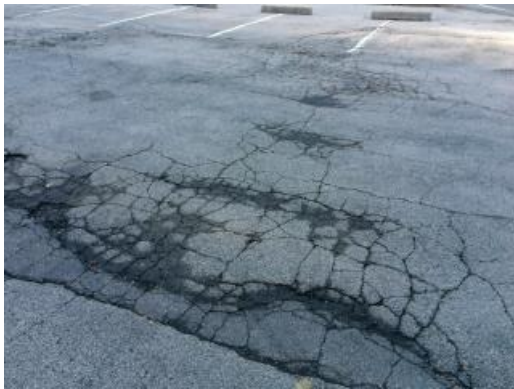
Cracks And Alligating

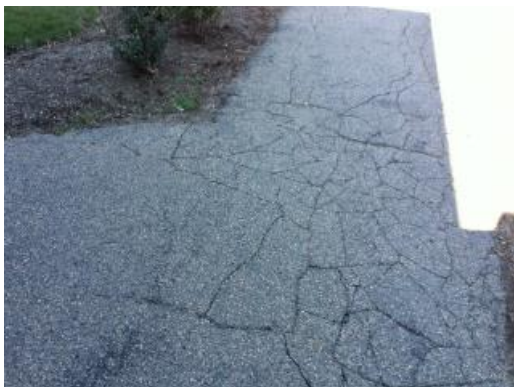
Cracking At Sidewalk

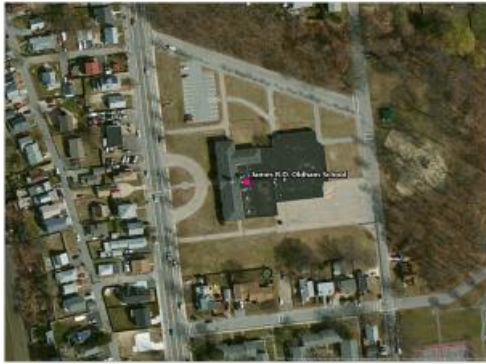
East Providence - James R. D. Oldham School

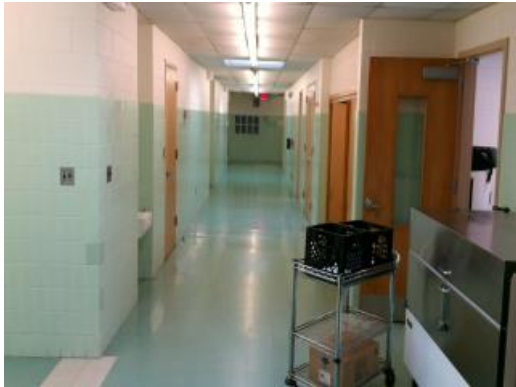
East Providence - James R. D. Oldham School

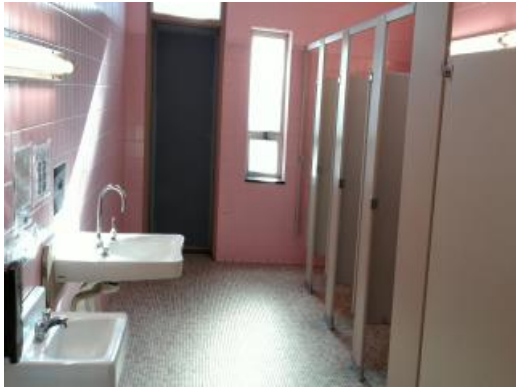
East Providence - James R. D. Oldham School

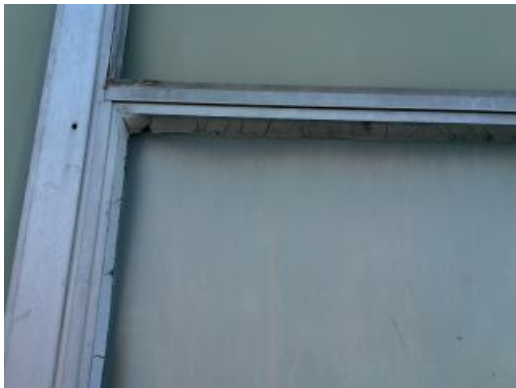
Damaged Aluminum Window

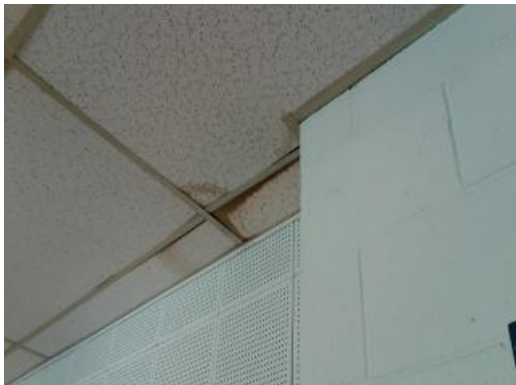
Stained Ceiling Tile

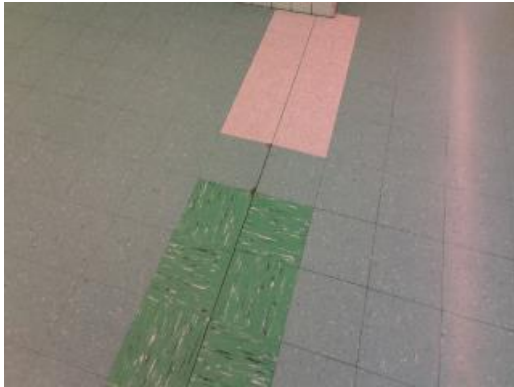
East Providence - James R. D. Oldham School

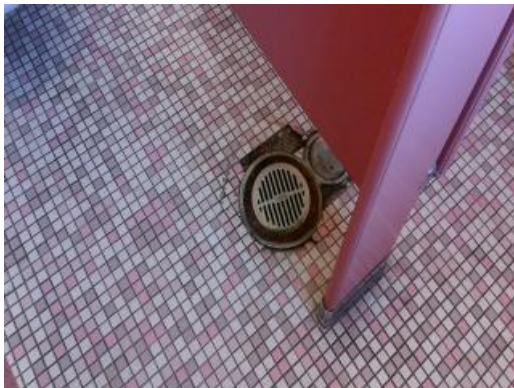
Damaged Ceramic Tile

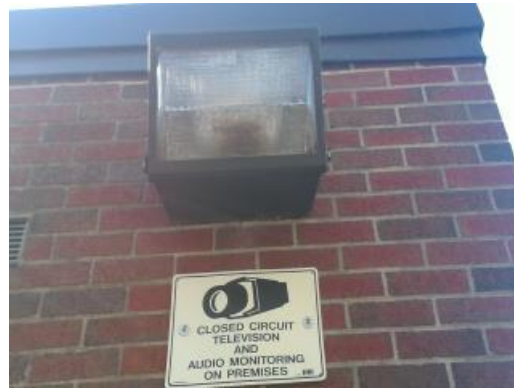
Mounted Building Light

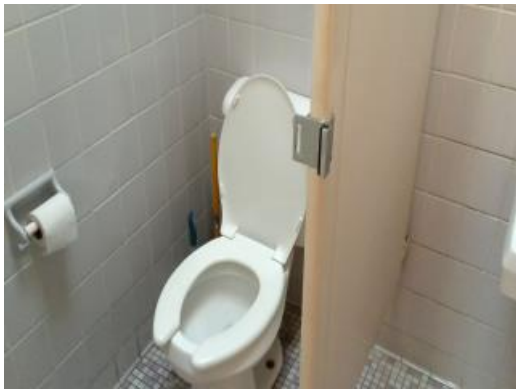
Non-ADA Toilet Stall

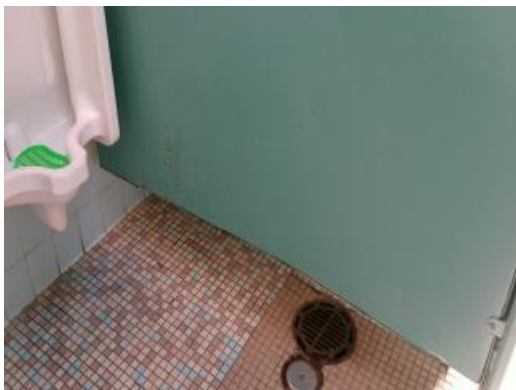
Rusted Toilet Partition

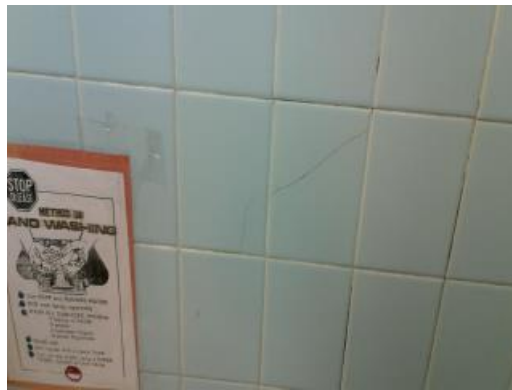
Cracked Restroom Ceramic Wall Tile

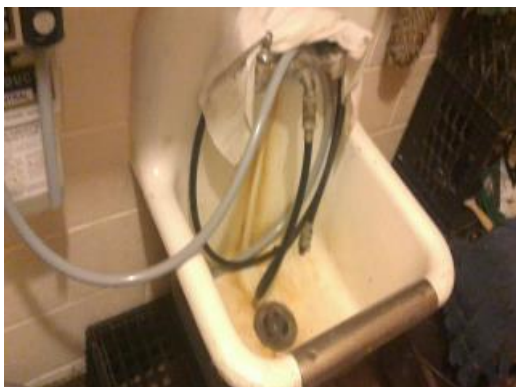
Damaged Service Sink

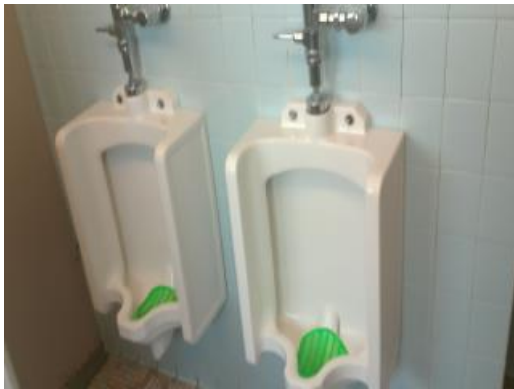
East Providence - James R. D. Oldham School

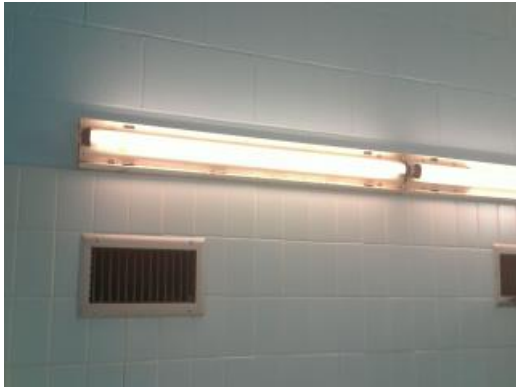
East Providence - James R. D. Oldham School

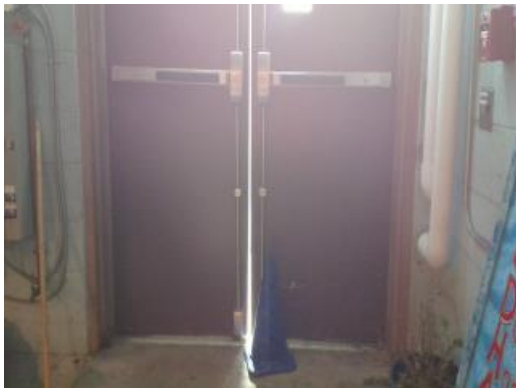
Missing Weather Stripping At Boiler Room Doors

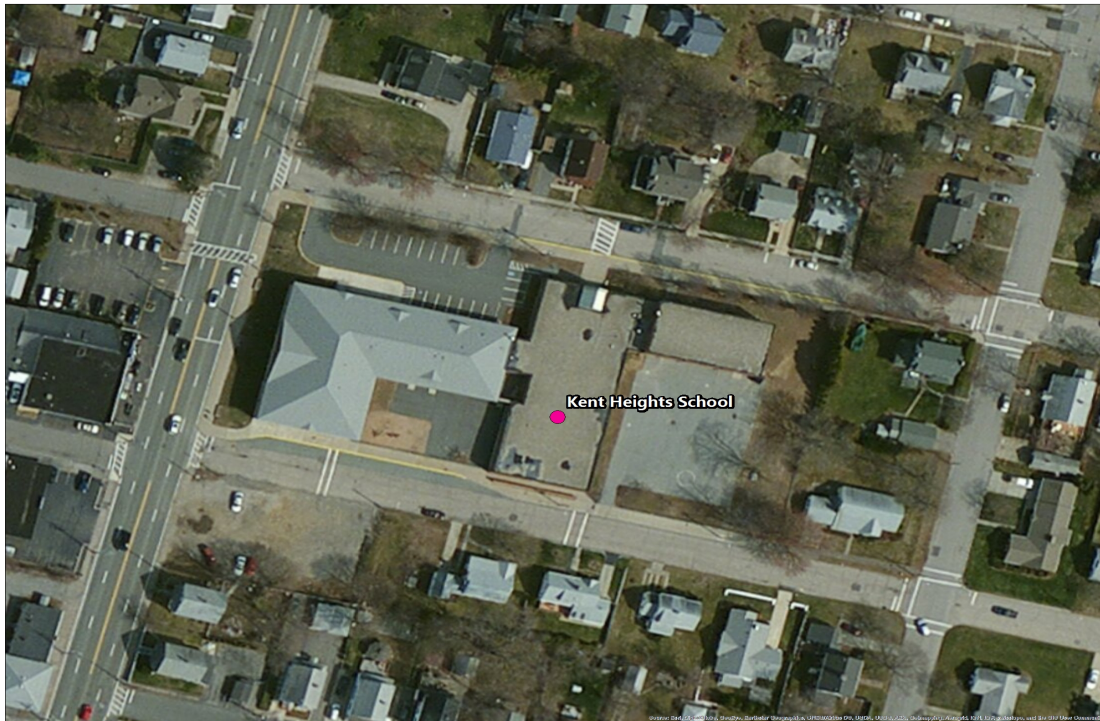
Figure 1: Aerial view of Kent Heights School

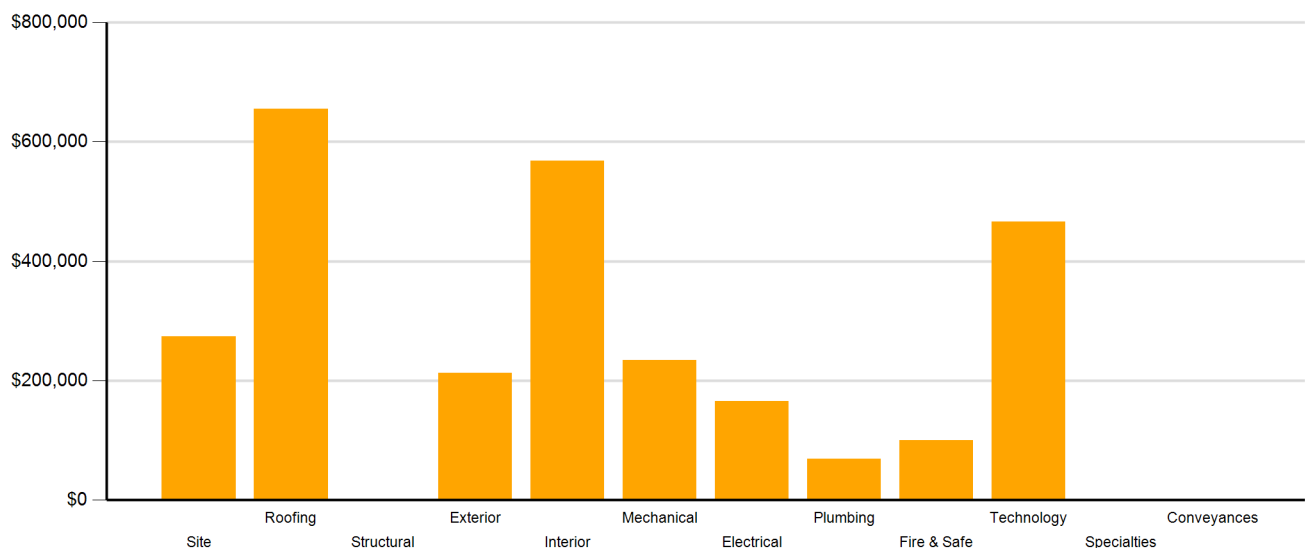
Figure 2: System Deficiencies

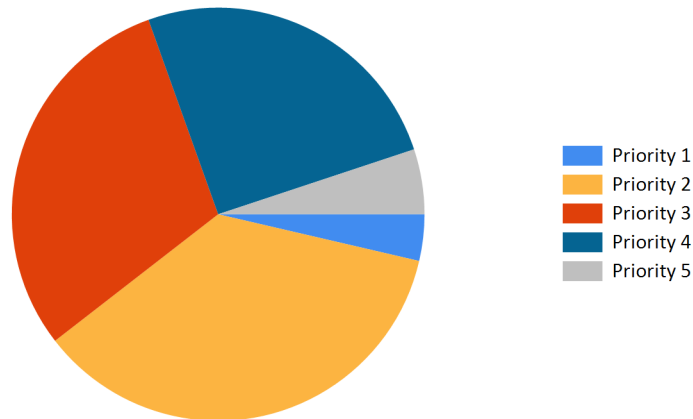
Figure 3: Current deficiencies by priority

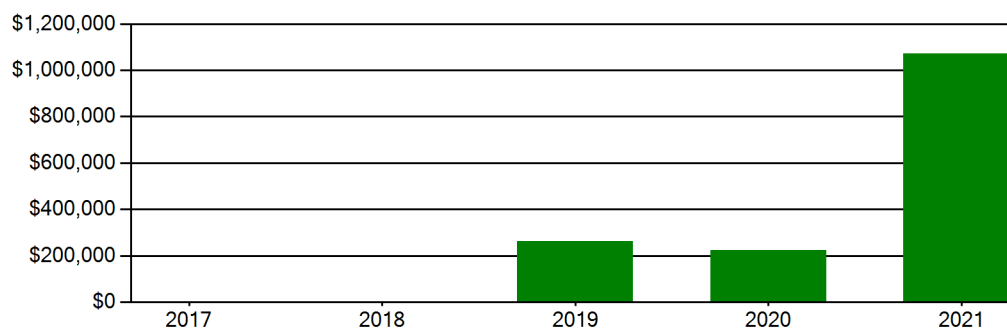
Figure 4: Life Cycle Capital Renewal Forecast

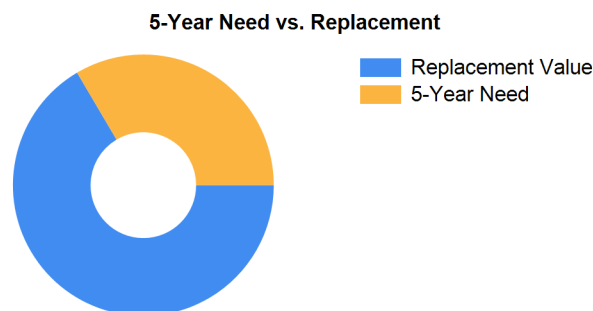
Figure 5: 5-Year FCI

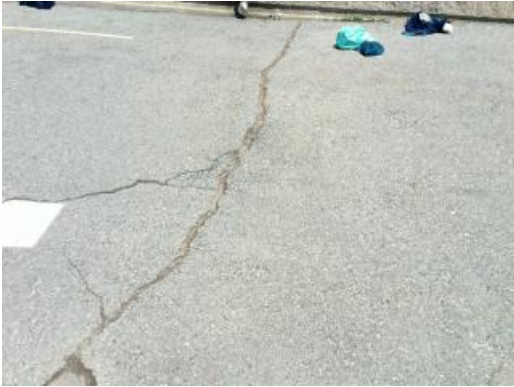
Cracked Paved Play Area

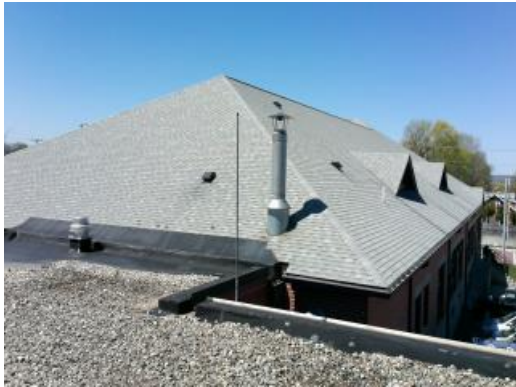
East Providence - Kent Heights School

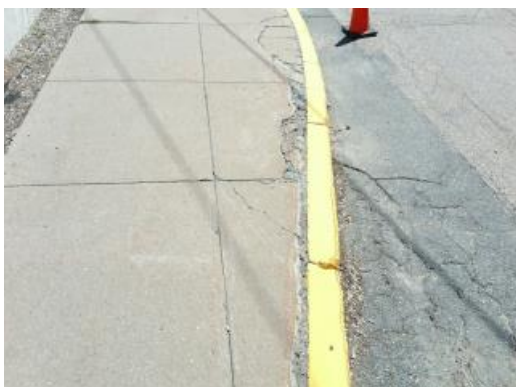
Sidewalk Edge Spalling

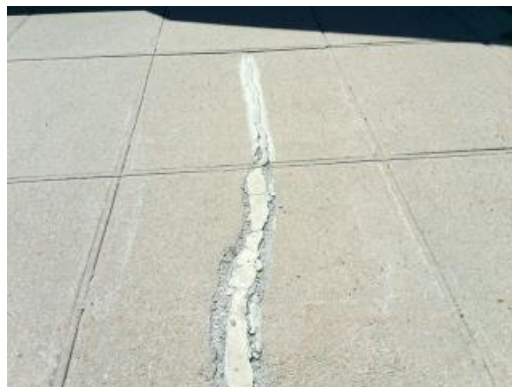
Patched Sidewalk Crack

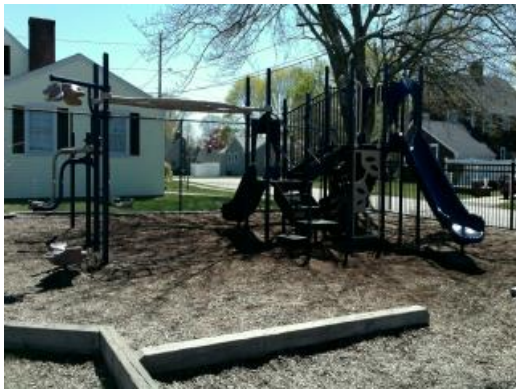
Playground Equipment

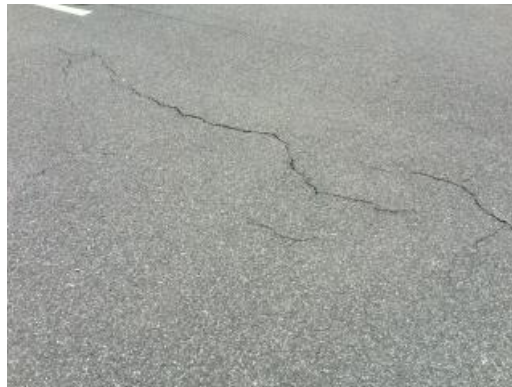
Cracked Asphalt Paving

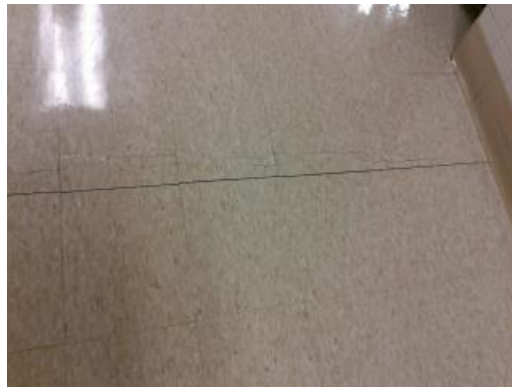
Cracked And Separated Vinyl Tiles

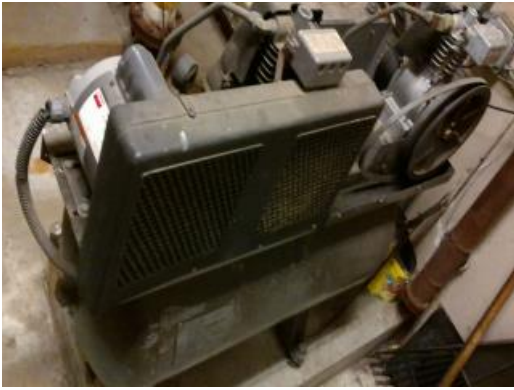
East Providence - Kent Heights School

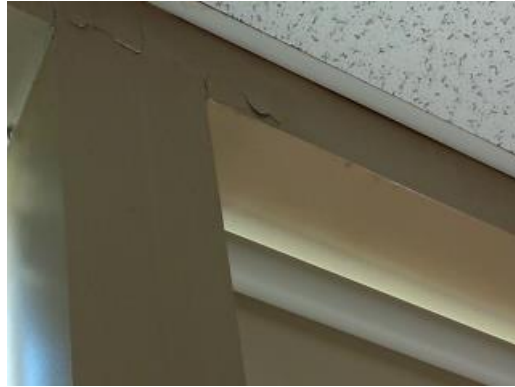
Water Damaged Gypsum Board

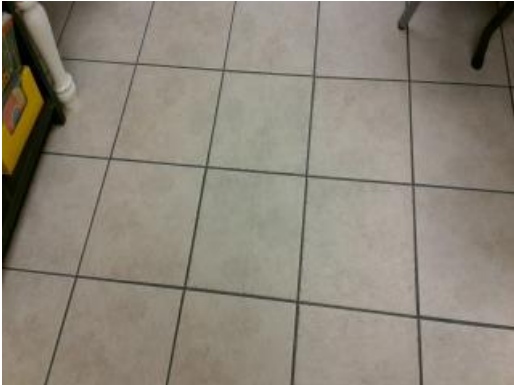
Cracked Ceramic Tile

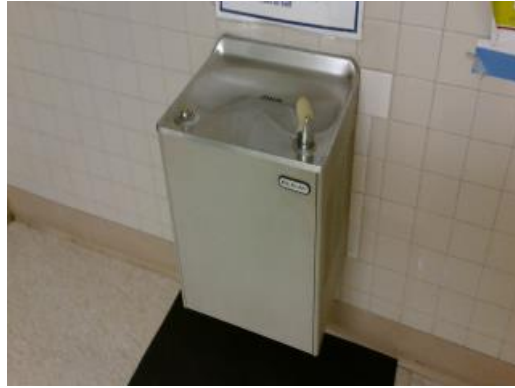
Aged Drinking Fountain

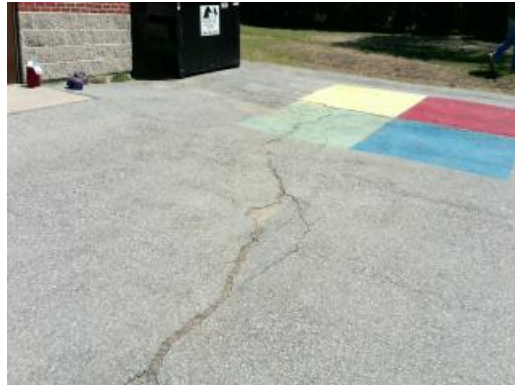
Cracked Paved Play Area

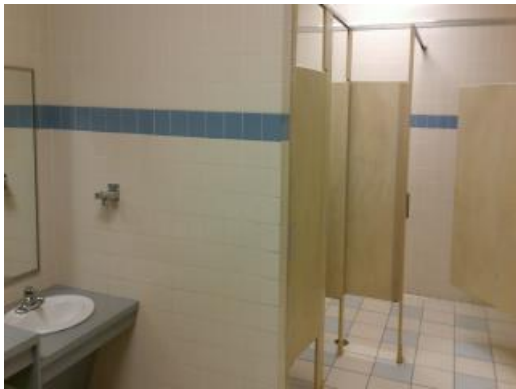
Restroom Fixtures And Finishes
