School Type by Count

School Type	SqFt
Elementary School	311,777
Middle School	297,353
High School	293,081
Total:	902,211

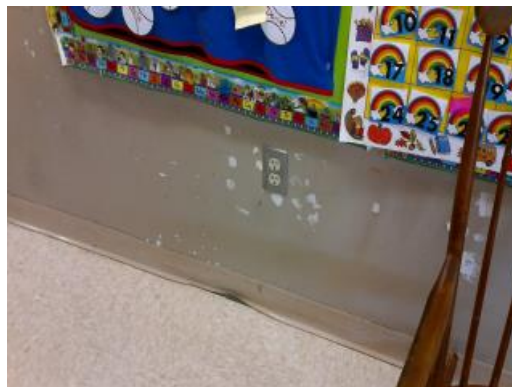
Chipped And Stained Wall Paint

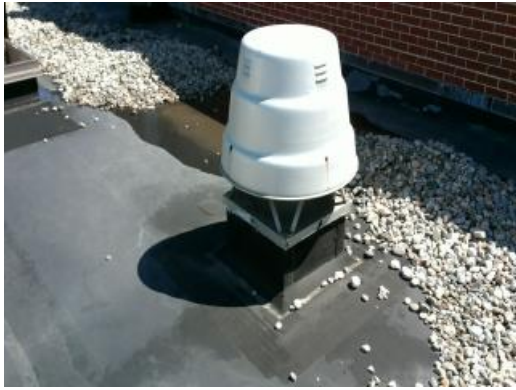
East Providence - Kent Heights School

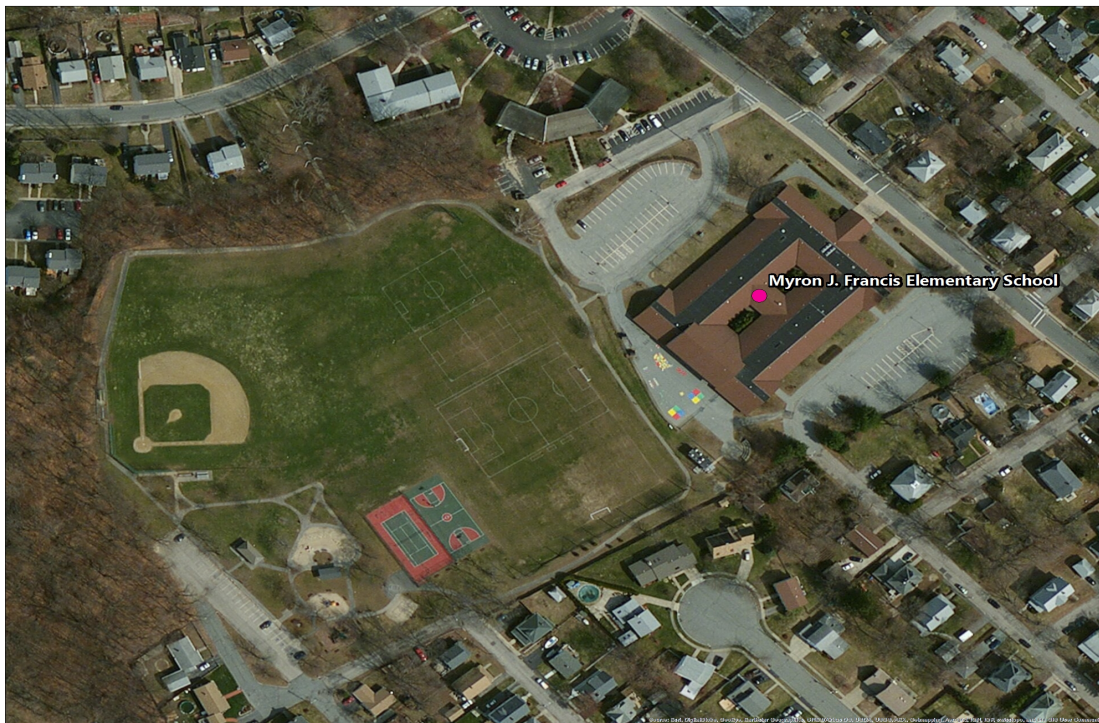
Figure 1: Aerial view of Myron J. Francis Elementary School

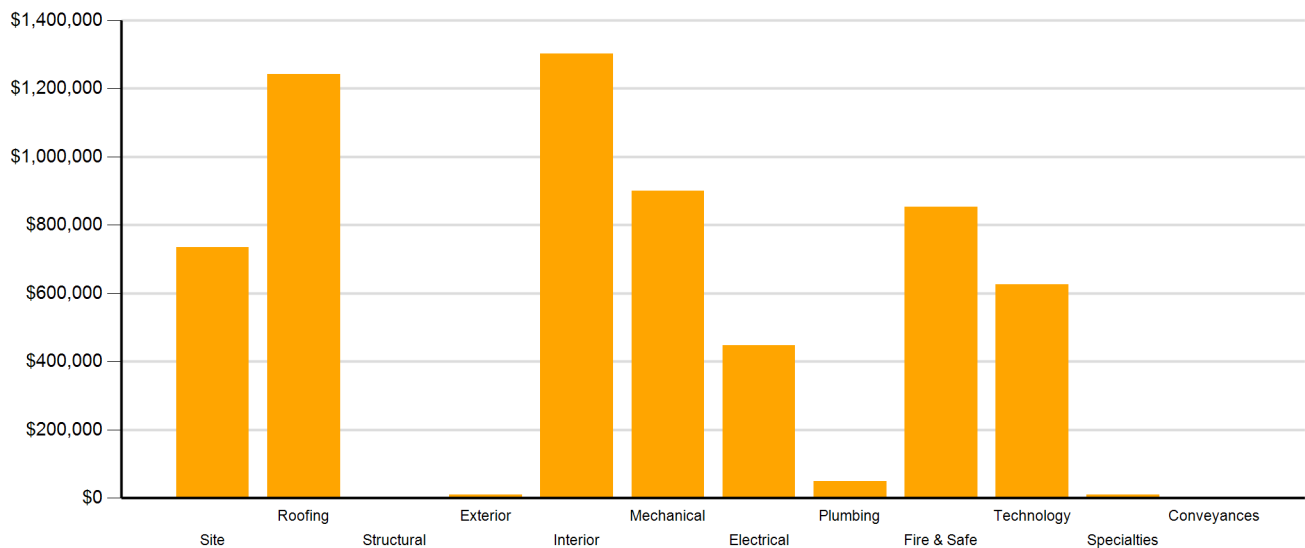
Figure 2: System Deficiencies

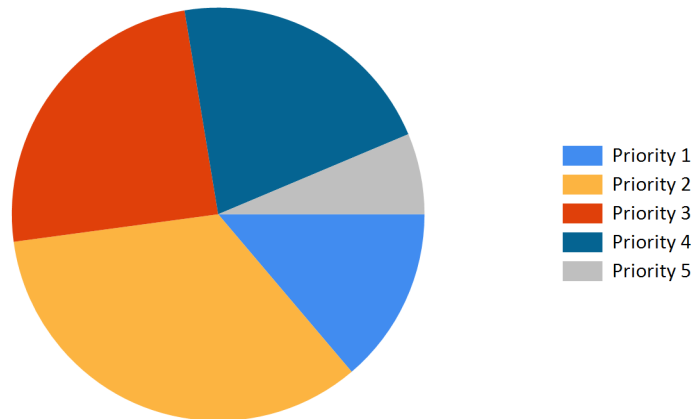
Figure 3: Current deficiencies by priority

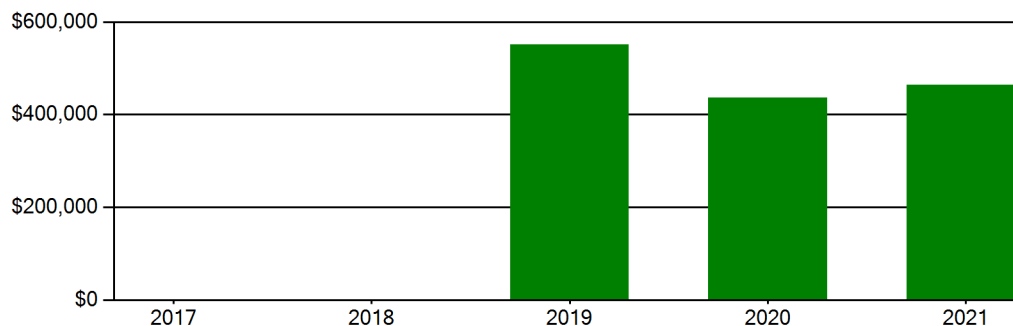
Figure 4: Life Cycle Capital Renewal Forecast

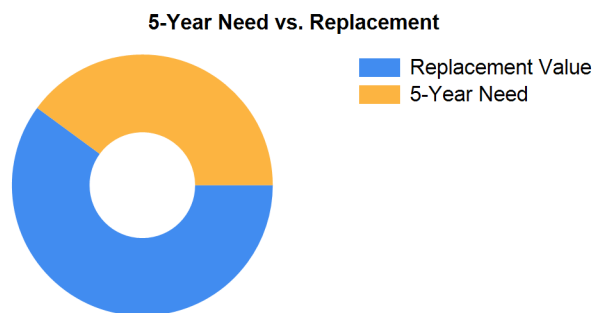
Figure 5: 5-Year FCI

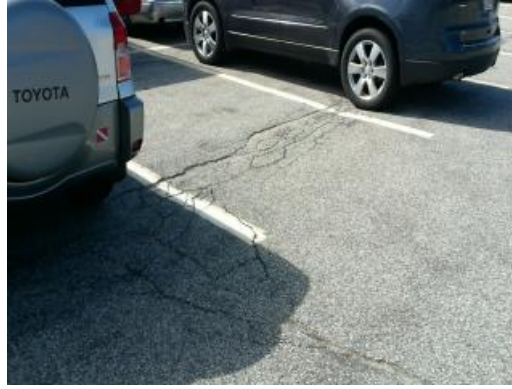
Cracked Asphalt Parking Lot

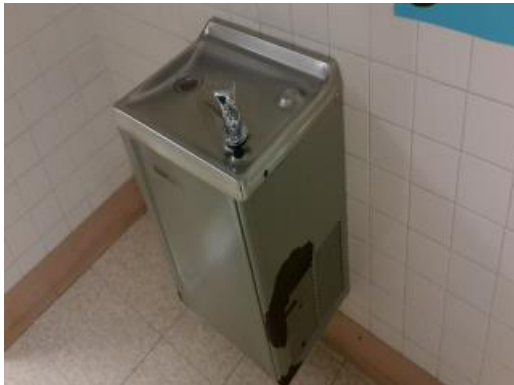
Refrigerated Water Fountain

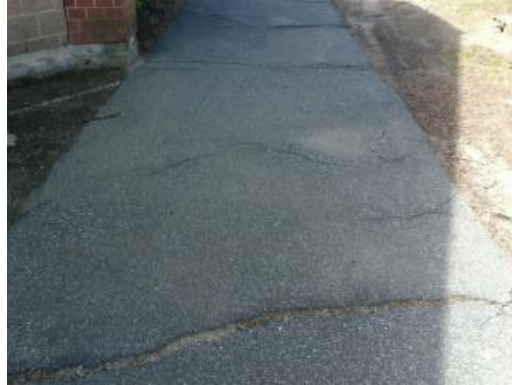
Cracked Asphalt Walkway

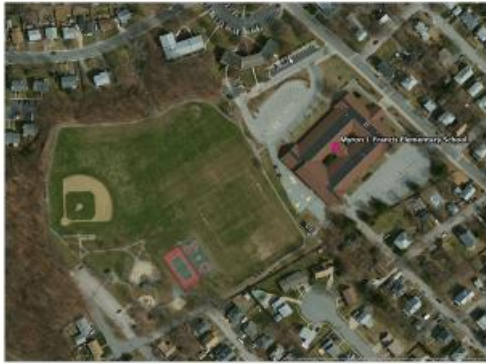
East Providence - Myron J. Francis Elementary School

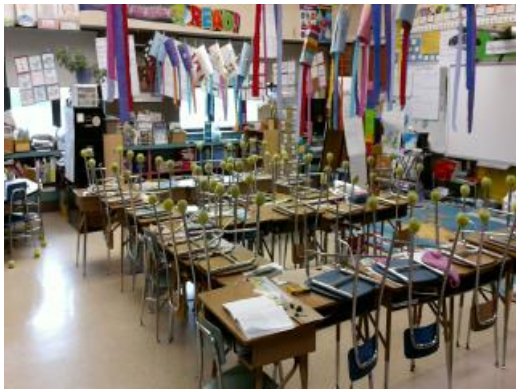
East Providence - Myron J. Francis Elementary School

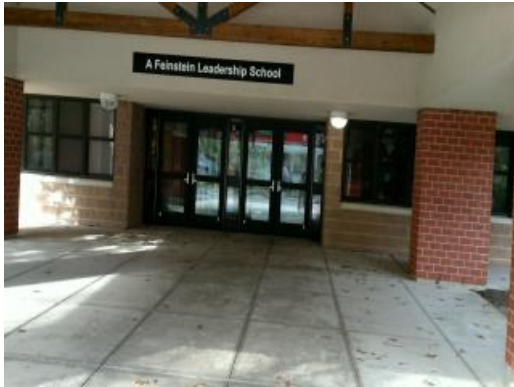
East Providence - Myron J. Francis Elementary School

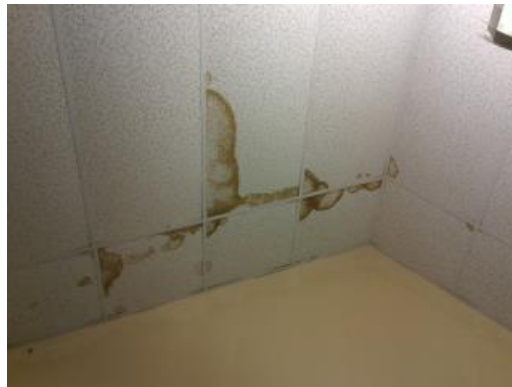
Stained Ceiling Tiles

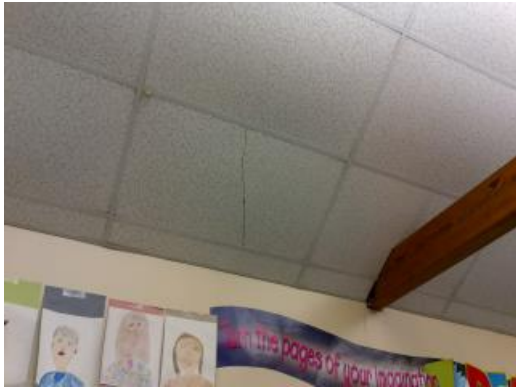
East Providence - Myron J. Francis Elementary School

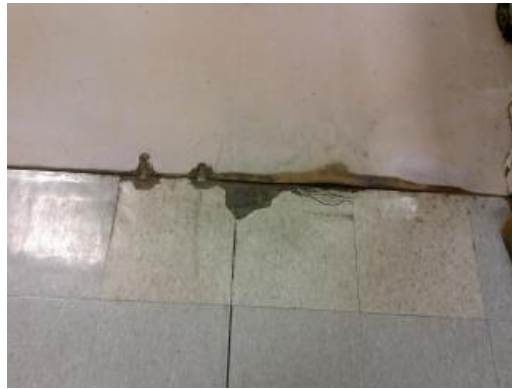
Chipped And Separating VCT

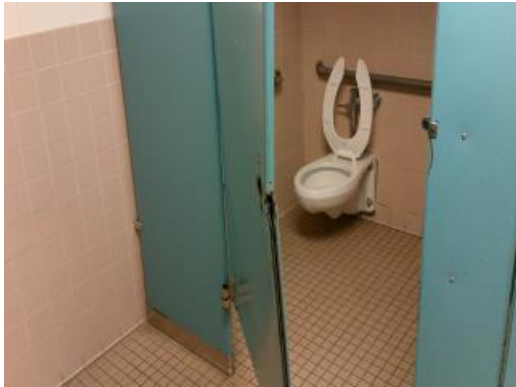
East Providence - Myron J. Francis Elementary School

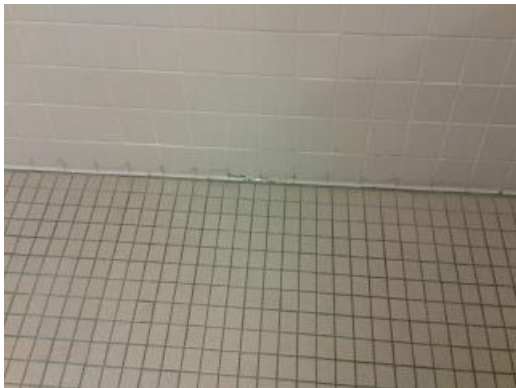
Cracked Ceramic Tile At Wall Base

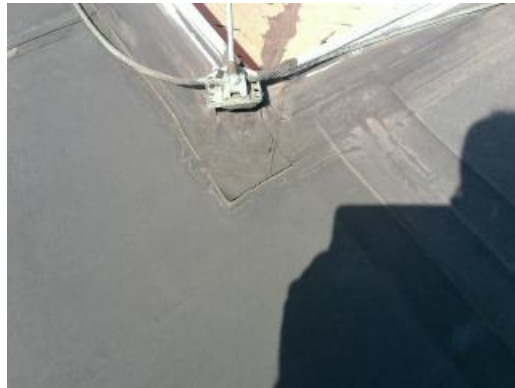
Typical Holes In EPDM

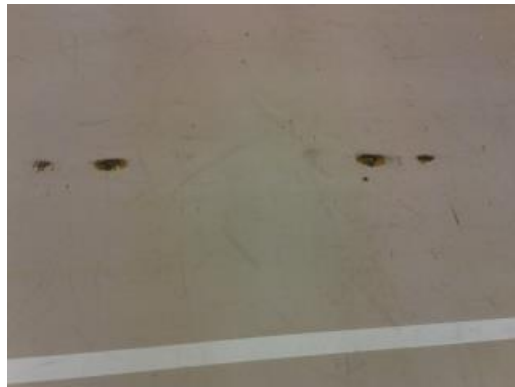
Holes In Sport Flooring

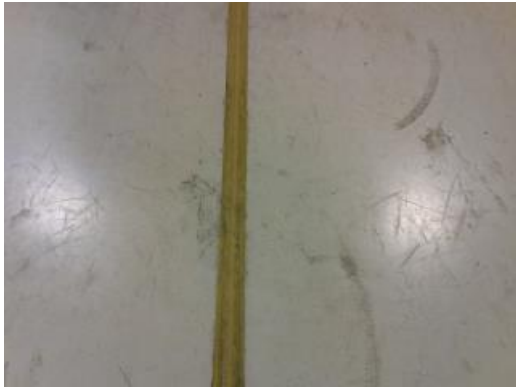
Worn Athletic Flooring

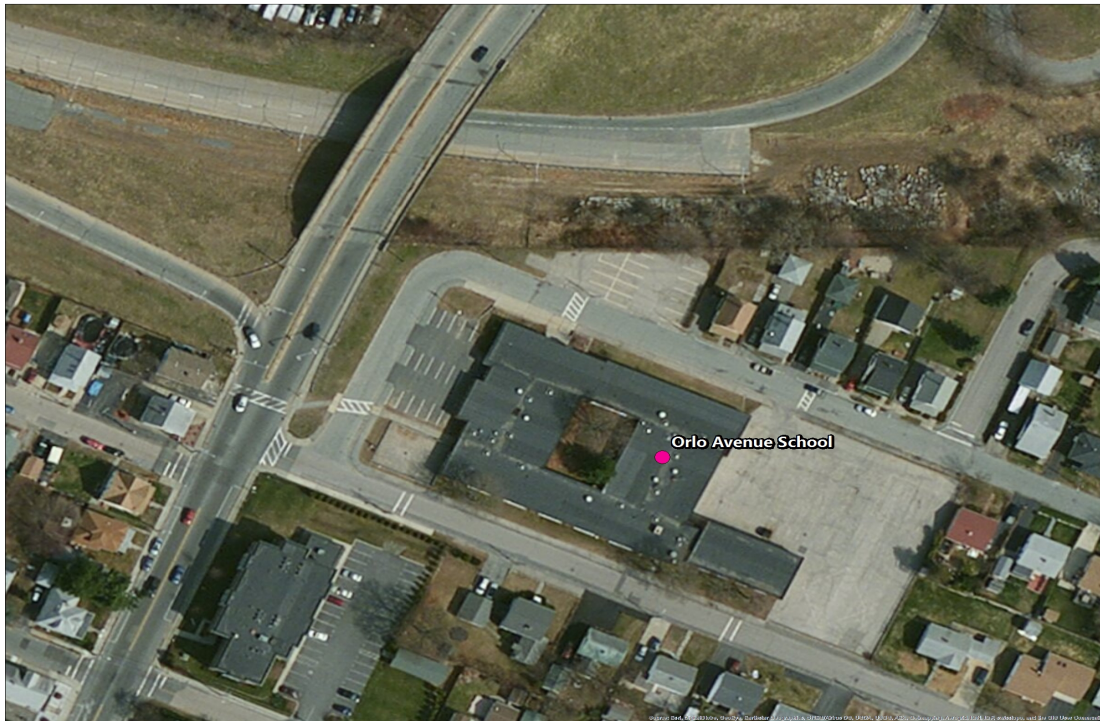
Figure 1: Aerial view of Orlo Avenue School

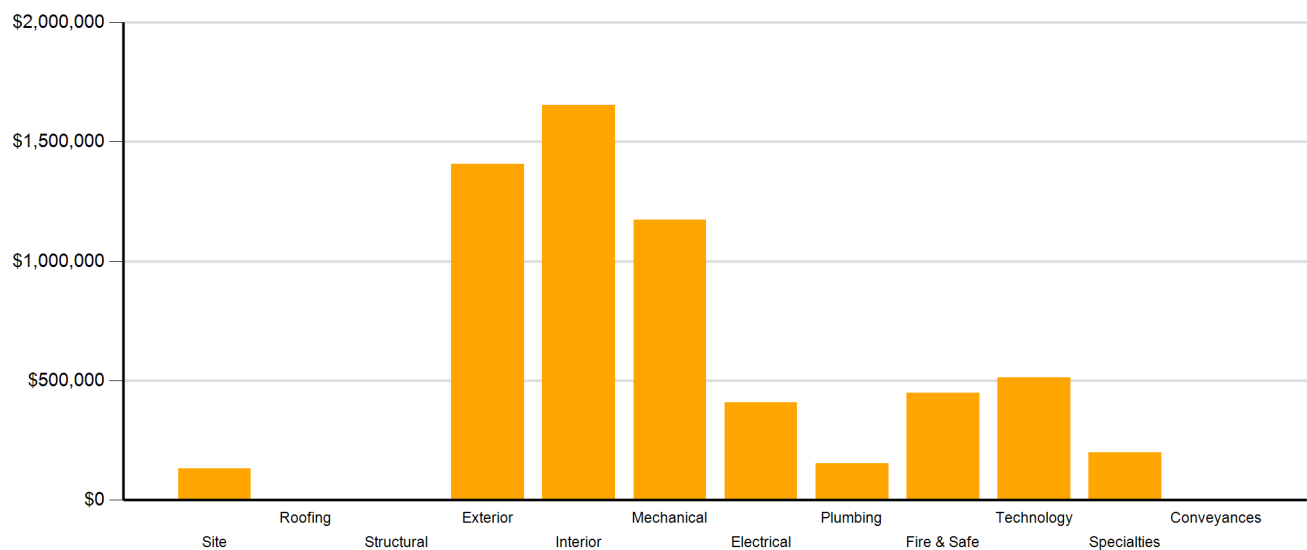
Figure 2: System Deficiencies

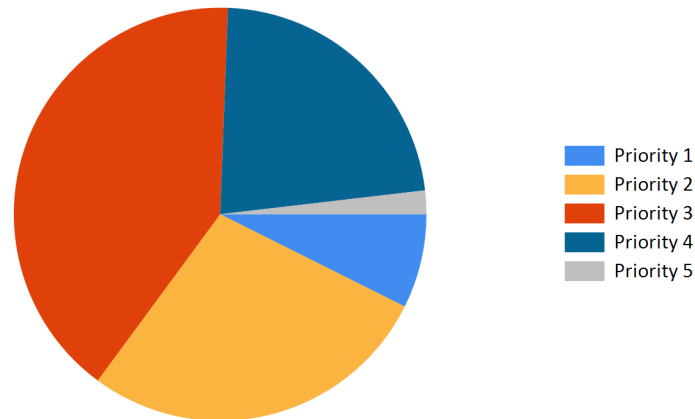
Figure 3: Current deficiencies by priority

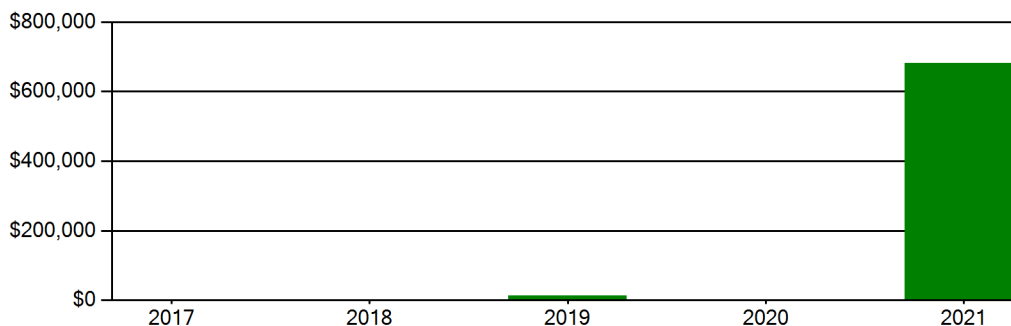
Figure 4: Life Cycle Capital Renewal Forecast

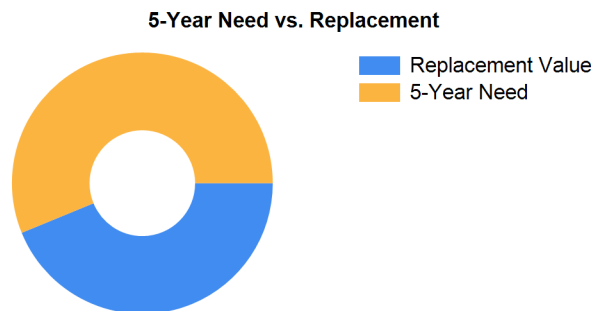
Figure 5: 5-Year FCI

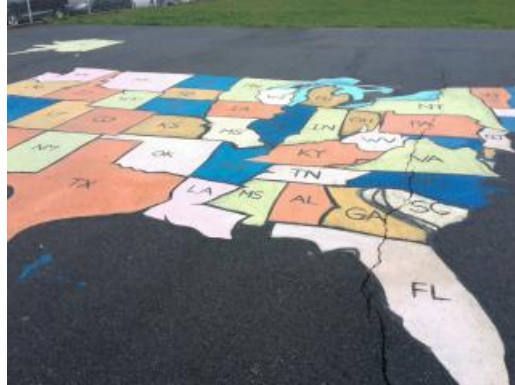
Alligatoring Parking Lot Pavement

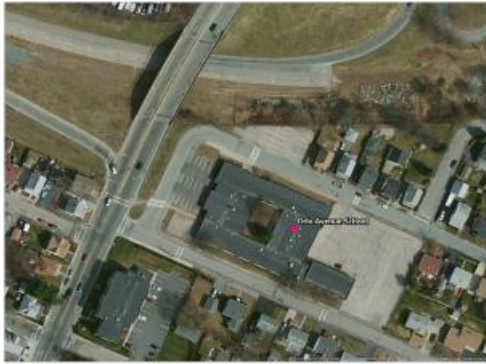
East Providence - Orlo Avenue School

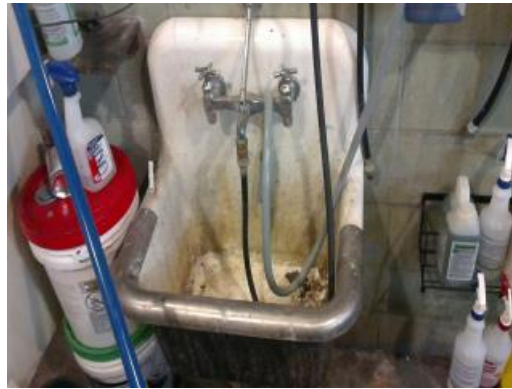
Stained Custodial Sink

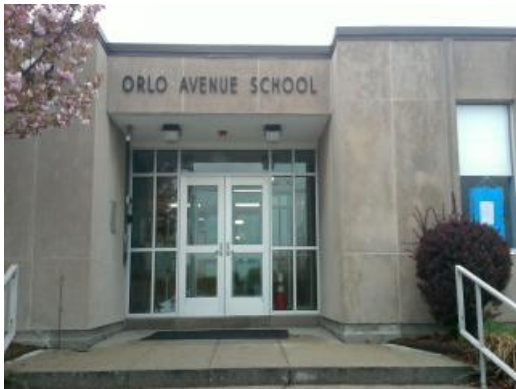
East Providence - Orlo Avenue School

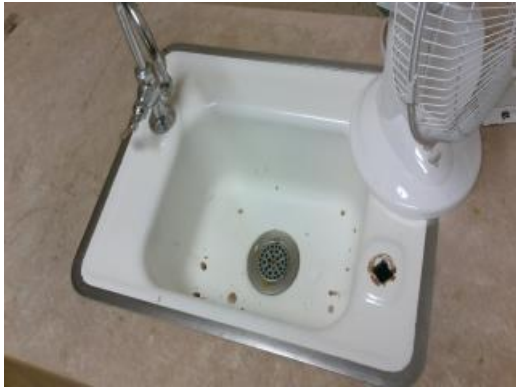
Typical Classroom Lavatory

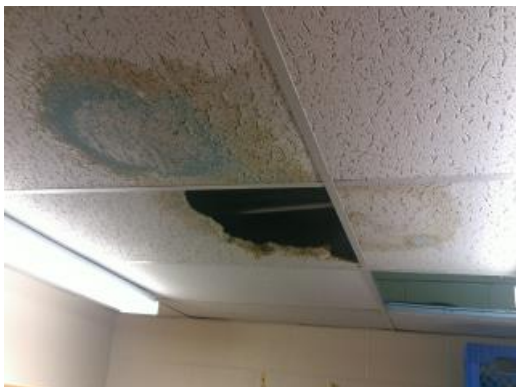
Stained And Broken Tiles

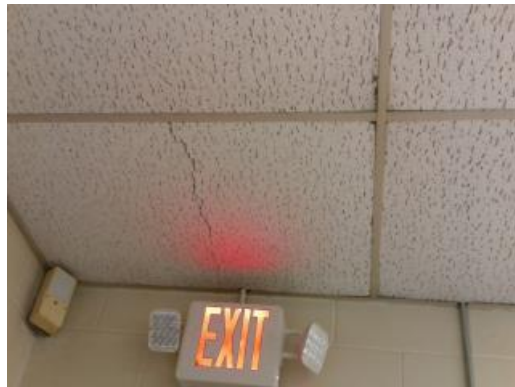
Cracked Ceiling Tile

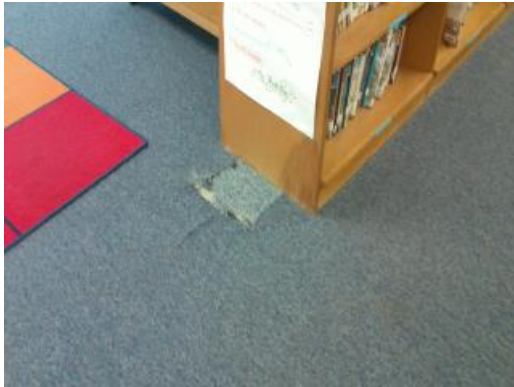
Worn And Frayed Carpet

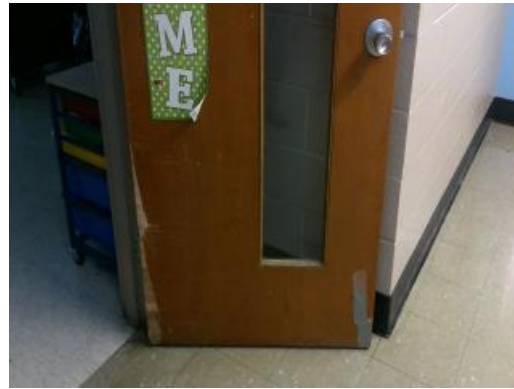
Worn Original Wood Door

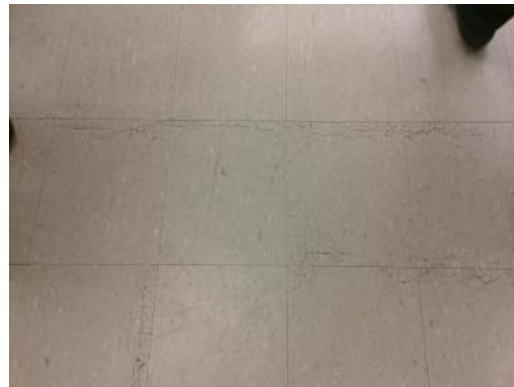
Cracked And Worn VCT

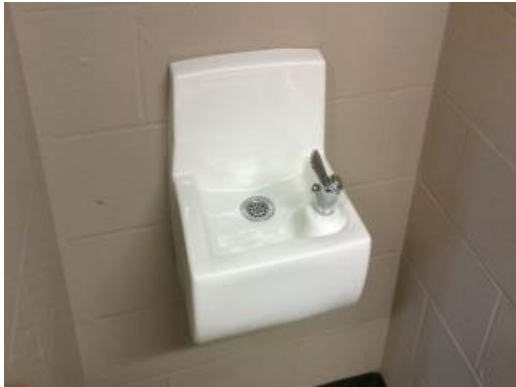
Non-Refrigerated Water Fountain

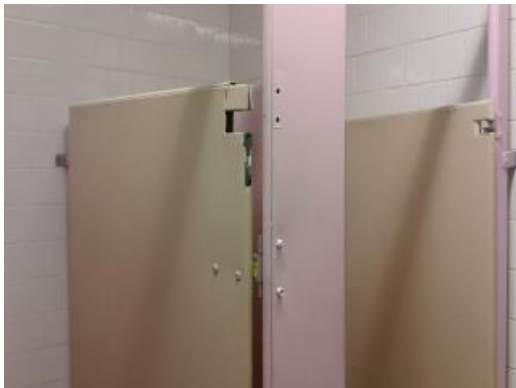
Damaged Toilet Partition

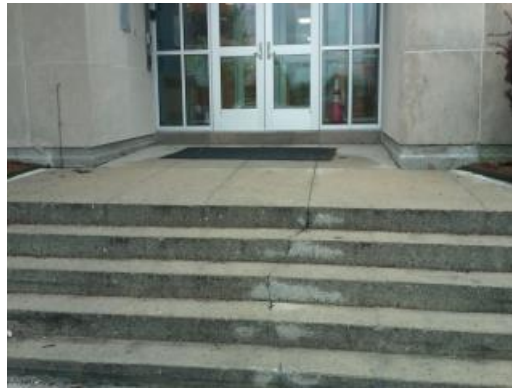
Non-Compliant Front Entrance

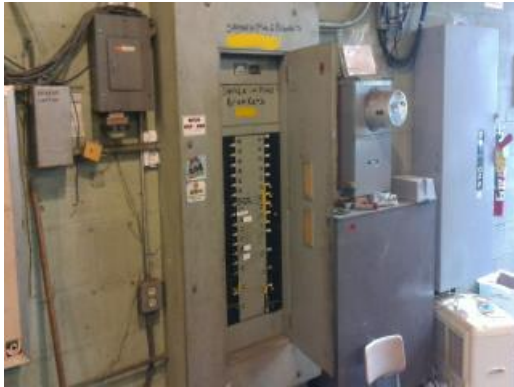
600 Amp Distribution Panel

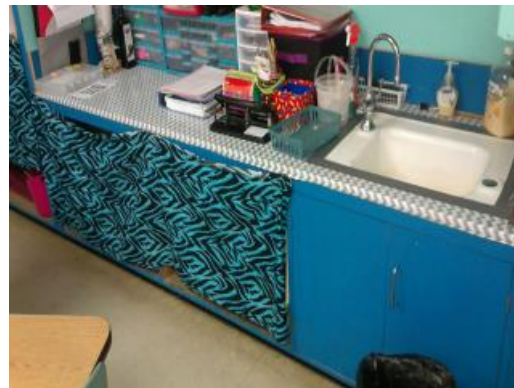
Aged Cabinetry Missing Doors

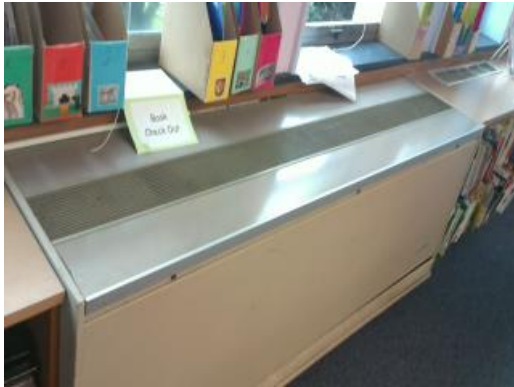
Cabinet Unit Ventilator

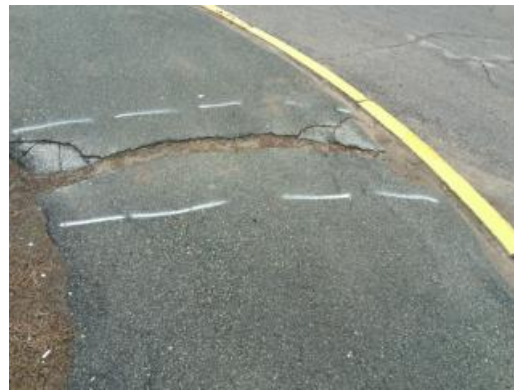
Cracked Asphalt Walkway

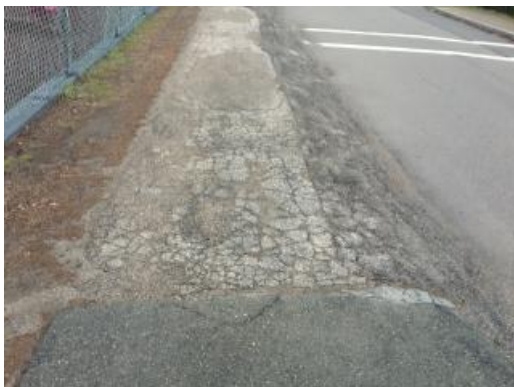
Deteriorated Asphalt Walkway

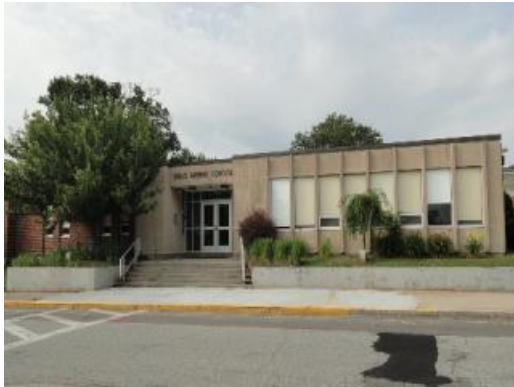
East Providence - Orlo Avenue School

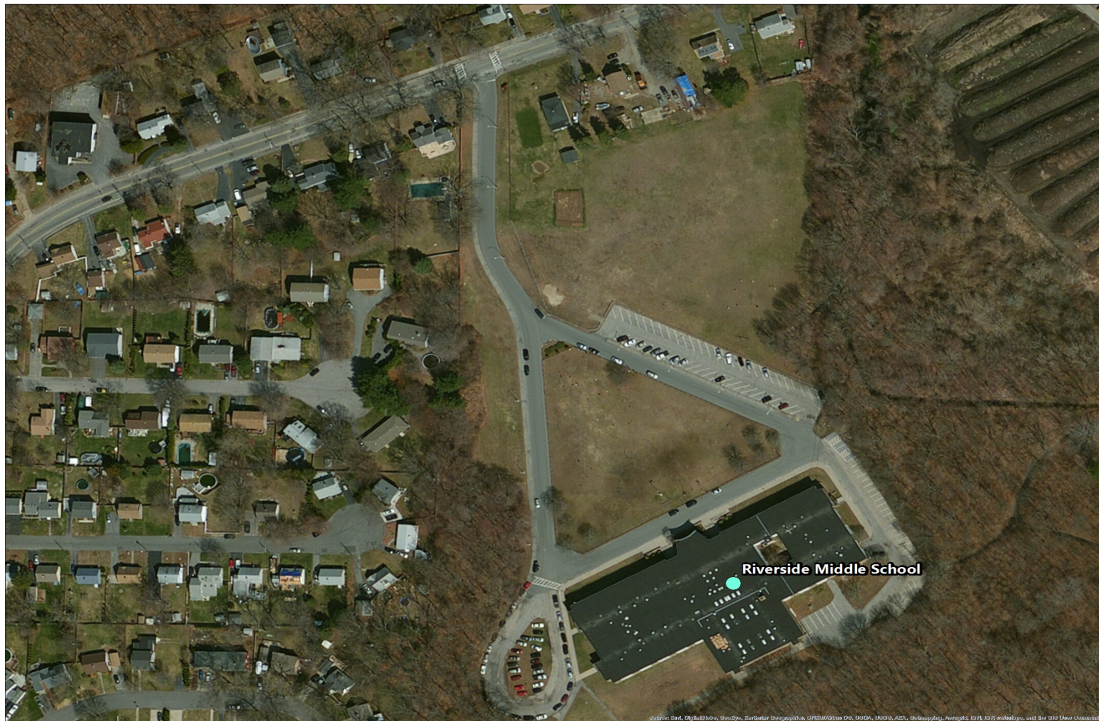
Figure 1: Aerial view of Riverside Middle School

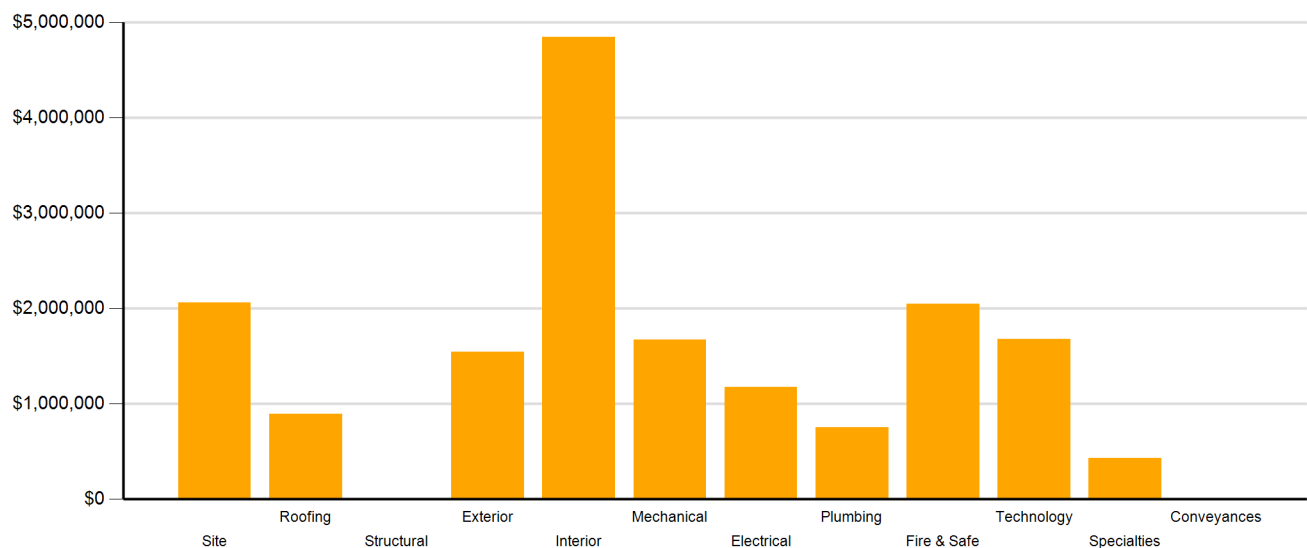
Figure 2: System Deficiencies

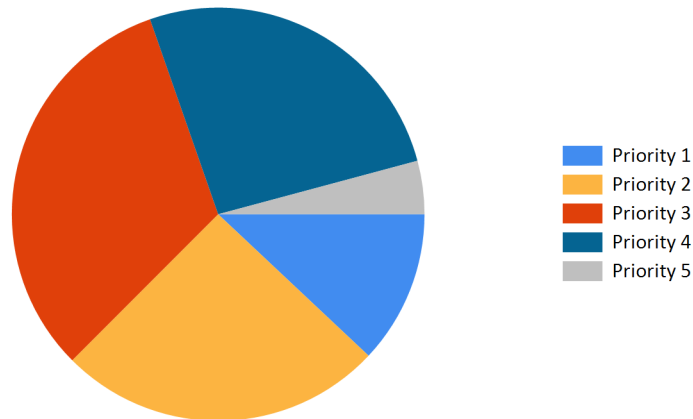
Figure 3: Current deficiencies by priority

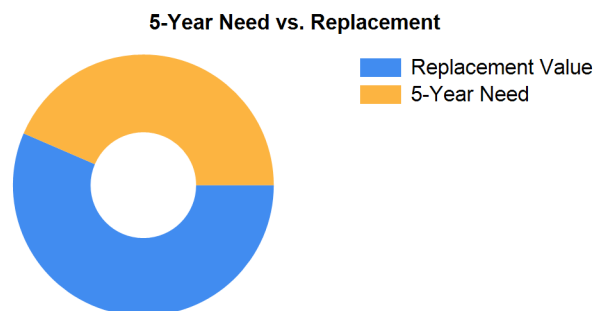
Figure 5: 5-Year FCI

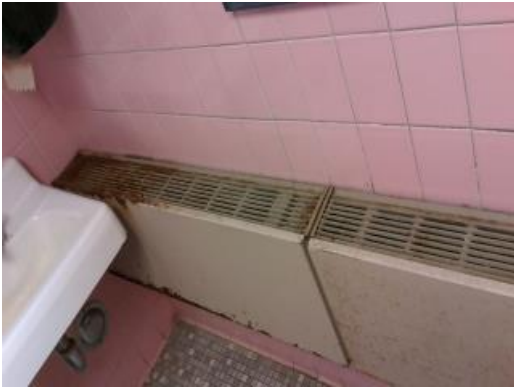
East Providence - Riverside Middle School

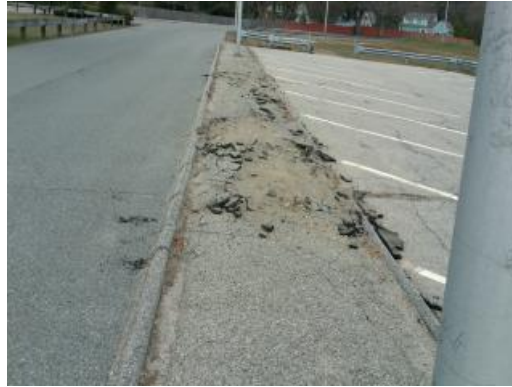
Typical Asphalt Sidewalk Condition

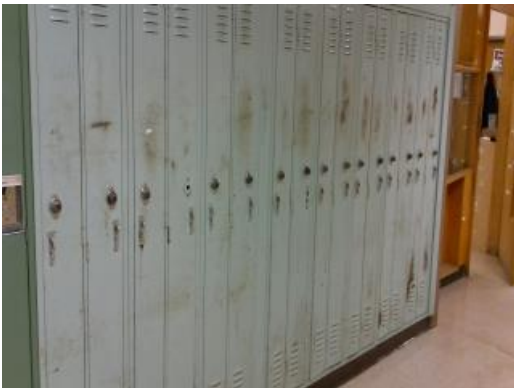
Typical Damaged Lockers

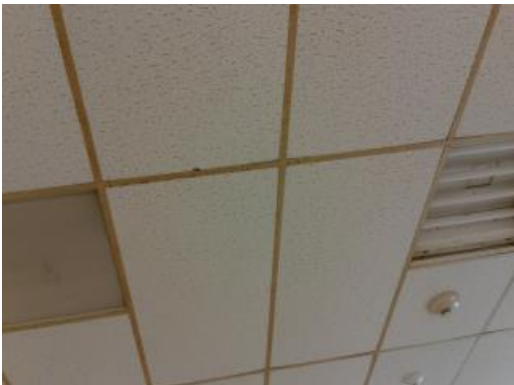
Aged And Stained Grid System

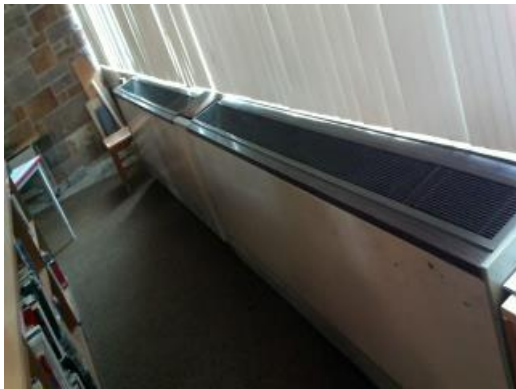
Cabinet Heating Unit

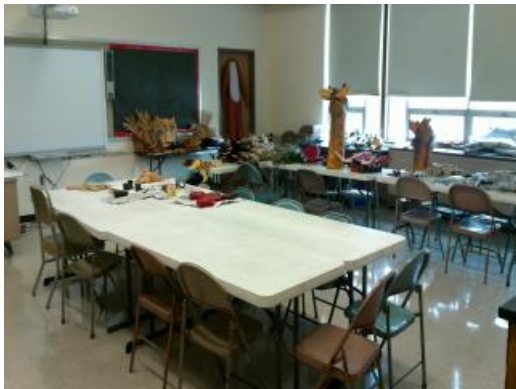
East Providence - Riverside Middle School

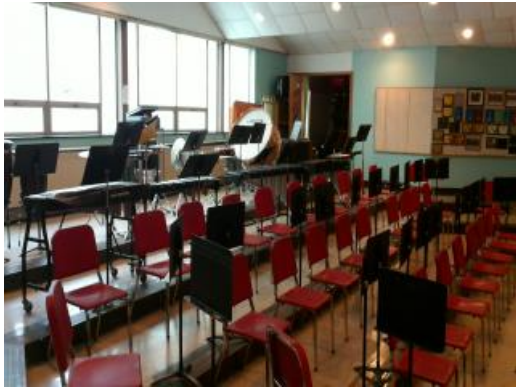
East Providence - Riverside Middle School

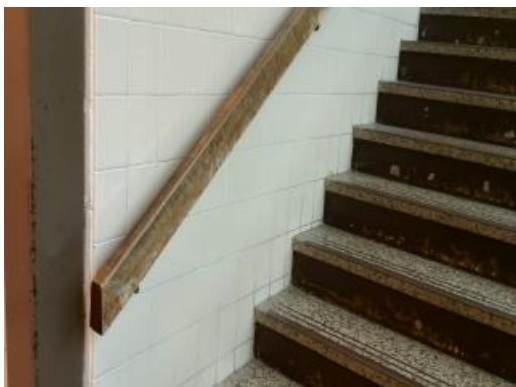
Worn Finish On Handrail

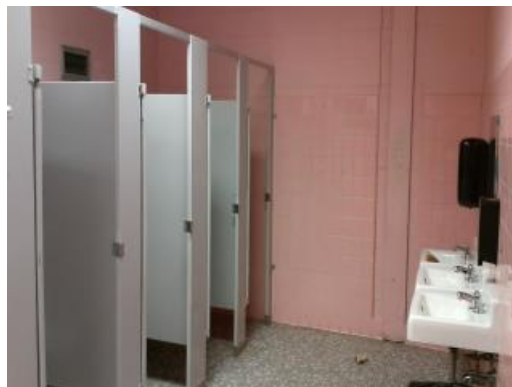
Typical Restroom Fixtures And Finishes

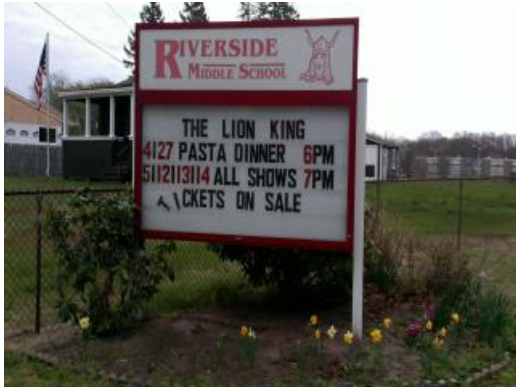
East Providence - Riverside Middle School

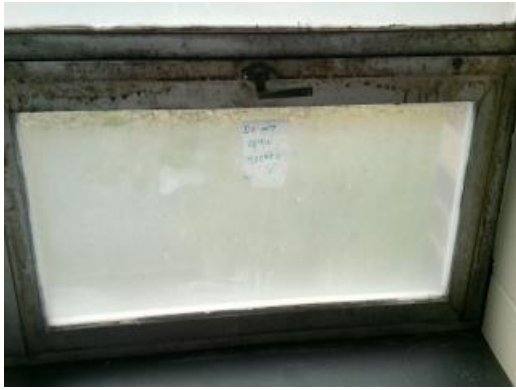
Aged Single Pane Window

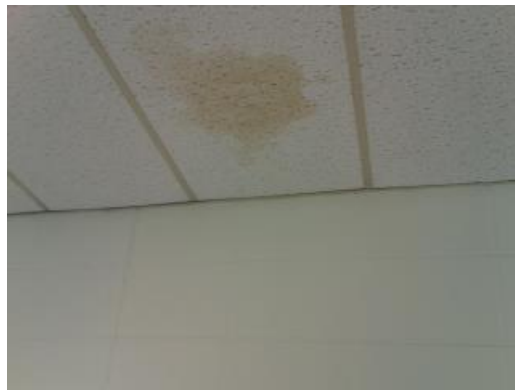
Stained Ceiling Tile

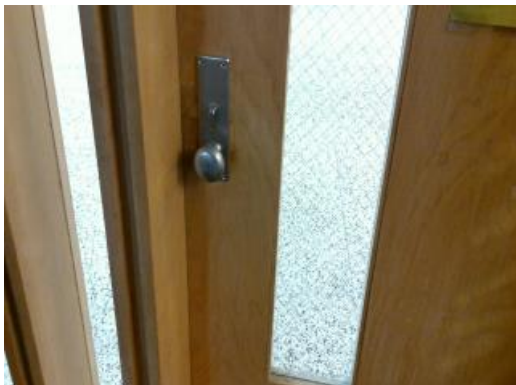
Typical Interior Door And Hardware

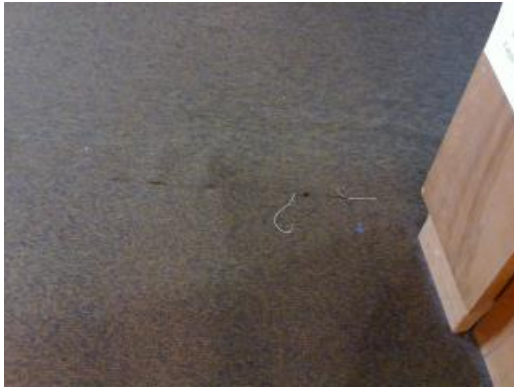
East Providence - Riverside Middle School

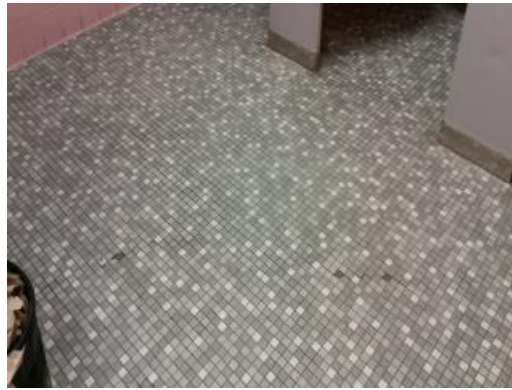
Chipped And Missing Ceramic Tiles

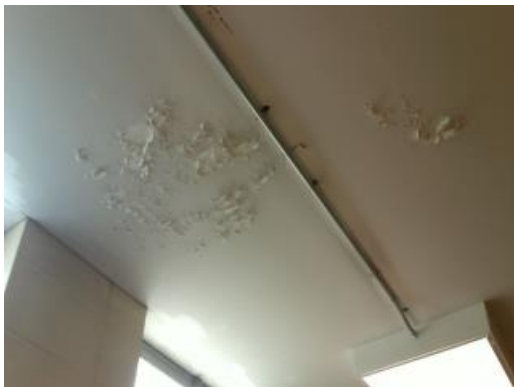
Paint Peeling On Ceiling

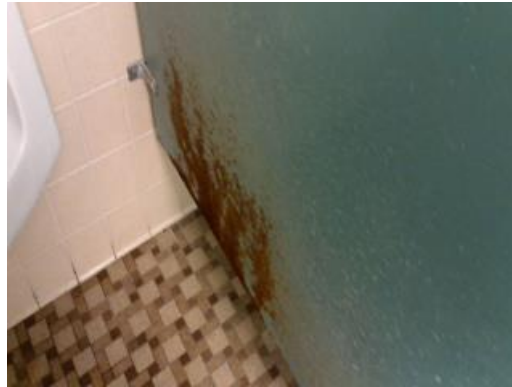
Rusted Toilet Partition

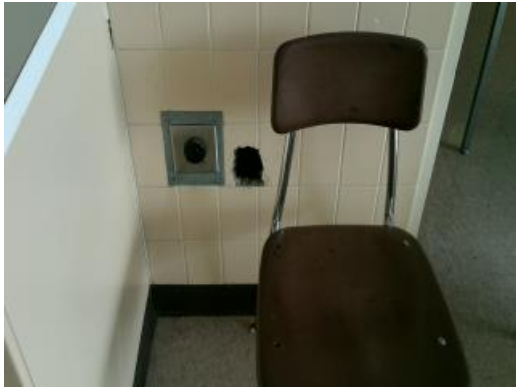
Hole In Ceramic Wall

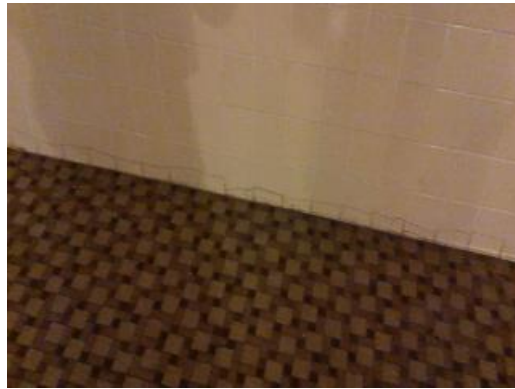
Chipped And Cracked Ceramic Tile Wall

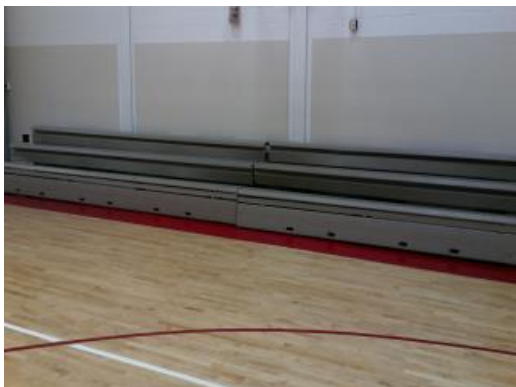
Retractable Bleachers

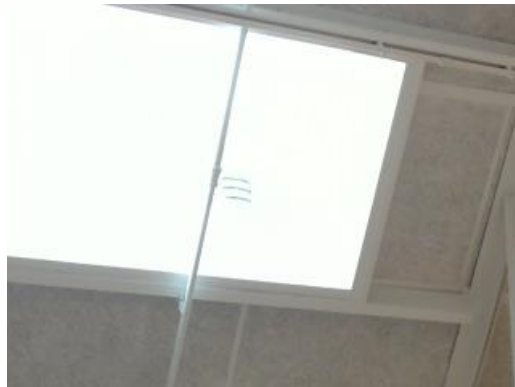
Typical Damaged Skylight

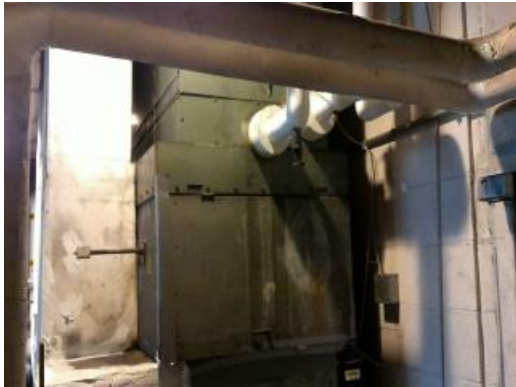
East Providence - Riverside Middle School

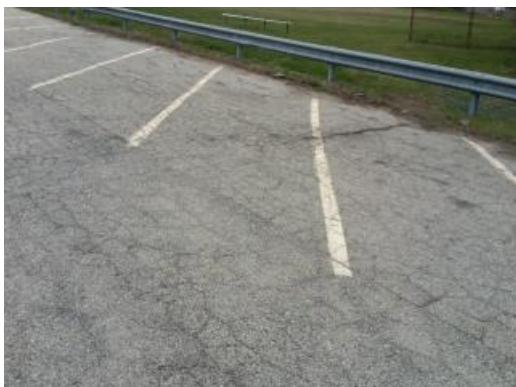
Alligatoring Parking Lot Pavement

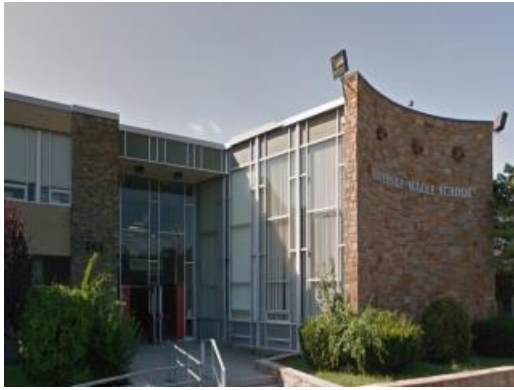
East Providence - Riverside Middle School

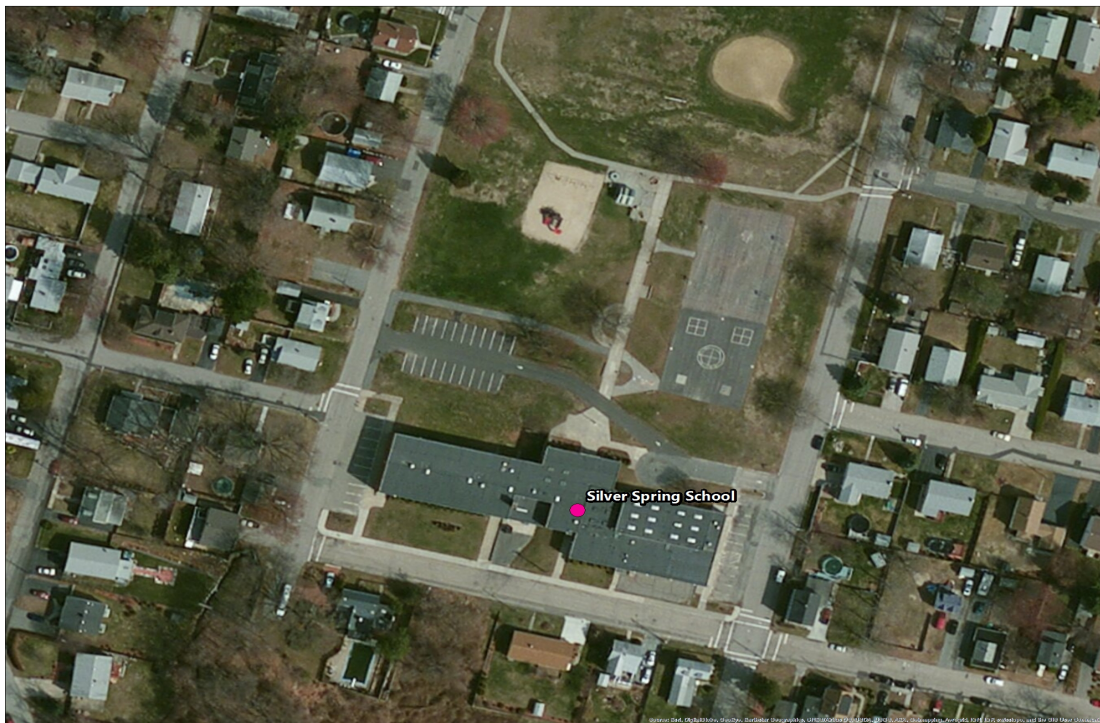
Figure 1: Aerial view of Silver Spring School

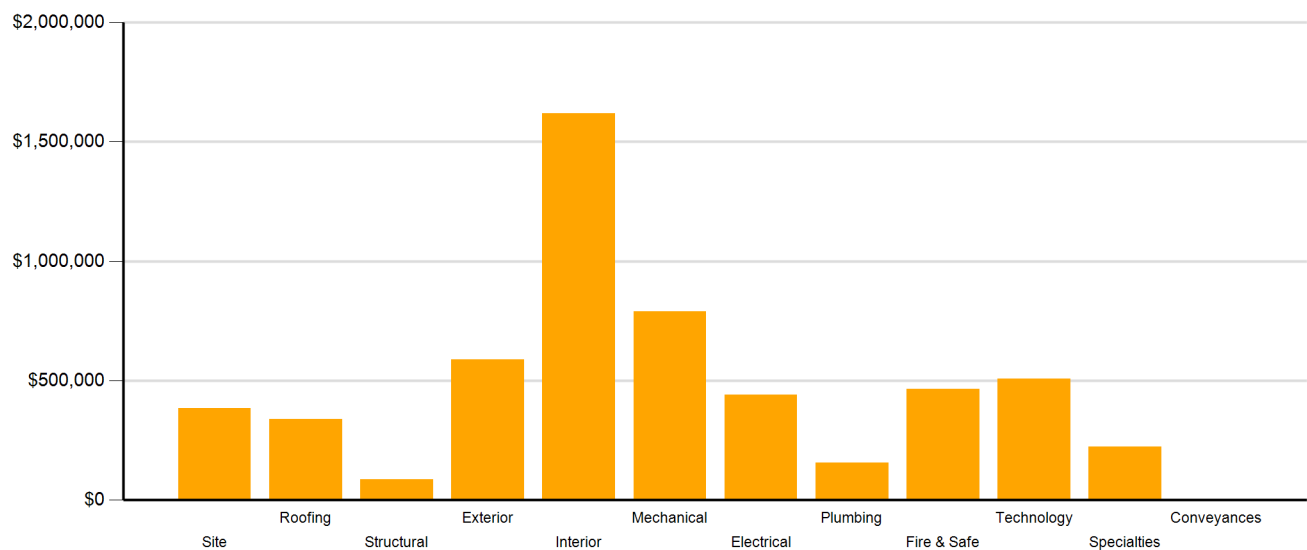
Figure 2: System Deficiencies

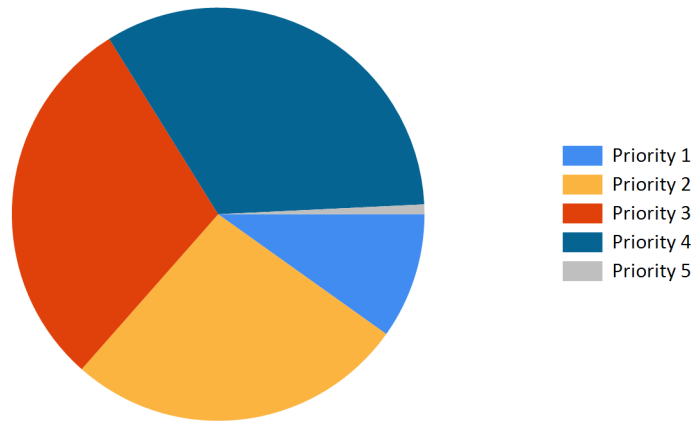
Figure 3: Current deficiencies by priority

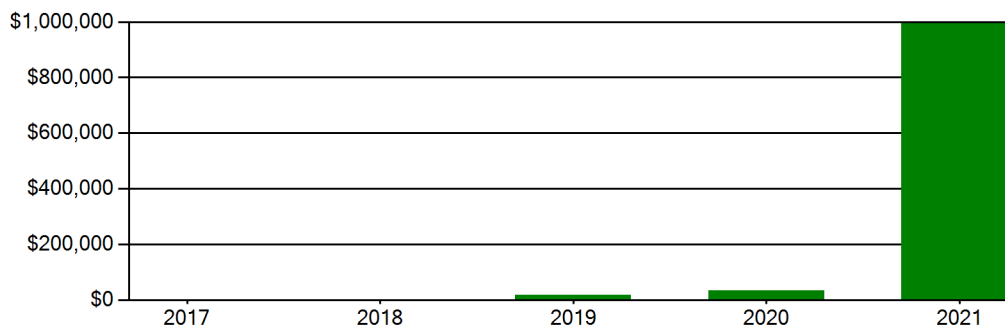
Figure 4: Life Cycle Capital Renewal Forecast

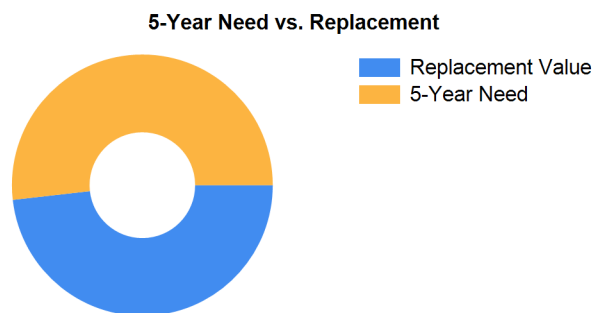
Figure 5: 5-Year FCI

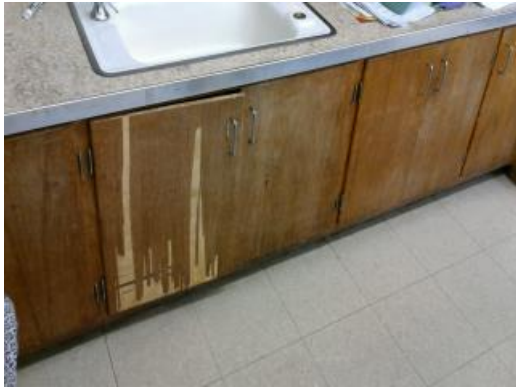
Typical Worn Casework

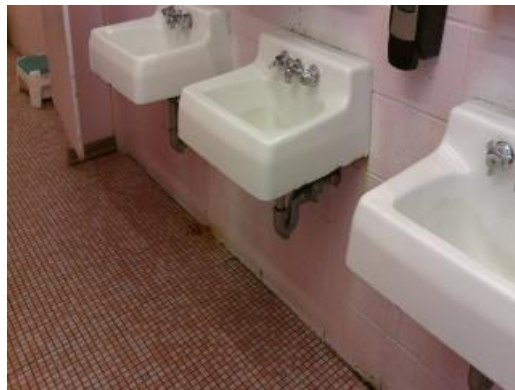
Pipe Insulation Missing

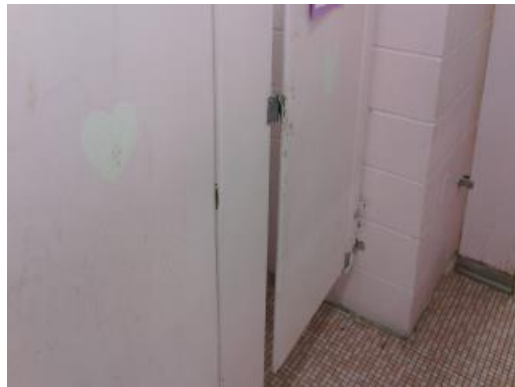
Damaged Toilet Partition

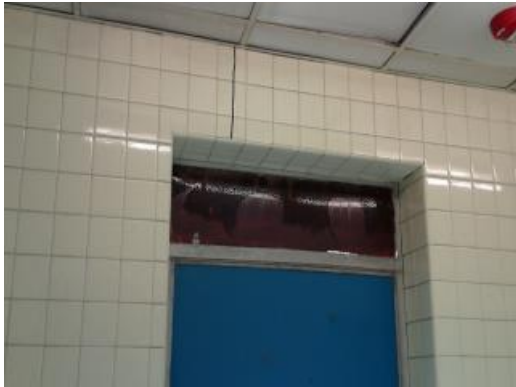
Cracked Ceramic Tile Wall

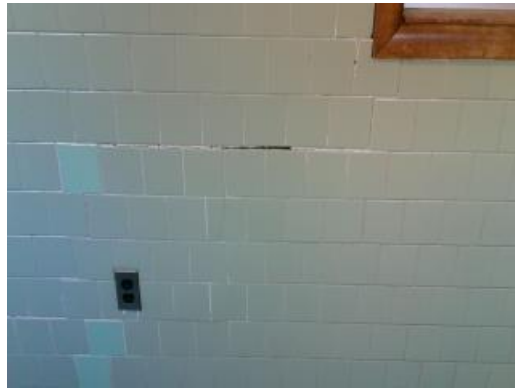
Cracked Ceramic Tile Wall

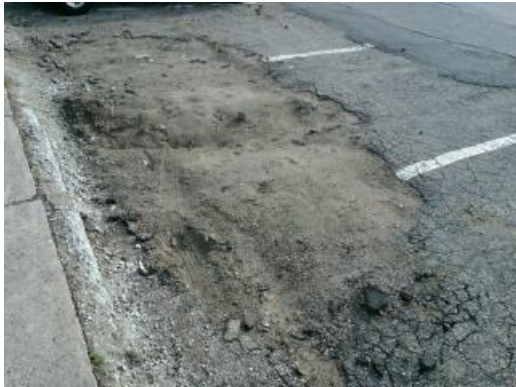
Fully Deteriorated Asphalt

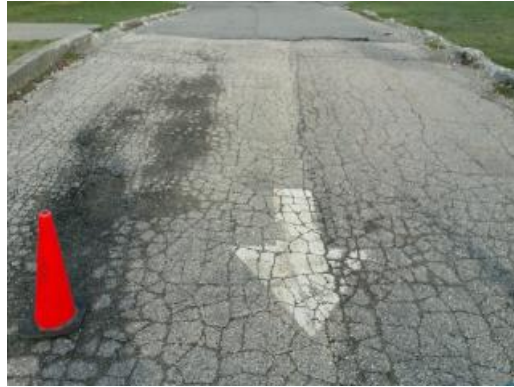
Alligatored Roadway Asphalt

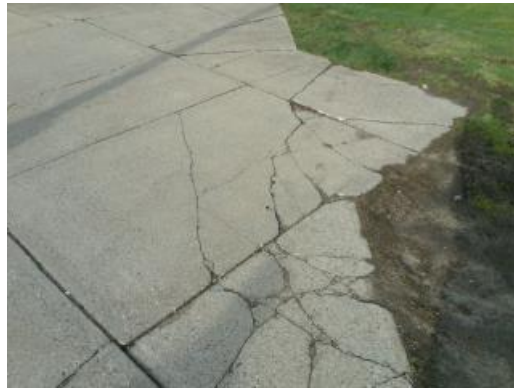
Pot Holes In Asphalt Drive

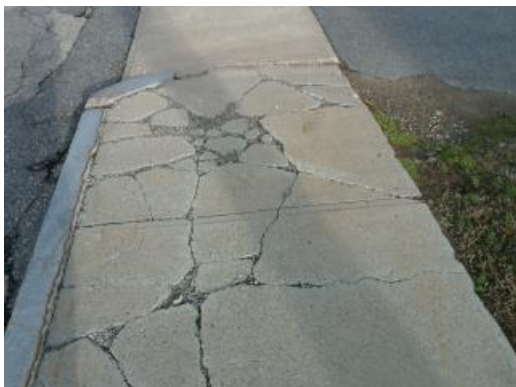
Severely Cracked Sidewalks
