School Type by Count

School Type	SqFt
Elementary School	311,777
Middle School	297,353
High School	293,081
Total:	902,211

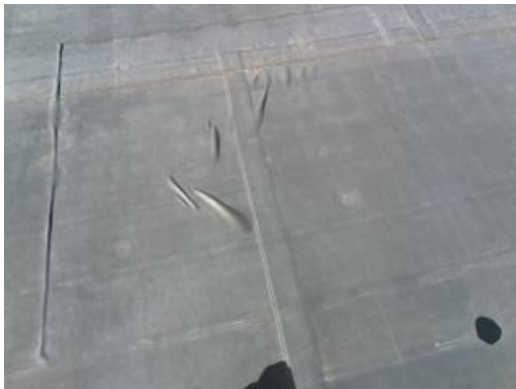
East Providence - Silver Spring School

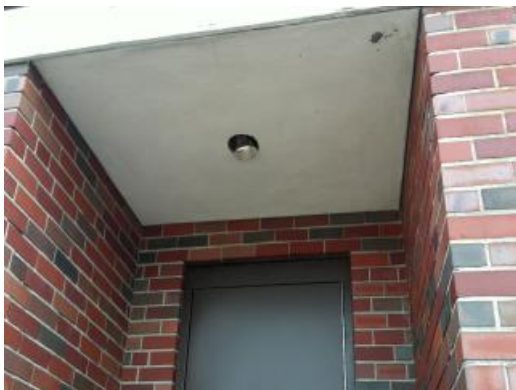
Damaged Canopy Light

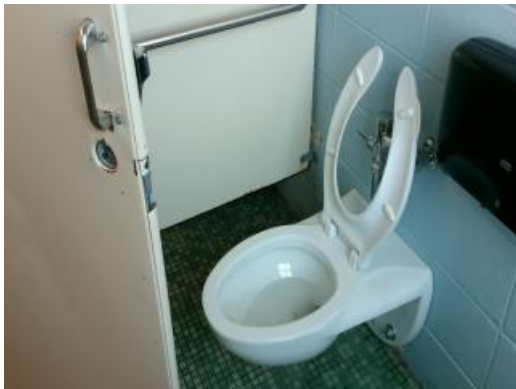
Stall Not Accessible

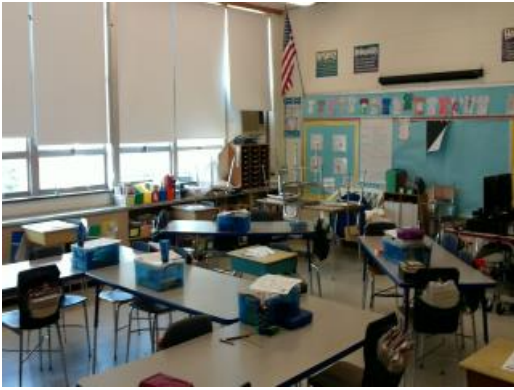
East Providence - Silver Spring School

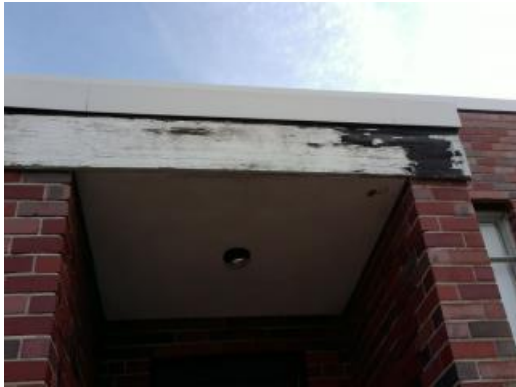
Exterior Soffit Paint

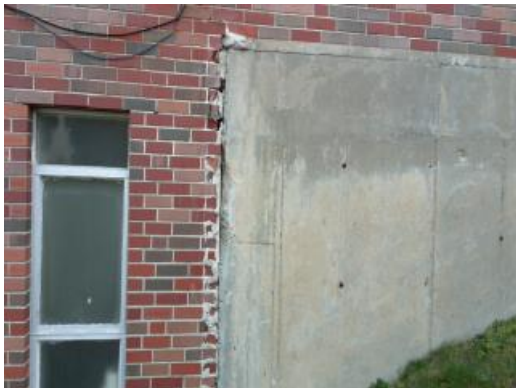
Damaged Brick At Concrete Wall

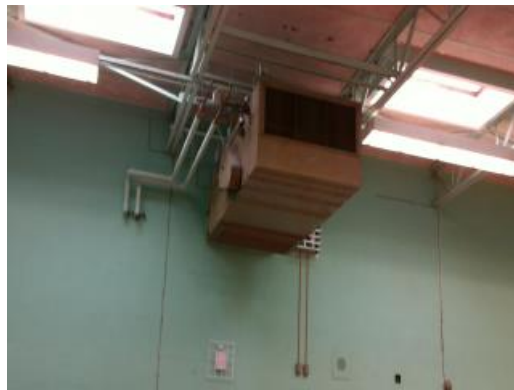
Aged Make Up Air Unit

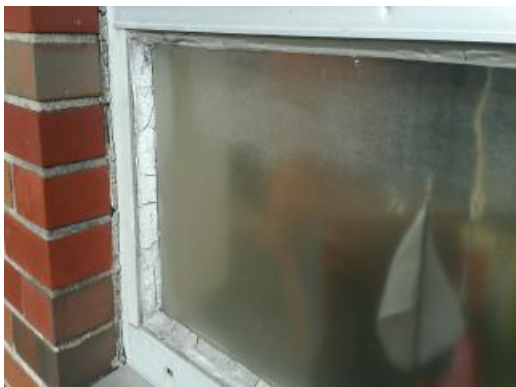
Single Pane Window With Deteriorated Sealant

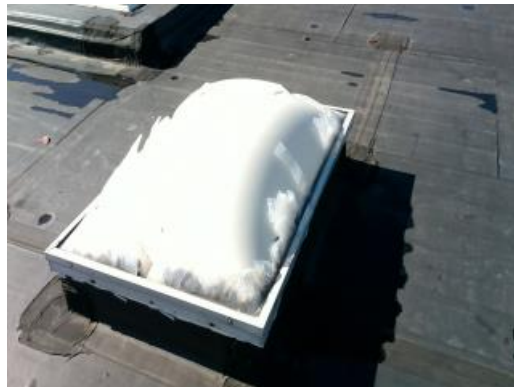
Typical Damaged Skylight

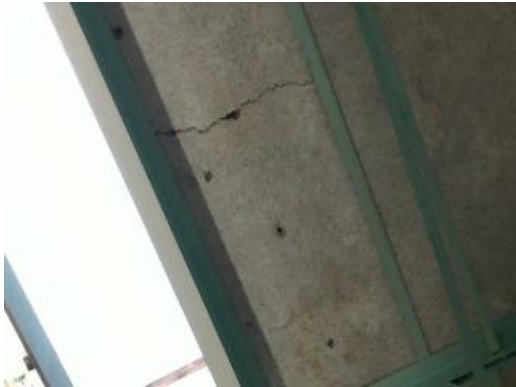
Cracked Tectum Ceiling

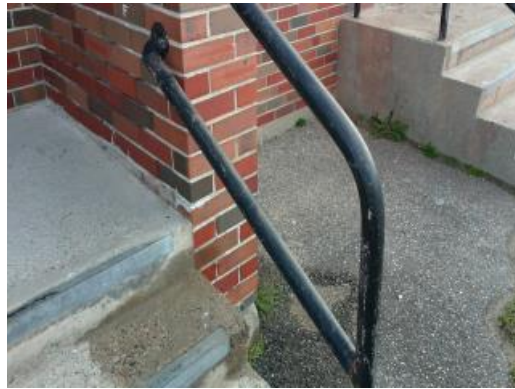
Worn Paint On Handrail

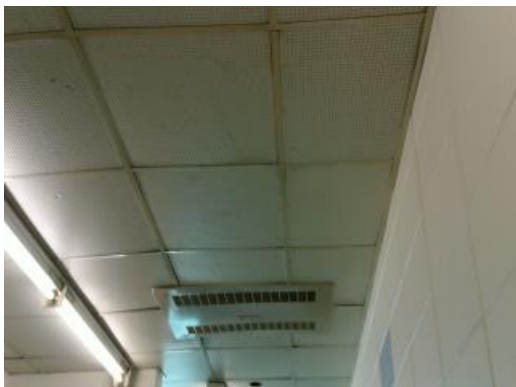
Aged And Stained Ceiling Tiles

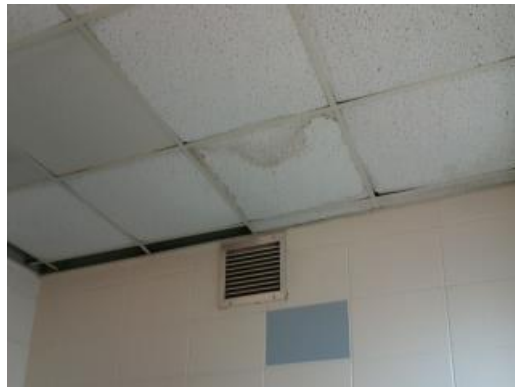
Stained Ceiling Tiles

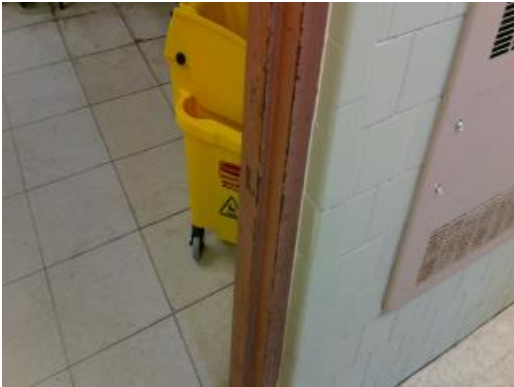
Worn Door Frame Painting

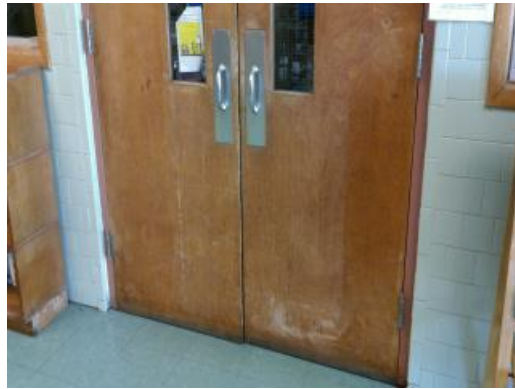
Typical Interior Wood Door.

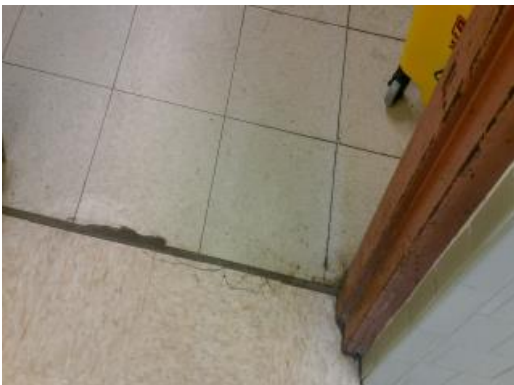
9x9 Tile In Gym/Cafeteria

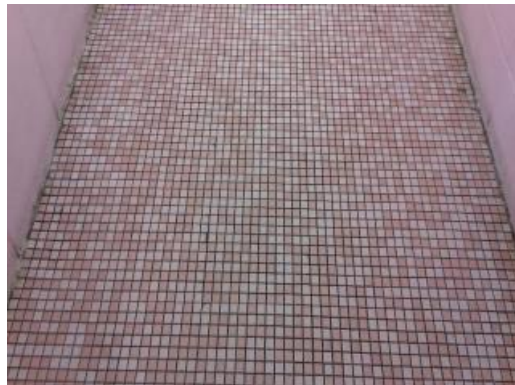
Typical Ceramic Floor Tile
