# Facility Condition Assessment

Exeter-West Greenwich - Exeter-West Greenwich Regional High School

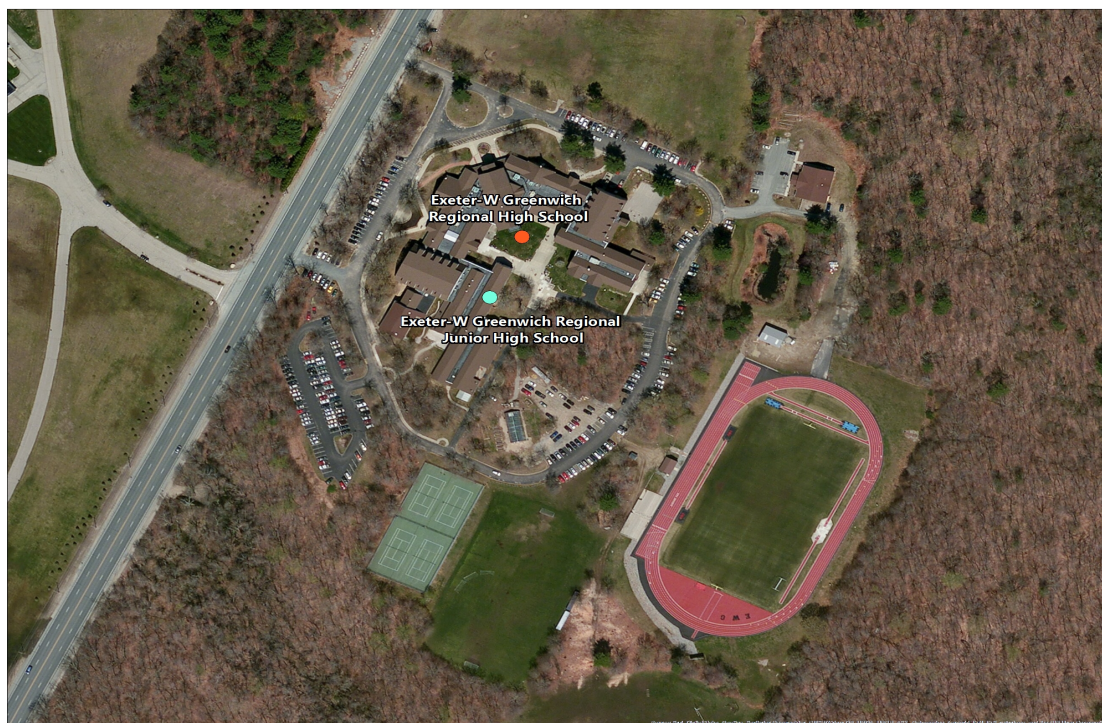
Figure 1: Aerial view of Exeter-West Greenwich Regional High School

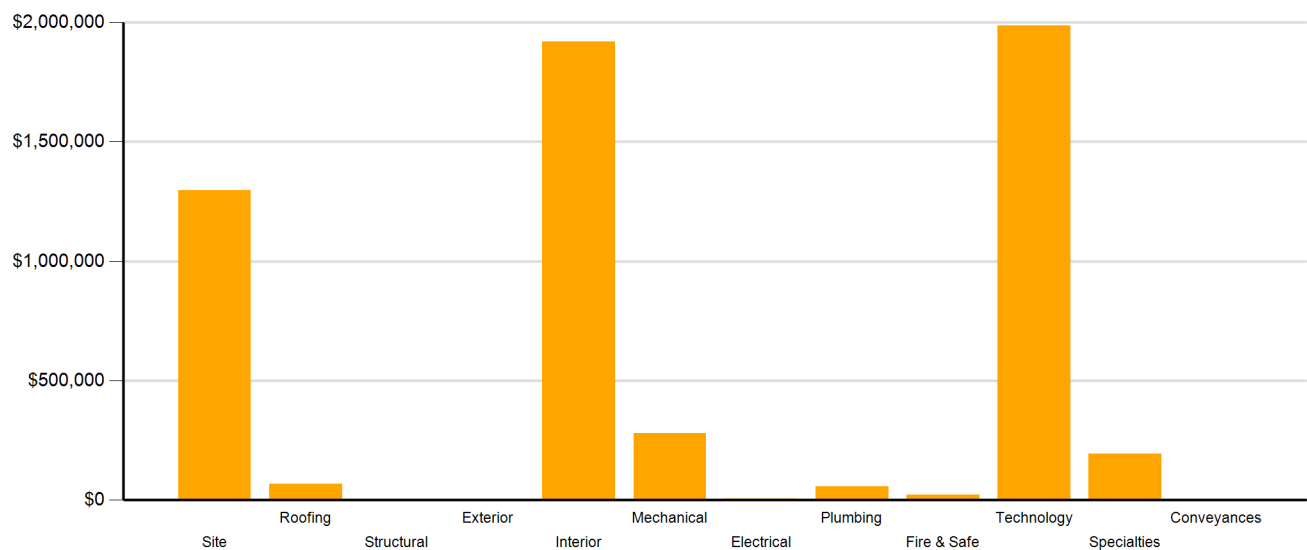
Figure 2: System Deficiencies

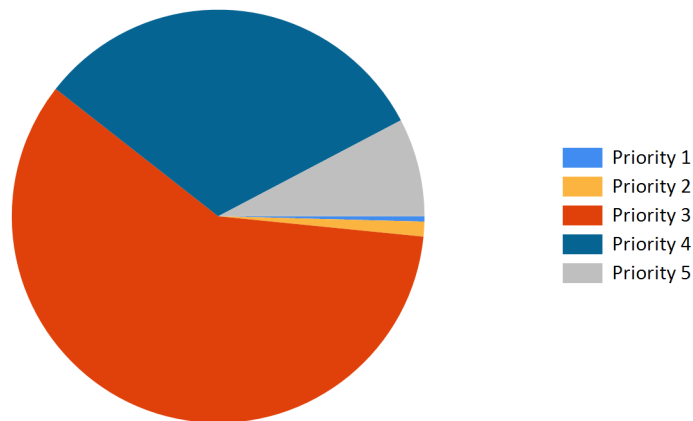
Figure 3: Current deficiencies by priority

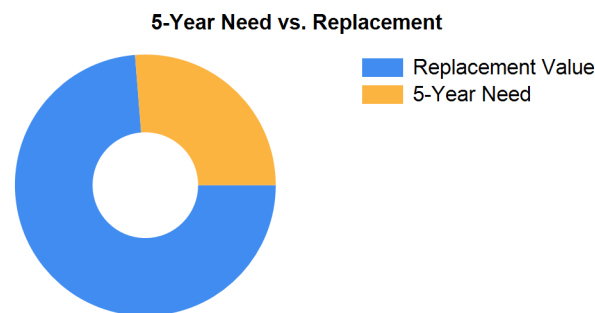
Figure 5: 5-Year FCI

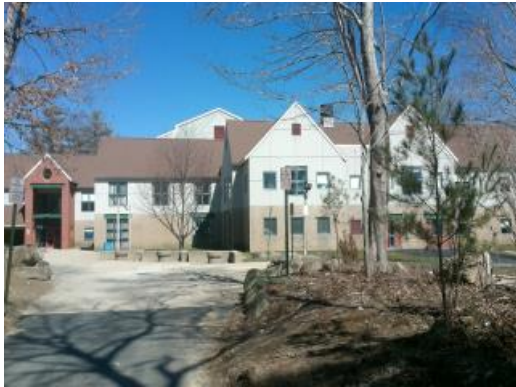
Main Building - East Elevation

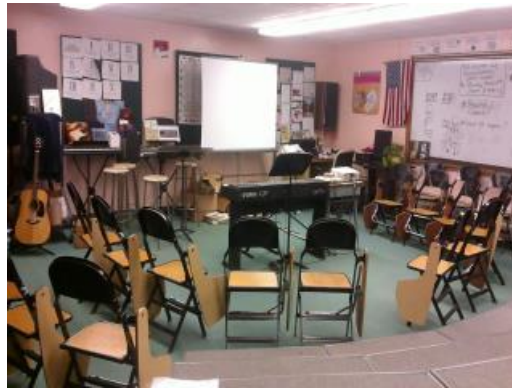
Choir Room Shared With Junior High

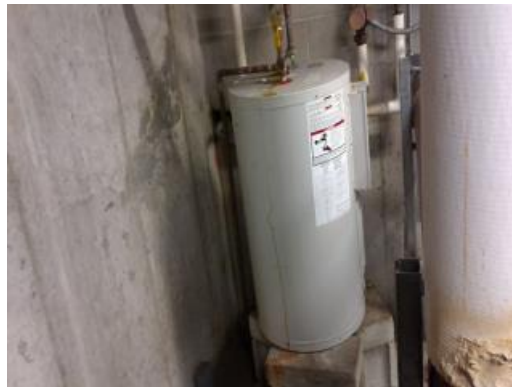
Main Building - Electric Water Heater

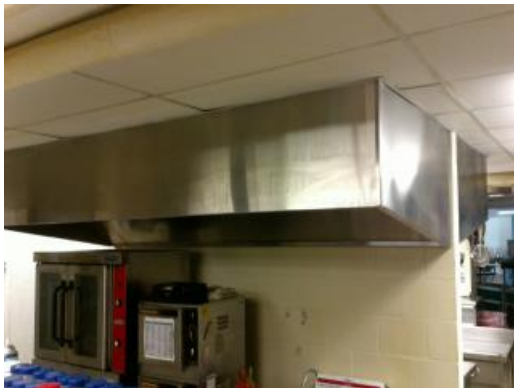
Main Building - Kitchen Hood

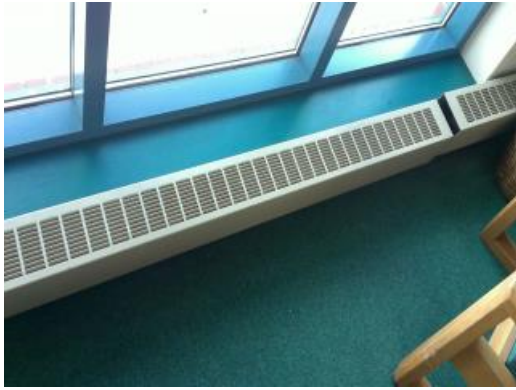
Main Building - Radiant Heaters

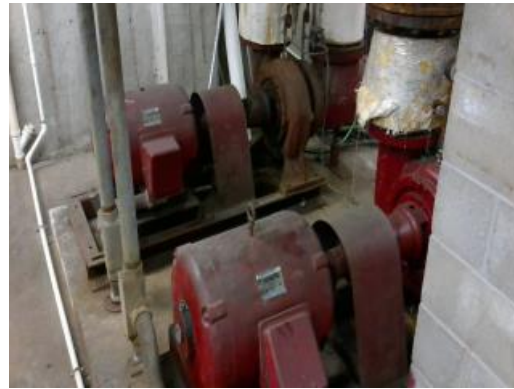
Main Building - Hot Water Pumps

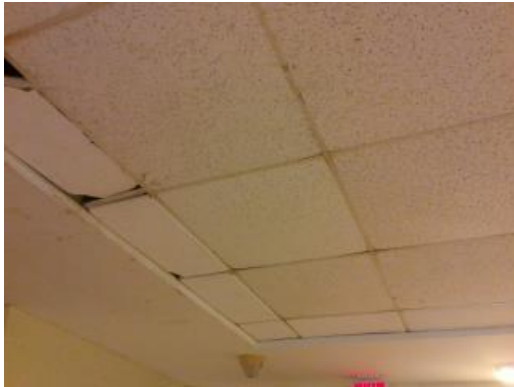
Main Building - Rusted Ceiling Grid

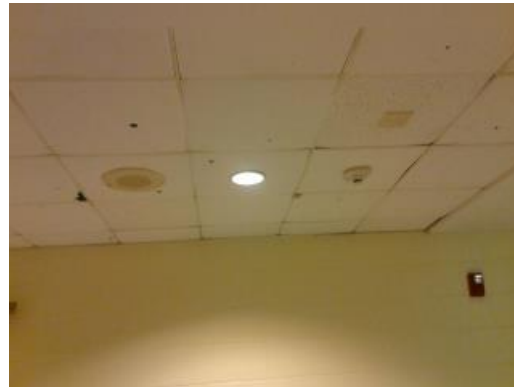
Main Building - Damaged Acoustical Ceiling Tiles

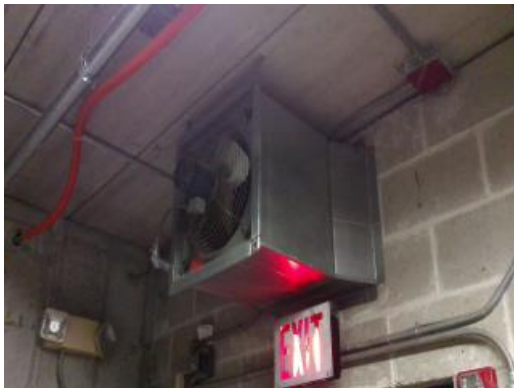
Main Building - Exhaust Fan

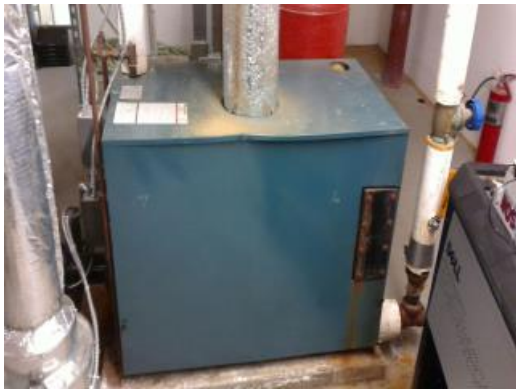
Building 02 - Boiler - Domestic Water

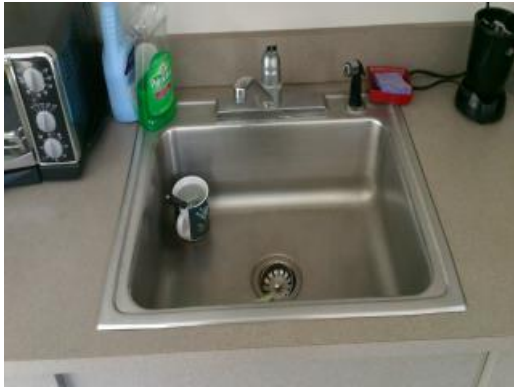
Building 02 - Lavatory

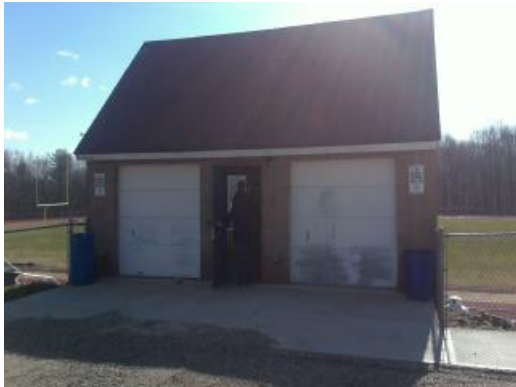
Building 04 - Concession Stand

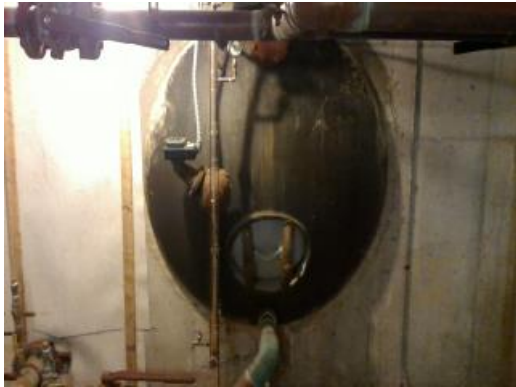
Building 04 - Domestic Water Storage Tank

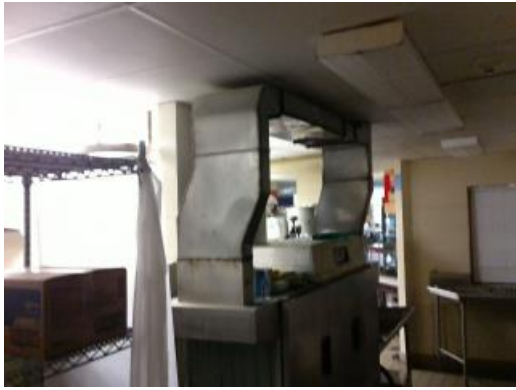
Main Building - Dishwasher Exhaust
