Facility Condition Assessment

North Kingstown - North Kingstown Senior High School

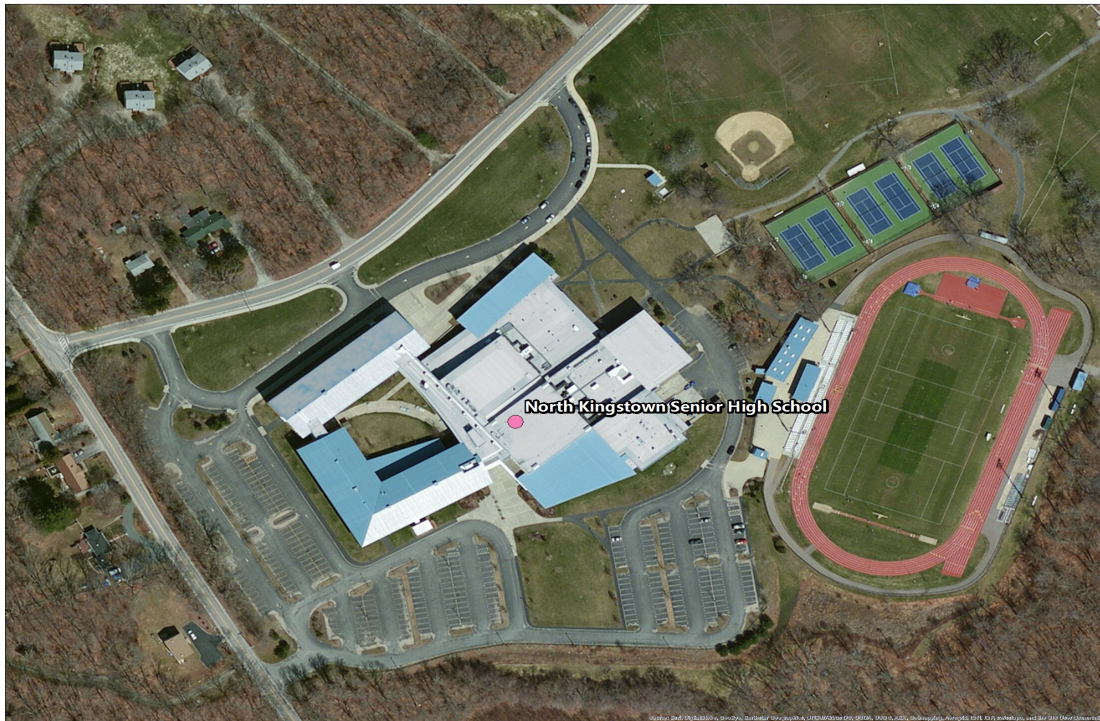
Figure 1: Aerial view of North Kingstown Senior High School

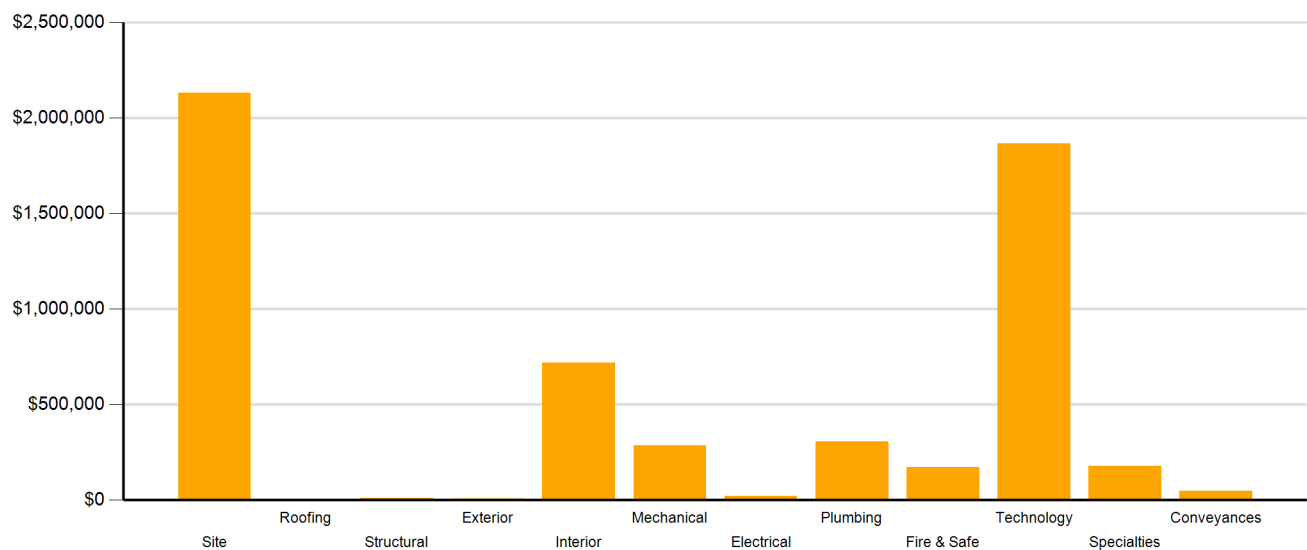
Figure 2: System Deficiencies

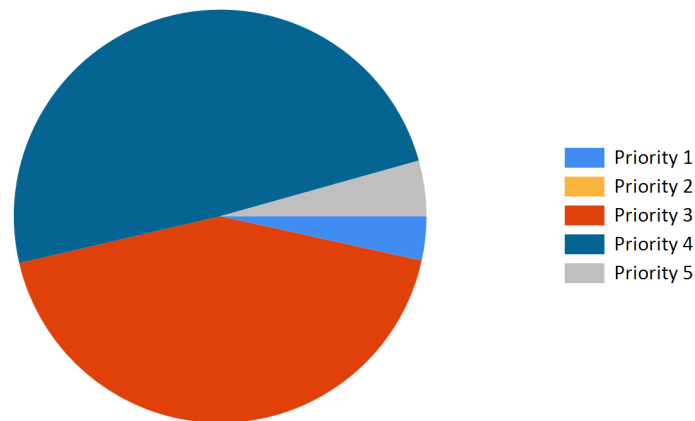
Figure 3: Current deficiencies by priority

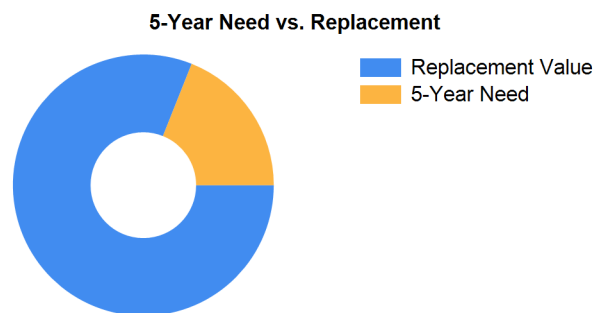
Figure 5: 5-Year FCI

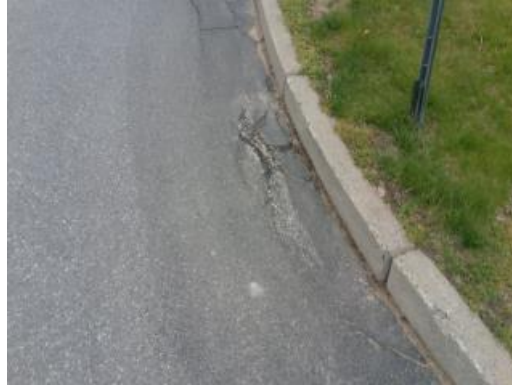
Worn Asphalt Roadway Pavement

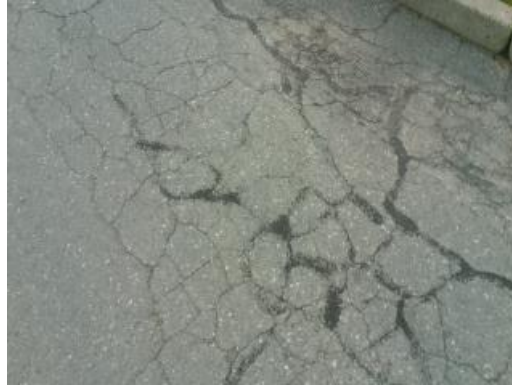
Worn Asphalt Parking Lot Pavement

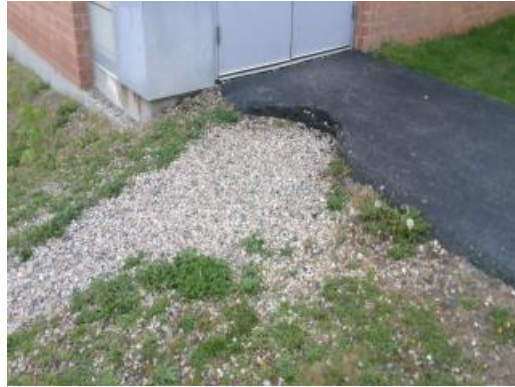
Damaged Asphalt Walks

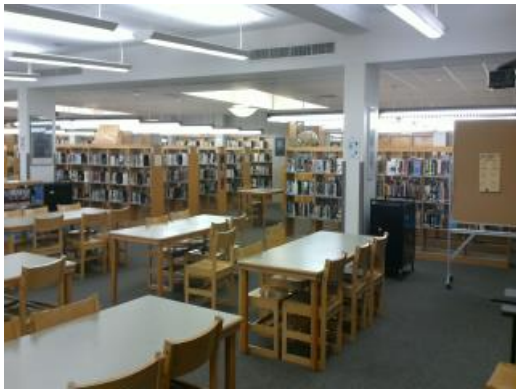
North Kingstown - North Kingstown Senior High School

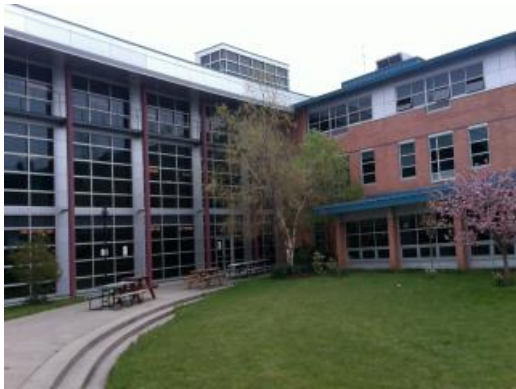
North Kingstown - North Kingstown Senior High School

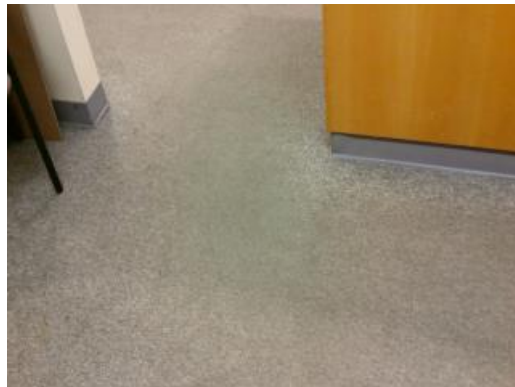
Worn Carpet At Main Office

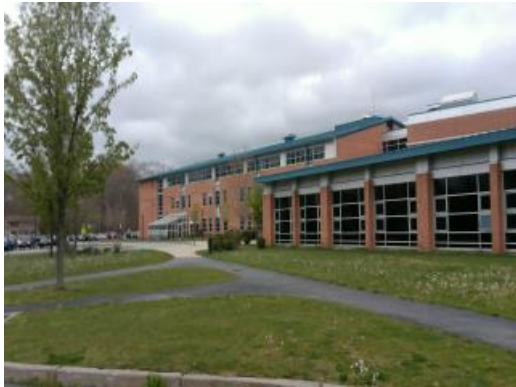
North Kingstown - North Kingstown Senior High School

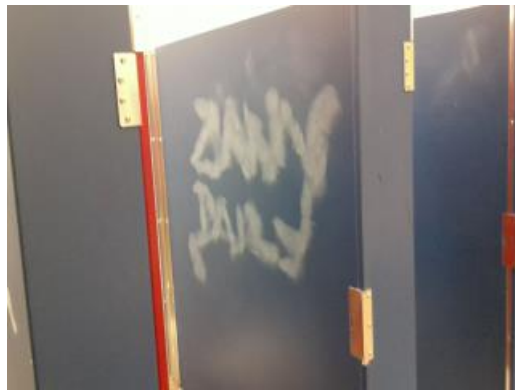
Damaged Partition At Girls Restroom

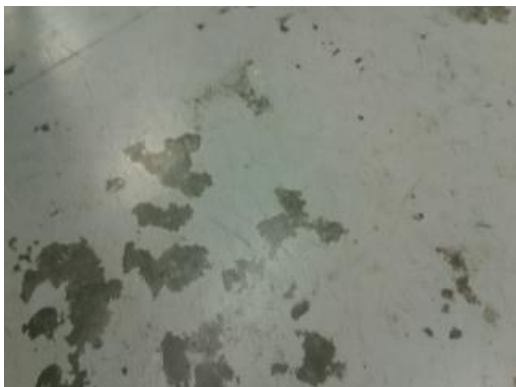
Worn Concrete Flooring At Lockers

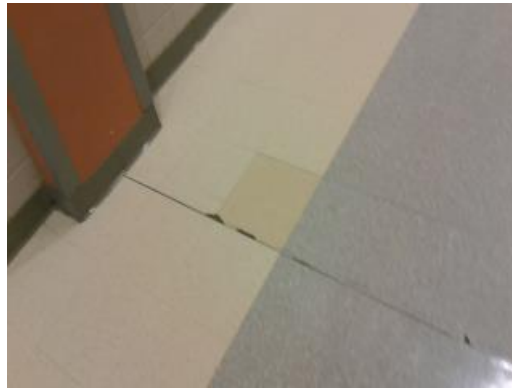
Cracked Flooring Outside of Cafeteria

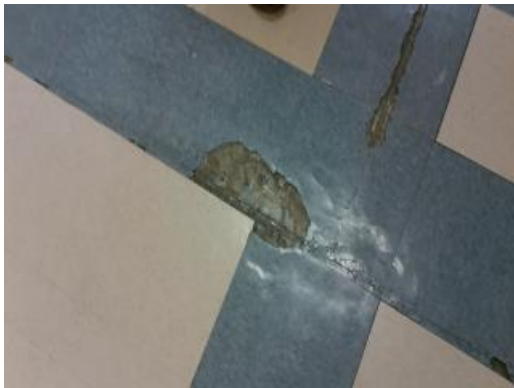
Cracked Flooring at Hallway Between Lockers

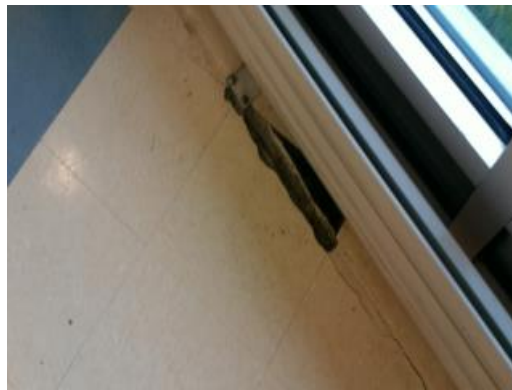
Cracked Flooring at Cafeteria

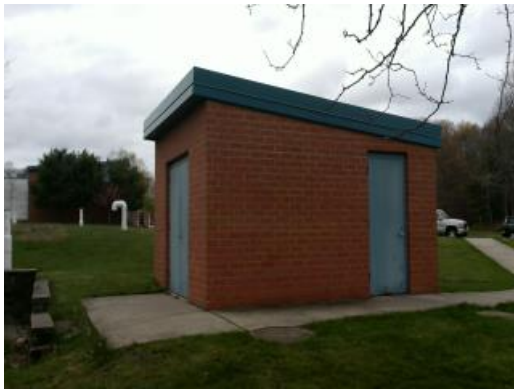
Utility Building Exterior

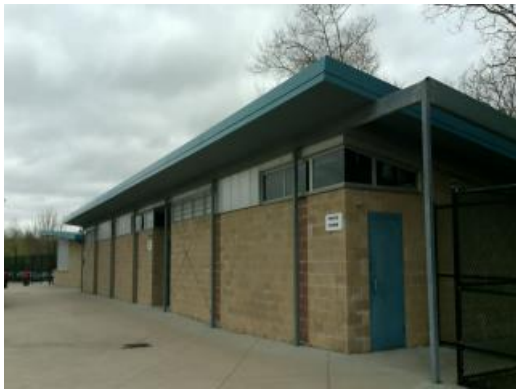
North Kingstown - North Kingstown Senior High School

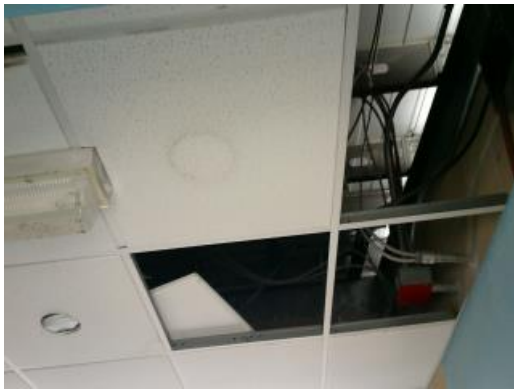
Press Box Acoustical Tile Ceiling

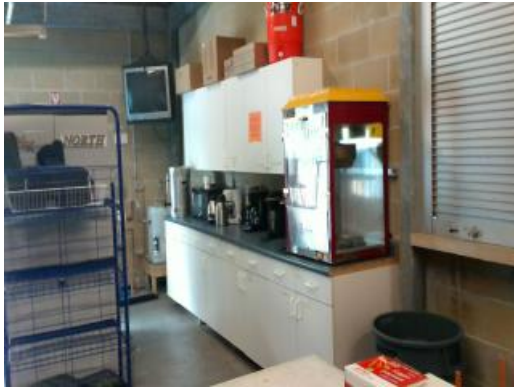
Concession Stand Interior

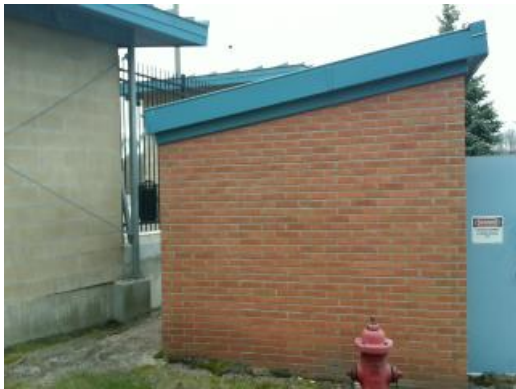
Utility Building-2 Side View
