Facility Condition Assessment

Pawtucket - William E Tolman Senior High School

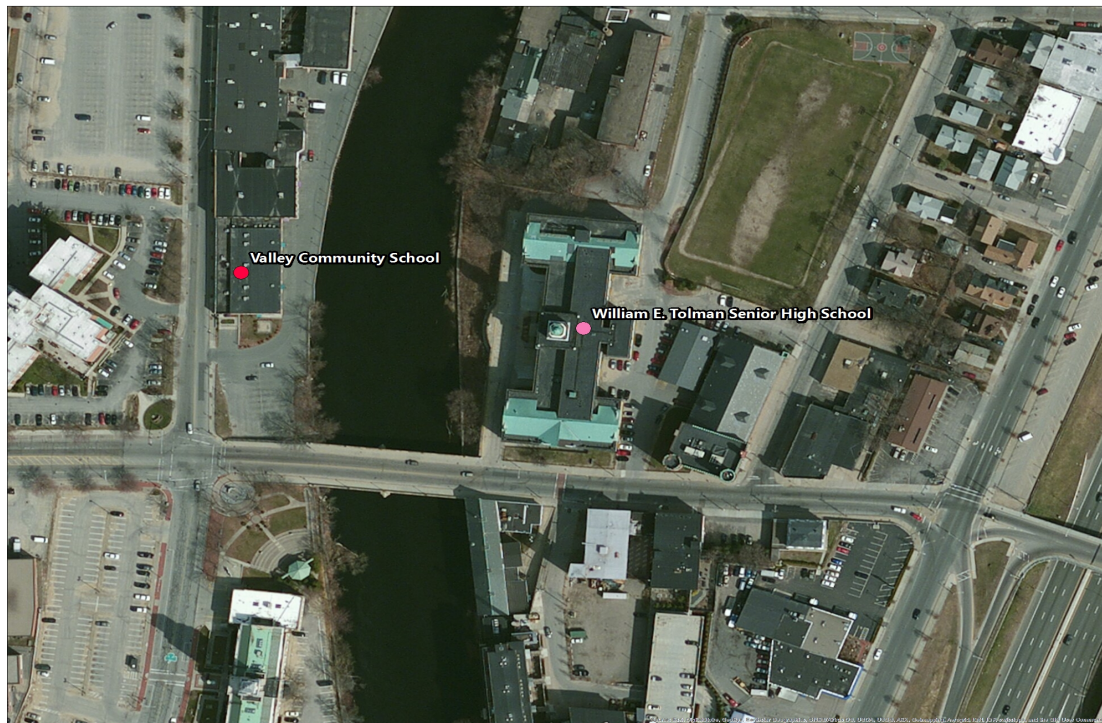
Figure 1: Aerial view of William E Tolman Senior High School

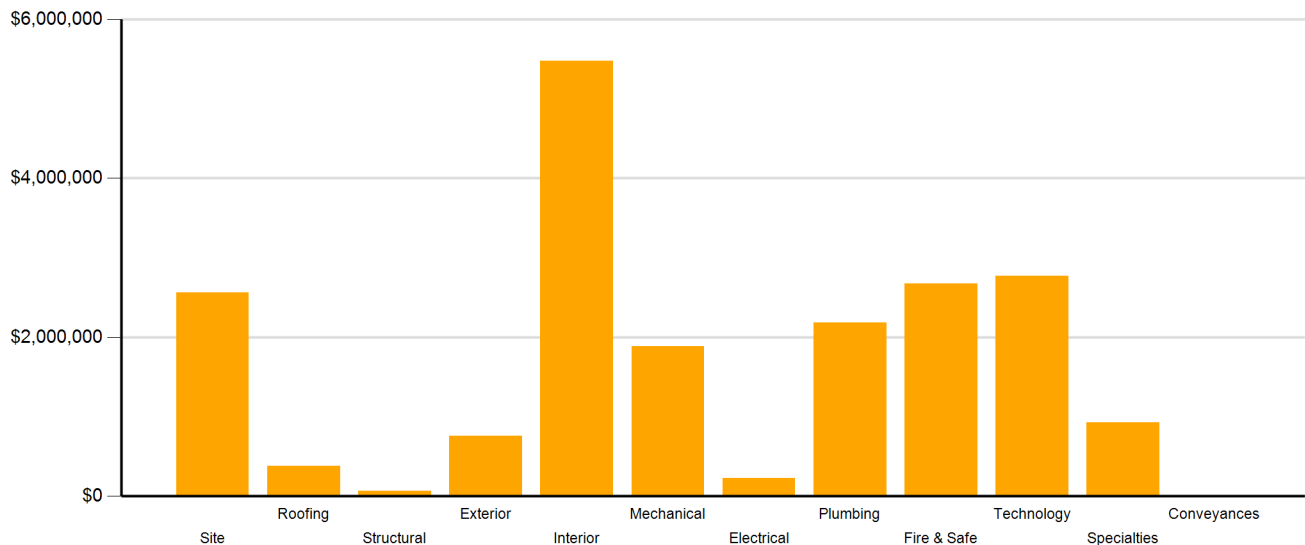
Figure 2: System Deficiencies

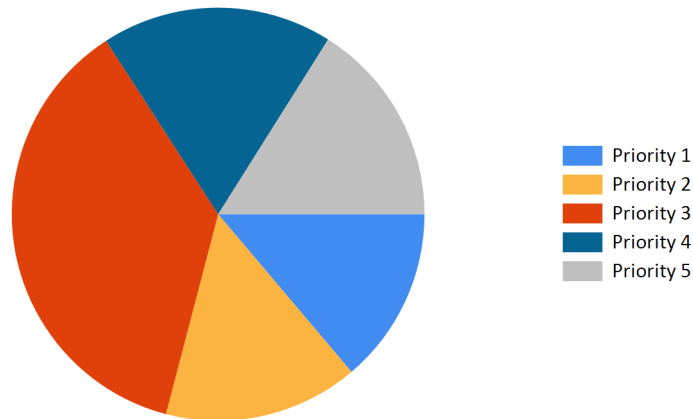
Figure 3: Current deficiencies by priority

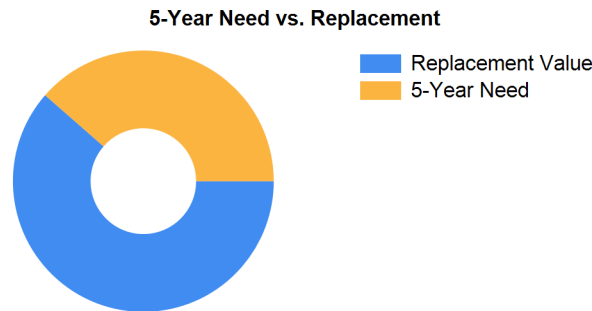
Figure 5: 5-Year FCI

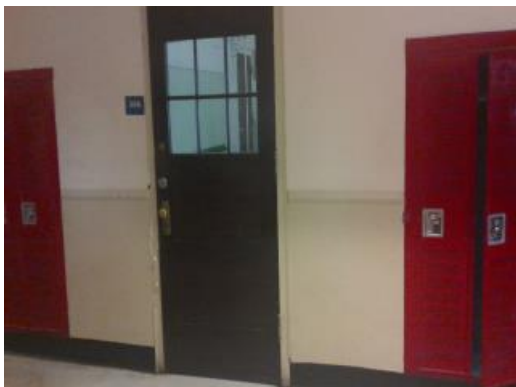
Original Door Hardware

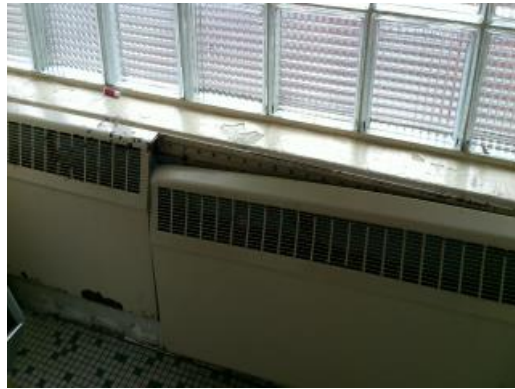
Damaged Fin Tube Heater

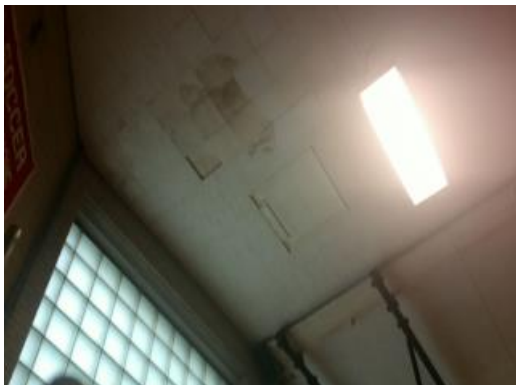
Stained And Missing Adhered Ceiling Tiles

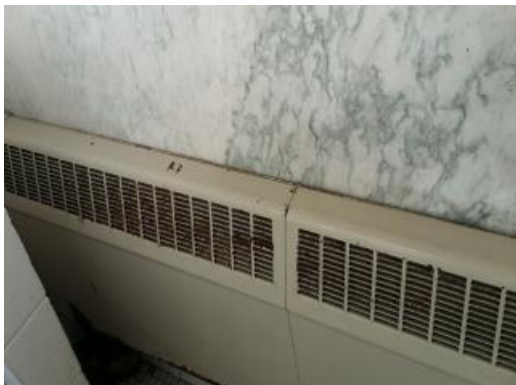
Rusted Fin Tube Heater

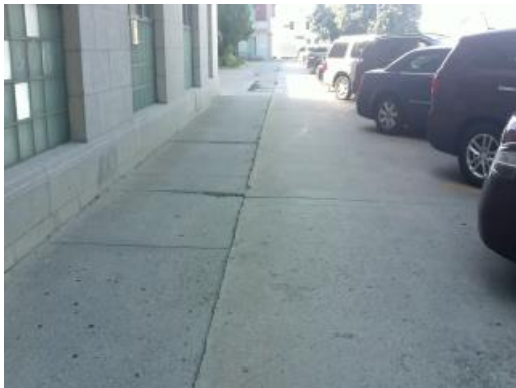
Cracked Concrete Parking

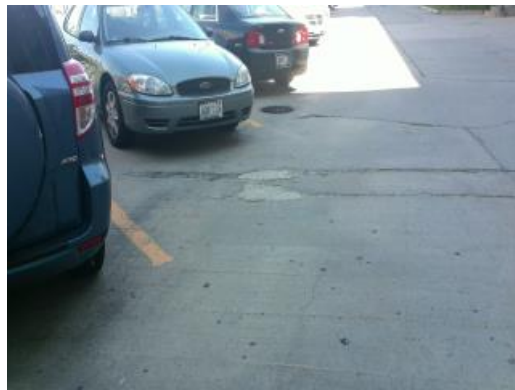
Cracked And Spalled Concrete Parking

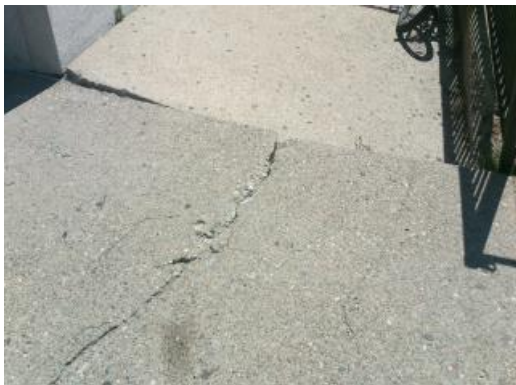
Heaved And Cracked Sidewalk

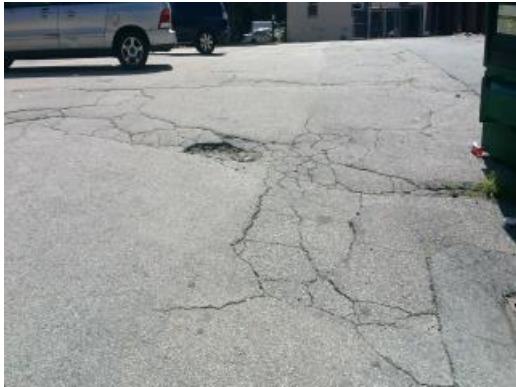
Cracked Asphalt Paving

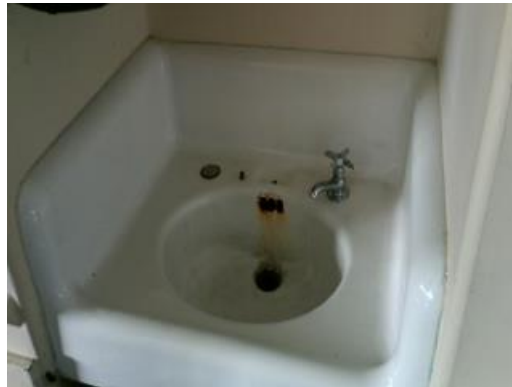
Rusted Classroom Lavatory

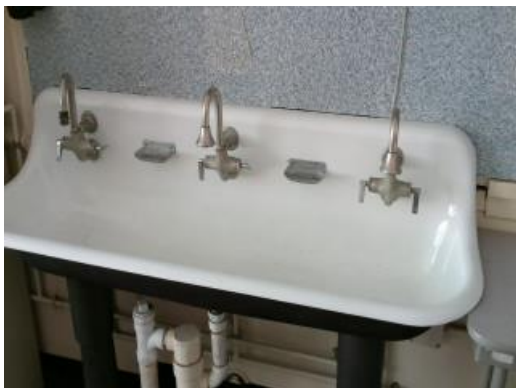
Original Classroom Lavatory

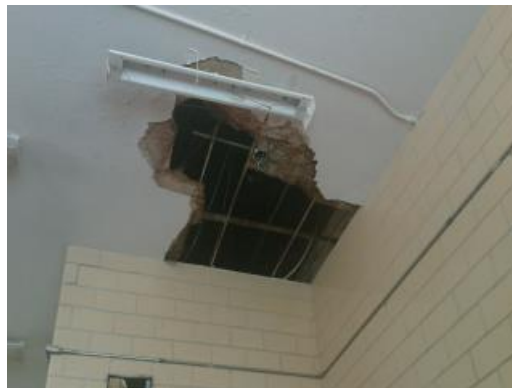
Damaged Plaster Ceiling

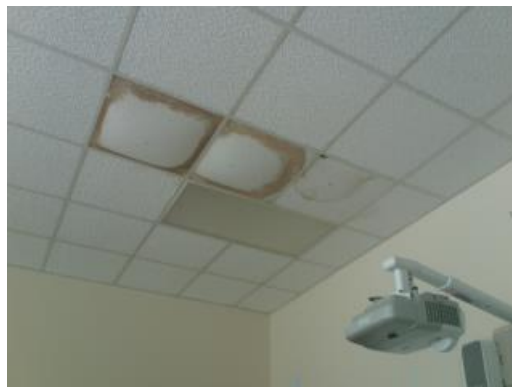
Stained And Sagging Ceiling Tiles

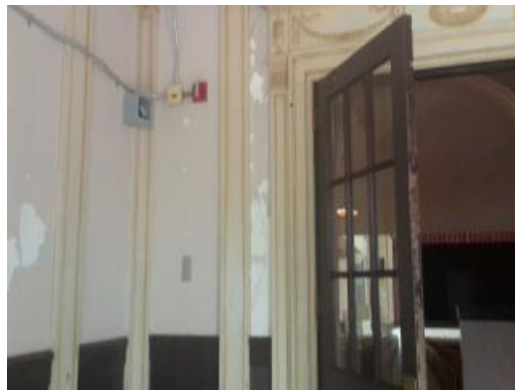
Damaged Plaster Wall

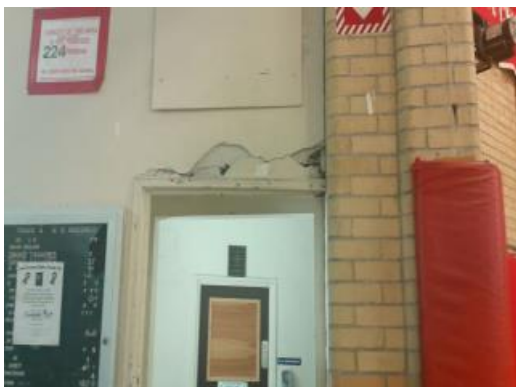
Cracked And Broken Plaster Wall

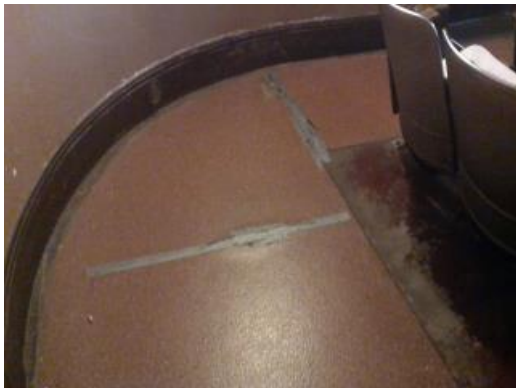
Cracked Vinyl Flooring

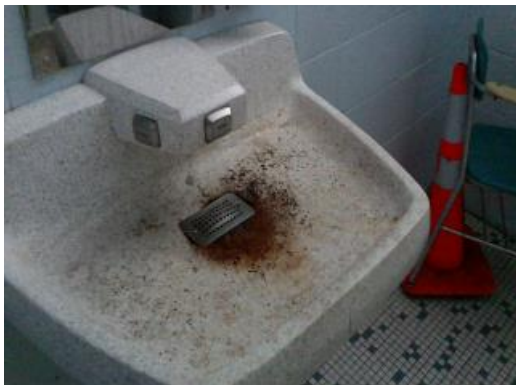
Rusted Bradley Half Sink
