Facility Condition Assessment

Providence - Hope High School / 360 High School

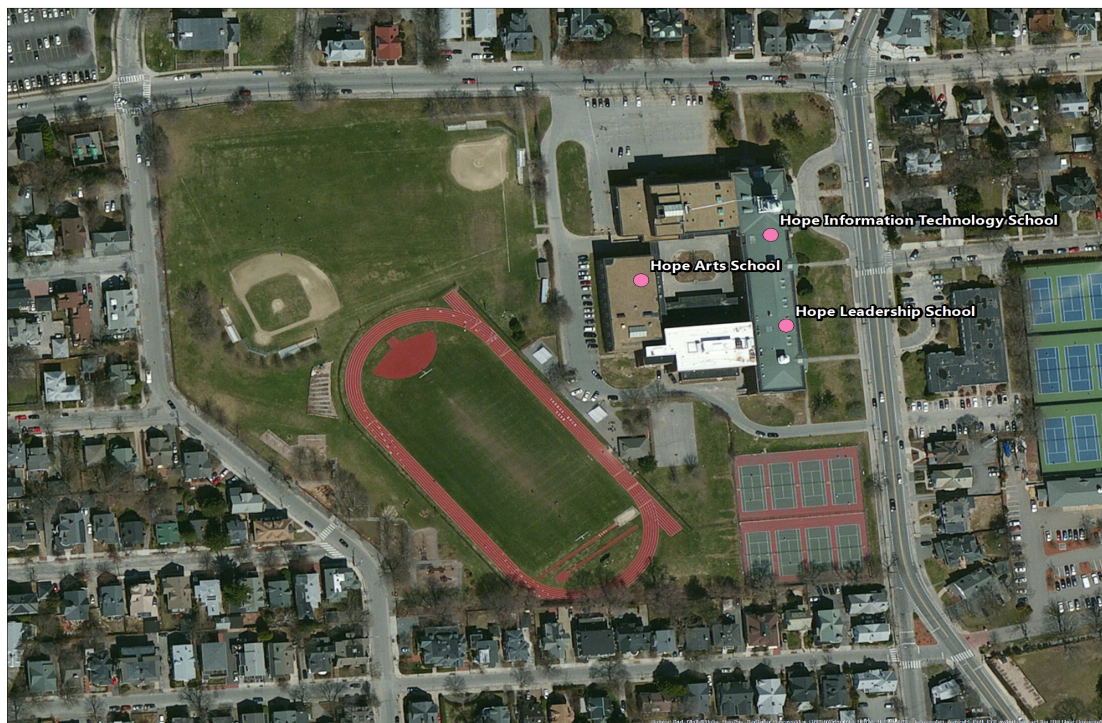
Figure 1: Aerial view of Hope High School / 360 High School

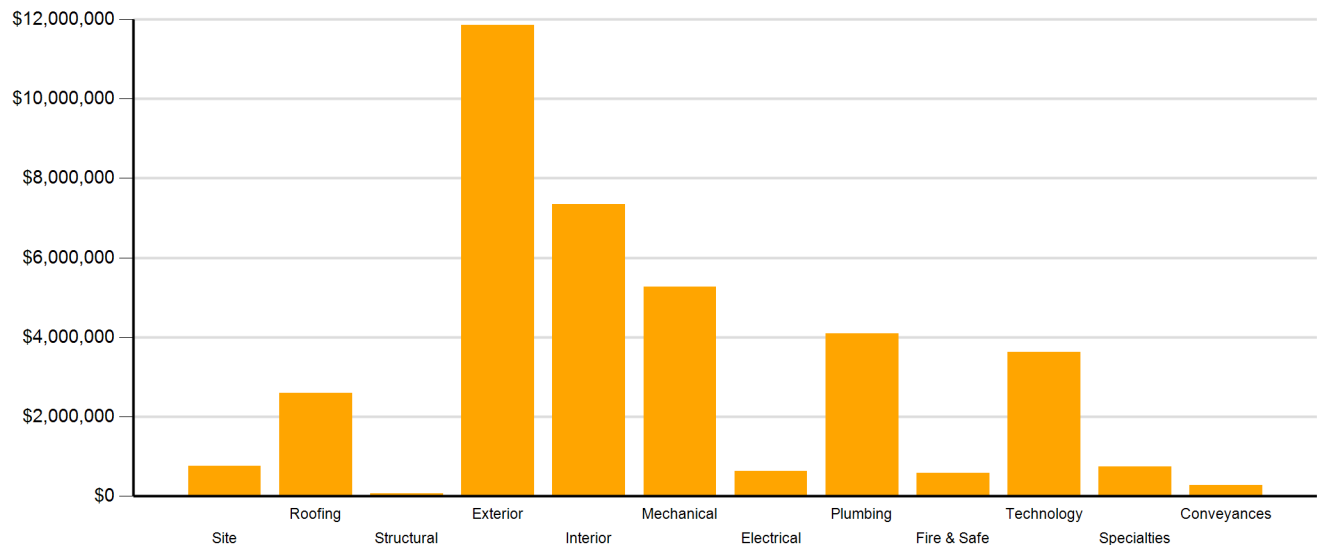
Figure 2: System Deficiencies

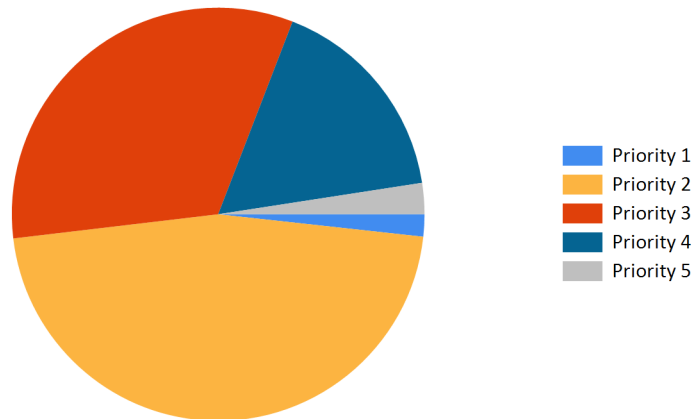
Figure 3: Current deficiencies by priority

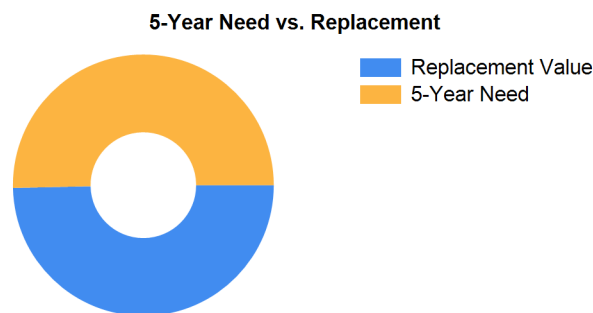
Figure 5: 5-Year FCI

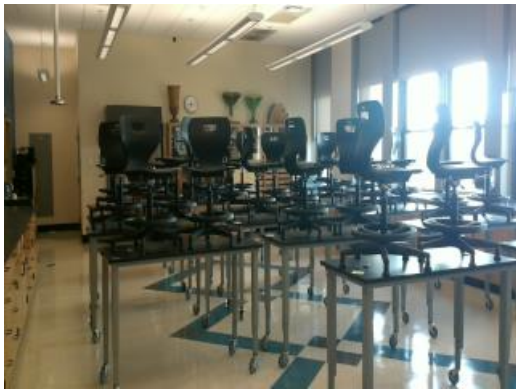
Providence - Hope High School / 360 High School

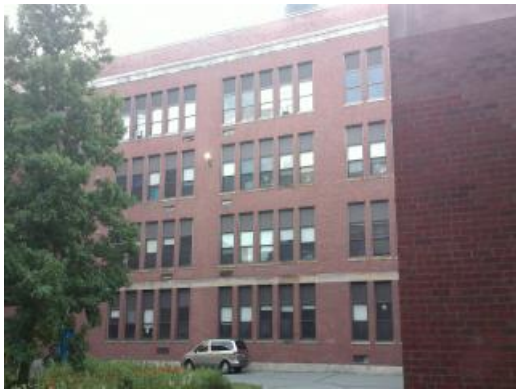
Providence - Hope High School / 360 High School

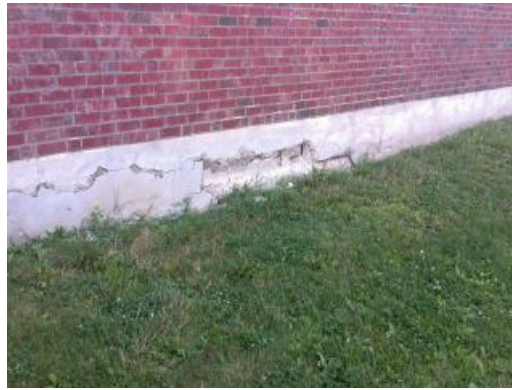
Old Single Pane Windows

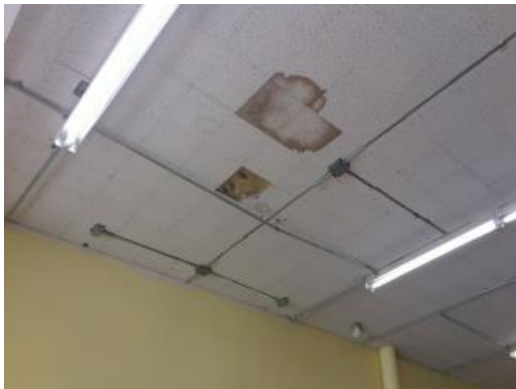
Stained And Missing Adhered Tiles

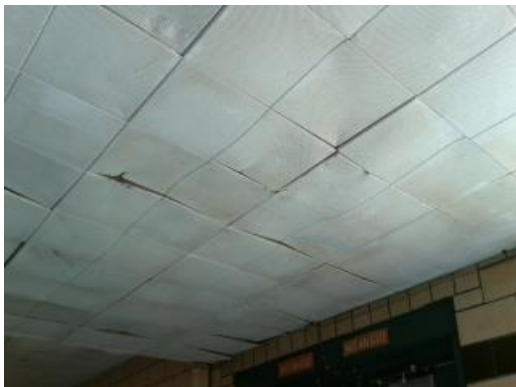
Stained And Warped Adhered Ceiling Tiles

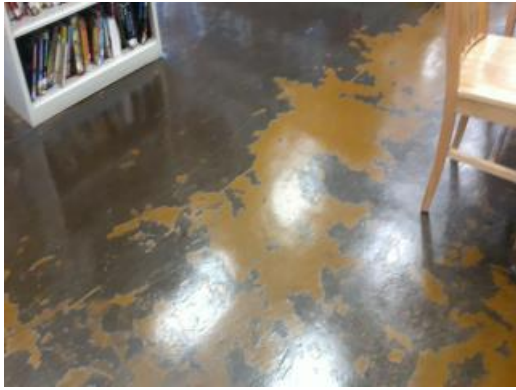
Providence - Hope High School / 360 High School

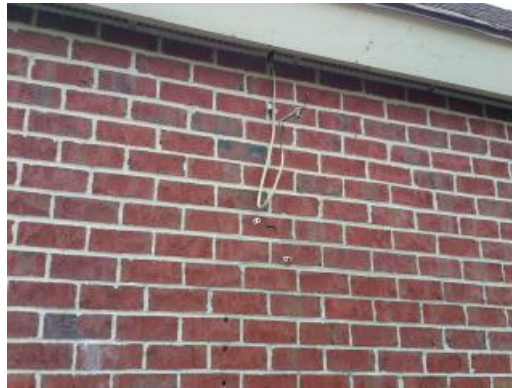
Missing Building Mounted Light Fixture

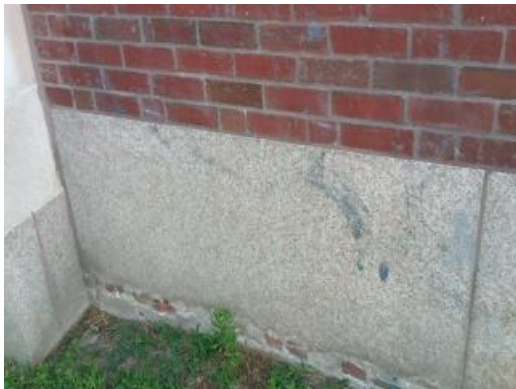
Providence - Hope High School / 360 High School

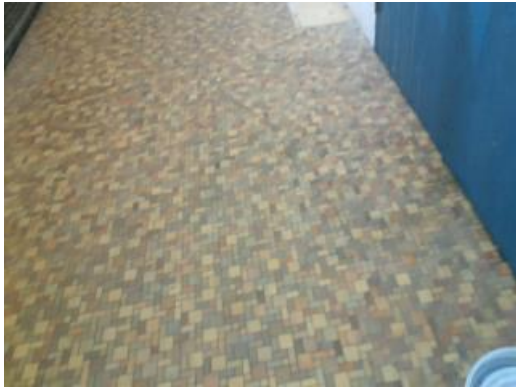
Providence - Hope High School / 360 High School

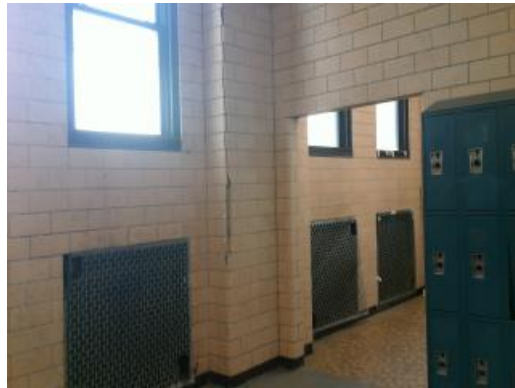
Crack In Boy's Locker Room Wall

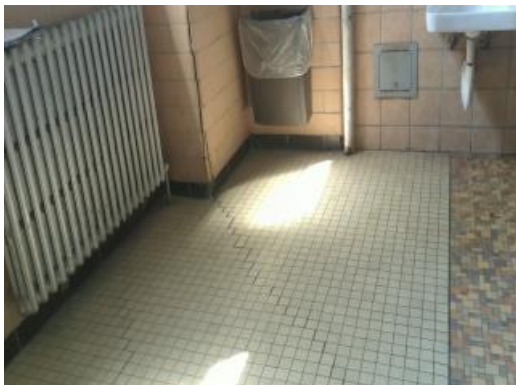
Cracked Floor And Wall In Boy's Locker Room

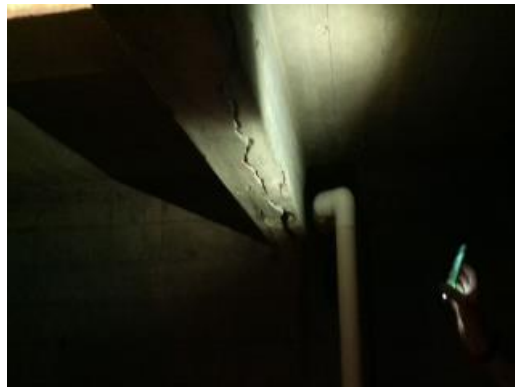
Concrete Beam Under Locker Rooms

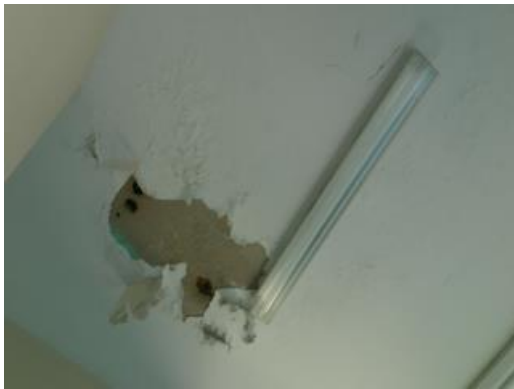
Deteriorating Ceiling

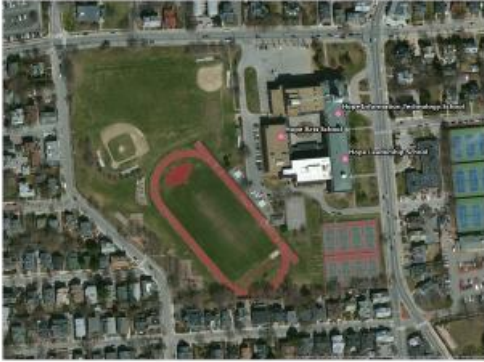
Providence - Hope High School / 360 High School

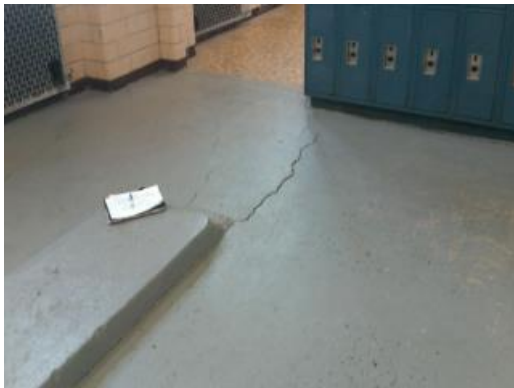
Crack In Boy's Locker Room Floor

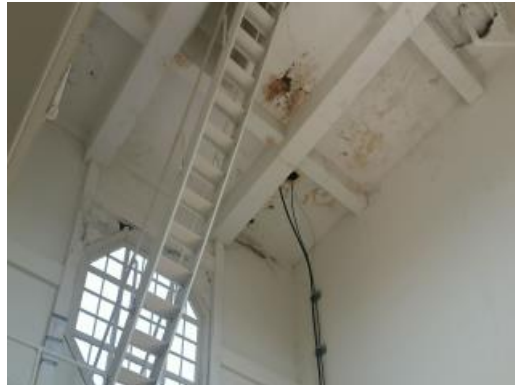
Deteriorating Ceiling

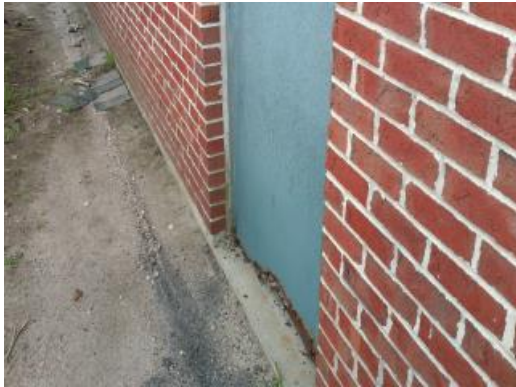
Rusted Exterior Door

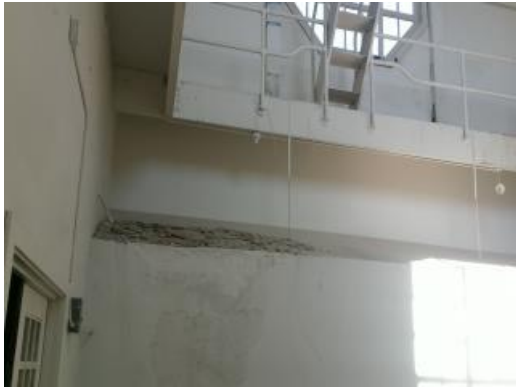
Providence - Hope High School / 360 High School

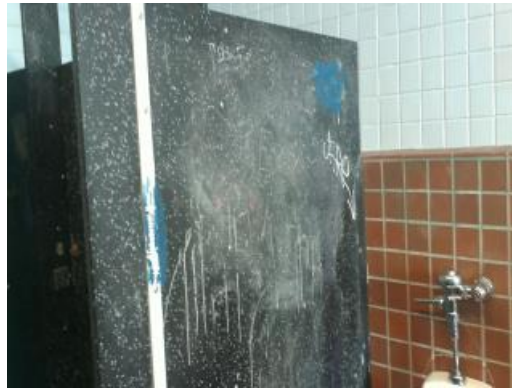
Graffiti On Toilet Partition

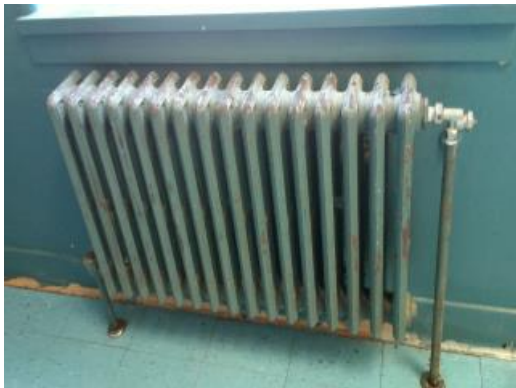
Rusted Radiant Heater

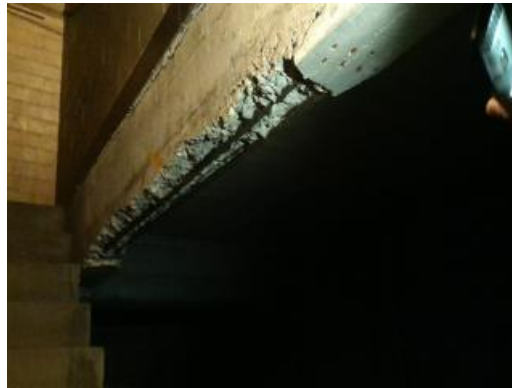
Concrete Beam Under Locker Rooms

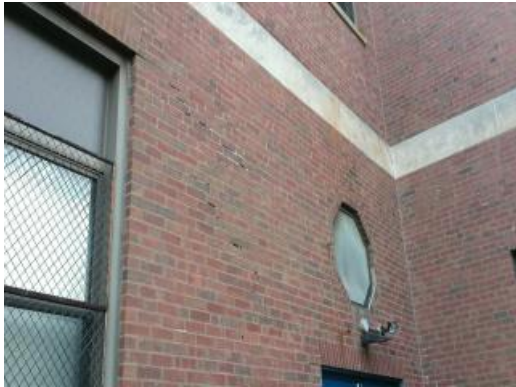
Providence - Hope High School / 360 High School

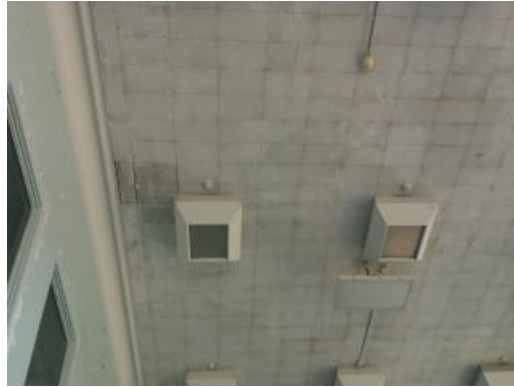
Worn Adhered Ceiling

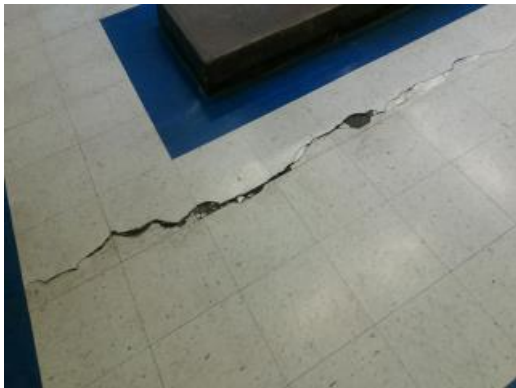
Cracked Floor In Girl's Locker Room

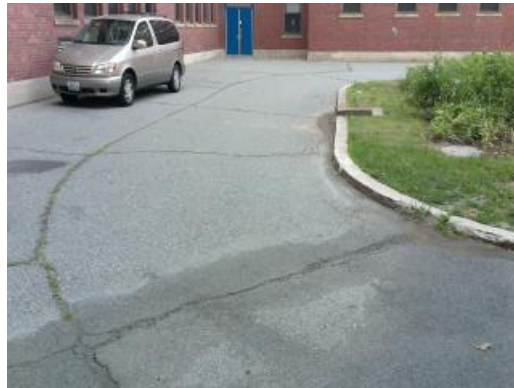
Cracked And Worn Asphalt Roadway

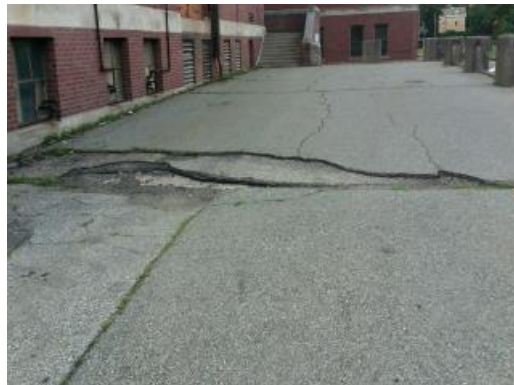
Cracking And Failing Asphalt Pavement

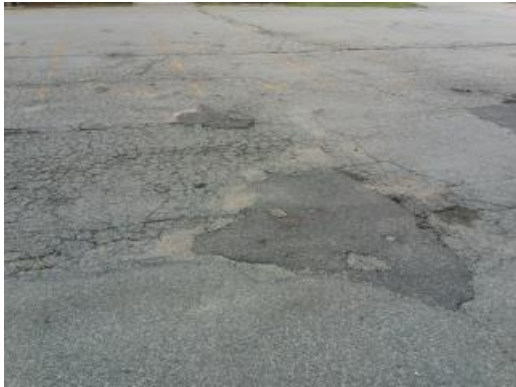
Providence - Hope High School / 360 High School

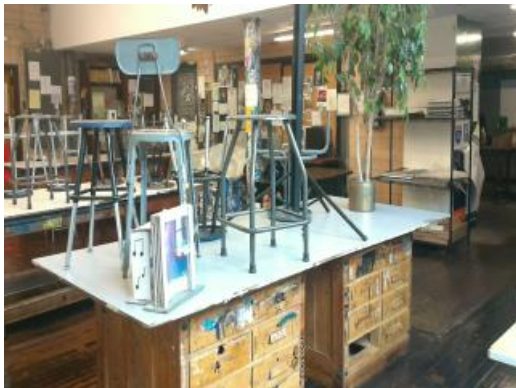
Worn Art Room Casework

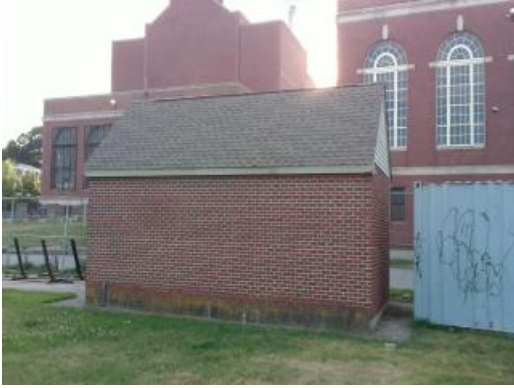
Providence - Hope High School / 360 High School
