# Facility Condition Assessment

Charter - Blackstone Academy Charter School

June 2017

334 Pleasant Street, Pawtucket, RI 02860

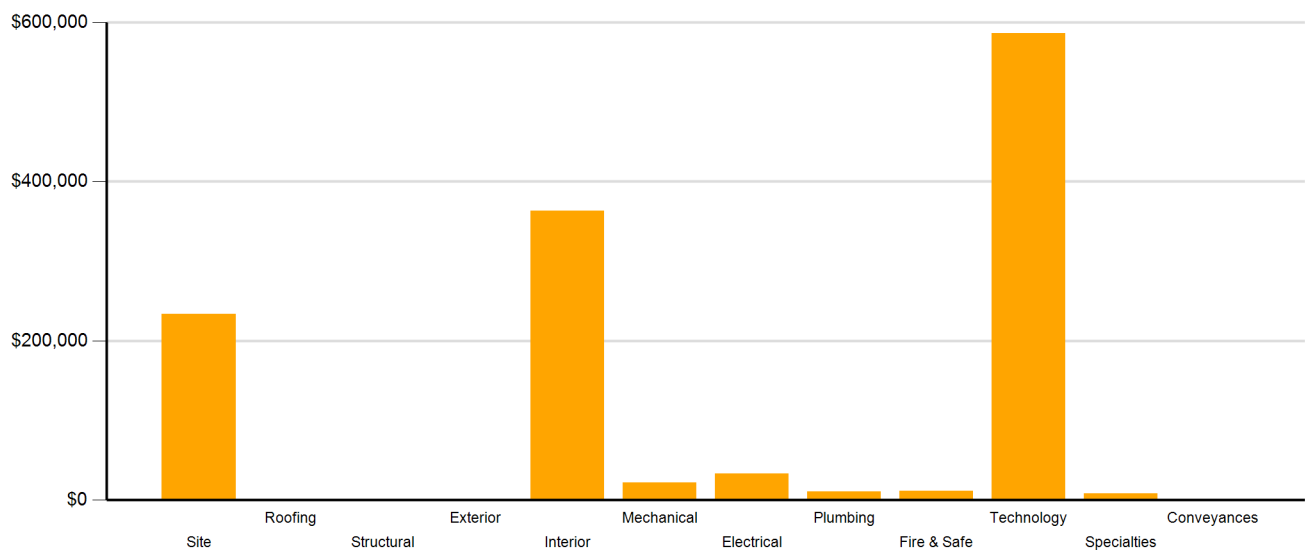
Figure 2: System Deficiencies

Technology	-	\$586,313
Interior	-	\$363,367
Site	-	\$233,483

The chart below represents the building systems and associated deficiency costs.

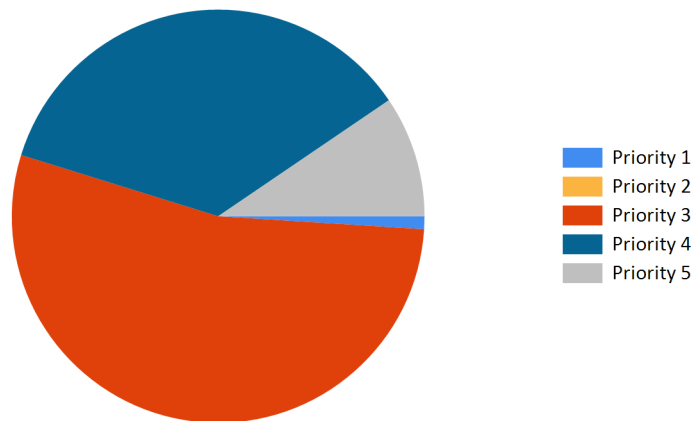
Figure 3: Current deficiencies by priority

The following chart and table represent the deficiency category by priority. This listing includes current deficiencies for all building systems.

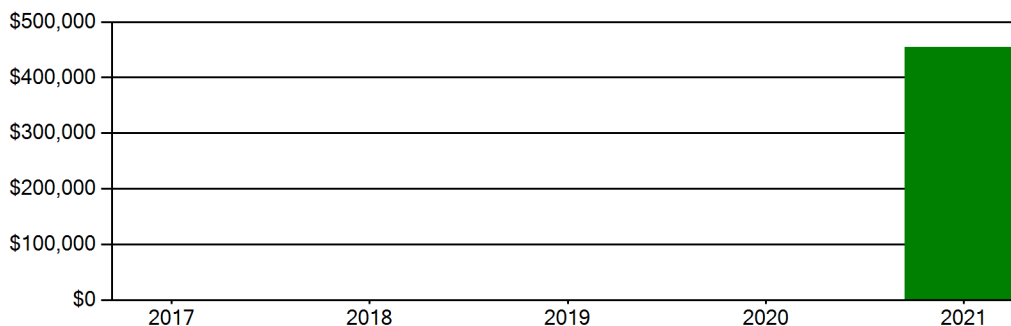
Figure 4: Life Cycle Capital Renewal Forecast

The following chart shows all current deficiencies and the subsequent 5-year life cycle capital renewal projections. The projections outline costs for major building systems in which a component is expected to reach the end of its useful life and require capital funding for replacement.

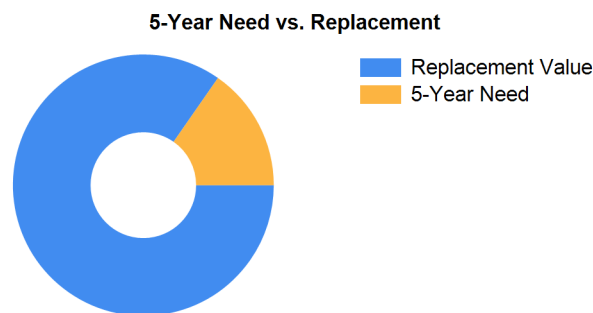
Figure 5: 5-Year FCI

The replacement value represents the estimated cost of replacing the current building with another building of like size, based on today's estimated cost of construction in the Providence, Rhode Island area. The estimated replacement cost for this facility is \$10,800,000. For planning purposes, the total 5-year need at the Blackstone Academy Charter School is \$1,722,638 (Life Cycle Years 1-5 plus the FCI deficiency cost). The Blackstone Academy Charter School facility has a 5-year FCI of 15.95%.

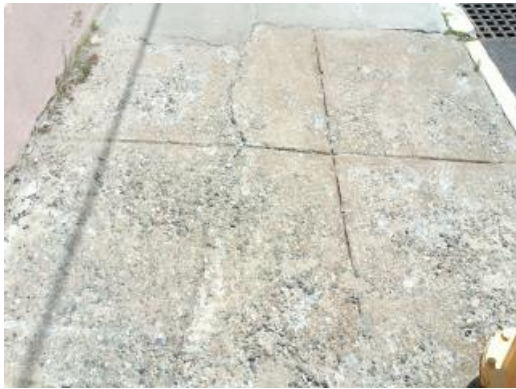
Spalled Sidewalk

Deficiency	Category	Qty	UoM	Priority	Repair Cost	ID
Concrete Walks Require Replacement	Capital Renewal	400	SF	3	\$8,121	16651
Install New Playground Equipment	Barrier to Accessibility	1	SF	3	\$87,771	54973
<b>Note:</b> Install New Playground Equipment						
Asphalt Paving Requires Replacement	Capital Renewal	12	CAR	4	\$39,435	16650
<b>Note:</b> Asphalt surface is cracked and weathered with some alligating.						
Backstops Require Replacement	Educational Adequacy	1	Ea.	4	\$28,329	28642
<b>Note:</b> Backstops Require Replacement						
Exterior Basketball Goals are Required	Educational Adequacy	1	Ea.	5	\$5,807	28838
<b>Note:</b> Exterior Basketball Goals are Required						
PE / Recess Playfield is Missing and is Needed	Educational Adequacy	1	Ea.	5	\$64,020	54974
<b>Note:</b> PE / Recess Playfield is Missing and is Needed						
<b>Sub Total for System</b>		<b>6</b>	<b>items</b>		<b>\$233,483</b>	
<b>Sub Total for School and Site Level</b>		<b>6</b>	<b>items</b>		<b>\$233,483</b>

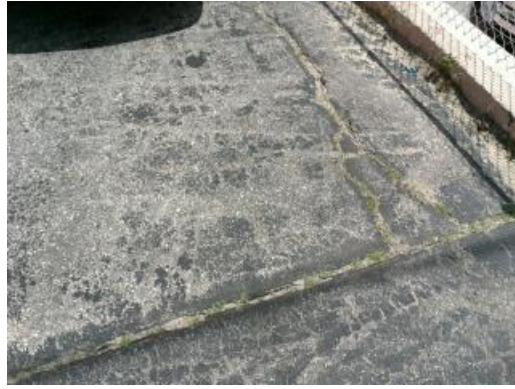
Cracked And Weathered Parking
