# Facility Condition Assessment

Exeter-West Greenwich - Wawaloam School

June 2017

100 Victory Highway, Exeter, RI 02822

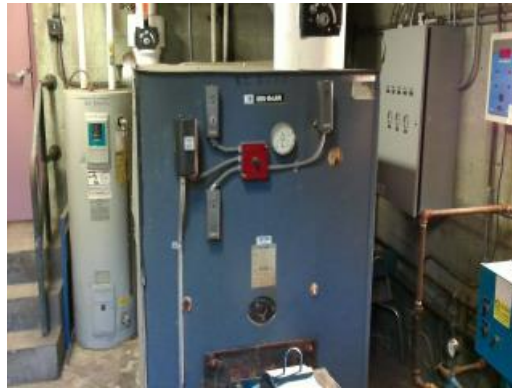
Original Boiler

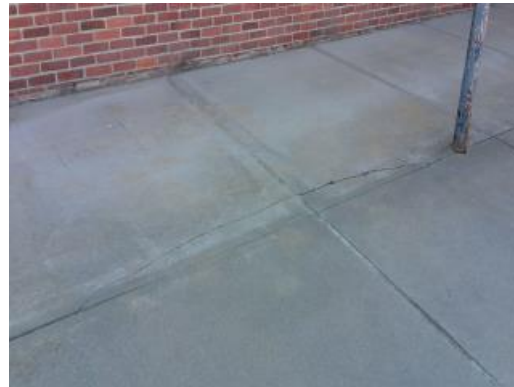
Sidewalk At North Entrance

Deficiency	Category	Qty	UoM	Priority	Repair Cost	ID
Concrete Walks Require Replacement	Capital Renewal	600	SF	3	\$12,181	964
Asphalt Paving Requires Replacement	Capital Renewal	68	CAR	4	\$199,057	967
Backstops Require Replacement	Educational Adequacy	1	Ea.	4	\$28,329	28474
<b>Note:</b> Backstops Require Replacement						
Exterior Basketball Goals are Required	Educational Adequacy	1	Ea.	5	\$5,807	28740
<b>Note:</b> Exterior Basketball Goals are Required						
	<b>Sub Total for System</b>	<b>4</b>	<b>items</b>		<b>\$245,375</b>	
	<b>Sub Total for School and Site Level</b>	<b>4</b>	<b>items</b>		<b>\$245,375</b>

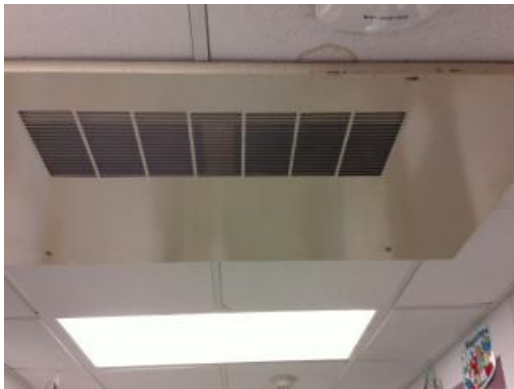
Unit Heater

Deficiency	Category	Qty	UoM	Priority	Repair Cost	ID
Steam/HW Unit Heater Requires Replacement	Capital Renewal	32	Ea.	2	\$76,421	961
Steam/HW Unit Heater Requires Replacement	Capital Renewal	7	Ea.	2	\$16,717	963
Existing Controls Are Inadequate And Should Be Replaced With DDC Controls	Capital Renewal	20,150	SF	4	\$121,328	1840
Existing Controls Are Inadequate And Should Be Replaced With DDC Controls	Capital Renewal	20,150	SF	4	\$136,107	1841
<b>Note:</b> Replace pneumatic controls with new DDC controls.						
Small HVAC Circulating Pump Requires Replacement	Capital Renewal	2	Ea.	4	\$19,060	954
	<b>Sub Total for System</b>	<b>5</b>	<b>items</b>		<b>\$369,633</b>

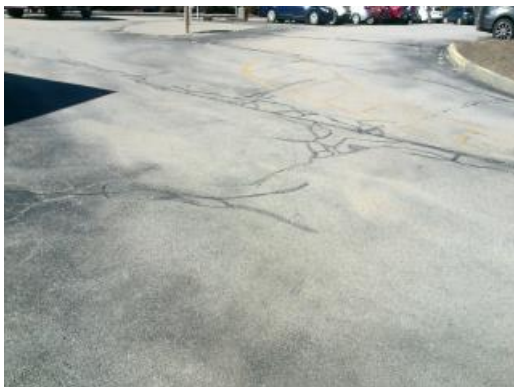
Cracked Asphalt Paving

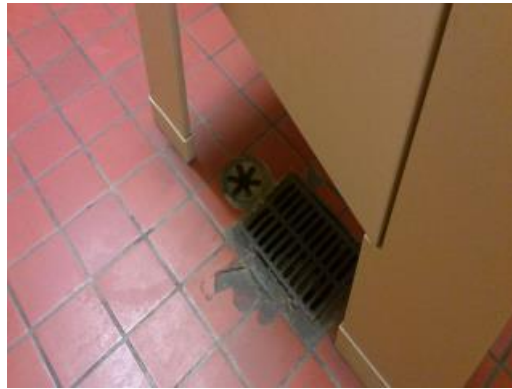
Broken Quarry Tile Flooring

<b>Note:</b> Gym						
Room Is Excessively Reverberant	Acoustics	4,000	SF	4	\$34,796	4747
<b>Note:</b> Cafeteria						
The Stone/Quarry Flooring Requires Replacement	Capital Renewal	574	SF	4	\$26,139	978
<b>Note:</b> Quarry tile in original boys and girls toilet rooms						
Room lacks appropriate sound control.	Educational Adequacy	100	SF	5	\$3,480	Rollup
	<b>Sub Total for System</b>	<b>9</b>	<b>items</b>		<b>\$313,029</b>

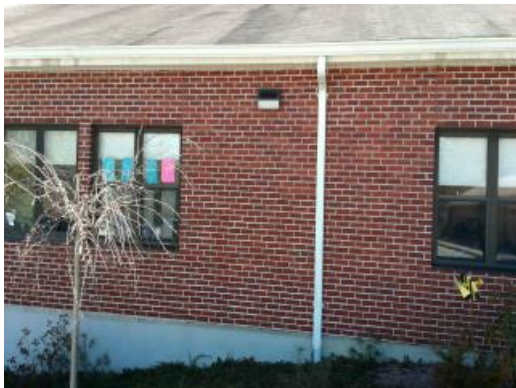
Older Building Lights

Uniformat Description	LC Type Description	Qty	UoM	Repair Cost	Remaining Life
Lighting Fixtures	Building Mounted Fixtures (Ea.)	17	Ea.	\$25,374	3
Lighting Fixtures	Light Fixtures (Bldg SF)	40,300	SF	\$239,457	5
		<b>Sub Total for System</b>	<b>2 items</b>	<b>\$264,831</b>

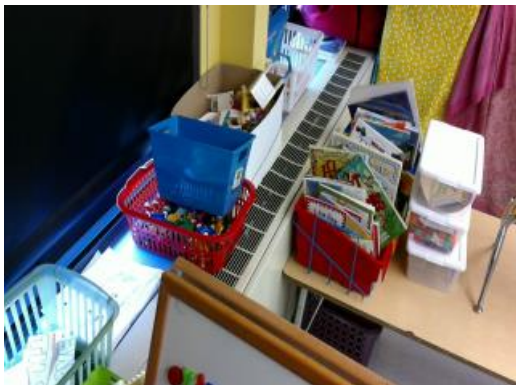
Blocked Vent

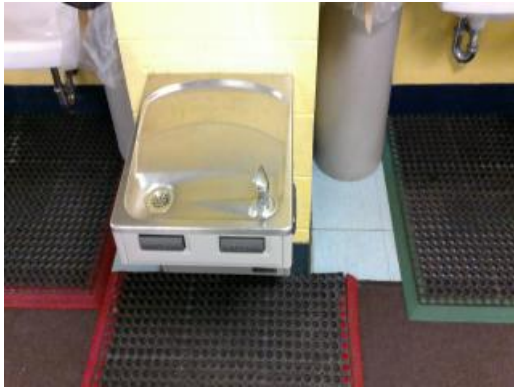
Refrigerated Drinking Fountain

Uniformat Description	LC Type Description	Qty	UoM	Repair Cost	Remaining Life
Plumbing Fixtures	Refrigerated Drinking Fountain	4	Ea.	\$29,510	3
Domestic Water Equipment	Water Heater - Electric - 52 gallon	1	Ea.	\$3,255	3
		<b>Note:</b> 52 gallon electric water heater			
		<b>Sub Total for System</b>	<b>2 items</b>	<b>\$32,765</b>

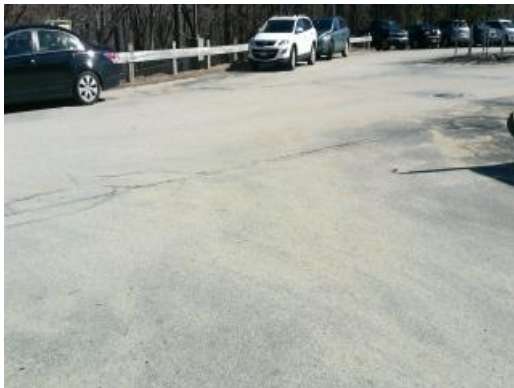
Weathered Asphalt

Uniformat Description	LC Type Description	Qty	UoM	Repair Cost	Remaining Life
Parking Lot Pavement	Asphalt	32	CAR	\$105,873	3
Roadway Pavement	Asphalt	17	CAR	\$56,245	3
		<b>Sub Total for System</b>	<b>2 items</b>	<b>\$162,118</b>	
		<b>Sub Total for Building -</b>	<b>2 items</b>	<b>\$162,118</b>
