# Facility Condition Assessment

Woonsocket - Citizens Memorial School

June 2017

250 Winthrop Street, Woonsocket, RI 02895

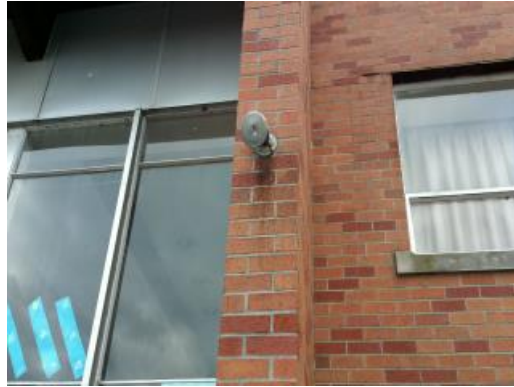
Original Building Mounted Lights

| Deficiency | Category | Qty | UoM | Priority | Repair Cost | ID |
|---|---|---|---|---|---|---|
| The Mounted Building Lighting Requires Replacement<br><b>Note:</b> Upgrade lighting. Replace lights with brighter, more energy efficient ones.<br><b>Location:</b> Exterior | Capital Renewal | 18 | Ea. | 3 | \$26,867 | 624 |

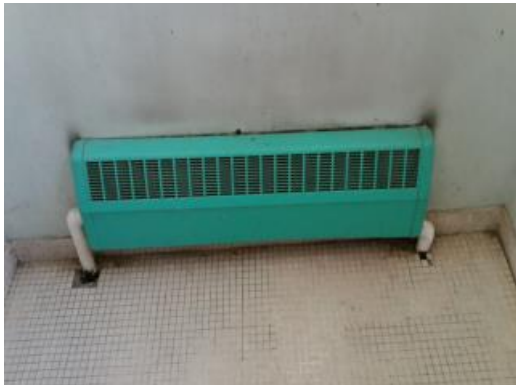
Original Radiant Heater

| Deficiency | Category | Qty | UoM | Priority | Repair Cost | ID |
|---|---|---|---|---|---|---|
| The Steam/Hot Water Radiant Heater Requires Replacement<br><b>Note:</b> Radiant heaters are original to the building and should be replaced. | Capital Renewal | 104 | Ea. | 2 | \$537,273 | 600 |

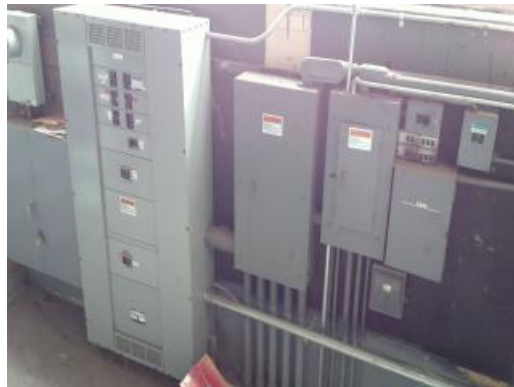
Boiler Room Panels

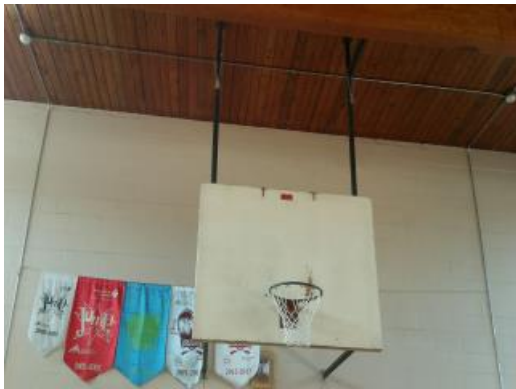
Gym Backboard

| Deficiency | Category | Qty | UoM | Priority | Repair Cost | ID |
|---|---|---|---|---|---|---|
| Exterior Basketball Goals Require Repair | Capital Renewal | 2 | Ea. | 5 | \$1,133 | 636 |

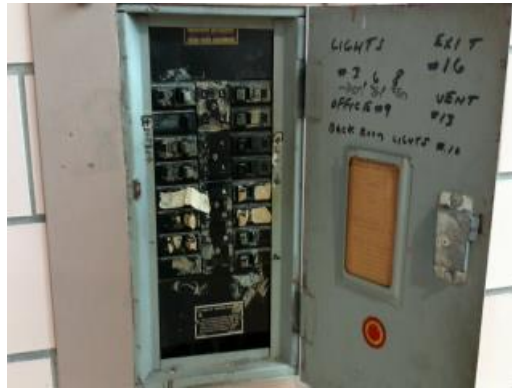
Gym Panelboard

| Deficiency | Category | Qty | UoM | Priority | Repair Cost | ID |
|---|---|---|---|---|---|---|
| The Panelboard Requires Replacement<br><b>Location:</b> Gymnasium | Capital Renewal | 1 | Ea. | 2 | \$4,849 | 628 |

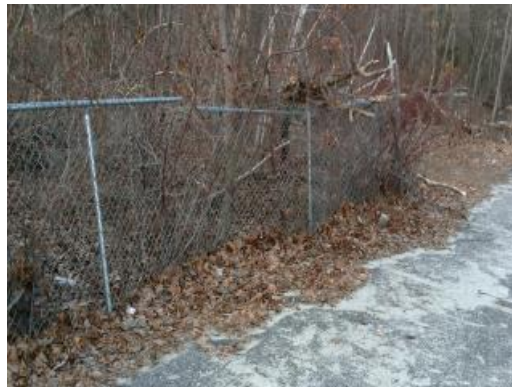
Failing Chain Link Fence

| Deficiency | Category | Qty | UoM | Priority | Repair Cost | ID |
|---|---|---|---|---|---|---|
| Fencing Requires Replacement (4' Chain Link Fence) | Capital Renewal | 425 | LF | 4 | \$27,290 | 623 |

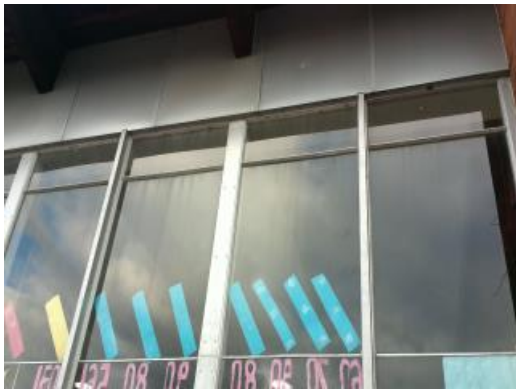
| Deficiency | Category | Qty | UoM | Priority | Repair Cost | ID |
|---|---|---|---|---|---|---|
| <b>Note:</b> Glazing is currently failing, glass is cloudy | | | | | | |

Clouded Storefront Windows

| Deficiency | Category | Qty | UoM | Priority | Repair Cost | ID |
|---|---|---|---|---|---|---|
| The Storefront/Curtain Wall Requires Replacement (Bldg SF) | Functional Deficiency | 13,758 | SF | 2 | \$1,109,158 | 625 |

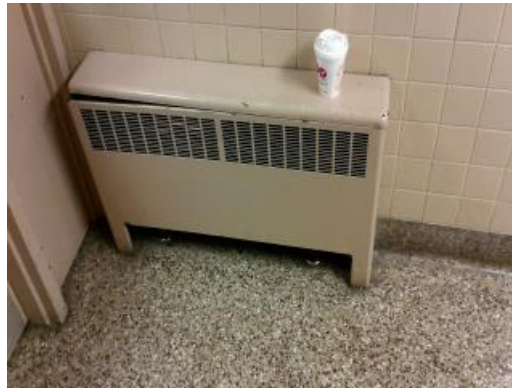
Damaged Radiant Heater

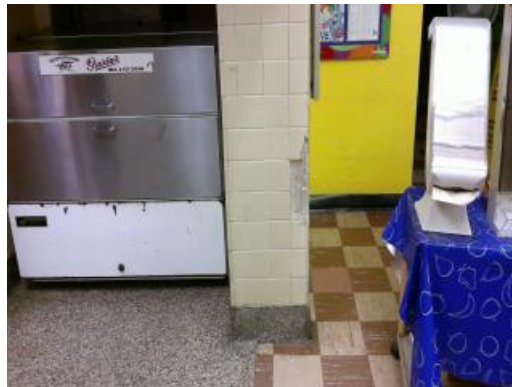
Damaged Ceramic Tile Wall

| Deficiency | Category | Qty | UoM | Priority | Repair Cost | ID |
|---|---|---|---|---|---|---|
| Interior Ceramic Walls Require Repair Or Replacement<br><b>Note:</b> Tiles are missing or broken.<br><b>Location:</b> Cafeteria | Capital Renewal | 600 | SF | 4 | \$13,348 | 610 |

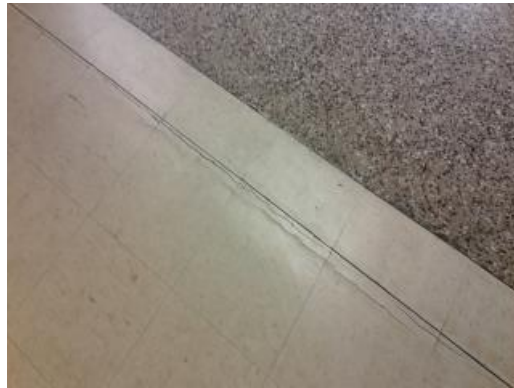
Cracked VCT

| Deficiency | Category | Qty | UoM | Priority | Repair Cost | ID |
|---|---|---|---|---|---|---|
| The Vinyl Composition Tile Requires Replacement | Capital Renewal | 12,000 | SF | 3 | \$137,661 | 638 |

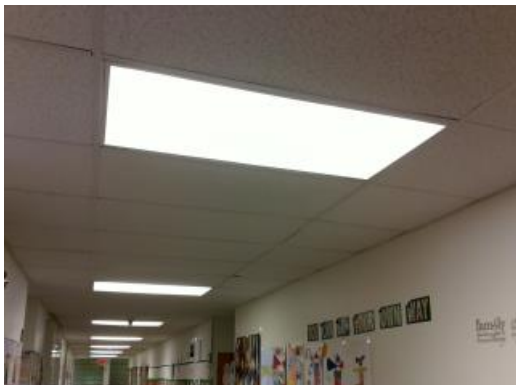
Hallway/Corridor Lighting

| Deficiency | Category | Qty | UoM | Priority | Repair Cost | ID |
|---|---|---|---|---|---|---|
| The Lighting Fixtures Require Replacement<br><b>Note:</b> Fluorescent lighting | Capital Renewal | 30,000 | SF | 2 | \$178,256 | 618 |

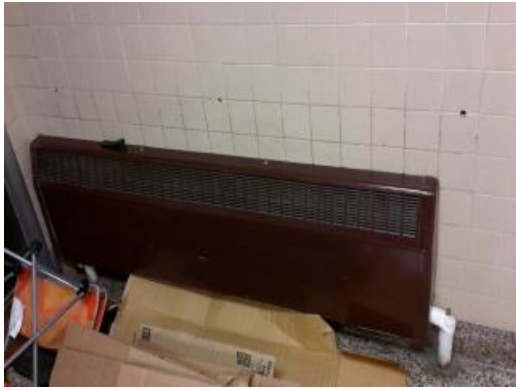
Original Radiant Heater

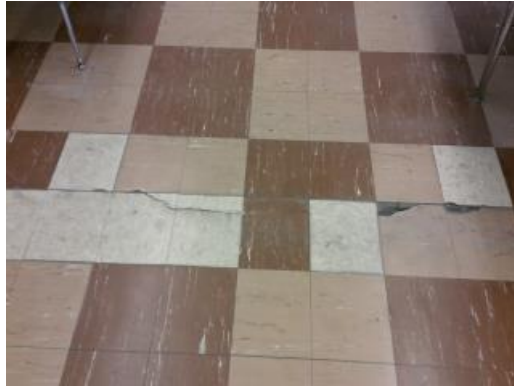
Chipped And Cracked 9X9 Tile

| Deficiency | Category | Qty | UoM | Priority | Repair Cost | ID |
|---|---|---|---|---|---|---|
| 9x9 Asbestos Tile Present and In Active Use, Greater than 25 Percent has Significant Deterioration | Hazardous Material | 16,051 | SF | 4 | \$457,789 | Rollup |

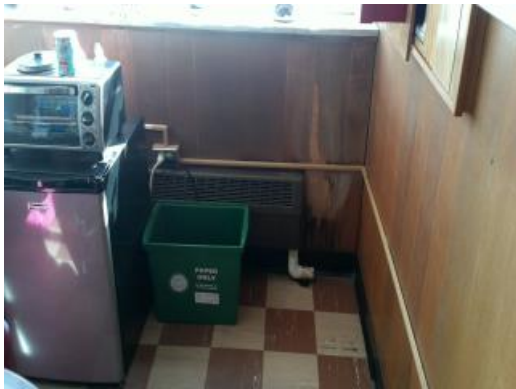
Damaged Wood Panel Walls

| Deficiency | Category | Qty | UoM | Priority | Repair Cost | ID |
|---|---|---|---|---|---|---|
| Interior Wood Walls Require Replacement<br><b>Location:</b> Principal's Office | Capital Renewal | 250 | SF | 4 | \$2,282 | 620 |

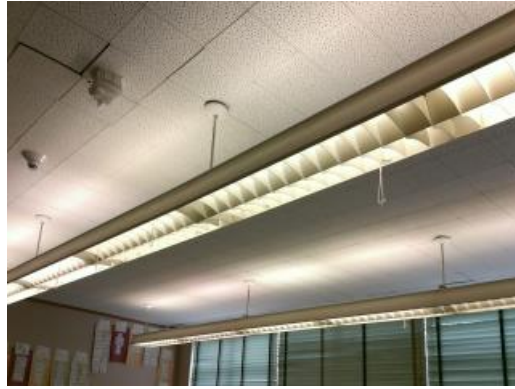
Old Wing Classroom Lighting

| Deficiency | Category | Qty | UoM | Priority | Repair Cost | ID |
|---|---|---|---|---|---|---|
| The Lighting Fixtures Require Replacement<br><b>Note:</b> H8 light hanging fixtures<br><b>Location:</b> 4th & 5th classrooms | Capital Renewal | 15,000 | SF | 2 | \$89,128 | 617 |

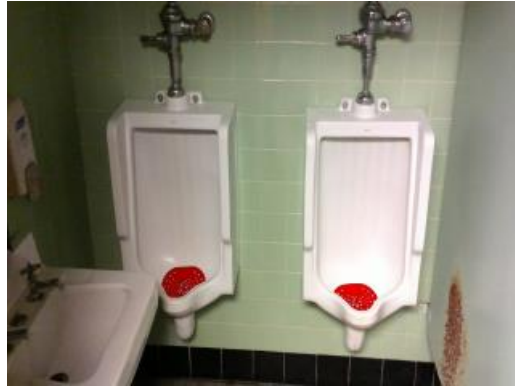
Urinals

| Deficiency | Category | Qty | UoM | Priority | Repair Cost | ID |
|---|---|---|---|---|---|---|
| The Urinal Plumbing Fixtures Require Replacement | Capital Renewal | 2 | Ea. | 3 | \$2,658 | 605 |

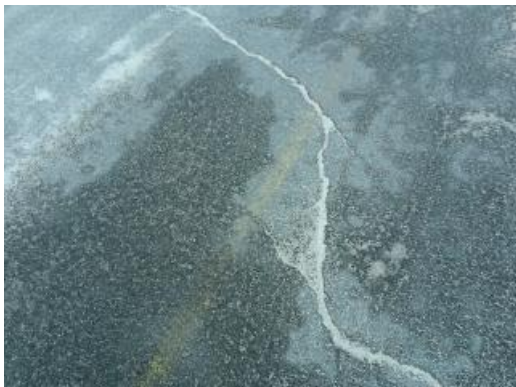
| Deficiency | Category | Qty | UoM | Priority | Repair Cost | ID |
|---|---|---|---|---|---|---|
| <b>Note:</b> Paved play area is cracked and worn. | | | | | | |

Cracked Asphalt

| Deficiency | Category | Qty | UoM | Priority | Repair Cost | ID |
|---|---|---|---|---|---|---|
| Asphalt Paving Requires Replacement | Capital Renewal | 55 | CAR | 4 | \$180,743 | 645 |

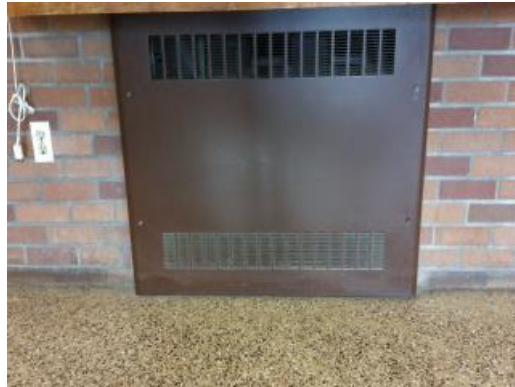
| Deficiency | Category | Qty | UoM | Priority | Repair Cost | ID |
|---|---|---|---|---|---|---|
| Steam/HW Unit Heater Requires Replacement<br><b>Note:</b> Original unit heaters | Capital Renewal | 3 | Ea. | 2 | \$8,448 | 604 |

Original Unit Heater

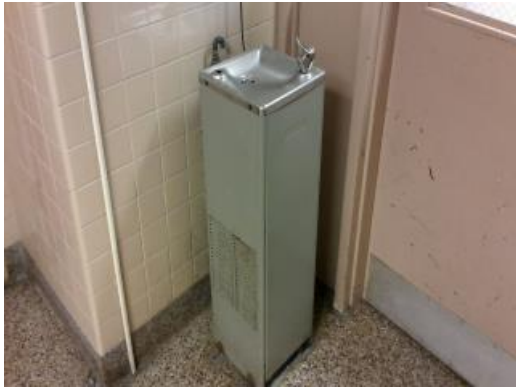
Original Water Cooler

| Deficiency | Category | Qty | UoM | Priority | Repair Cost | ID |
|---|---|---|---|---|---|---|
| The Refrigerated Water Cooler Requires Replacement | Capital Renewal | 3 | Ea. | 4 | \$22,132 | 603 |

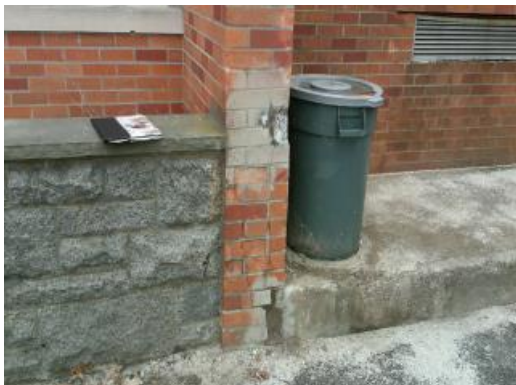
Damaged Brick Wall

| Deficiency | Category | Qty | UoM | Priority | Repair Cost | ID |
|---|---|---|---|---|---|---|
| The Brick Exterior Requires Repair | Capital Renewal | 20 | SF Wall | 3 | \$1,331 | 648 |

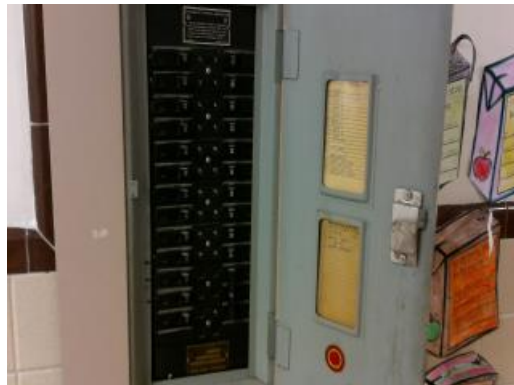
Aged Panelboard

| Deficiency | Category | Qty | UoM | Priority | Repair Cost | ID |
|---|---|---|---|---|---|---|
| The Panelboard Requires Replacement<br><b>Note:</b> 4th Grade Hallway Panel | Capital Renewal | 1 | Ea. | 2 | \$4,849 | 630 |

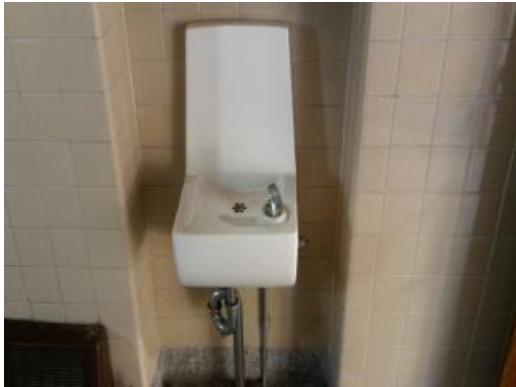
Broken Drinking Fountain

| Deficiency | Category | Qty | UoM | Priority | Repair Cost | ID |
|---|---|---|---|---|---|---|
| Non-Refrigerated Drinking Fountain Requires Replacement | Capital Renewal | 1 | Ea. | 4 | \$10,220 | 629 |

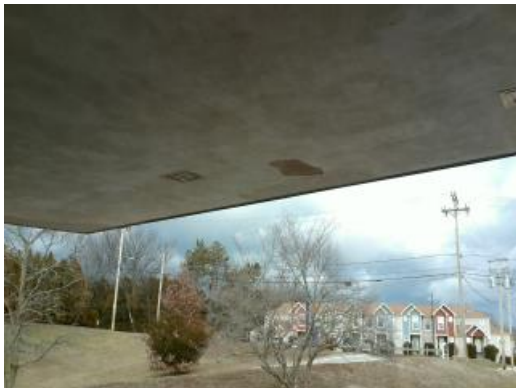
| Deficiency | Category | Qty | UoM | Priority | Repair Cost | ID |
|---|---|---|---|---|---|---|
| <b>Note:</b> Soffit shows signs of water damage | | | | | | |

Water Damaged Soffit

| Deficiency | Category | Qty | UoM | Priority | Repair Cost | ID |
|---|---|---|---|---|---|---|
| The Exterior Soffit Requires Repair | Capital Renewal | 300 | SF | 5 | \$6,548 | 632 |

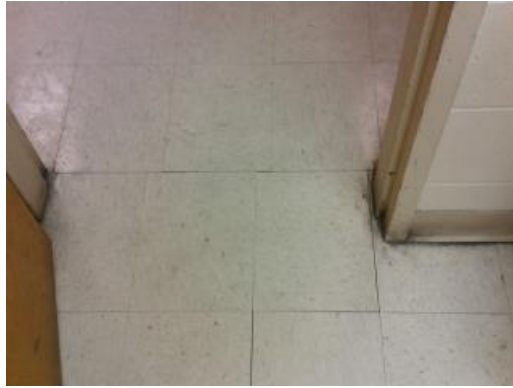
Separating VCT Flooring

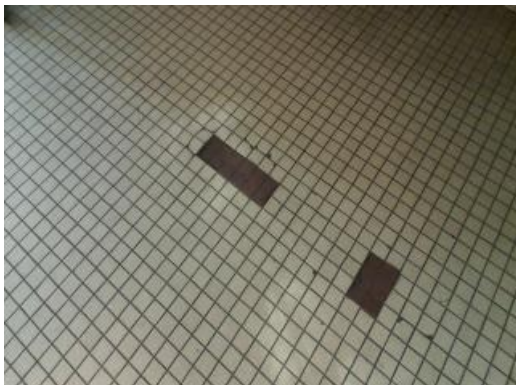
Missing Ceramic Tiles

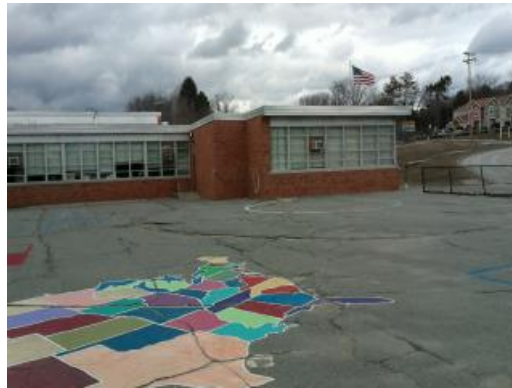
Paved Play Area

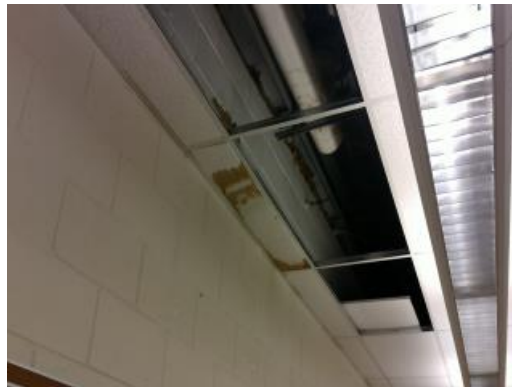
| Deficiency | Category | Qty | UoM | Priority | Repair Cost | ID |
|---|---|---|---|---|---|---|
| <b>Note:</b> Evidence of leaking in classrooms. | | | | | | |

Leaking Roof Drain

| Deficiency | Category | Qty | UoM | Priority | Repair Cost | ID |
|---|---|---|---|---|---|---|
| EPDM Roofing Requires Replacement (Bldg SF) | Functional Deficiency | 12,000 | SF | 2 | \$151,731 | 631 |

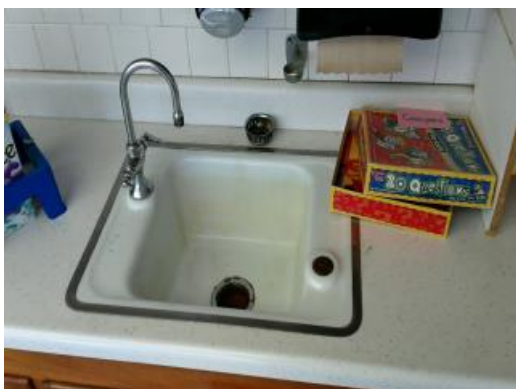
Original Classroom Lavatory

| Deficiency | Category | Qty | UoM | Priority | Repair Cost | ID |
|---|---|---|---|---|---|---|
| The Classroom Lavatories Plumbing Fixtures Require Replacement | Capital Renewal | 5 | Ea. | 4 | \$13,595 | 608 |

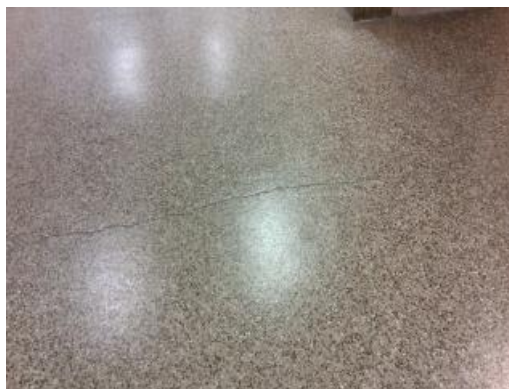
Cracked Terrazzo

| Deficiency | Category | Qty | UoM | Priority | Repair Cost | ID |
|---|---|---|---|---|---|---|
| The Terrazzo Flooring Requires Replacement | Capital Renewal | 2,000 | SF | 3 | \$148,309 | 634 |

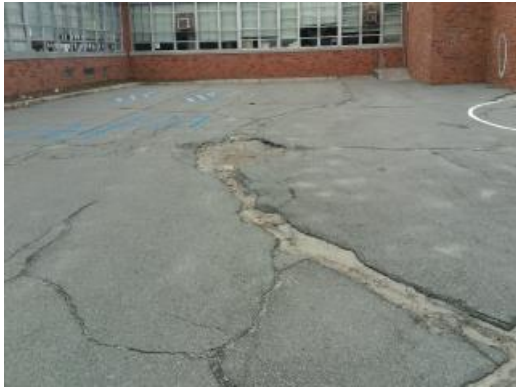
Worn Play Area Asphalt

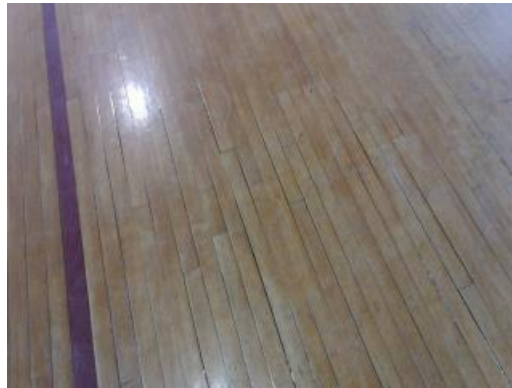
Worn Gym Floor

| Deficiency | Category | Qty | UoM | Priority | Repair Cost | ID |
|---|---|---|---|---|---|---|
| The Wood Flooring Requires Repair<br><b>Location:</b> Gymnasium | Capital Renewal | 600 | SF | 4 | \$864 | 637 |

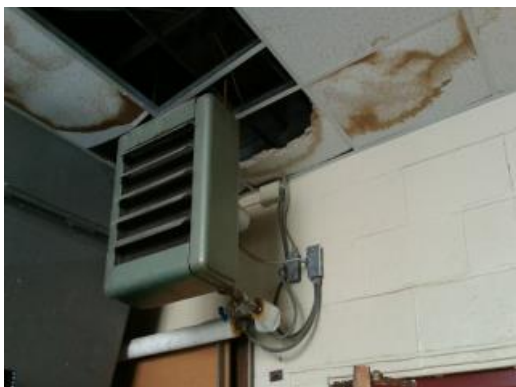
Original Unit Heater

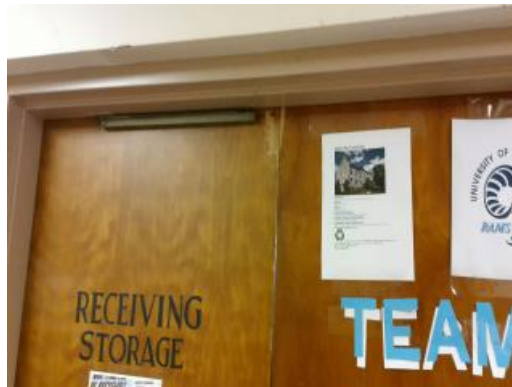
| Deficiency | Category | Qty | UoM | Priority | Repair Cost | ID |
|---|---|---|---|---|---|---|
| <b>Note:</b> Doors and frames are aged and worn and hardware is not compliant. | | | | | | |

Interior Wood Door

| Deficiency | Category | Qty | UoM | Priority | Repair Cost | ID |
|---|---|---|---|---|---|---|
| Interior Doors Require Replacement | Capital Renewal | 66 | Door | 3 | \$304,318 | 613 |

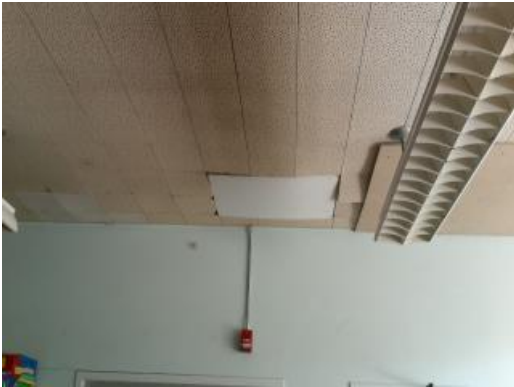
Discolored and Falling Adhered Ceiling Tiles

| Deficiency | Category | Qty | UoM | Priority | Repair Cost | ID |
|---|---|---|---|---|---|---|
| Adhered Acoustical Ceiling Tile Requires Replacement<br><b>Location:</b> Original Building | Capital Renewal | 18,344 | SF | 4 | \$198,920 | 622 |
