Facility Condition Assessment

June 2017

Austin T. Levy School, located at 135 Harrisville Main Street in Harrisville, Rhode Island, was built in 1958. It comprises 42,600 gross square feet. Each school across the district was visited three times during the Facility Condition Assessments by three teams of specialists in the spring/summer of 2016.

Burrillville - Austin T. Levy School

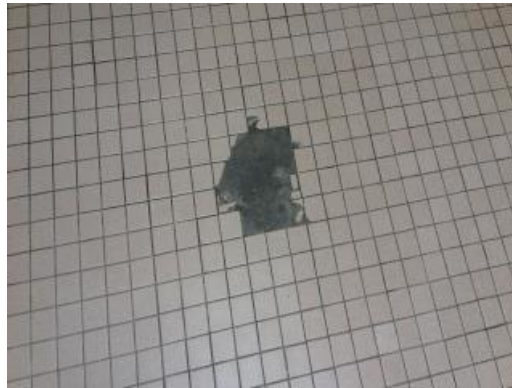
Damaged Ceramic Tile

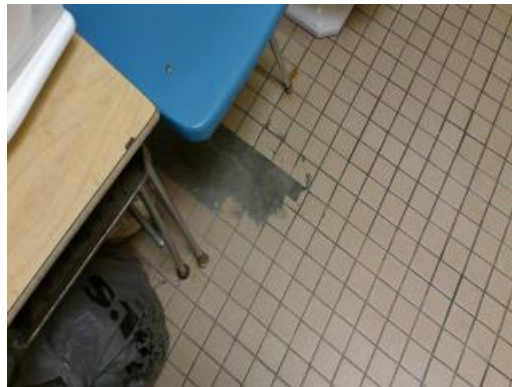
Damaged Ceramic Tile

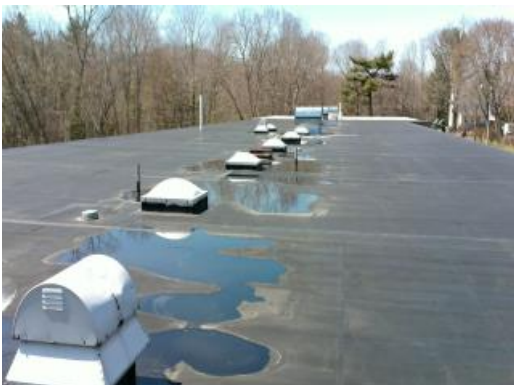
Roof With Ponding

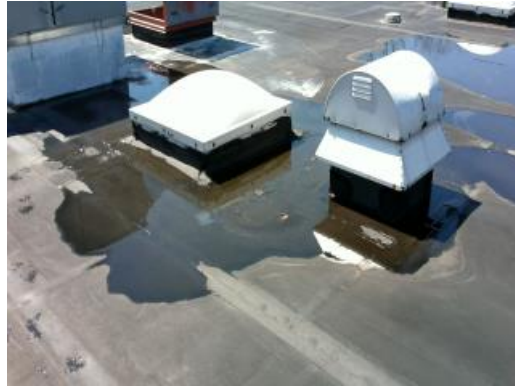
Roof With Ponding

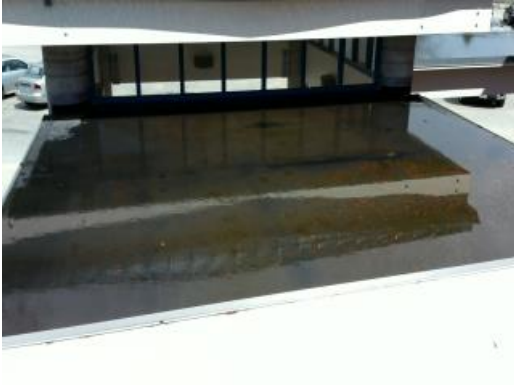
Ponding On Roof

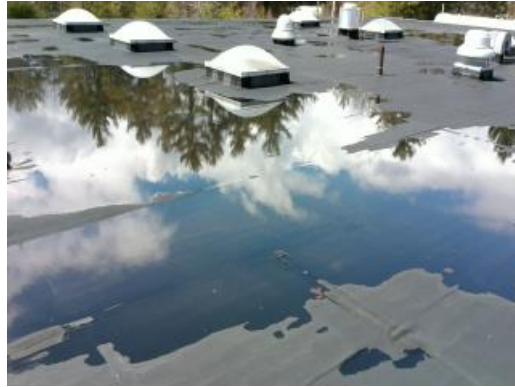
Ponding On Roof

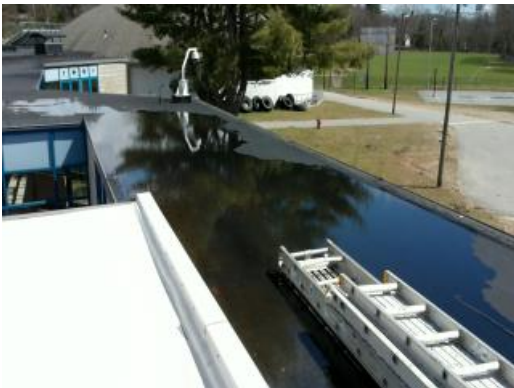
Ponding On Roof

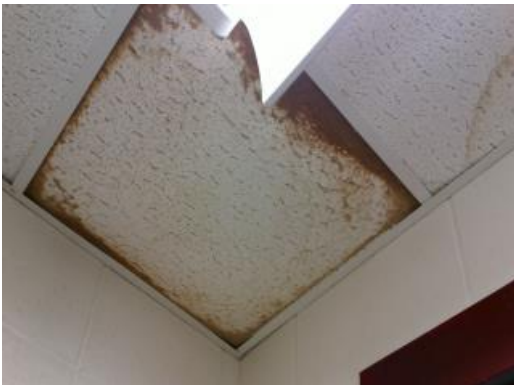
Stained Ceiling Tile

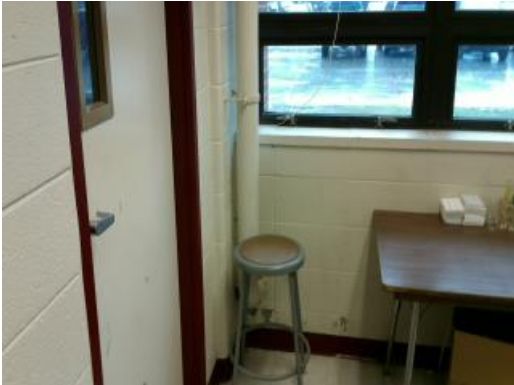
Non-Insulated Storm Drain Piping

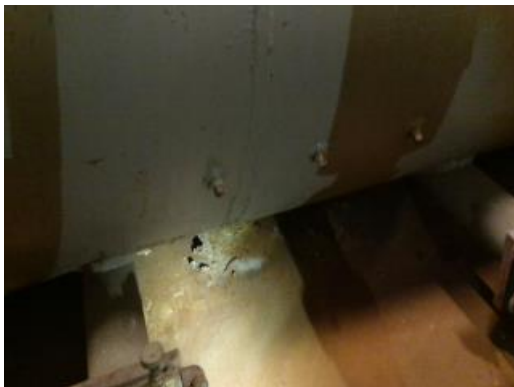
Leakage And Corrosion At Steam Condensate Receiver

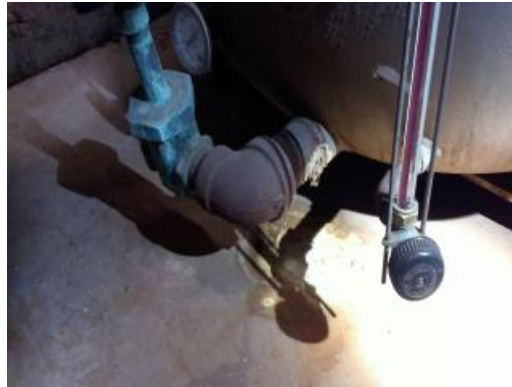
Leakage And Corrosion At Steam Condensate Receiver

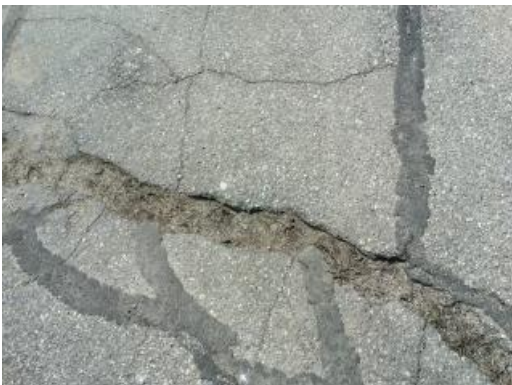
Parking Lot Damage

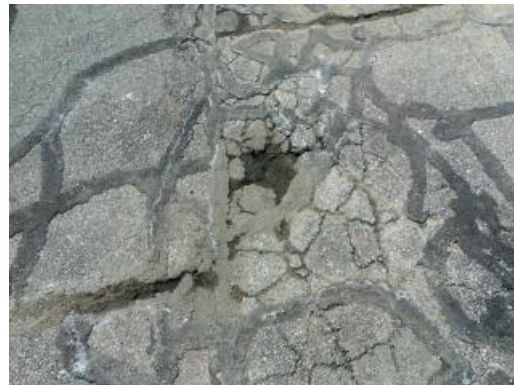
Parking Lot Damage

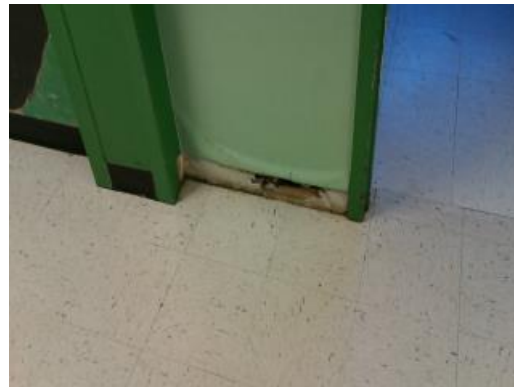
Damaged Gypsum Board

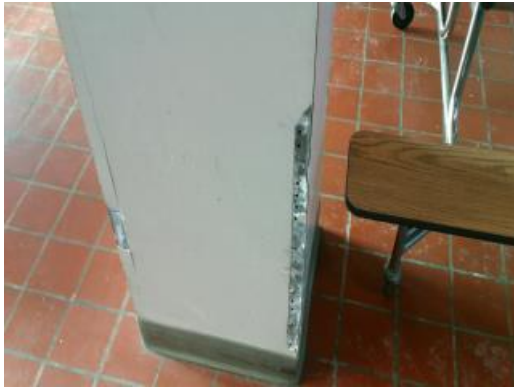
Damaged Gypsum Board

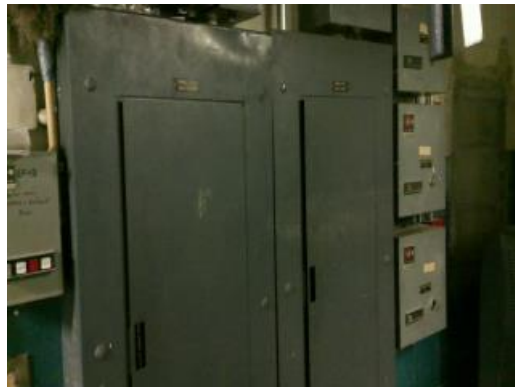
Electrical Panel Board

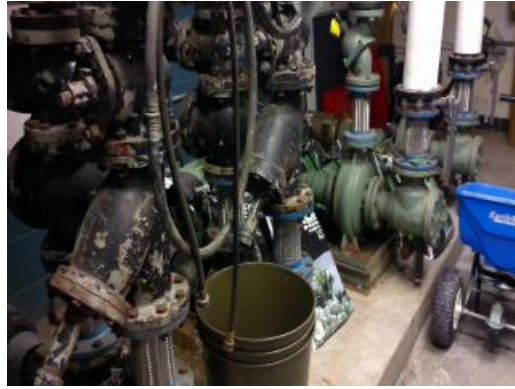
Heating Hot Water Circulating Pumps

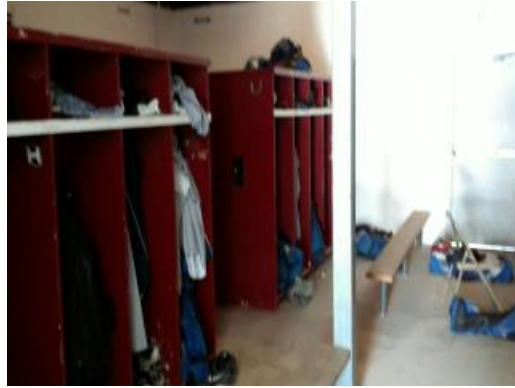
Deficiency	Category	Qty	UoM	Priority	Repair Cost	ID
The Metal Student Lockers Require Replacement	Capital Renewal	50	Ea.	4	\$26,649	8366
Note: Replace all.						
	Sub Total for System	1	items		\$26,649	
	Sub Total for Building 02 - Field House	5	items		\$126,151	
	Total for Campus	43	items		\$2,956,163

Field House Lockers
