Exeter-West Greenwich totals 309,120 square feet and consists of the school type(s) detailed below. School(s) were visited three times during the Statewide Facilities Assessment by teams of specialists in March 2016. This report provides LEA summary findings for the statewide assessment program.

# Exeter-West Greenwich

# Facility Condition Assessment

Exeter-West Greenwich - Exeter-West Greenwich Regional High School

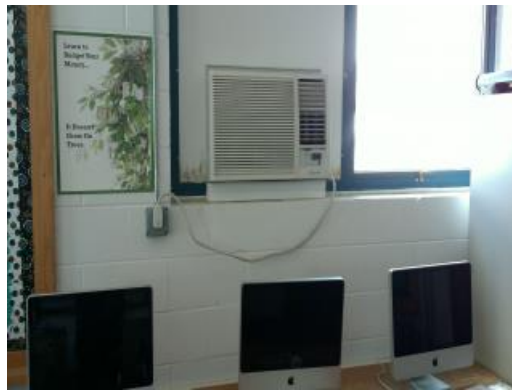
Main Building - Window AC Unit

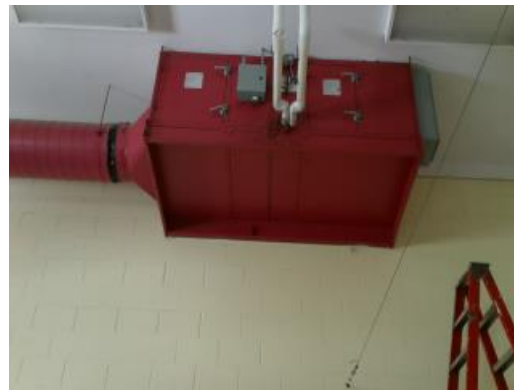
Main Building - Make-up Air Unit

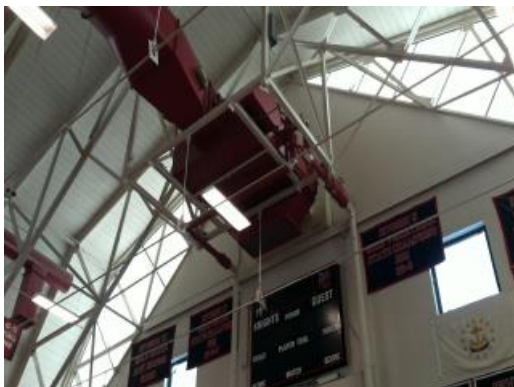
Main Building - Make-up Air Unit

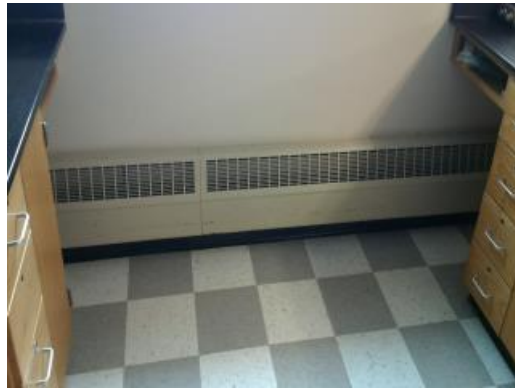
Main Building - Radiant Heaters

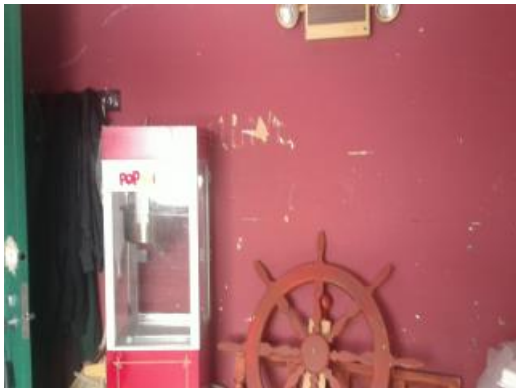
Main Building - Chipped Wall Paint

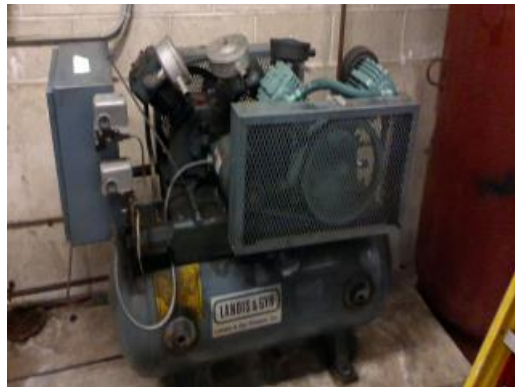
Main Building - Compressor

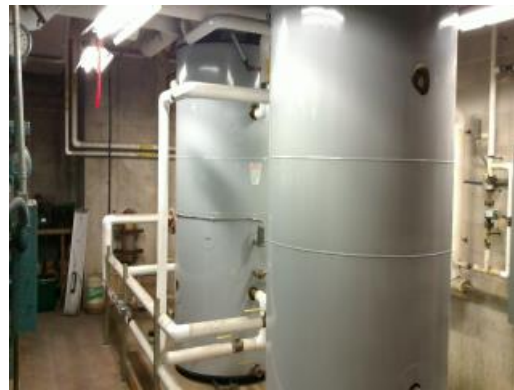
Main Building - Hot Water Storage Tanks

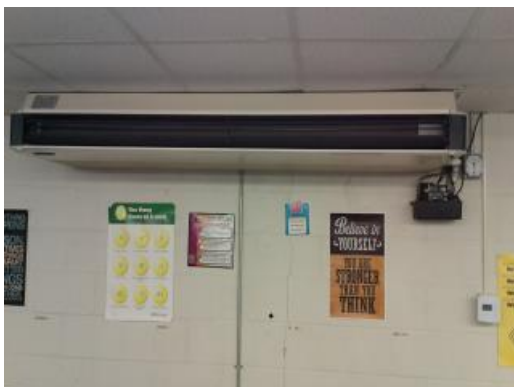
Main Building - Fan Coil

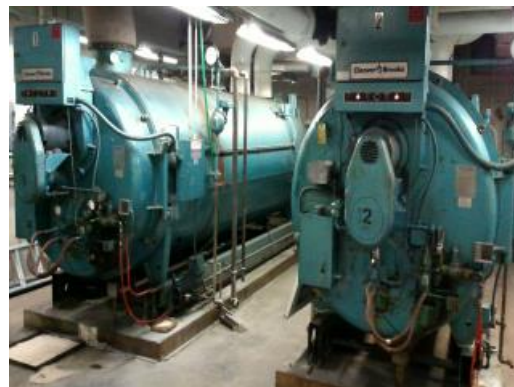
Main Building - Boilers

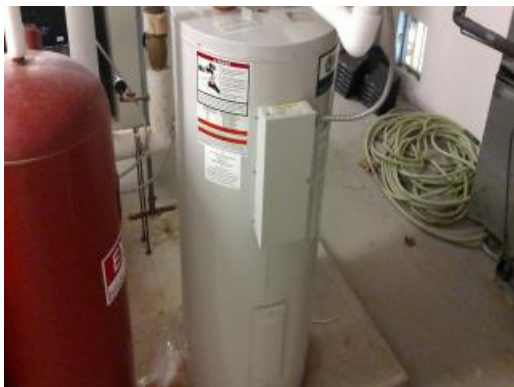
Building 02 - Water Heater

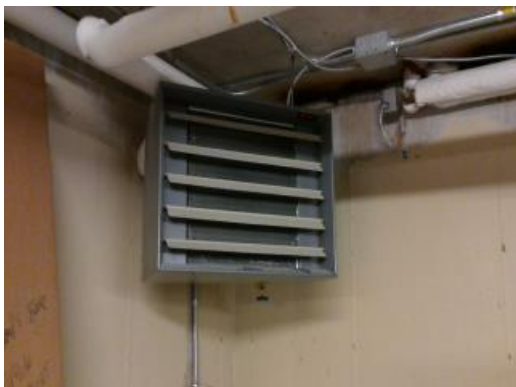
Building 02 - Hot Water Unit Heater

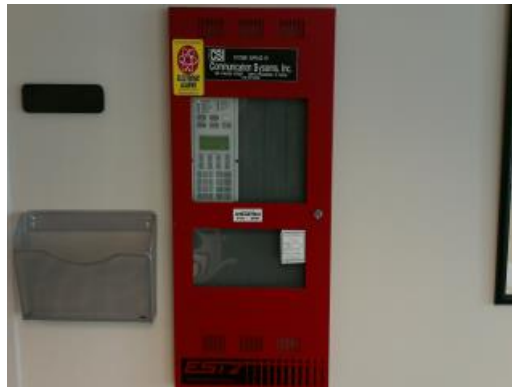
Building 02 - Electronic Alarm System

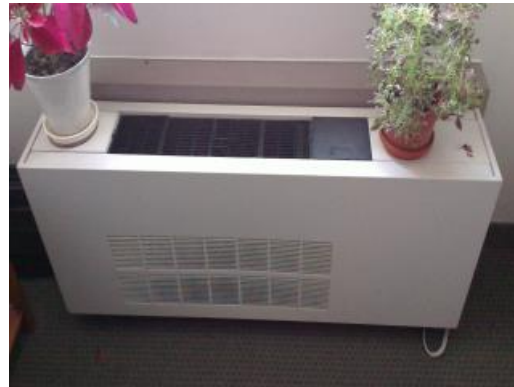
Building 02 - Unit Ventilator

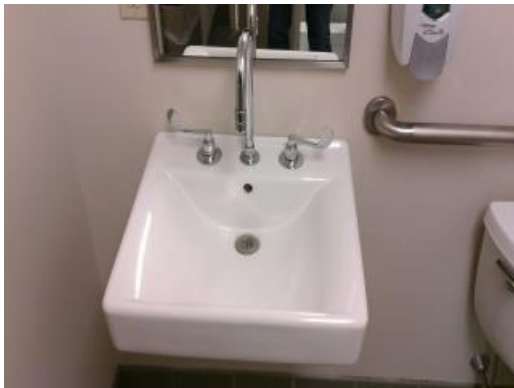
Building 02 - Typical Restroom Finish

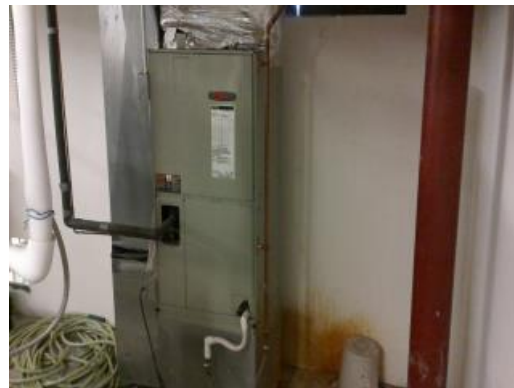
Building 02 - Air Handling Unit

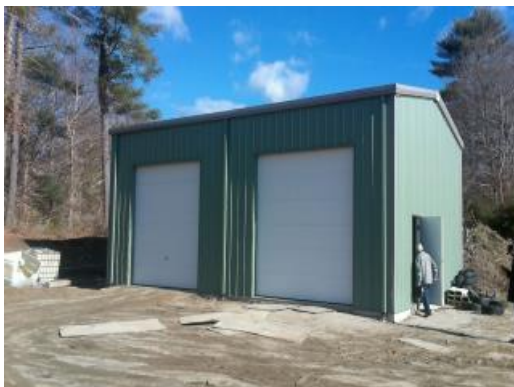
Building 03 - Exterior Elevation

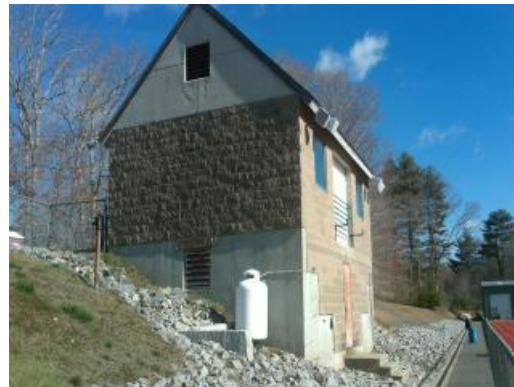
Building 04 - Pump House

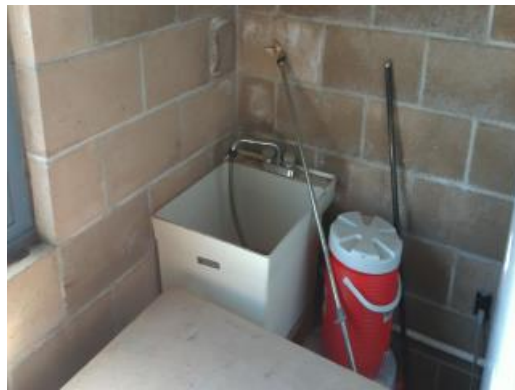
Building 04 - Mop Sink

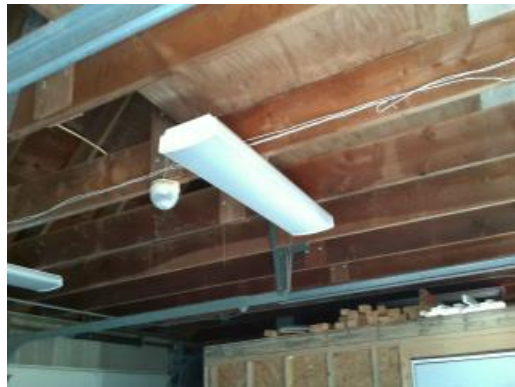
Building 04 - Typical Light Fixture

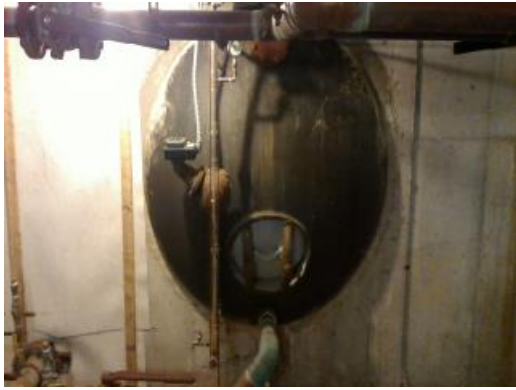
Building 04 - Domestic Water Storage Tank

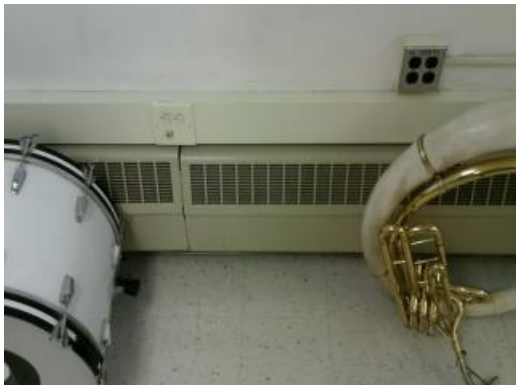
Main Building - Radiant Baseboards

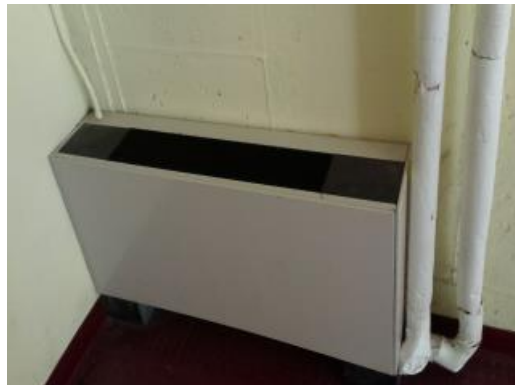
Main Building - Classroom Unit Heater

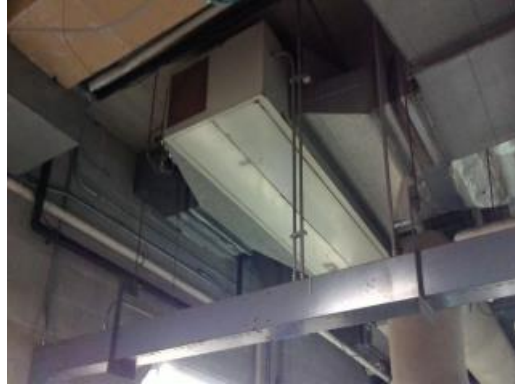
Main Building - Ducted Ceiling Hung Unit Heater

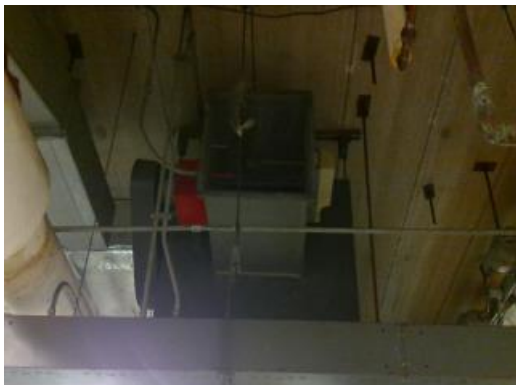
Make-up Air Unit

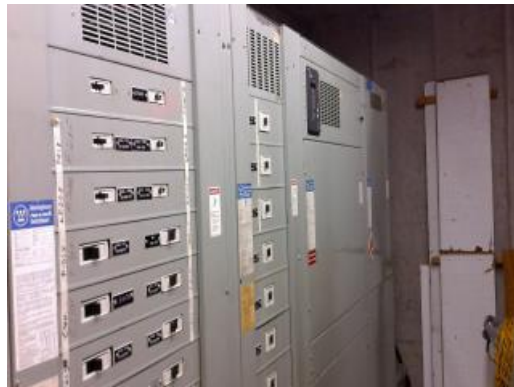
Main Electrical Service

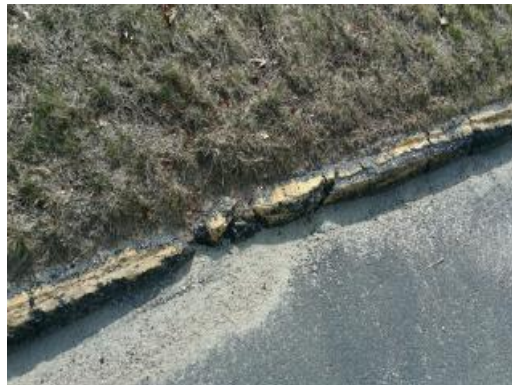
Damaged Asphalt Curbs

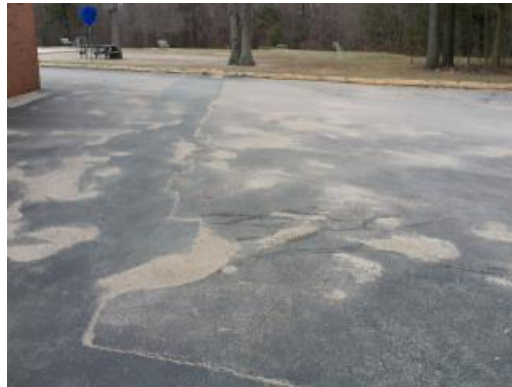
Worn Asphalt Paving

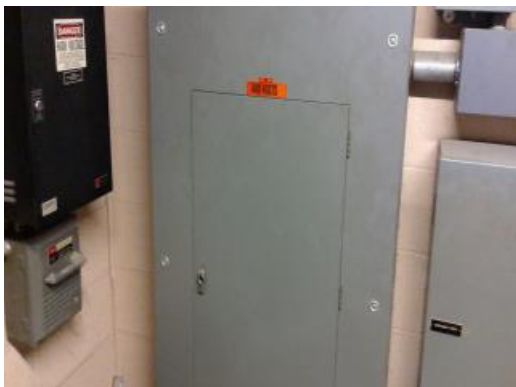
Federal Pacific Panelboard

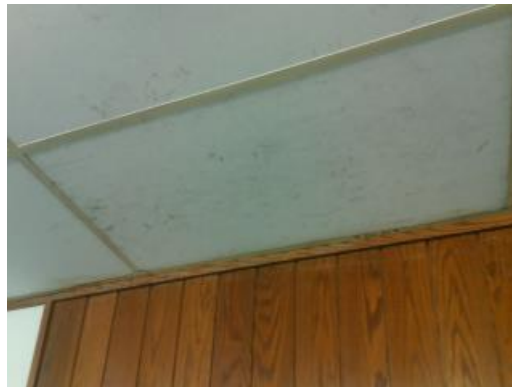
Rusting Ceiling Grid

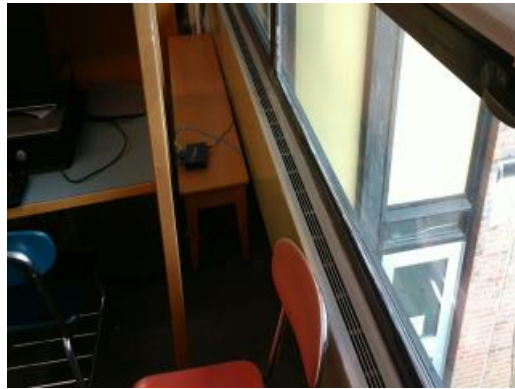
Original Radiant Heater

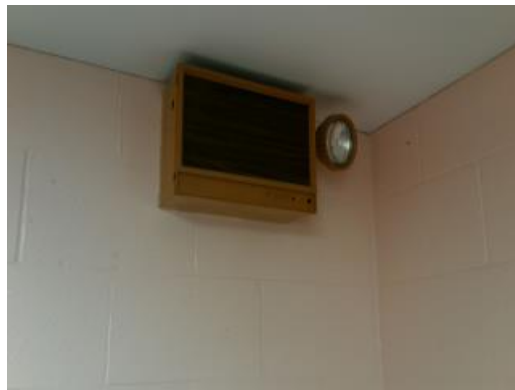
Original Battery Backup Lights

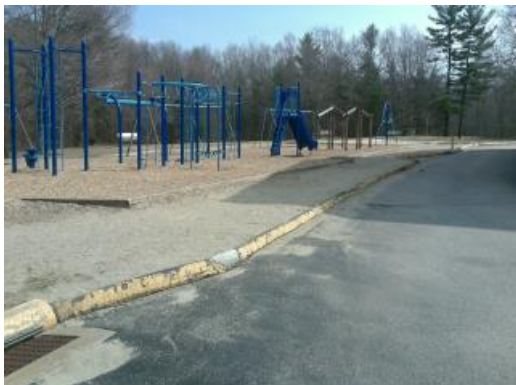
No ADA Playground Access

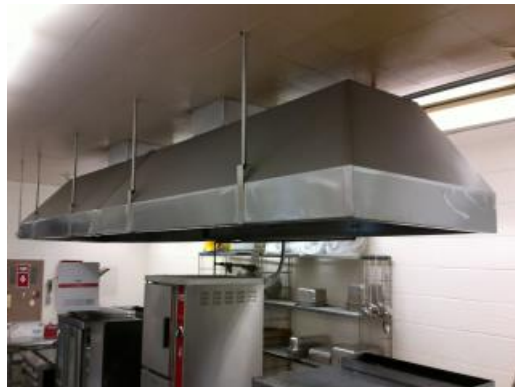
Original Kitchen Exhaust Hood

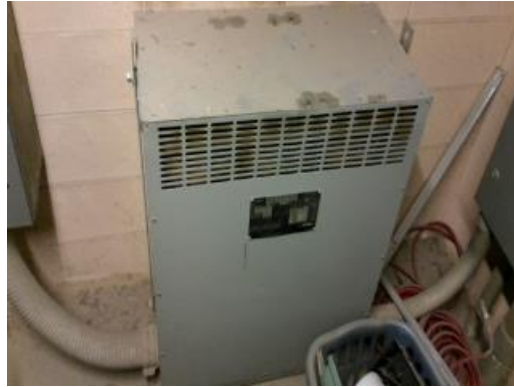
Federal Pacific Transformer

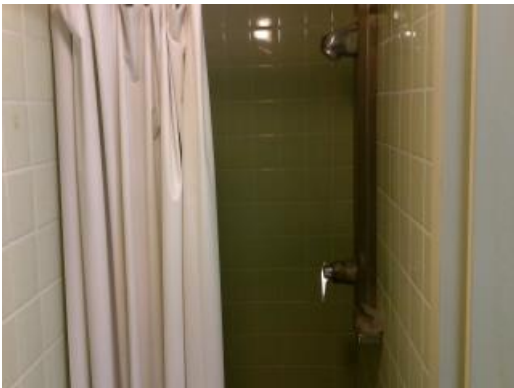
Original Shower Fixture

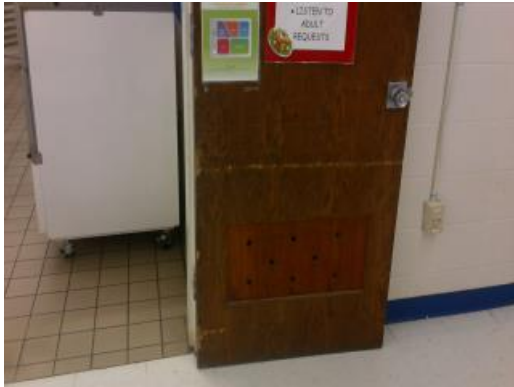
Worn Kitchen Door

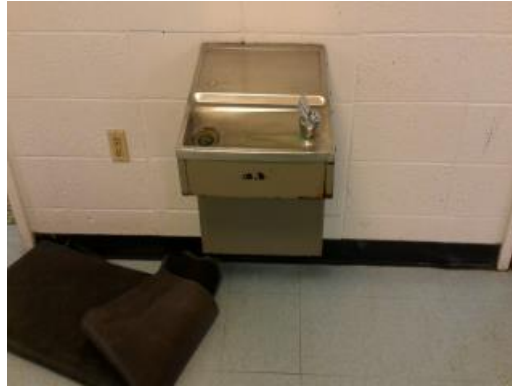
Damaged Refrigerated Drinking Fountain

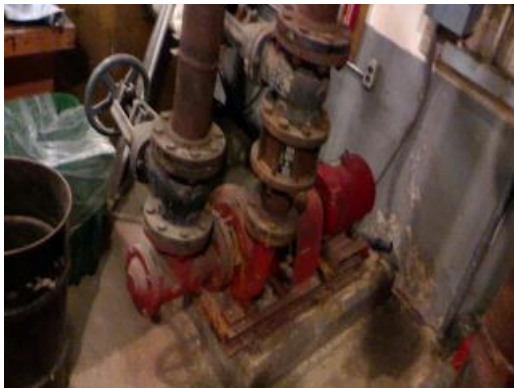
Original Heating Hot Water Pumps

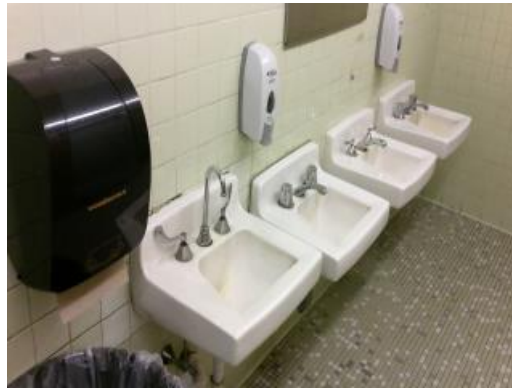
Original Restroom Lavatories

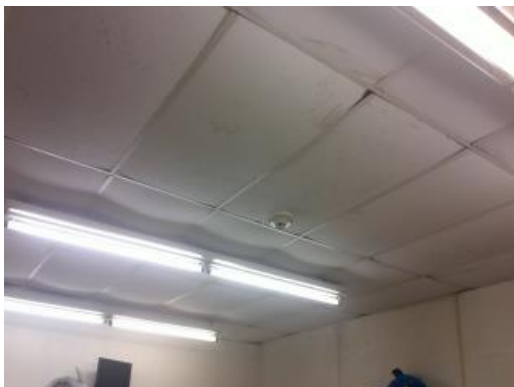
Sagging Ceiling Tiles

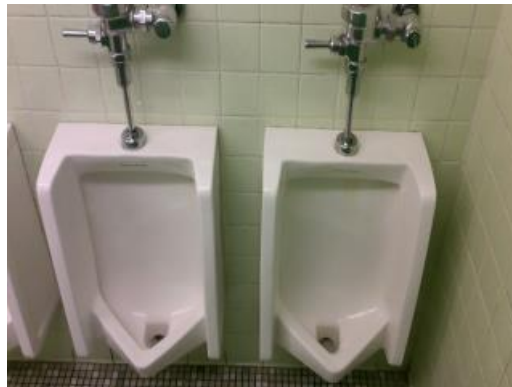
Original Urinal Fixtures

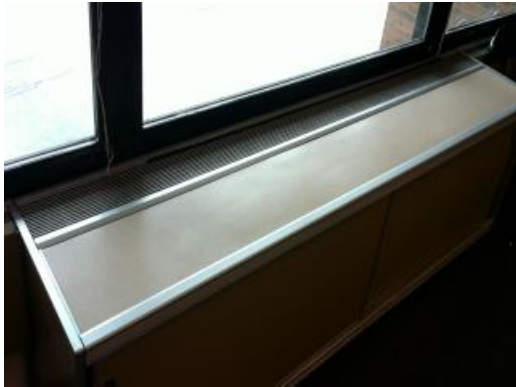
Original Heating Unit

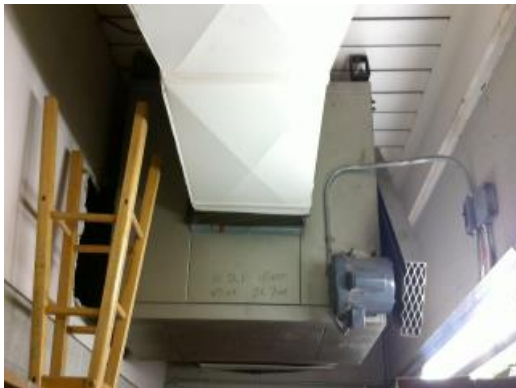
Original Make-up Air Unit

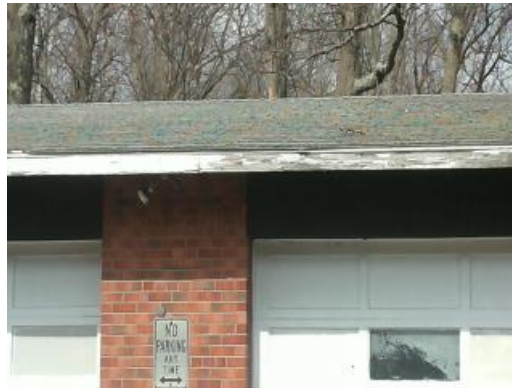
Deteriorating Shingle Roof

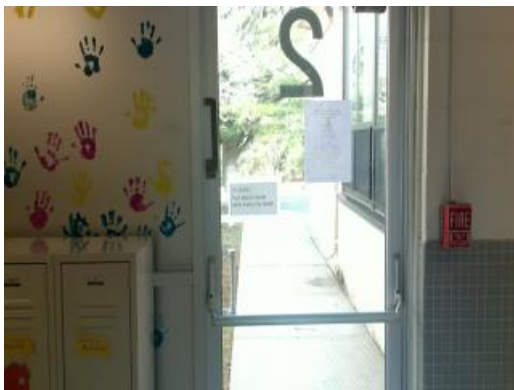
Exterior Door Not Closing Properly

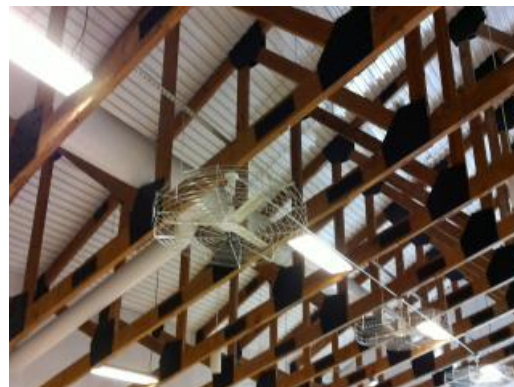
Cafeteria Exposed Ceiling

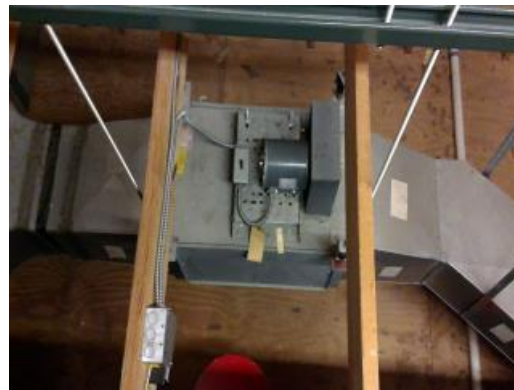
Exhaust System Ventilator For New Wing 4X
