Facility Condition Assessment

June 2017

Charter - Highlander Charter School - Lower School (Providence)

Charter - Highlander Charter School - Upper School (Warren)

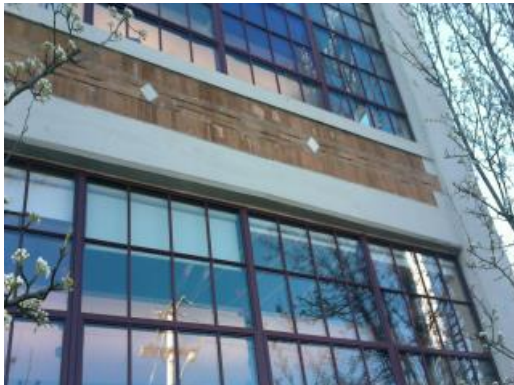
Exterior Brick Walls Require Repointing

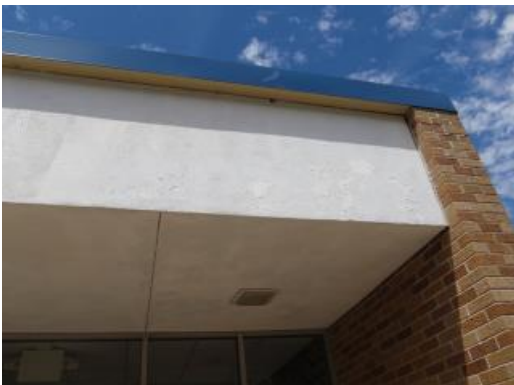
Chipped Stucco Paint
