# South Kingstown

# Facility Condition Assessment

Academic Success Academy, located at 153 School Street in Wakefield, Rhode Island, was built in 1920. It comprises 26,503 gross square feet. Each school across the district was visited three times during the Facility Condition Assessments by three teams of specialists in the spring/summer of 2016.

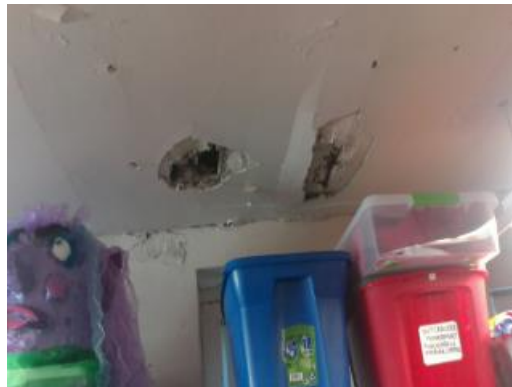
Holes In Gypsum Board Ceiling

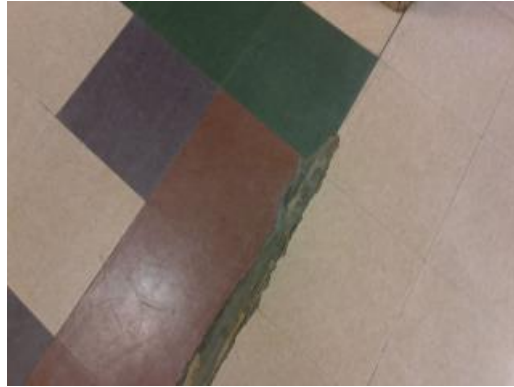
Chipped VCT Flooring

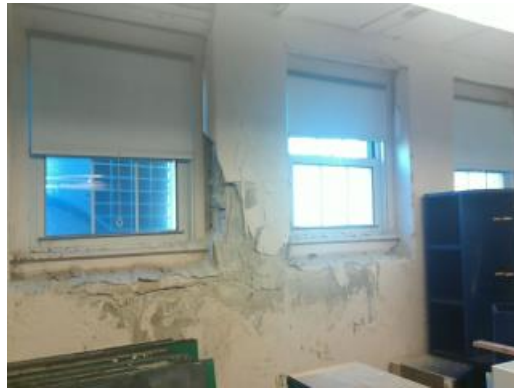
Water Damaged Basement Wall

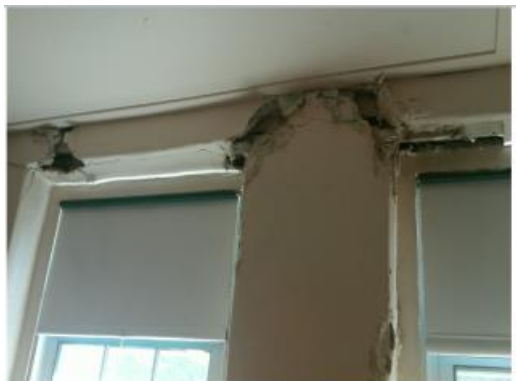
Water Damage At Basement Windows

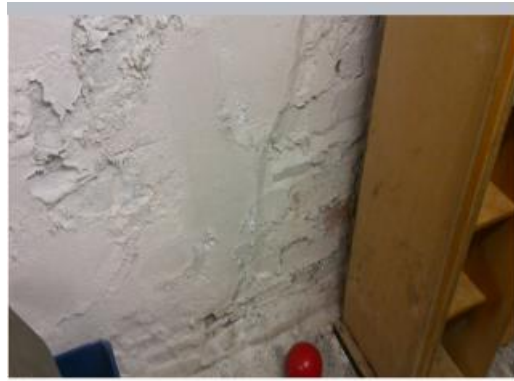
Damaged Basement Wall

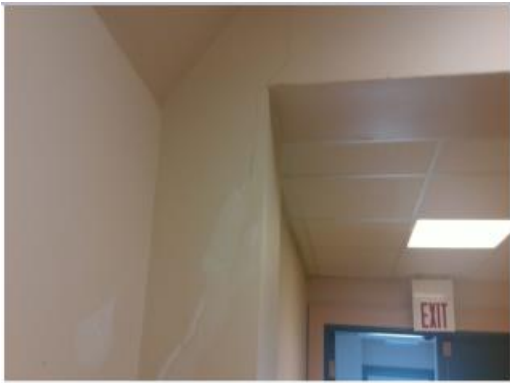
Crack At Stairwell Wall

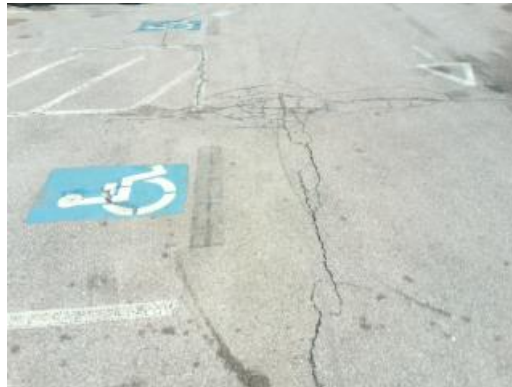
Cracked Parking Lot Pavement

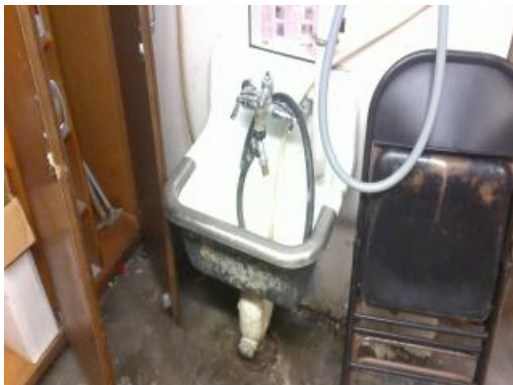
Rusted And Leaking Custodial Sink

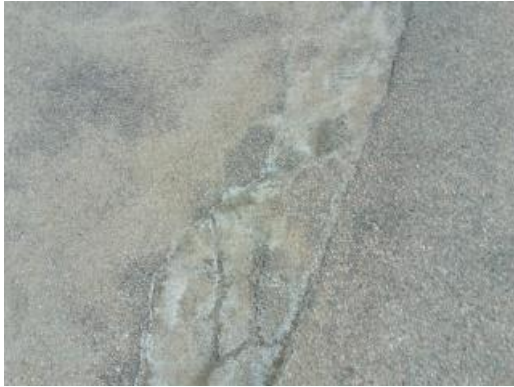
Cracked Asphalt Paving

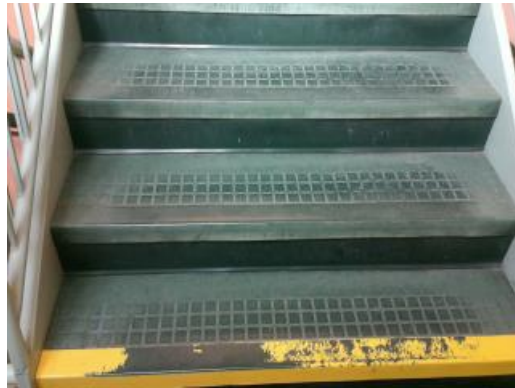
Worn Stair Treads

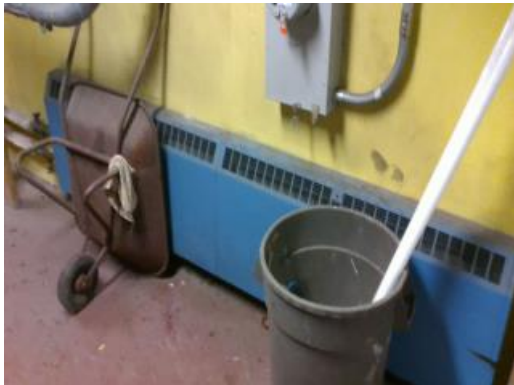
Aged Heating Unit

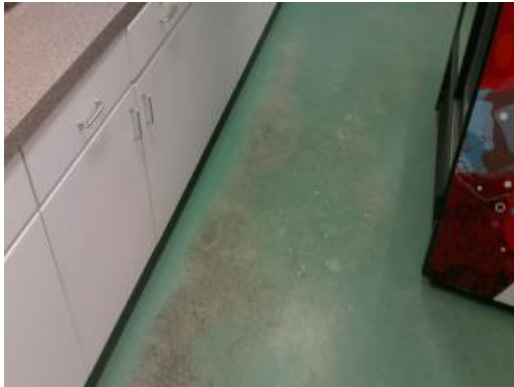
Worn Floor Coating

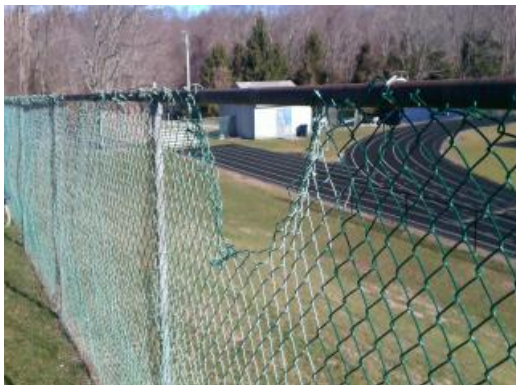
Damaged Chain Link Fence

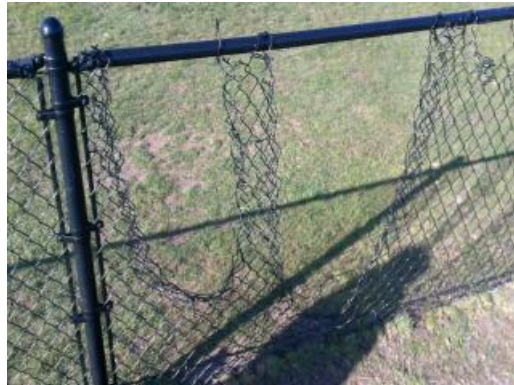
Damaged Chain Link

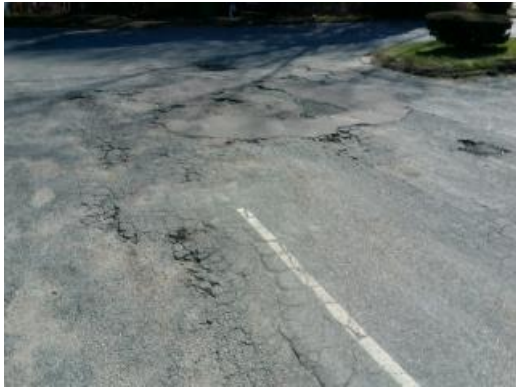
Alligatored And Patched Asphalt Parking

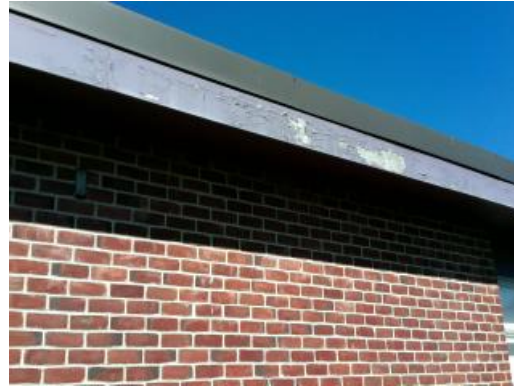
Peeling Exterior Paint

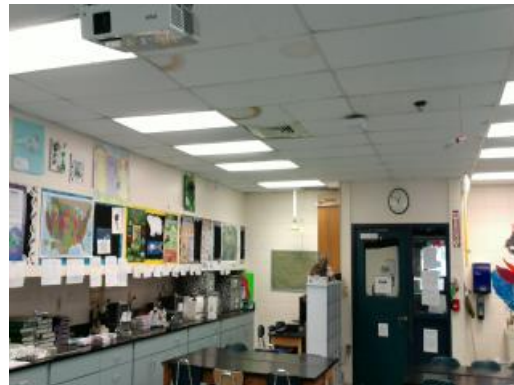
Stained And Broken Ceiling Tiles

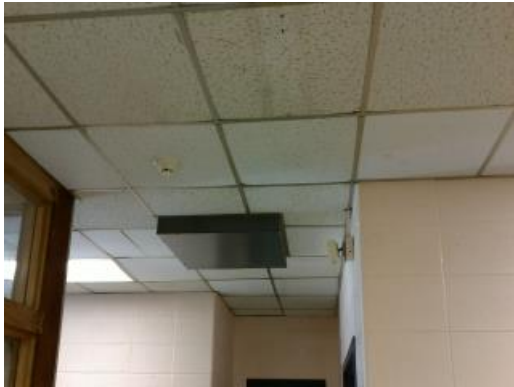
Stained Ceiling Grid

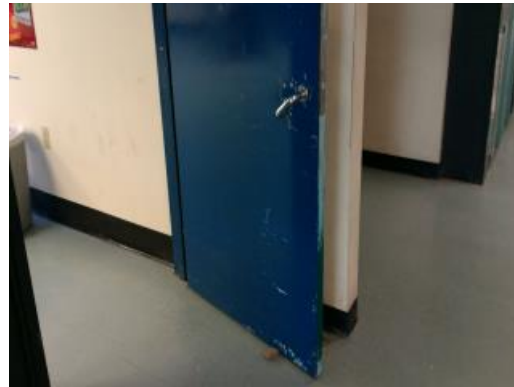
Scratched Door Paint

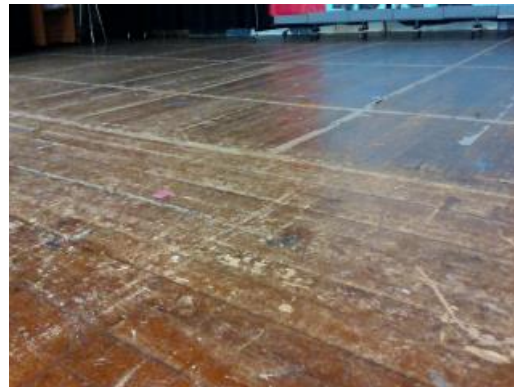
Worn Wood Floor At Stage

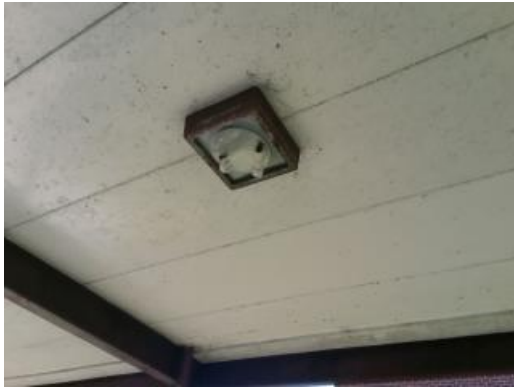
Damaged Canopy Light

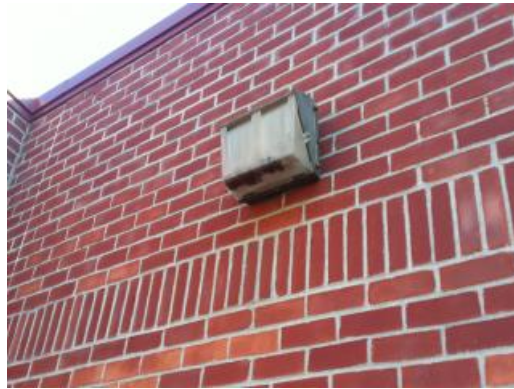
Aged Building Mounted Light

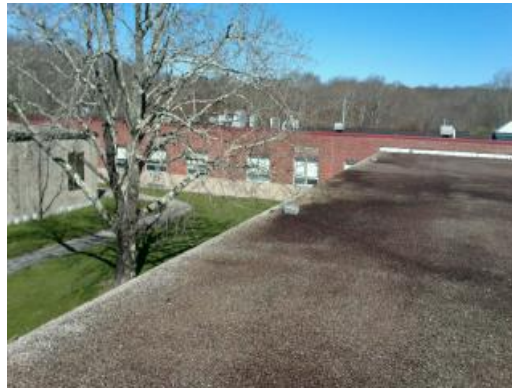
Evidence Of Ponding On Roof

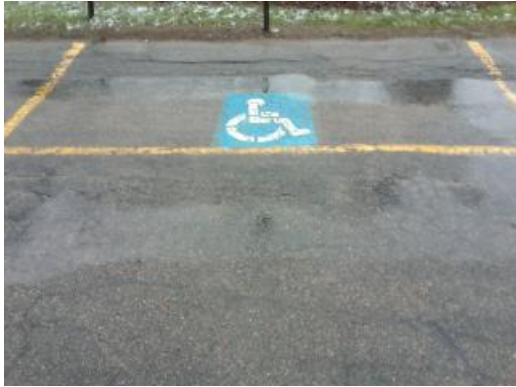
Cracked And Worn Parking

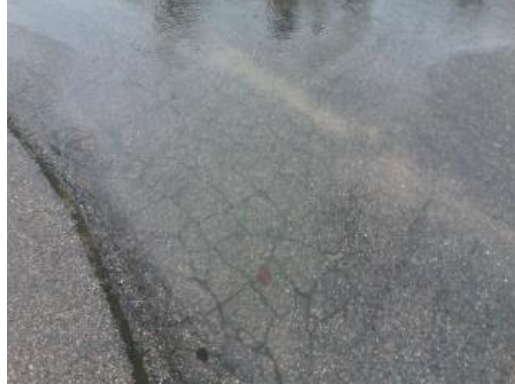
Alligatored Parking Lot Paving

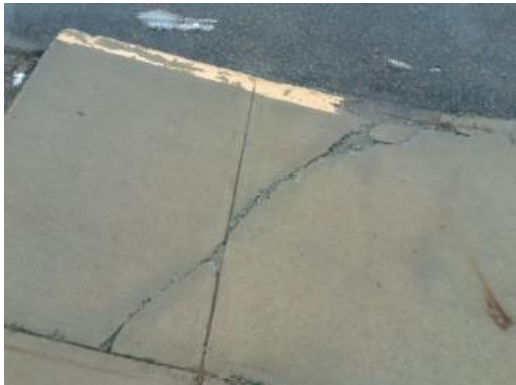
Cracked Concrete Walkway

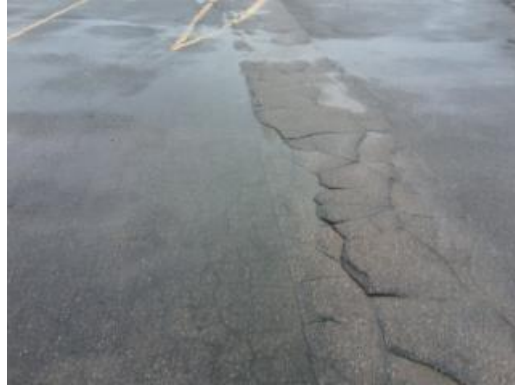
Sinking And Cracking Pavement

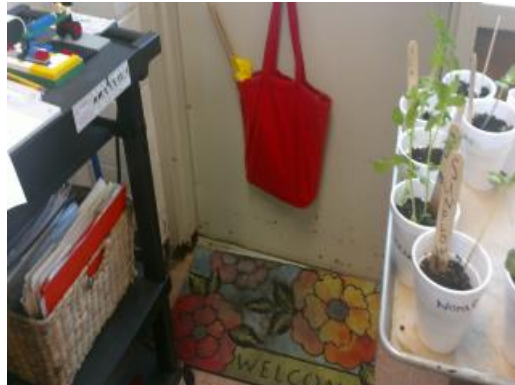
Exterior Door Rusting

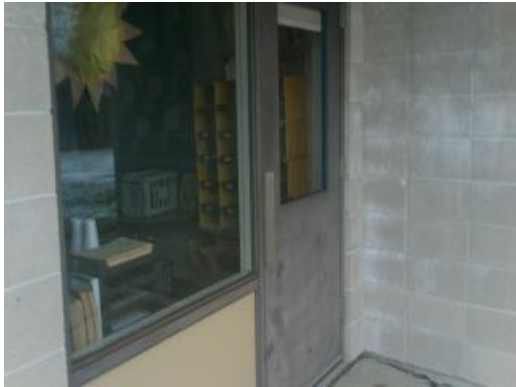
Faded And Worn Exterior Door

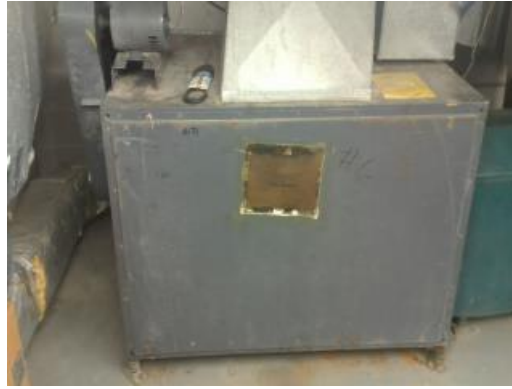
Aged Air Handling Unit

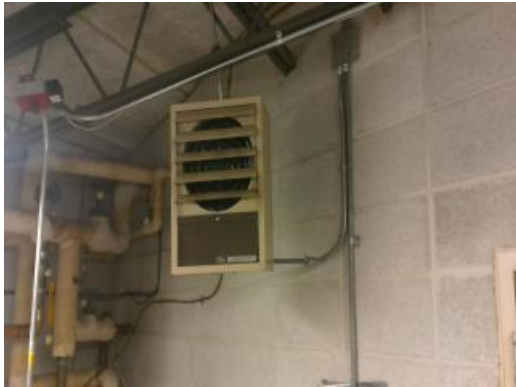
Non-Functional Electric Unit Heater

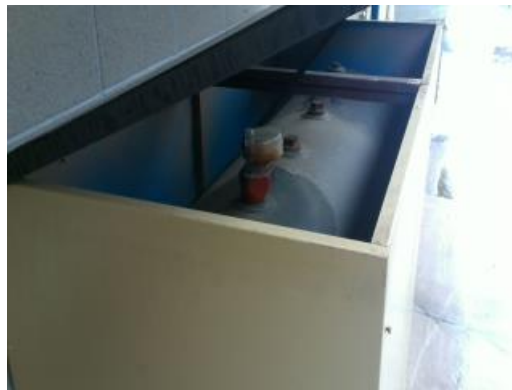
Aged Fuel Storage Tank

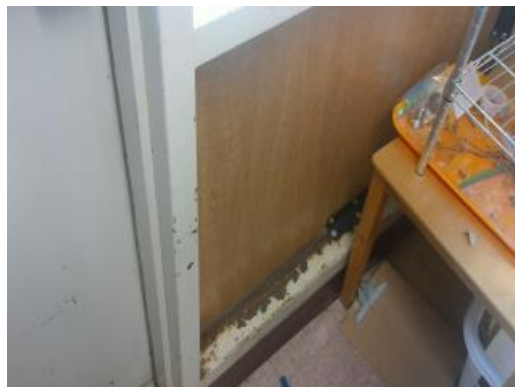
Rusted Window Frame

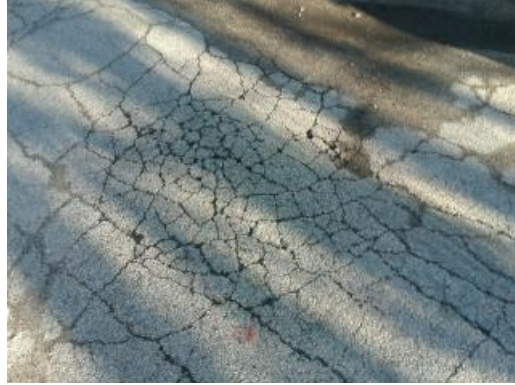
Parking Alligator Cracking

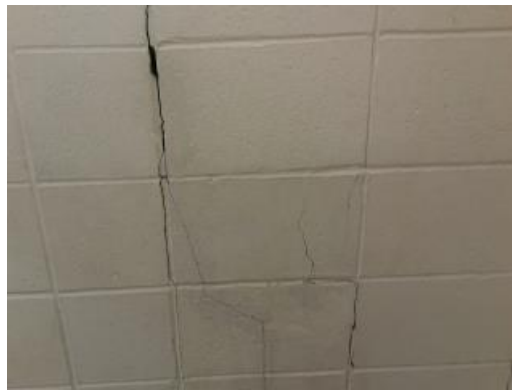
Southwest Basement Stairway Crack

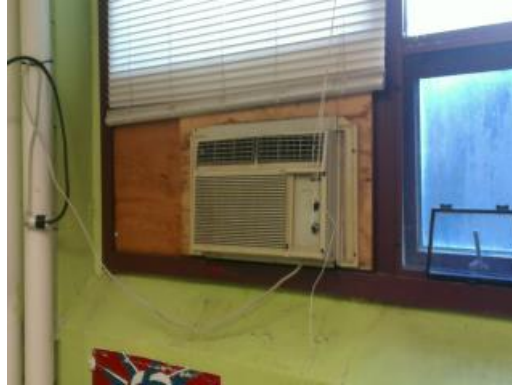
Failing Window Unit

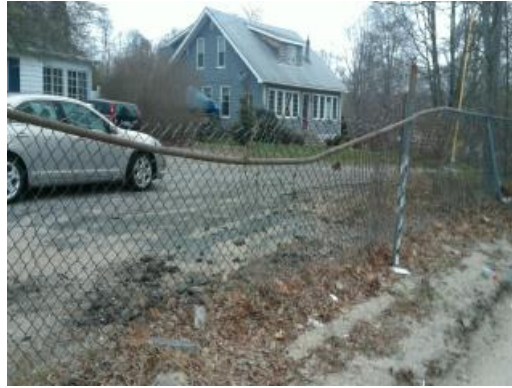
Rusted And Falling Fence

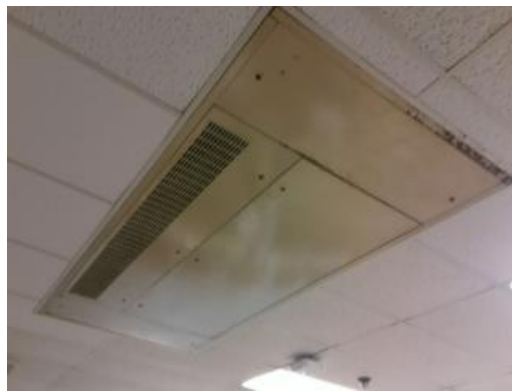
Rusted And Molding Split System

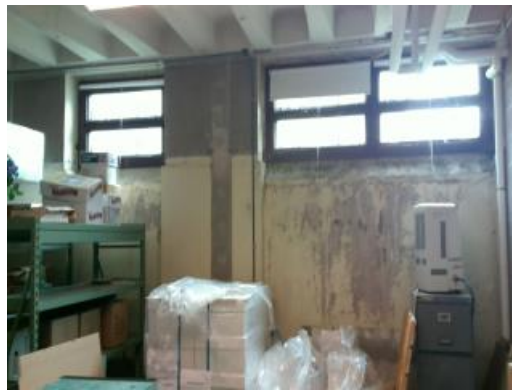
Peeling Paint In Storage

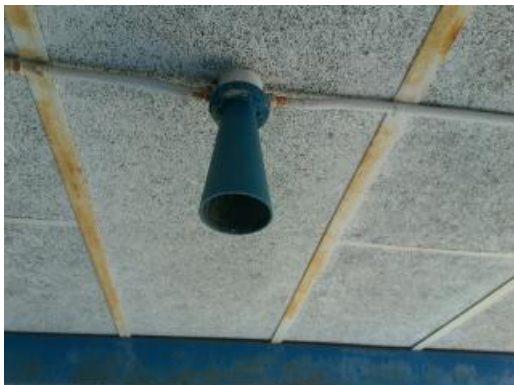
Non-Functional Canopy Light

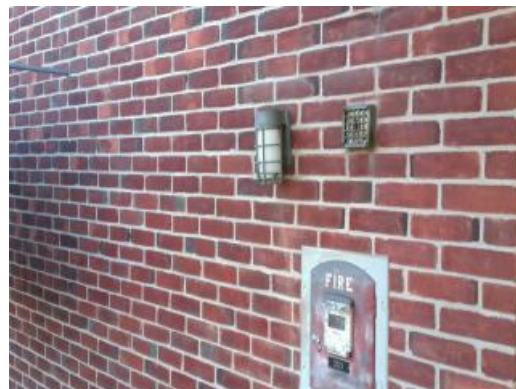
Aged Building Mounted Light

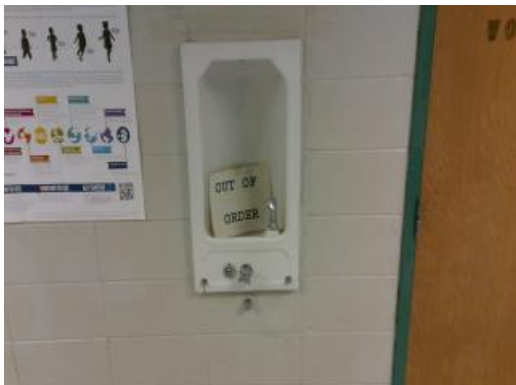
Non-Functional Drinking Fountain

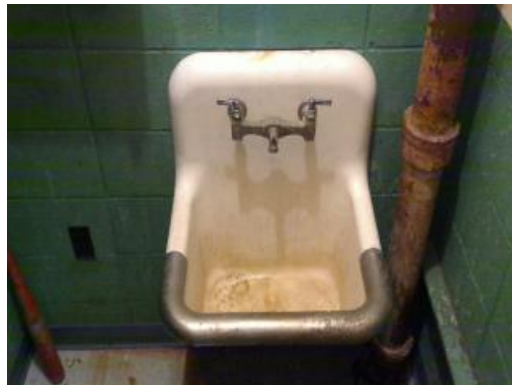
Stained Service Sink

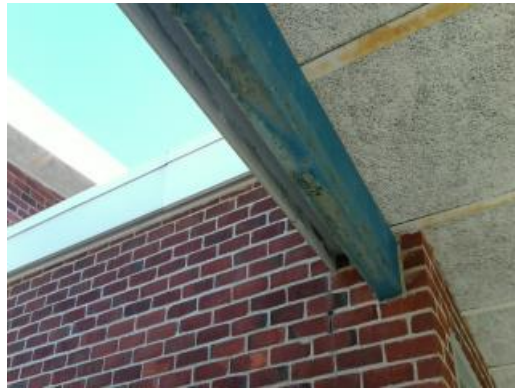
Paint Peeling At Canopies

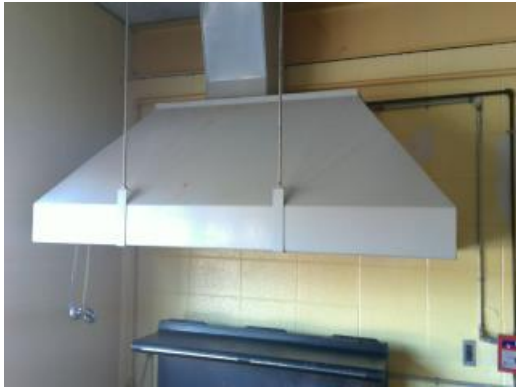
Rusting Kitchen Hood

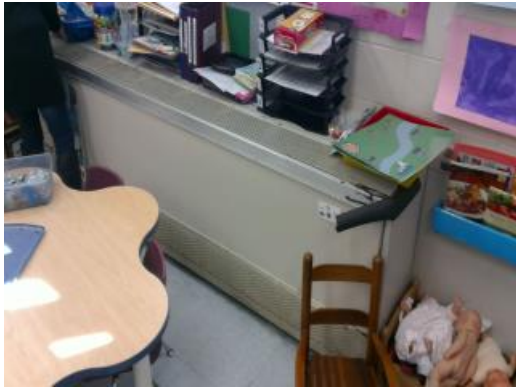
Unit Vent Heater Coils Clogged

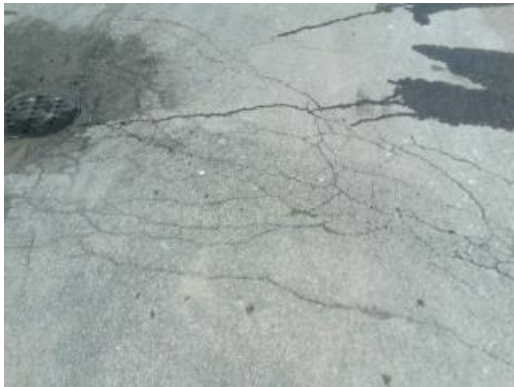
Cracked Parking Lot Asphalt

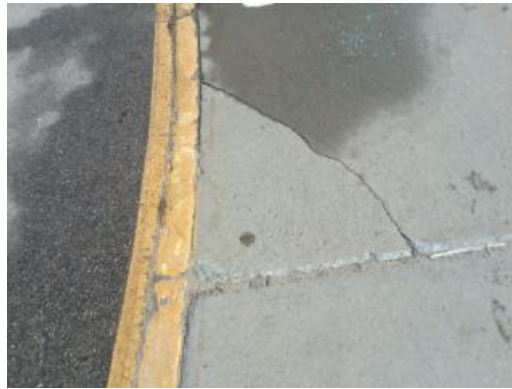
Cracked Concrete Walkway

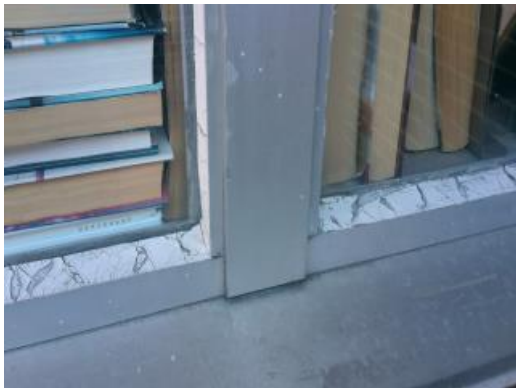
Failed Caulking At Windows

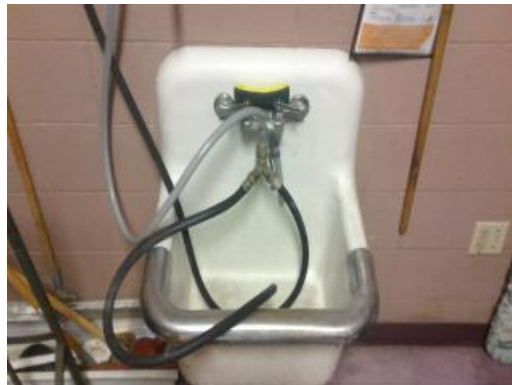
Stained Custodial Sink

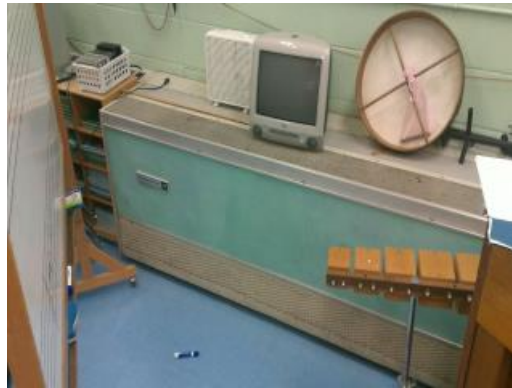
Damaged Heating Unit

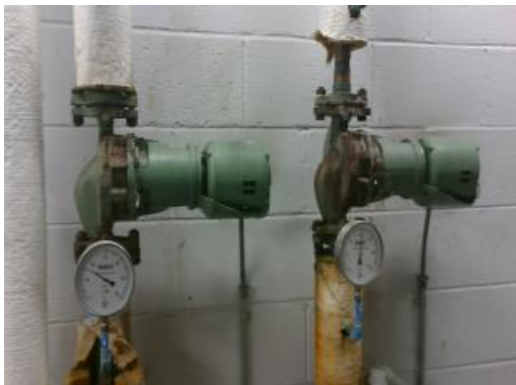
Aged Heating Unit

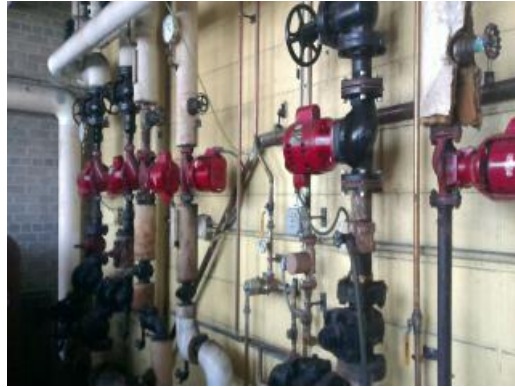
Pumps Rusted And Leaking - Old Section

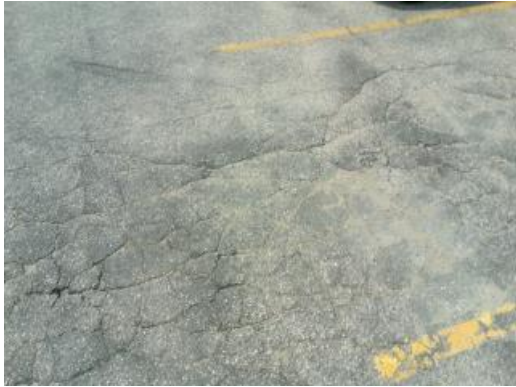
Alligatored Parking Pavement

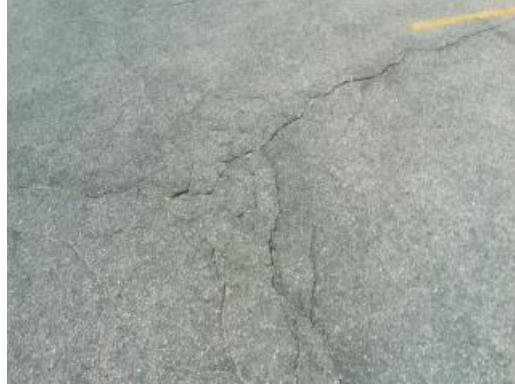
Splitting Asphalt Pavement

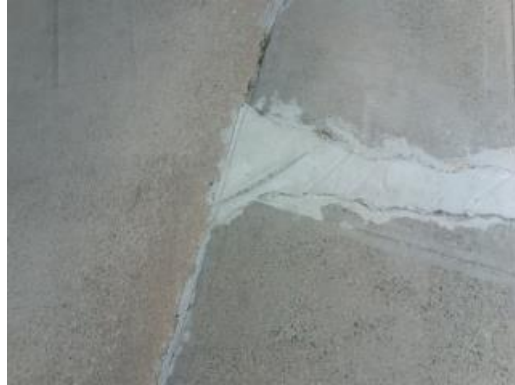
Cracked Concrete Walkway

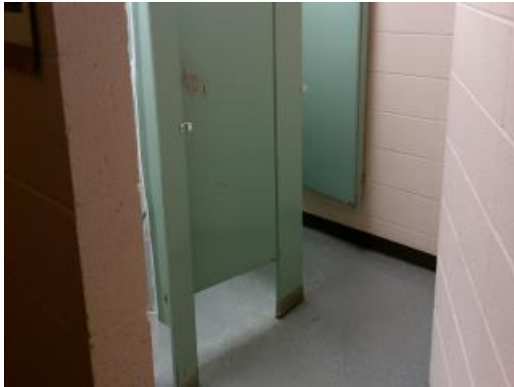
Faculty Restroom With No ADA

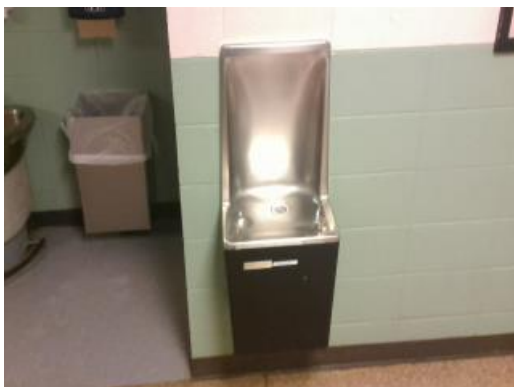
Drinking Fountain With Non-Functional Compressor

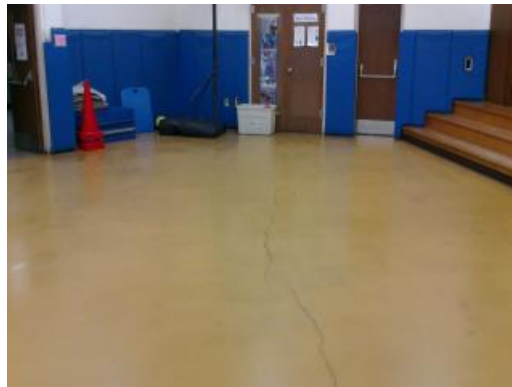
Cracked Gym Floor

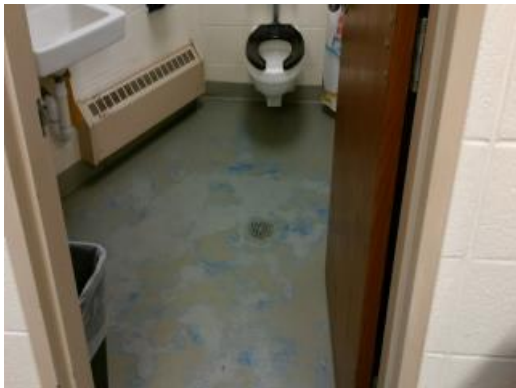
Worn Epoxy At Restroom

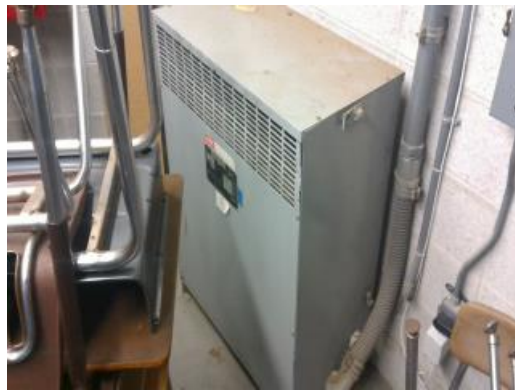
Federal Pacific Transformer

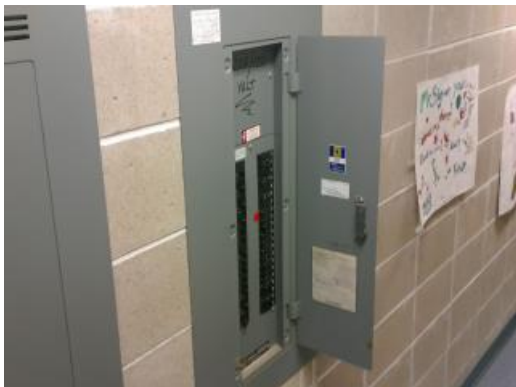
Federal Pacific Panelboard

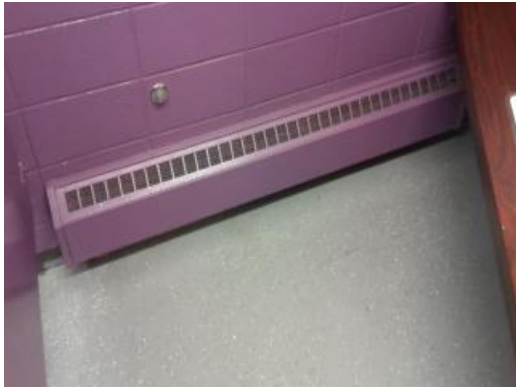
Aged Radiant Heater

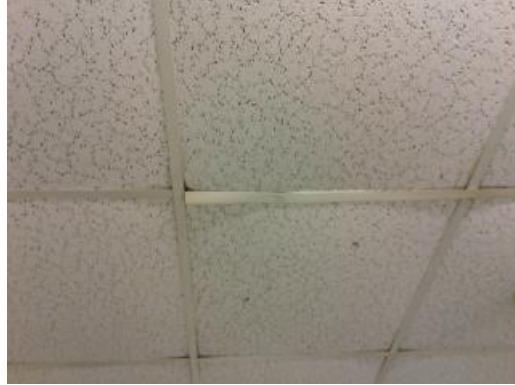
Broken Ceiling Grid

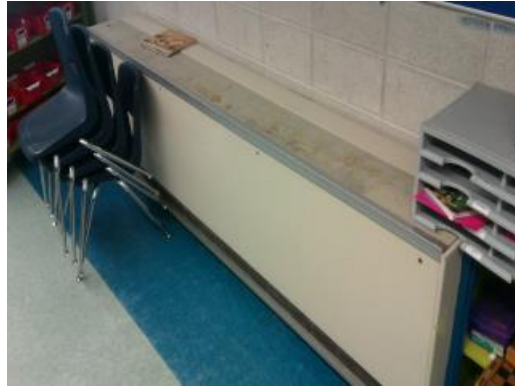
Aged Heating Unit

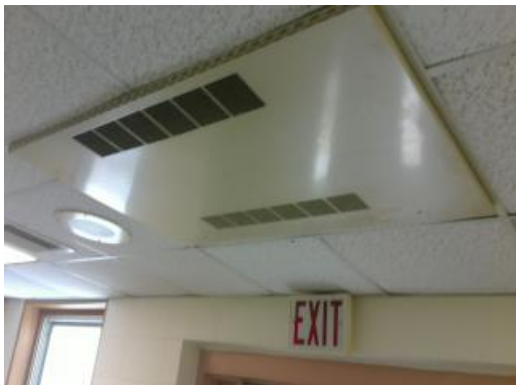
Heating Unit Vent

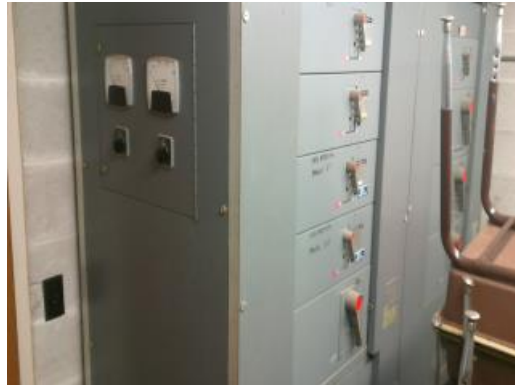
Federal Pacific Switchgear
