# Facility Condition Assessment

Bristol Warren - Mt. Hope High School

June 2017

199 Chestnut Street, Bristol, RI 02809

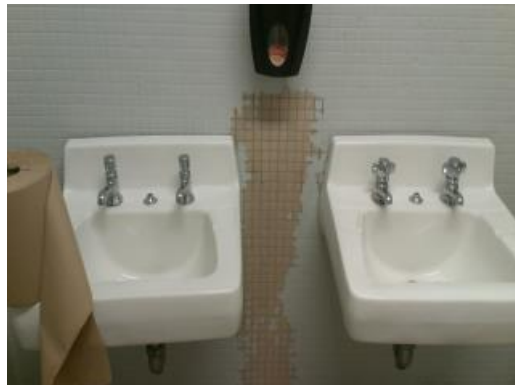
Peeling Wall Paint

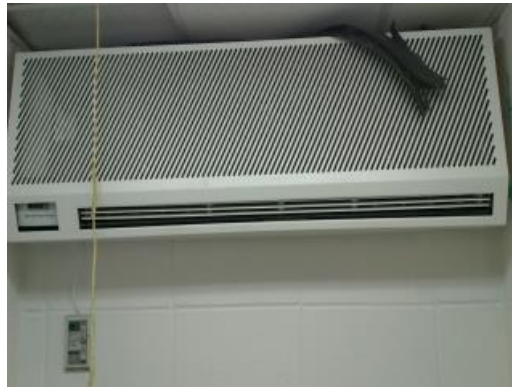
Aged Fan Coil Unit

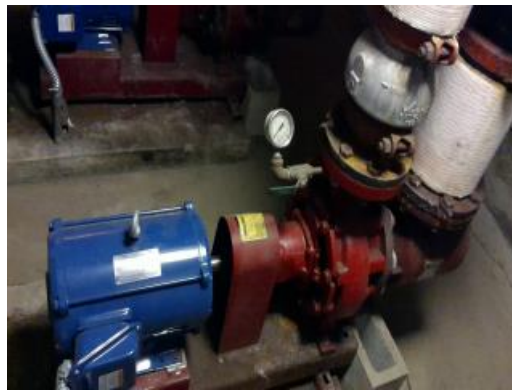
10 HP Circulating Pump

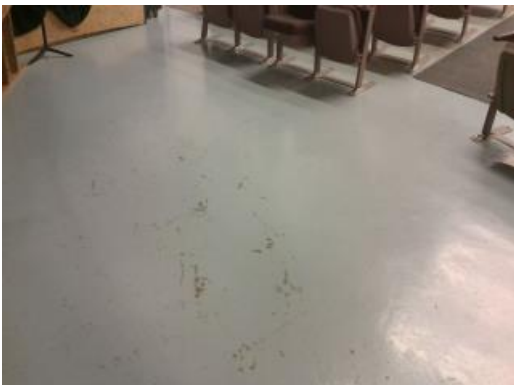
Chipped Paint On Auditorium Floor
