Facility Condition Assessment

Cumberland - Cumberland High School

June 2017

2600 Mendon Road, Cumberland, RI 02864

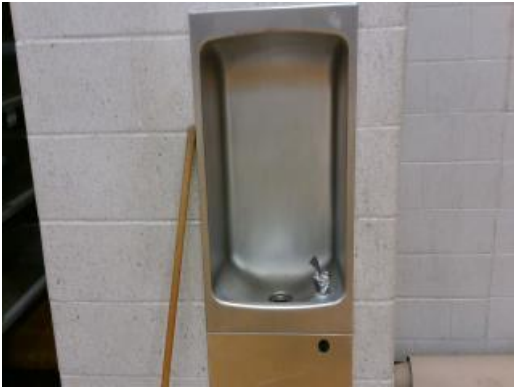
Typical Drinking Fountain

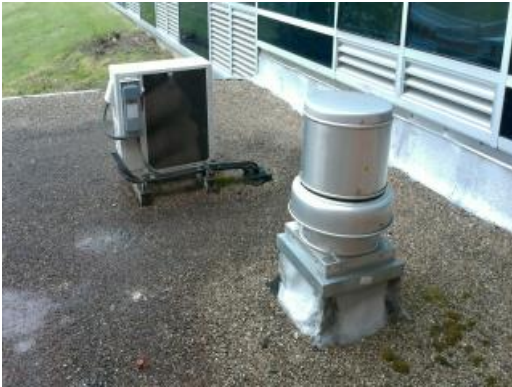
Condensing Unit And Exhaust Fan
